Our Ref: 1712/DJB/BB

18 March 2024

**DETAILED SEISMIC ASSESSMENT OF GLASSWORKS BUILDING  
AT BREMNESS ROAD, ASHBURTON**

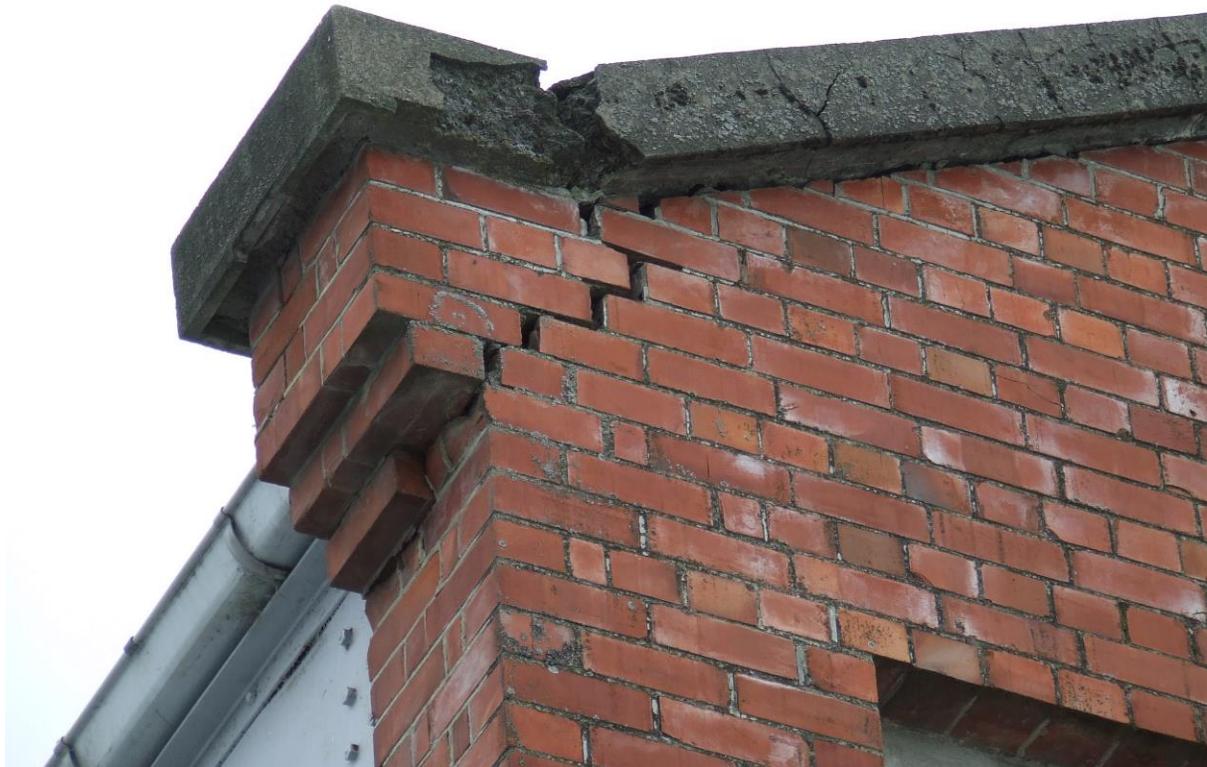
- (ii) Building 1 grid 1H – a diagonal crack approximately 5mm wide raking downwards from the top of the west corner to the sill of the adjacent window.
- (iii) The eaves brickwork on the gable end of the main hall in building 1 (room D) has slid outwards by approximately 25mm. The coping beam has also slid along the top of the wall by the same amount. This occurs on both ends of the wall.
- (iv) A 500 long by 200 high area has spalled at the bottom of the concrete bond beam between grids 3H and 4H on building 1. At the centre of this spalling is a vertical crack approximately 3-4mm in width extending to the top of the beam.
- (v) No major distress noted on buildings 2 and 3.

Photo 9. Damage to gable end brickwork and coping on Building 1 west corner.

8. Installation of brickwork restraints on the gable end walls of the main hall.
9. Connection of existing roof structure to brick walls on grids 1 and 2.
10. Installation of fixing between the existing concrete copings and brick wall below.
11. Repair of various areas of damage.

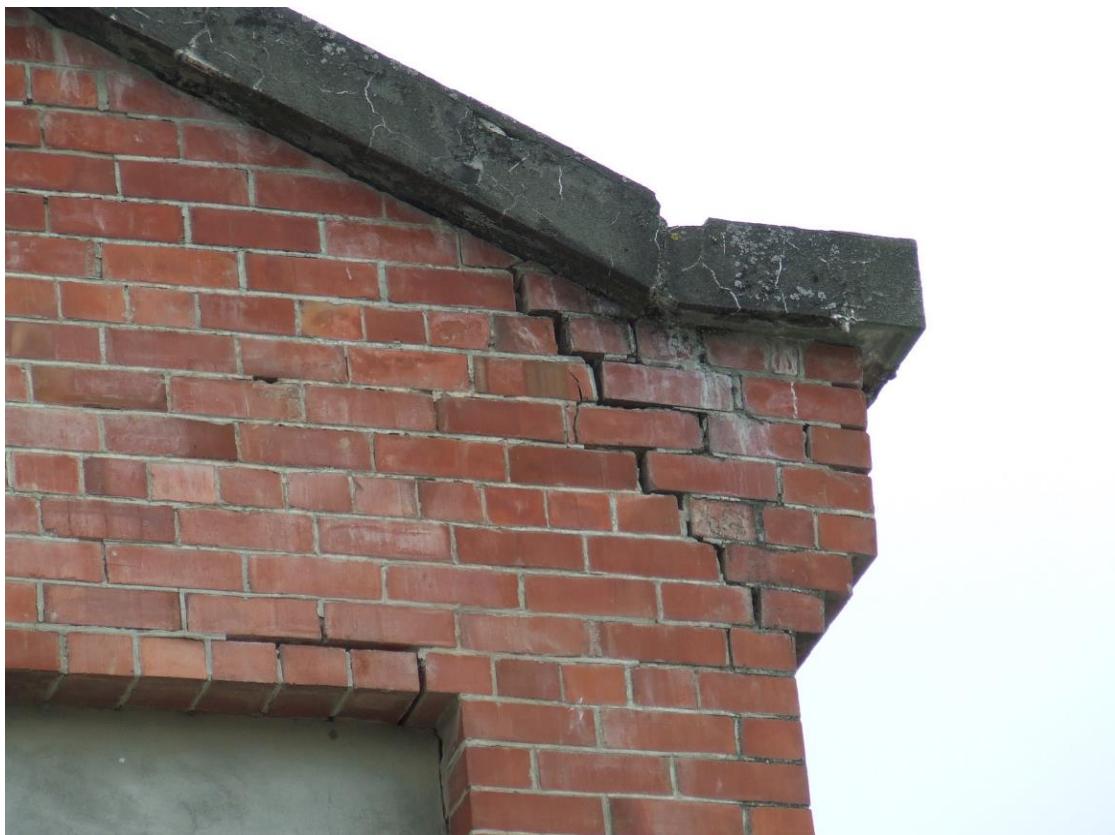
Photo 10. Eaves brickwork and coping damage on Building 1 gable end west corner.

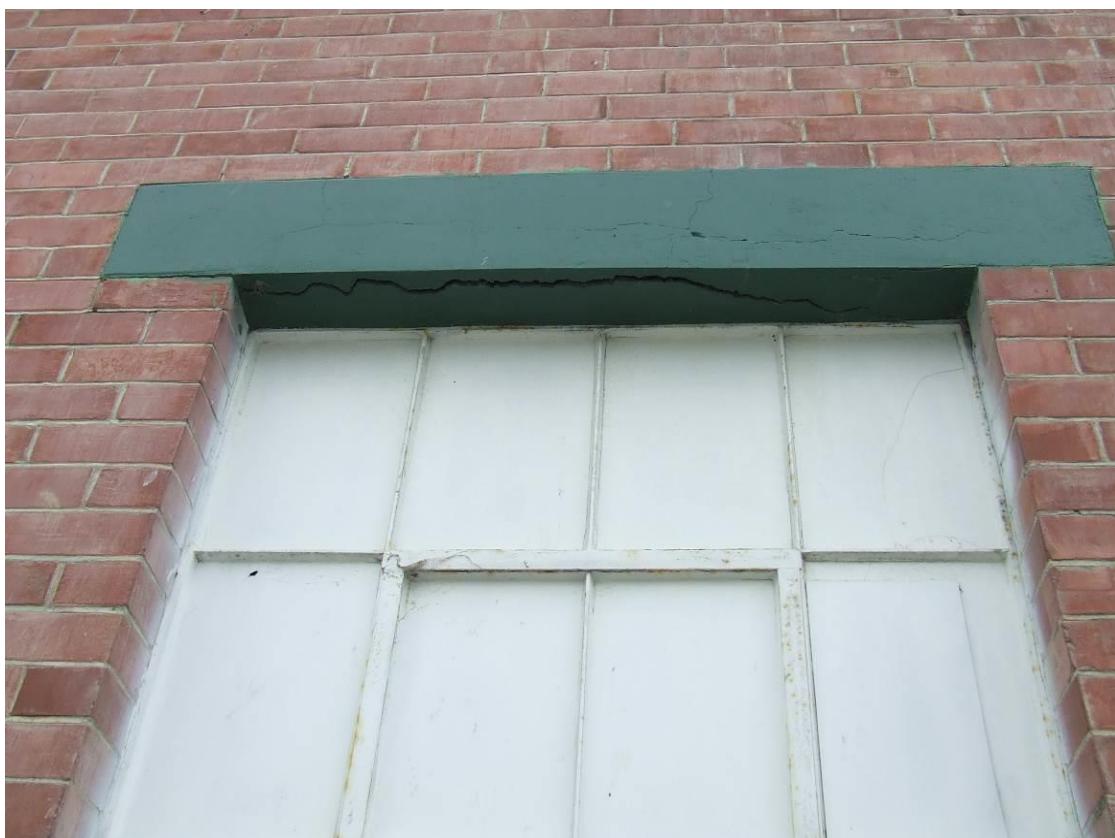
- (vi) Building 1 grid 1P – A diagonal crack approximately 3mm wide raking downwards from the top of the north corner to the sill of the adjacent window.
- (vii) The eaves brickwork on each side of the gable end of the main hall in building 1 have slid outwards by approximately 20mm. The coping beams have also slid along the top of the wall by the same amount.
- (viii) Impact damage on the brick pier on the southeast side of roller shutter door into the main hall of building 1.
- (ix) 10mm wide crack in the base of the concrete lintel above the southeast window between grids 12 to 13.

Photo 11. Lintel cracking due to reinforcement corrosion on Building 1 Northeast Elevation.

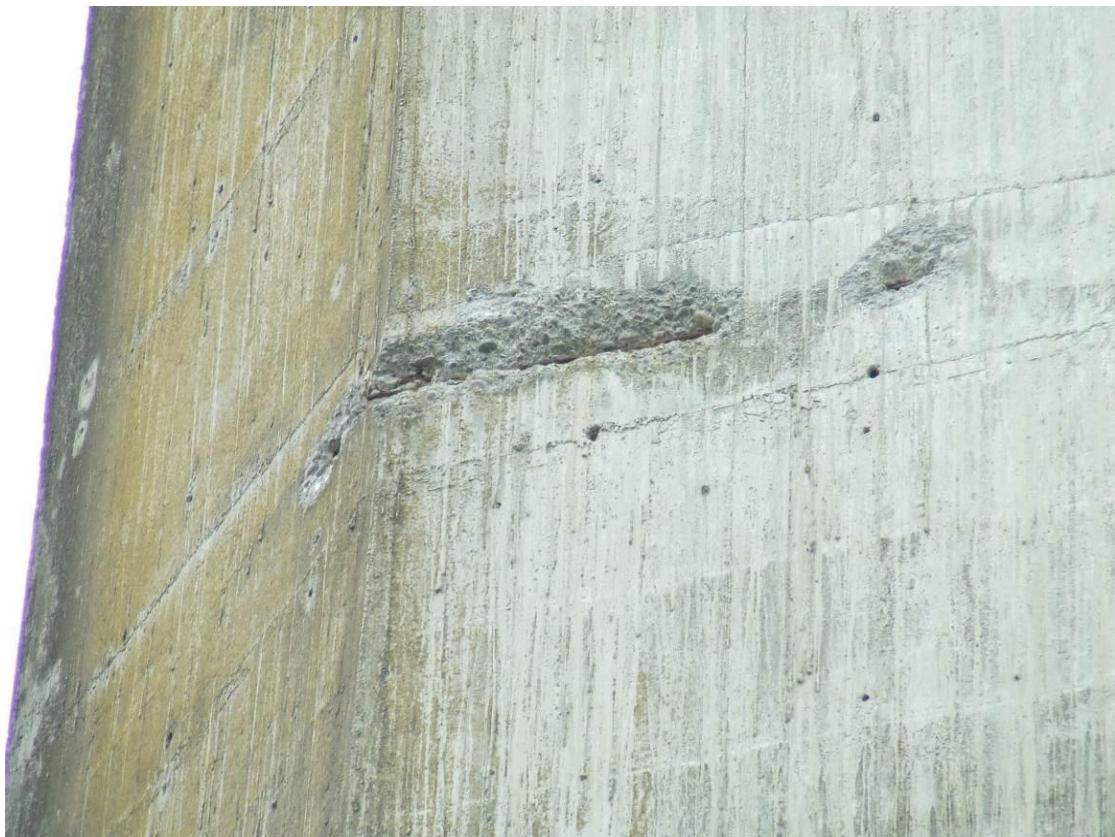
- (xiv) A large horizontal line of spalled concrete on the northeast side at approximately half height. The spalling is due to corrosion of the horizontal reinforcement along the same line.
- (xv) A small area of spalled concrete of approximately 250 diameter on the northeast side just above ground level. The spalling is due to corrosion of a vertical reinforcing rod.

- The chimney concrete is likely to have suffered from carbonation which reduces the PH of the concrete and allows the reinforcement to corrode. There is also a possibility that sulphates from burning coal may have also affected the concrete.

Photo 12. Chimney – Spalling due to reinforcement corrosion.

1. Demolish chimney.

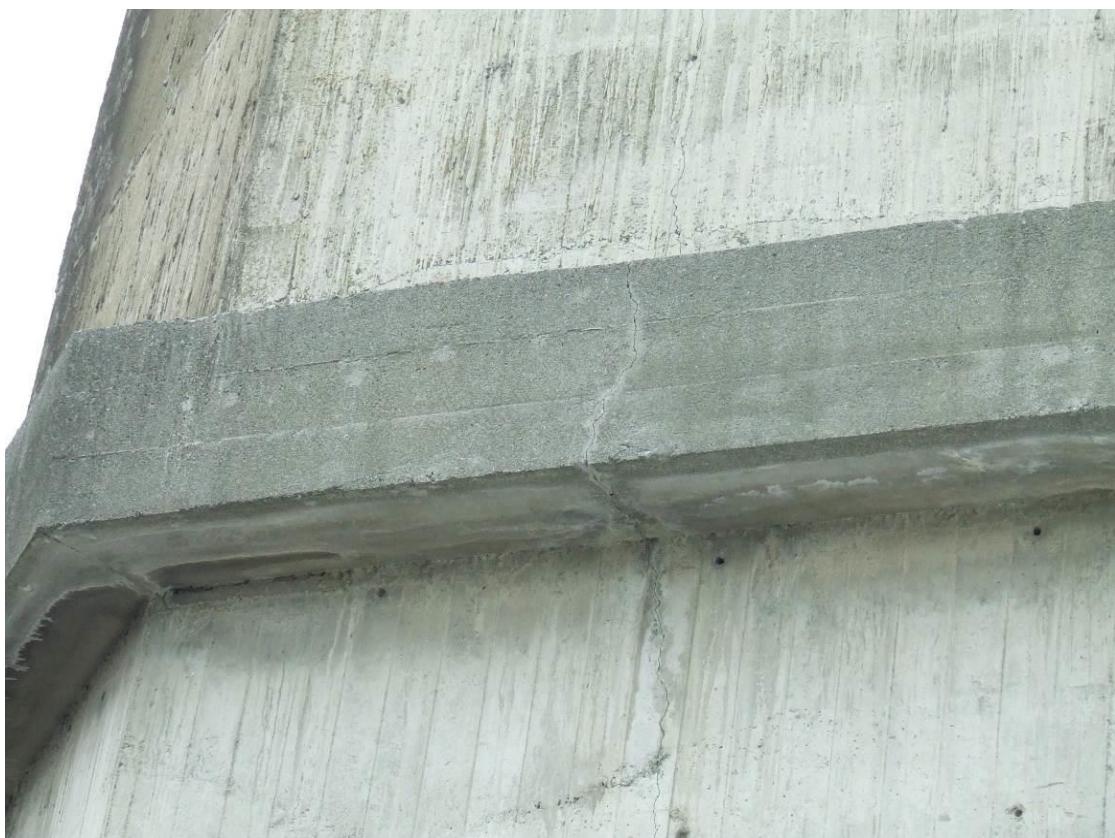
- (xi) A crack approximately 2-3mm in width running vertically upwards on the northeast side.
- (xii) A crack approximately 4mm in width running vertically upwards on the southwest side.
- (xiii) A large hole approximately 500 diameter has been cut into the southwest side at approximately 4 metres above ground level.

Photo 13. Chimney – Vertical crack on northeast side.

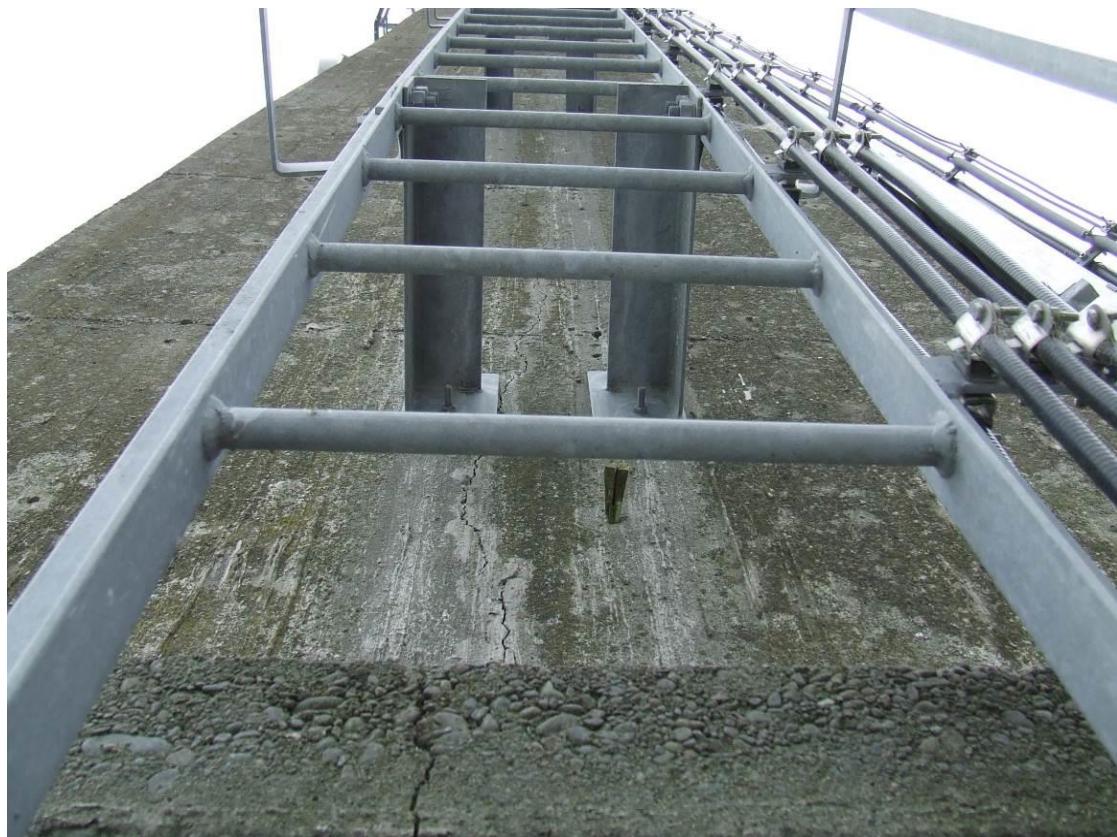
Photo 14 Chimney – Vertical crack on southwest side.

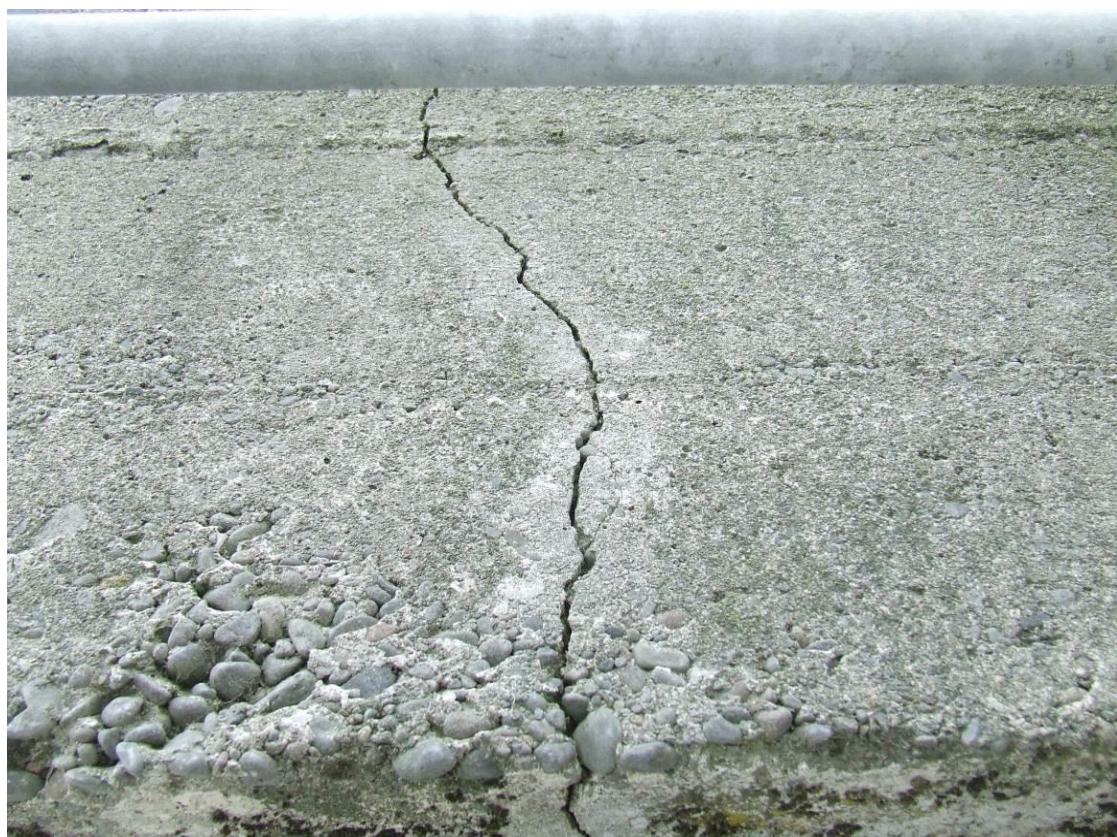
Photo 15. Chimney – Vertical crack on southwest side.

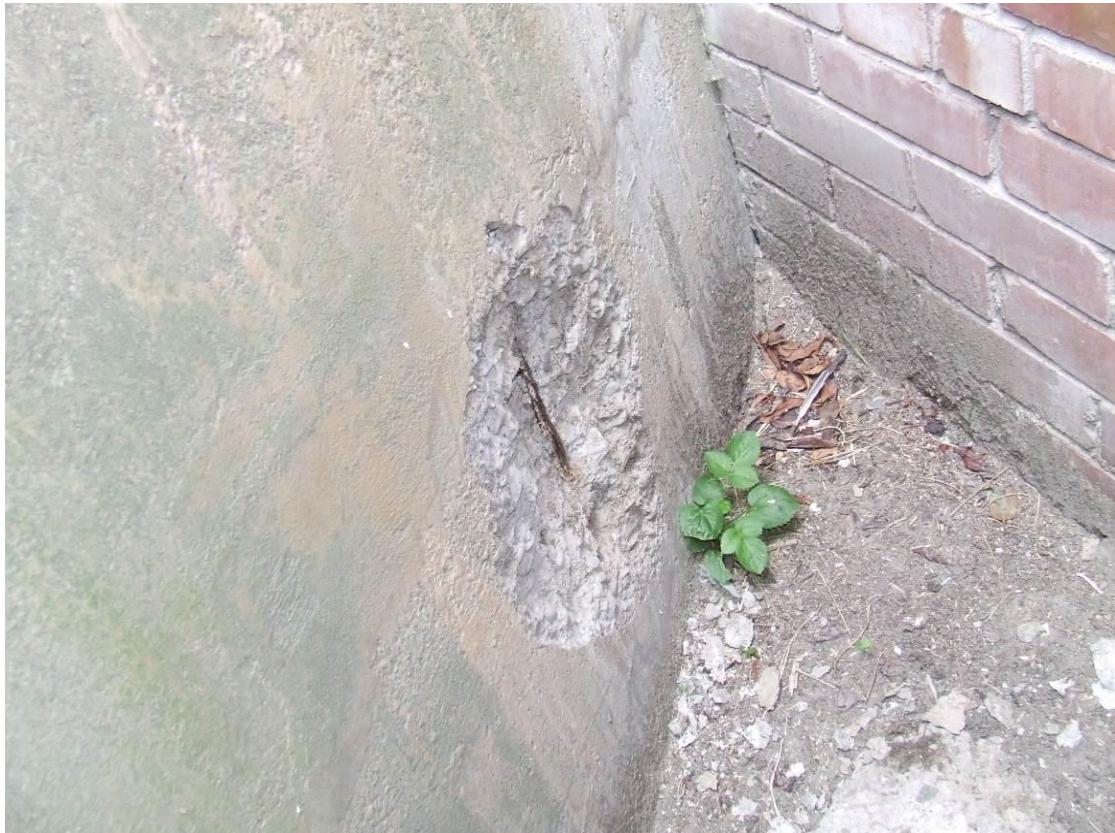
Photo 16. Chimney – Spalling on northeast side.

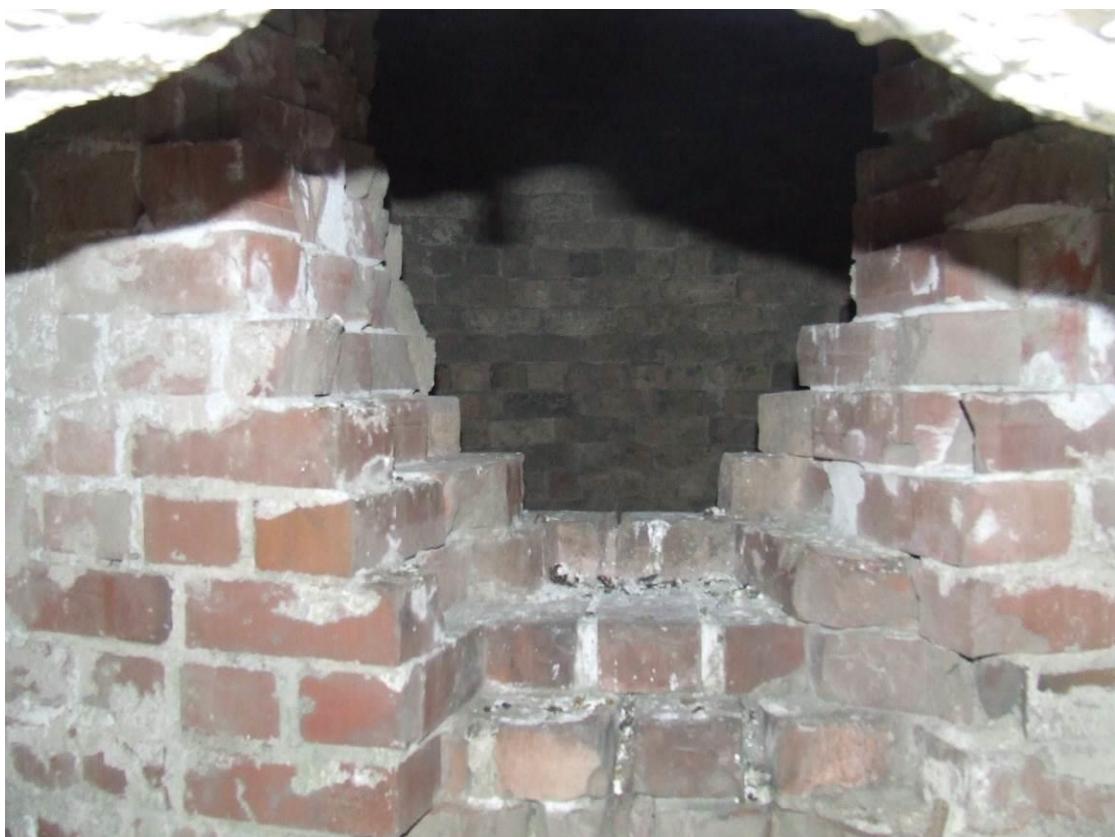
Photo 17. Chimney – Hole in southwest side. View of internal brick flue.

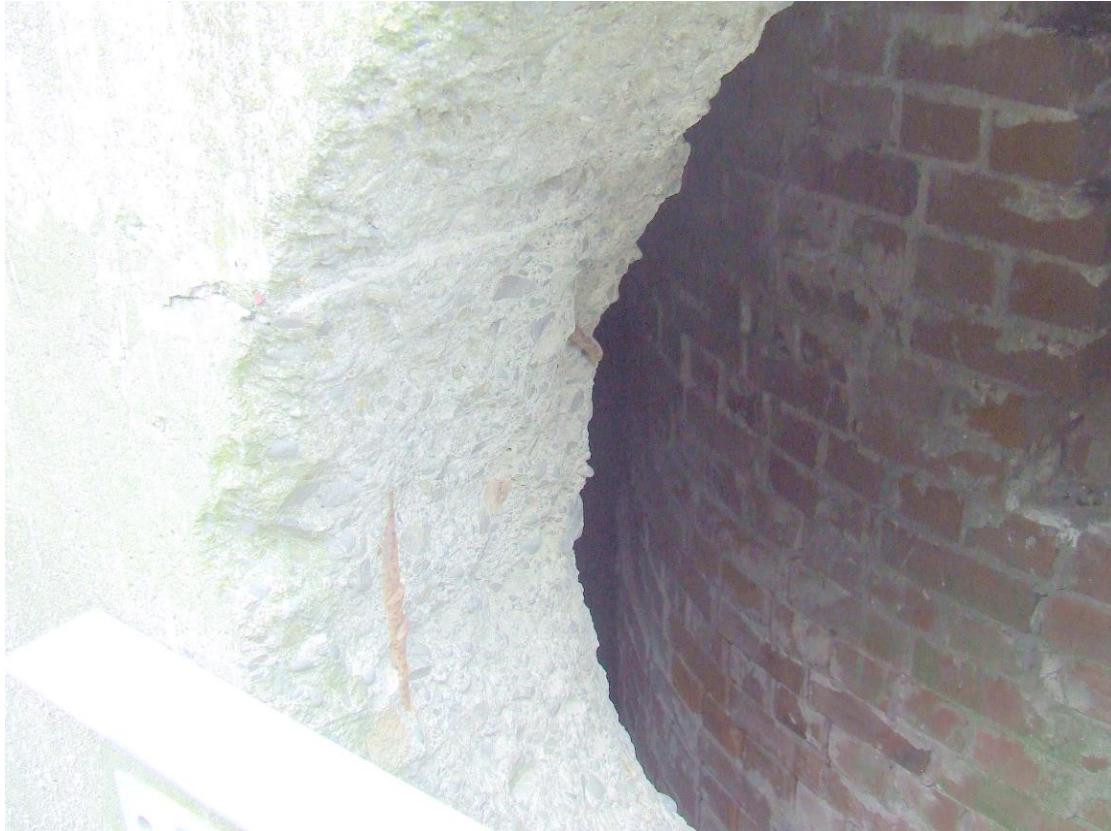
Photo 18. Chimney – Hole in southwest wall.

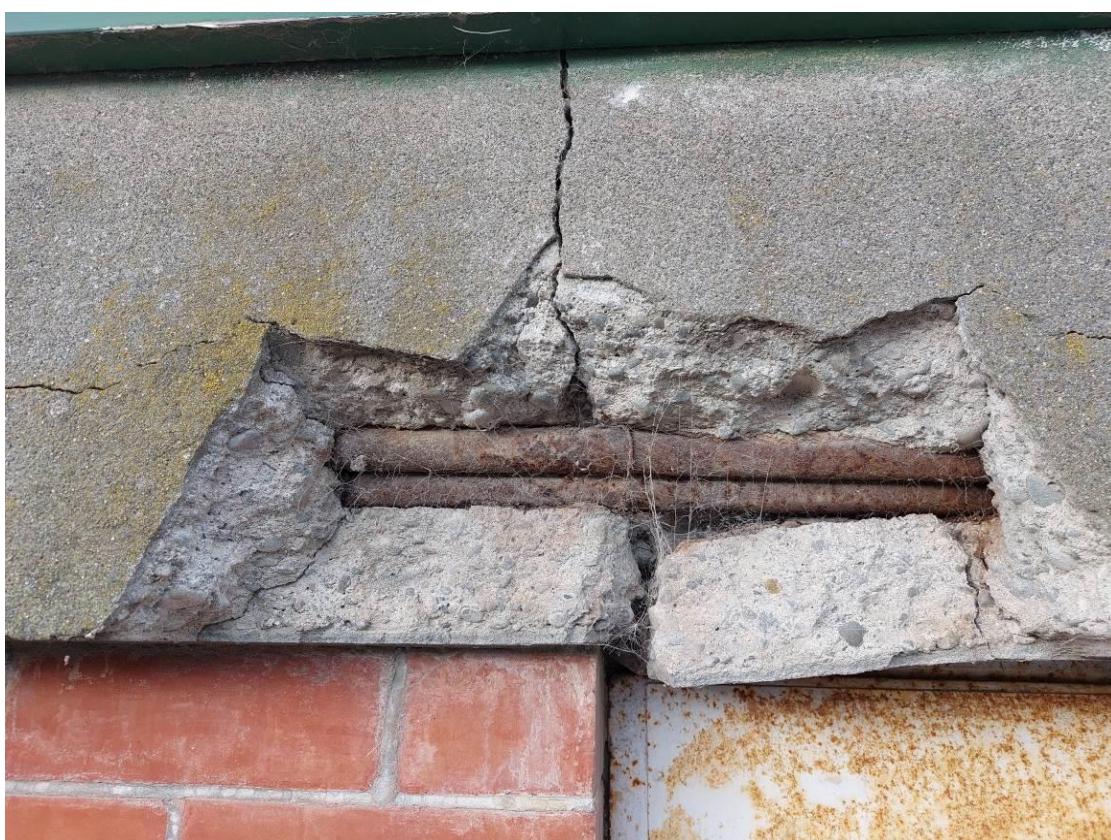
- The bond beam reinforcement assumed for the assessment is based on the reinforcement visible at the damaged bond beam on grid H.
- The chimney reinforcement used in the assessment is based on the reinforcement measured within the hole at the southwest side.
- The reinforcement and pad size for the cantilever columns on grid 14 is based on the requirements of the design standards of the time.

Photo 19. Building 1. – Spalled concrete on bond beam on grid H.

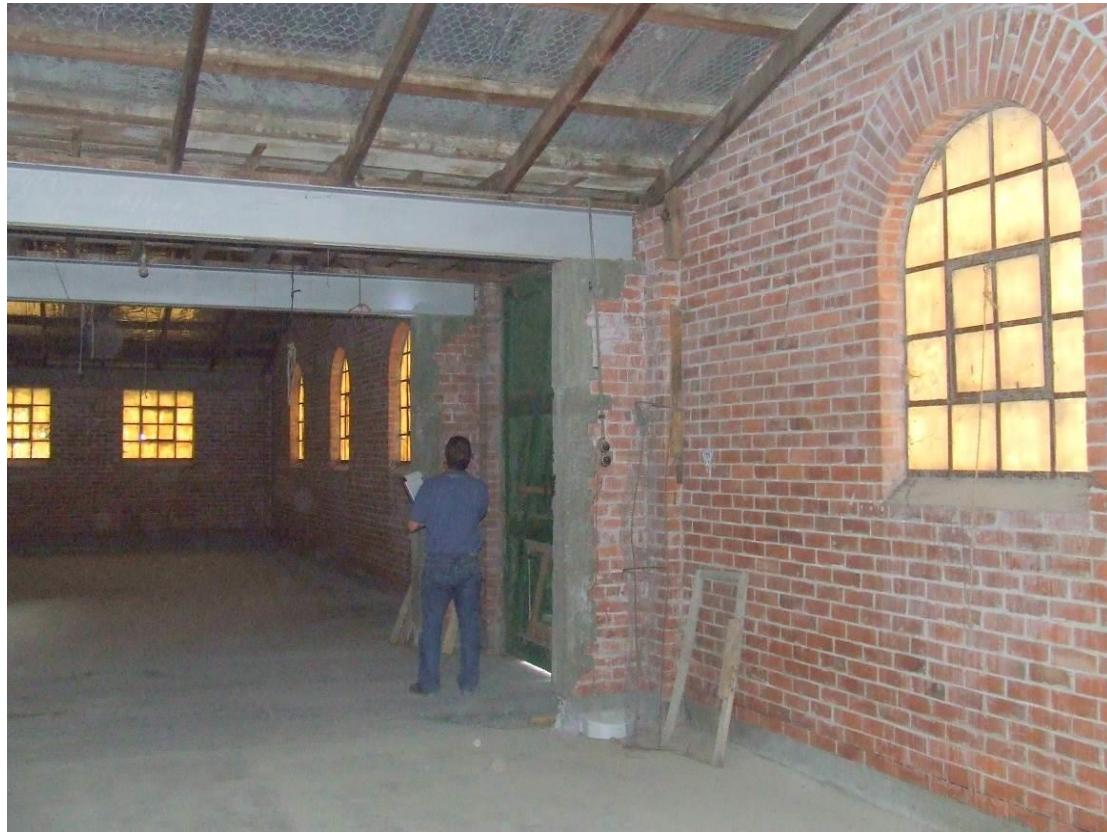
- (iii) A crack in the concrete lintel above the sliding door access into room U from the main hall and impact damage to the supporting brickwork.
- (iv) Diagonal cracks on the northwest and southeast walls in rooms P and N. The cracks rake down from the southwest and northeast corners down to the sill of the adjacent windows.

- (v) Horizontal concrete cracking at the support of the steel roof beams in rooms P and N adjacent to grid 1L.
- (vi) Slight relative movement of the wall on grid 1 and the timber roof beams. This appears to be associated with outward movement of the top of the wall.

Photo 32. Building 1. Room P & N

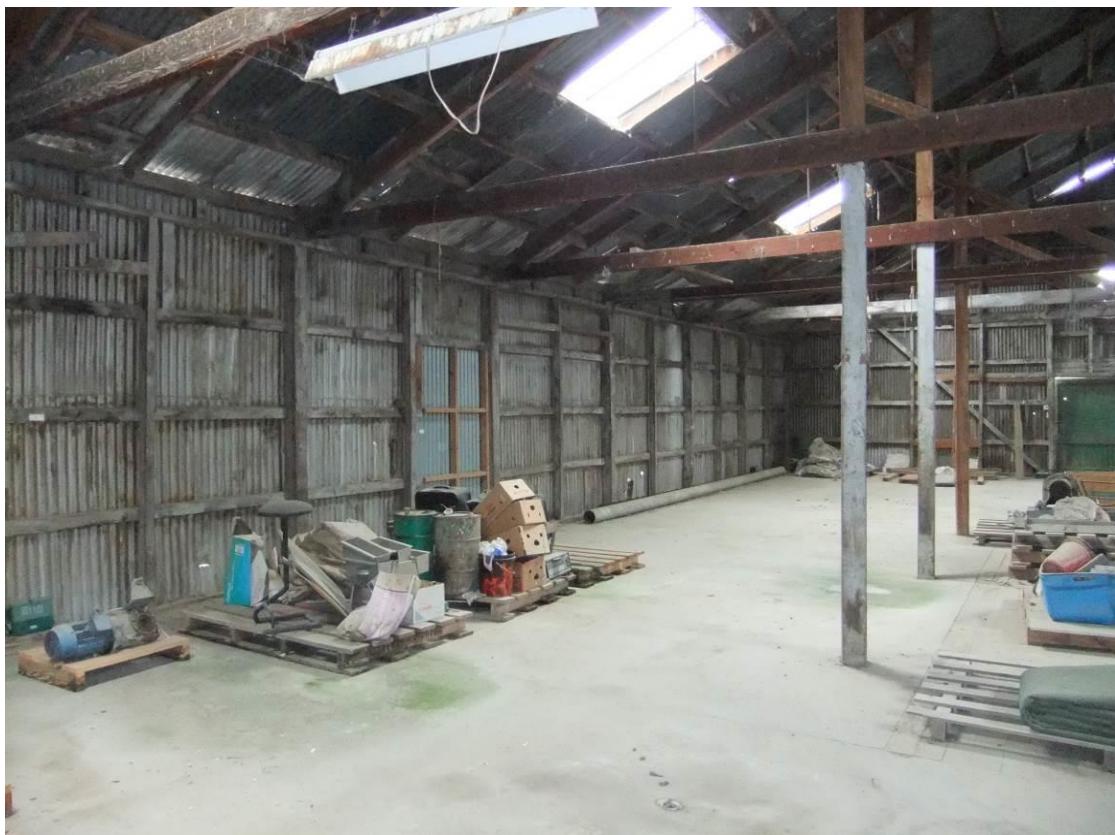
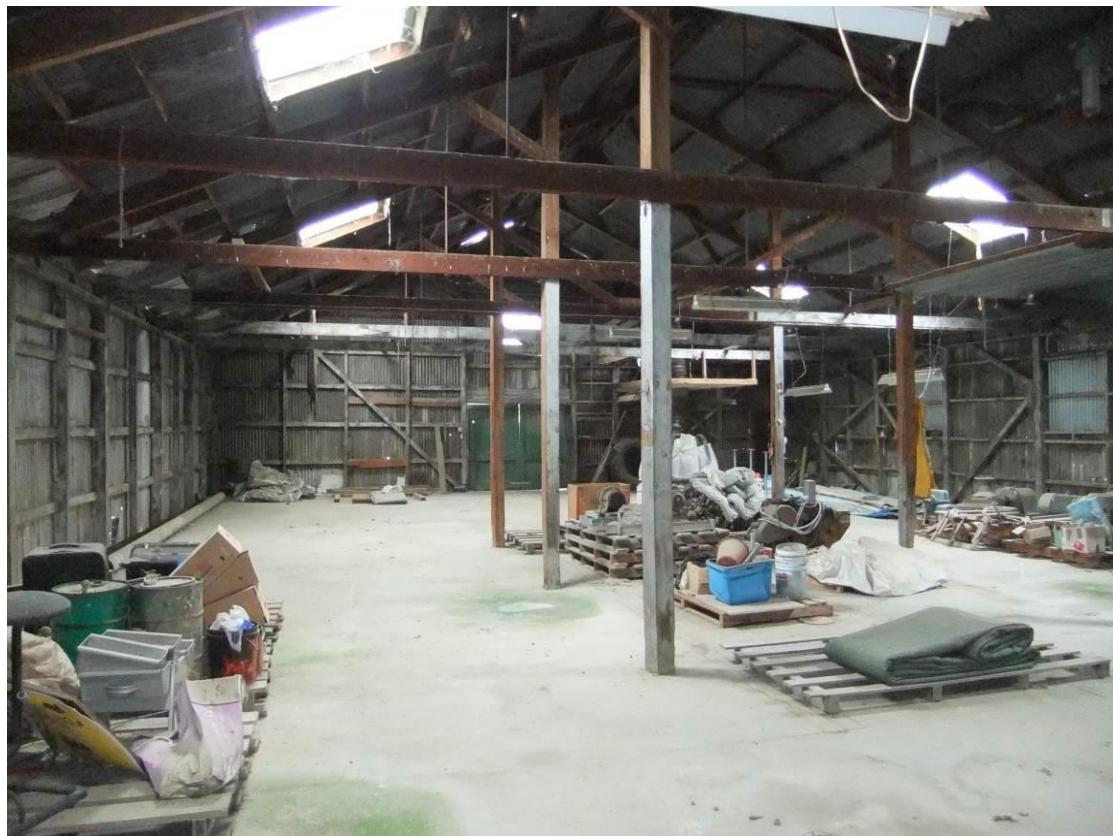
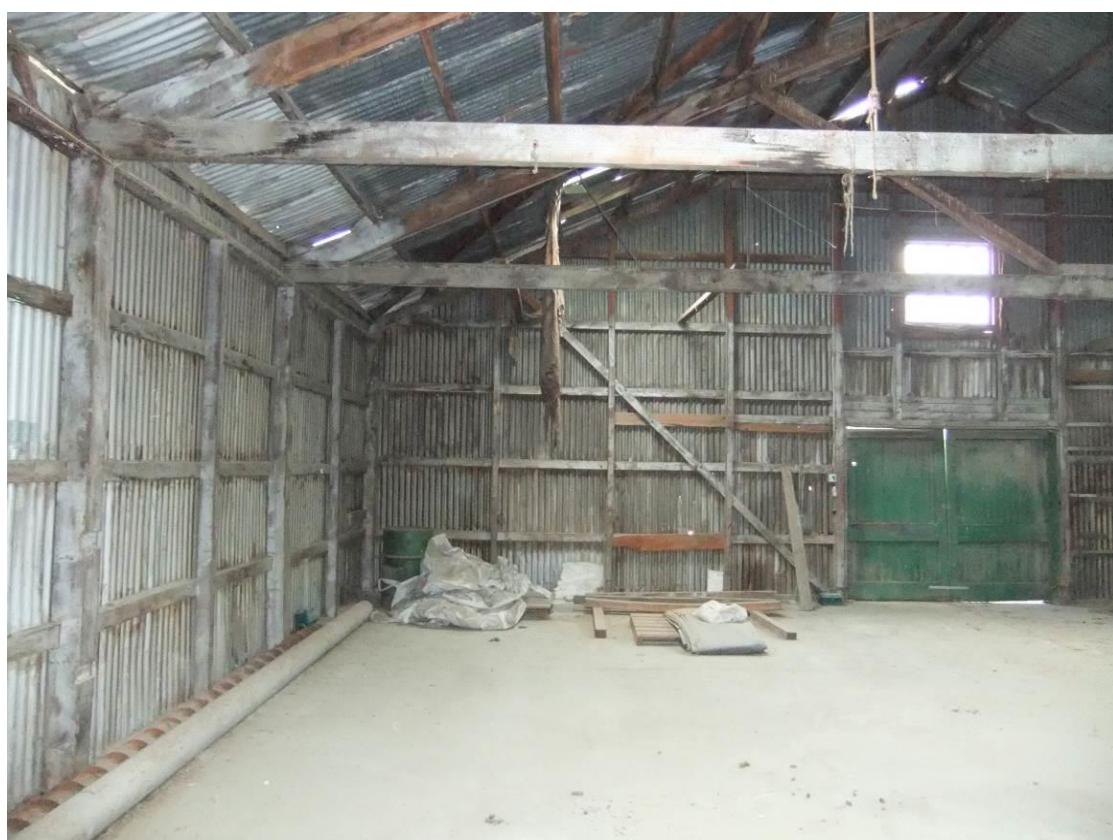
- (vii) No major distress noted in the other rooms or buildings.
- (viii) Building 3 is in a dilapidated condition. Many of the structural timbers are riddled with borer and/or have rotted. The roof and wall cladding are also past the point of repair.

1. Demolish building 3 due to its dilapidated state.

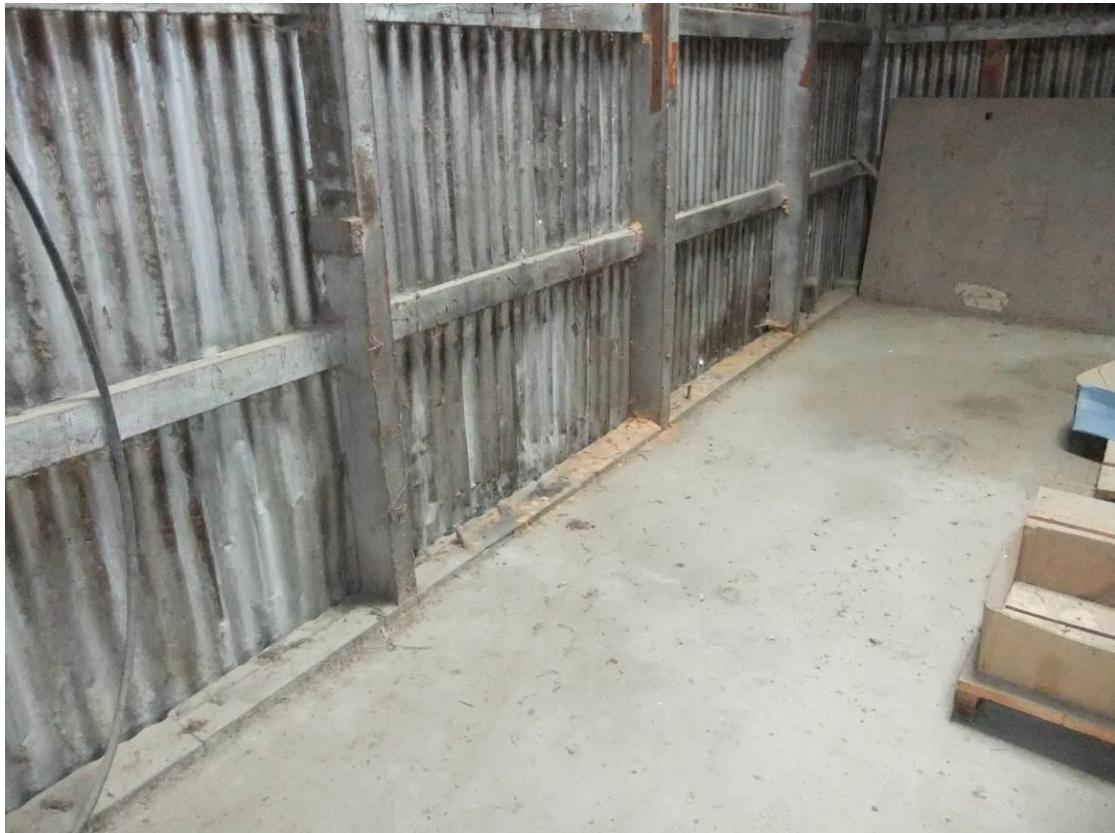
Photo 44. Building 3. - Dust from borer.

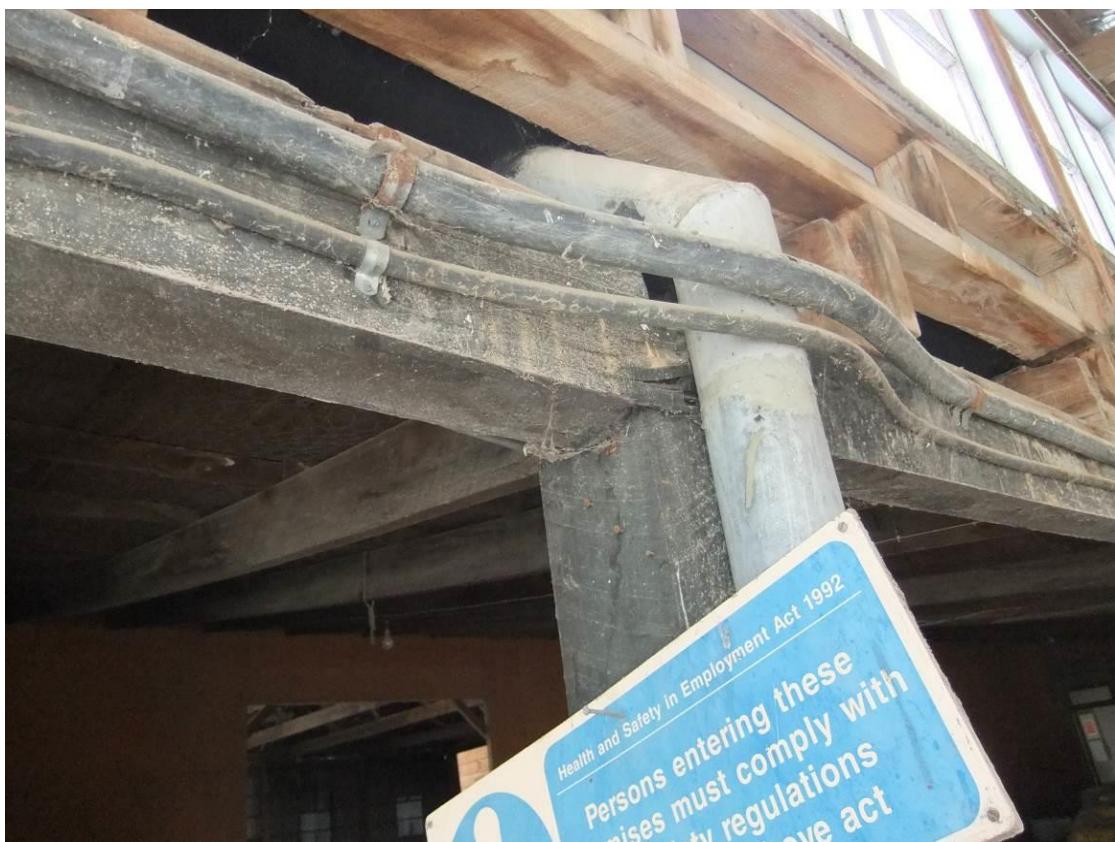
Photo 47. Building 2. Timber beam rotten over post due to downpipe leak.
