**SEISMIC ASSESSMENT REPORT
-HINDS COMMUNITY POOL
CHANGING SHED
-ISLEWORTH RD -
- HINDS-**

**Report prepared by:
Kelvin Lysaght BE Civil (Hons), CPEng, CMEngNZ, IntPE(NZ)
Chartered Structural Engineer,
Lysaght & Associates Limited,
49 Grigg St,
Ashburton.**

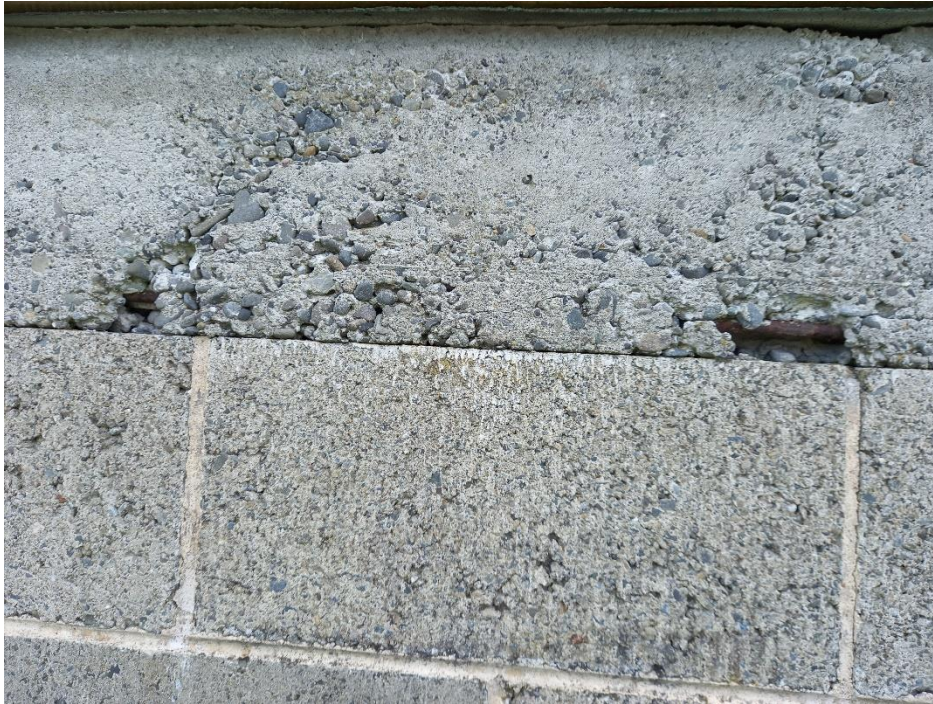
South Elevation concrete bond-beam showing poor original concrete compaction and low cover leading to reinforcement corrosion and spalling of concrete.

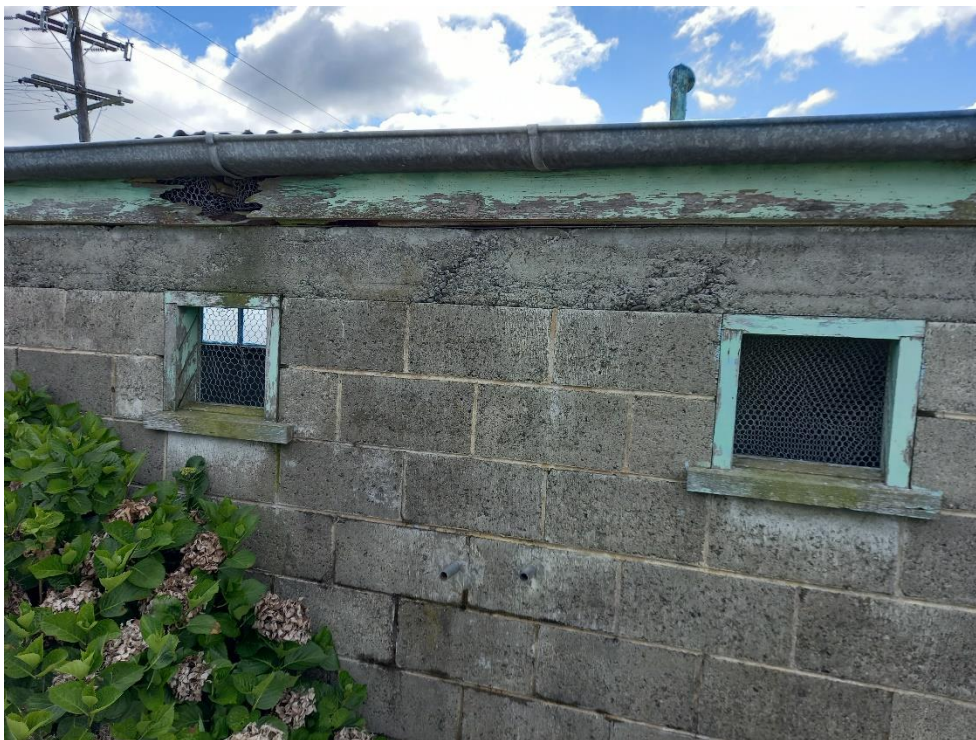
South Elevation above toilet windows showing rotten fascia board open to rain ingress and cracks below the left hand window in the joints.

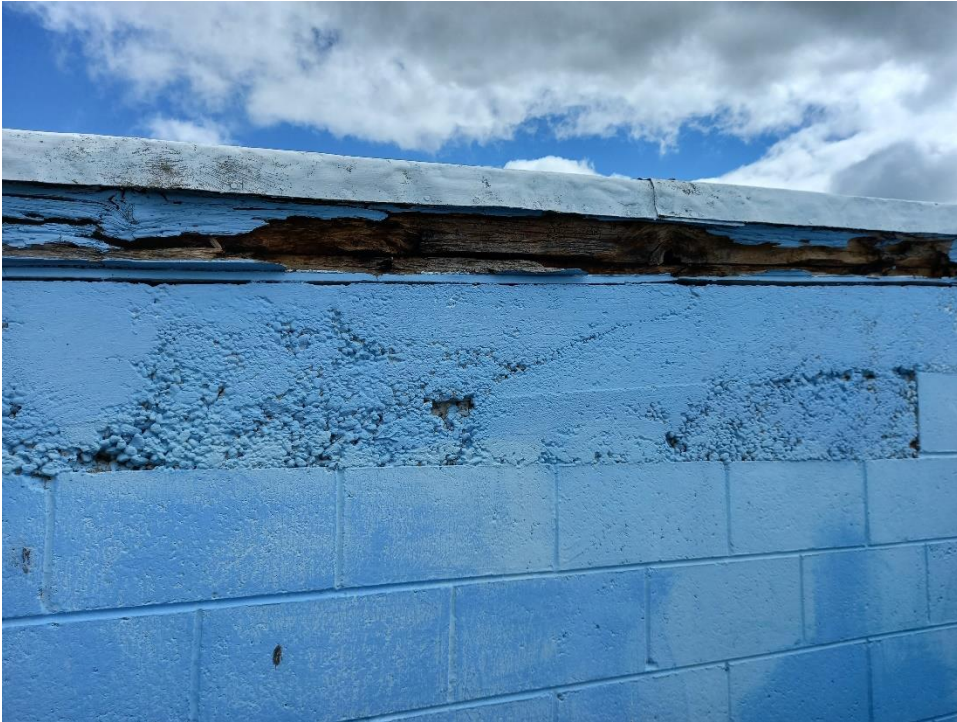
East End view of roof barge board totally rotten through with holes to the inside.

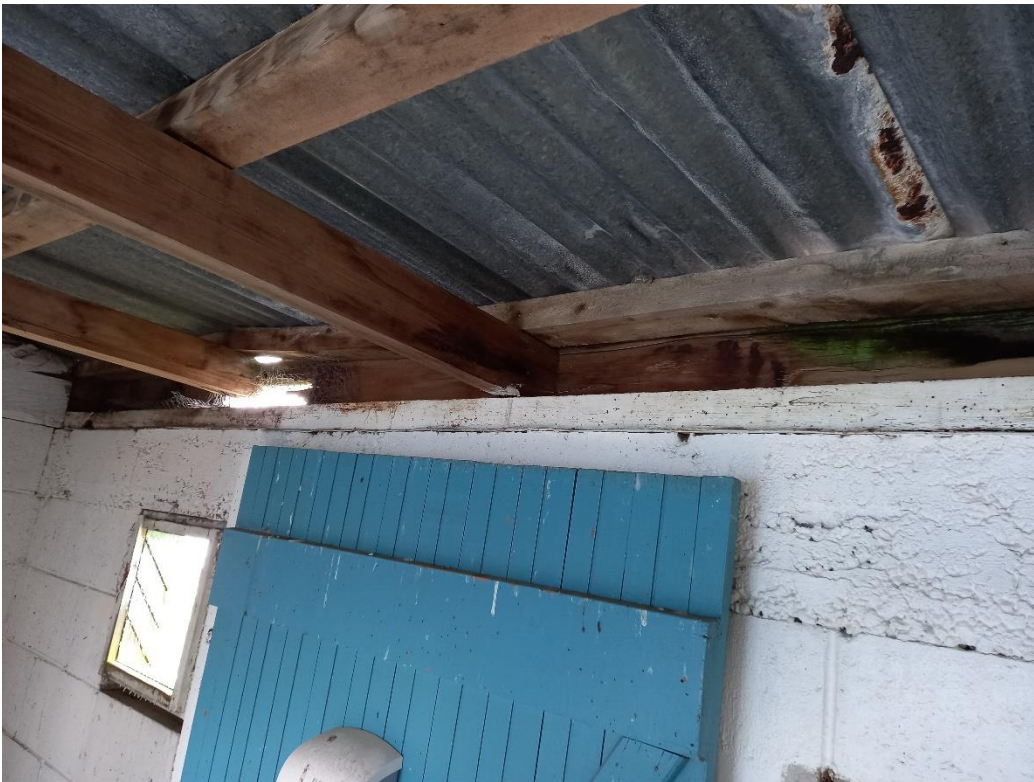
View internally of south wall in the male changing room showing end of one rafter missing and rotten and borer damage top plate.

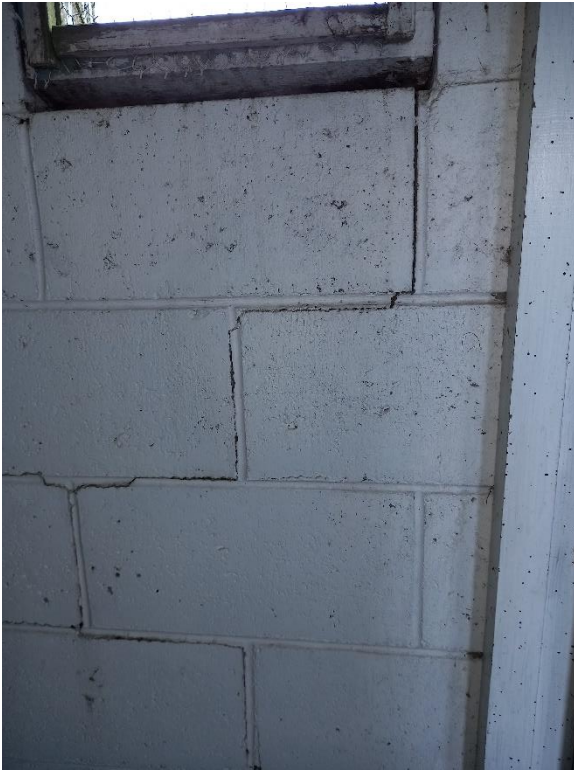
View of Male Toilet cubicle south wall and cracking to the hollow blockwall joints, symptomatic of past seismic movement.

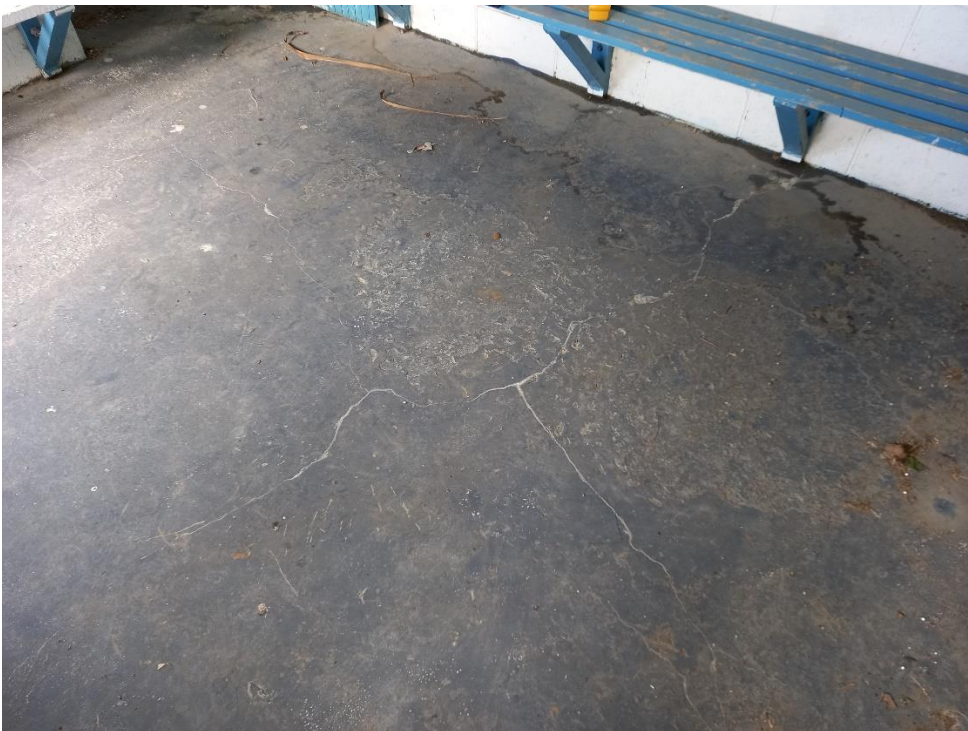
View of male changing room floor slab showing past floor slab cracking that has been filled in the past.

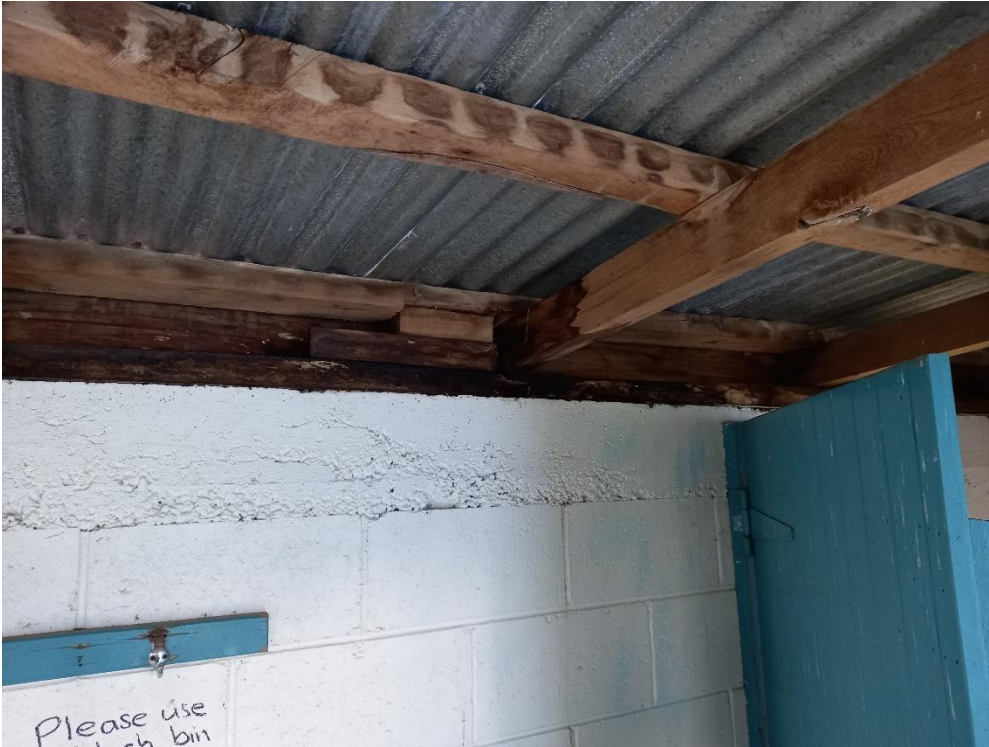
View within the female changing room showing water damage and rot along the south elevation eaves.

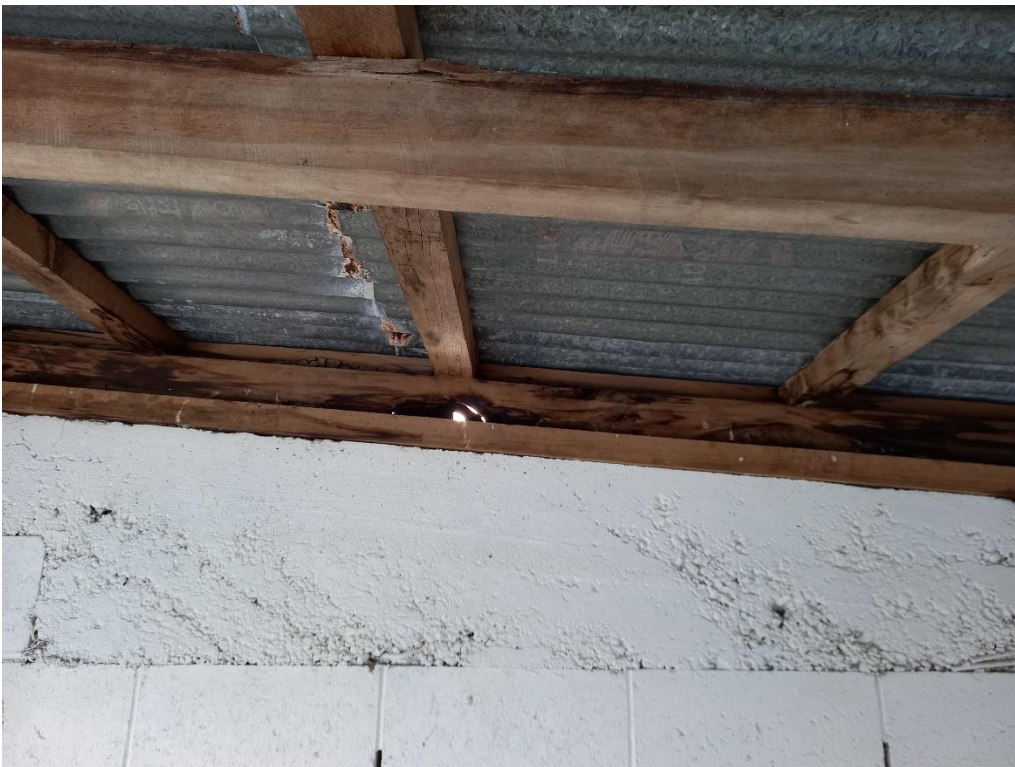
View of the east end of the female changing room barge, showing rot of end rafter, wall plate & ends of purlins.

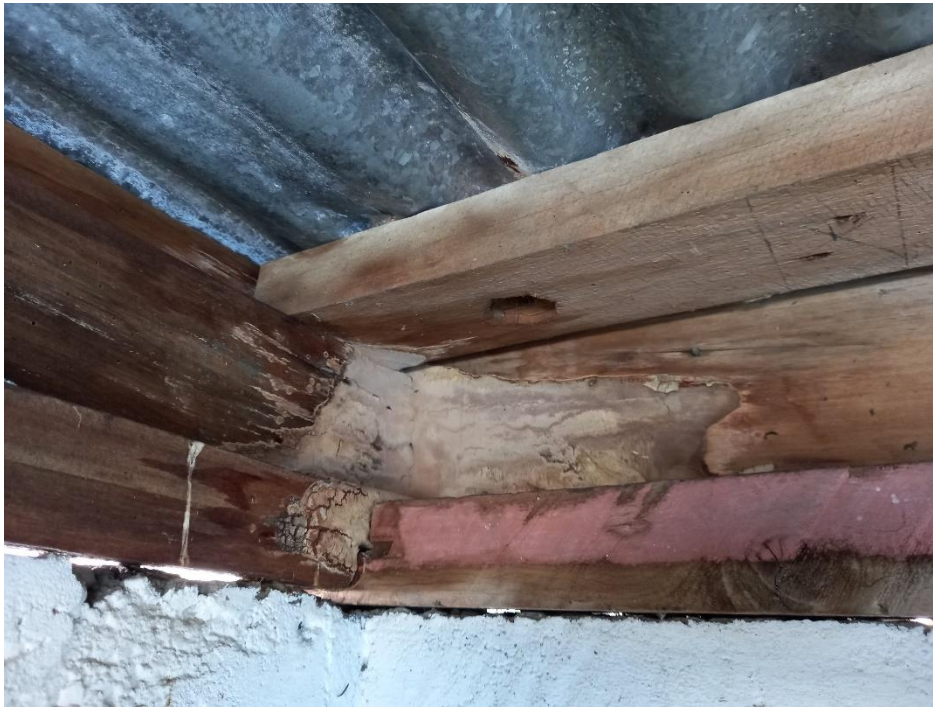
View of the south-east corner of the female changing room showing white fungus rot to all timber members and daylight under bottom plate.

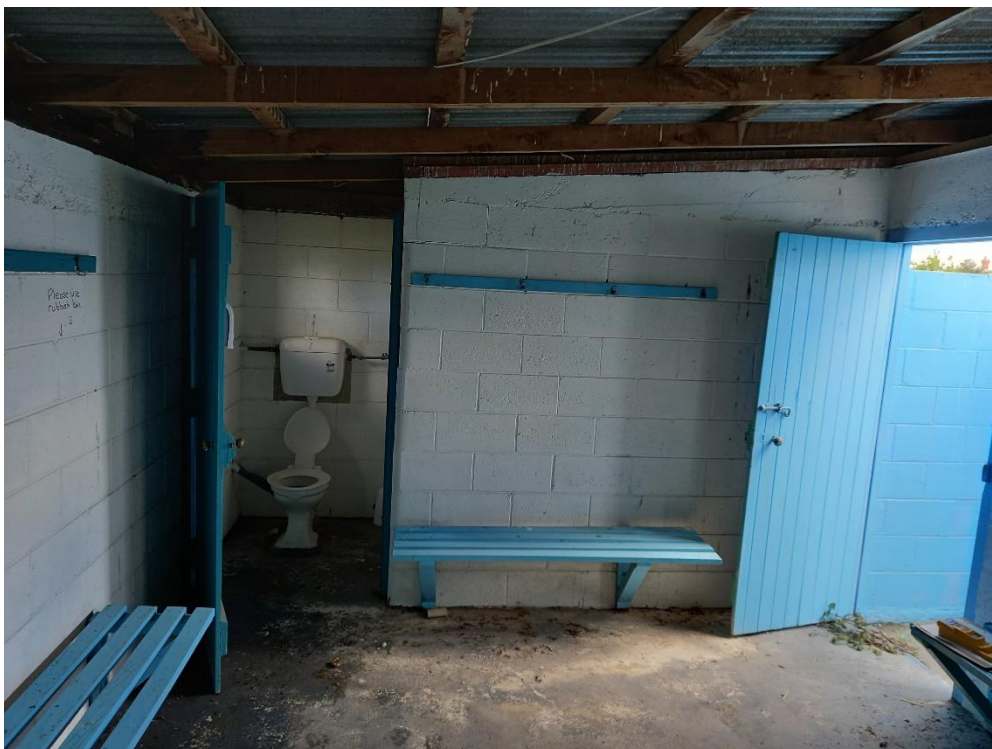
View of female toilet cubicle showing recent rainwater ingress on the floor slab adjacent the south wall and also a crack in the masonry blockwork under the bond-beam in centre of photo.

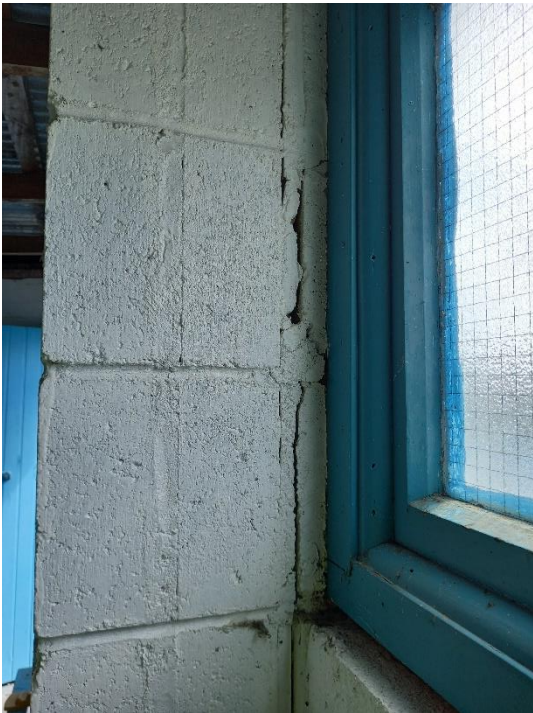
View of detachment of female changing room blockwork pier from north external wall, most likely during past seismic event.
