SEISMIC ASSESSMENT REPORT -RAKAIA COMMUNITY POOL CHANGING SHEDS & OFFICE -69 CRIDLAND ST - - RAKAIA-

November 2021.

SEISMIC ASSESSMENT REPORT OF RAKAIA COMMUNITY POOL CHANGING SHEDS & OFFICE, 69 CRIDLAND ST, RAKAIA.

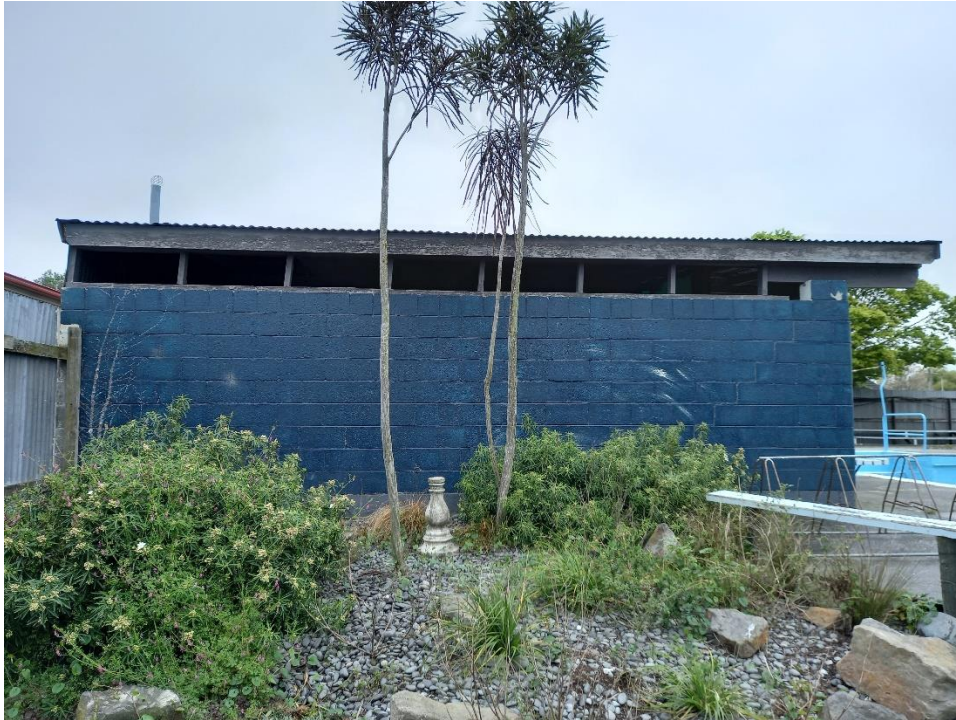
On the west elevation adjacent the south corner there is a stepped crack visible from high level down to floor level symptomatic of past earthquake damage that has been filled externally. The 2-3mm wide crack is visible internally. It goes around to the southern flank wall where the 3 blocks above the crack have moved inwards by 20mm. On the west elevation the 400mm high timber jack studs supporting the roof above the masonry are all visibly leaning by about 20-30mm, again symptomatic of past significant lateral forces. There is one wire dog and nails connecting the base of the jack stud to the bottom plate.

West Elevation showing filled saw-tooth cracking at south end and short timber jack studs leaning noticeably to the south.

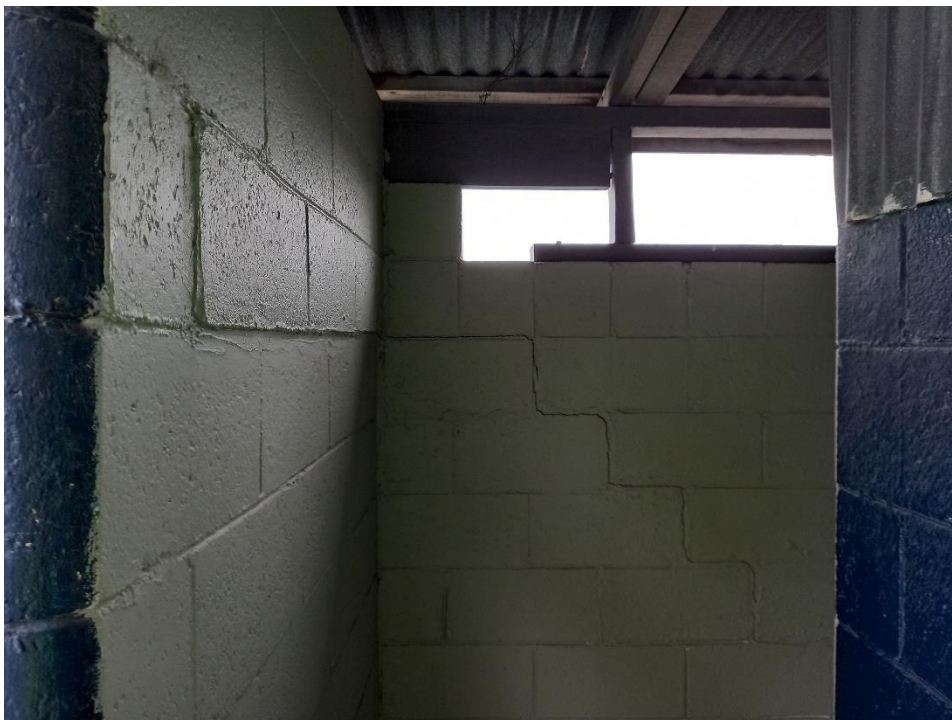
In the male changing room on the west side the sawtooth cracking at the south corner is right through the mortar joints. On the north wall there is also evidence of saw-tooth cracking from the toilet cubicle down to the base of the corner that has been filled and painted over.

Internal view in Mens changing room of west elevation wall cracking and south wall corner wall above the crack projecting 20mm inward.

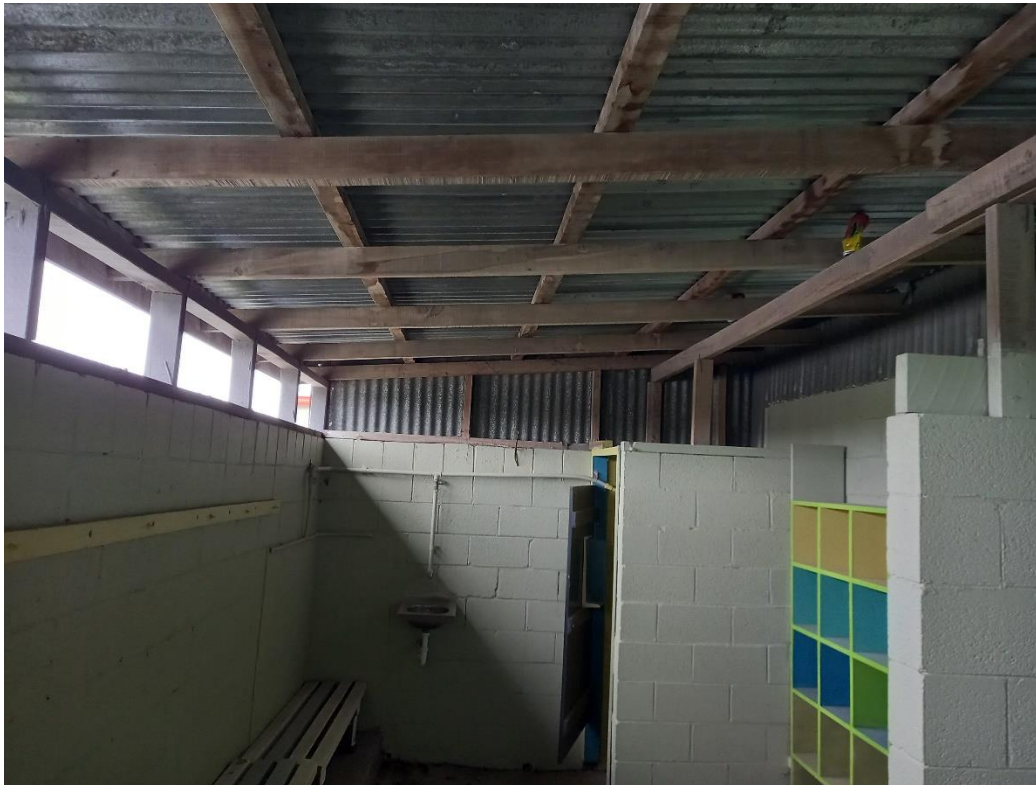
Internal of Male changing room showing sawtooth crack filled on north wall and short internal hollow block partition walls.

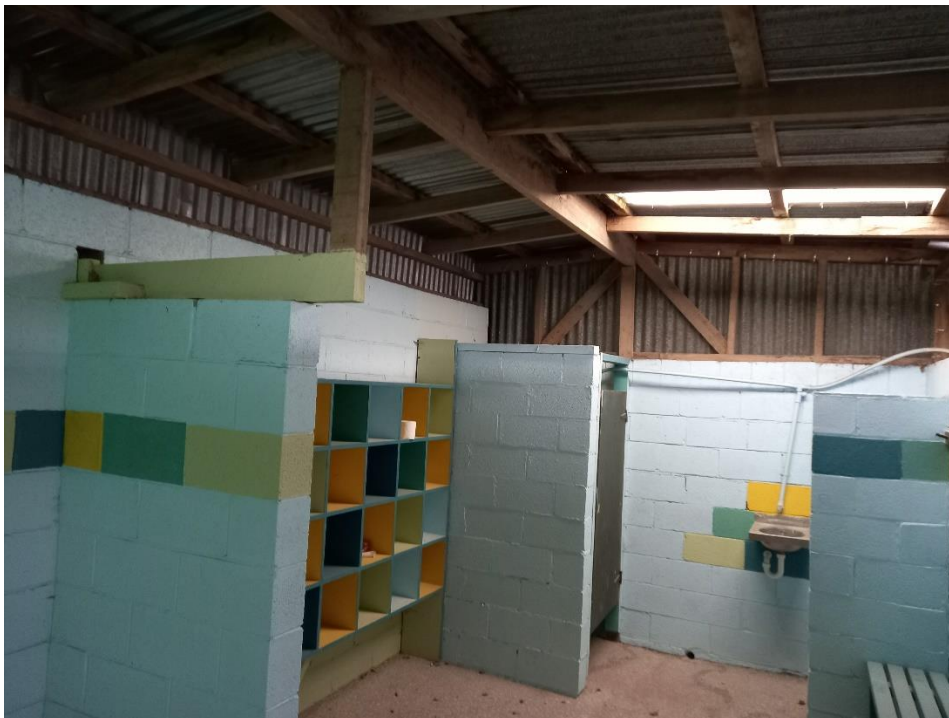
Within the female changing room the western most room with the toilet cubicle there are 3 number 1.2m long 140mm hollow concrete block flanking walls. The westernmost short wall has a 10mm gap at the top where it meets the north-south 190mm thick blockwall. 3 courses down from the top there is sign of horizontal movement of the top of the wall along a sawtooth pattern in a joint. The joint has been re-pointed at some time in the past. The 190mm thick eastern blockwall 2m high, dividing the female changing room was scanned and only a top horizontal rebar was detected.

Internal of female changing rooms showing hollow block partition walls. Note right hand wall shows signs of past lateral and horizontal movement.

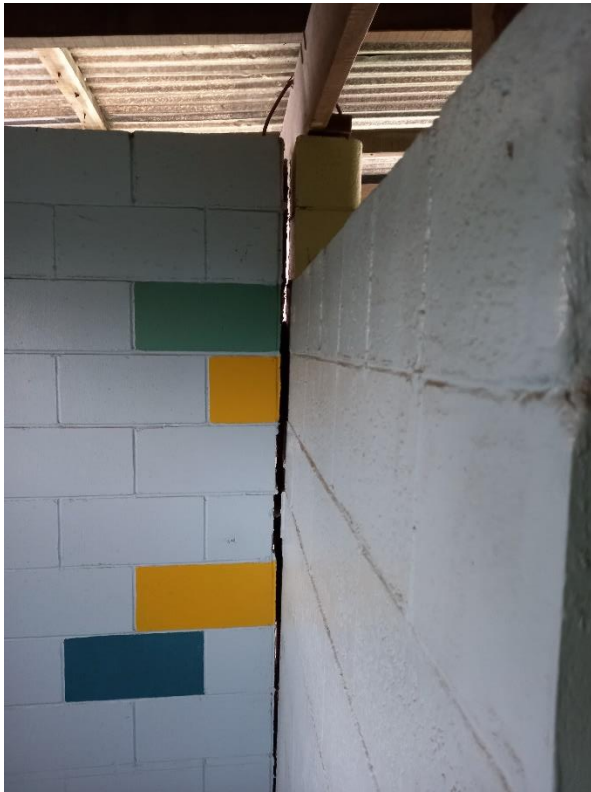
On the south elevation, where the apparent eastern addition connects to the original structure there is a vertical separation of the 190mm thick blockwalls that starts at hairline width at the floor level and increases to a 35mm open gap at the top of the blockwall. Therefore, it is a rotational movement of the wall and foundation. Along the eastern blockwall elevation there is surface water ponding on the external concrete slab adjacent the base of the wall. The slab is also significantly

View of south external wall internally within female changing room showing 35mm open gap at top of wall where the eastern elevation wall foundation has appeared to have settled causing the connected south wall to rotate.

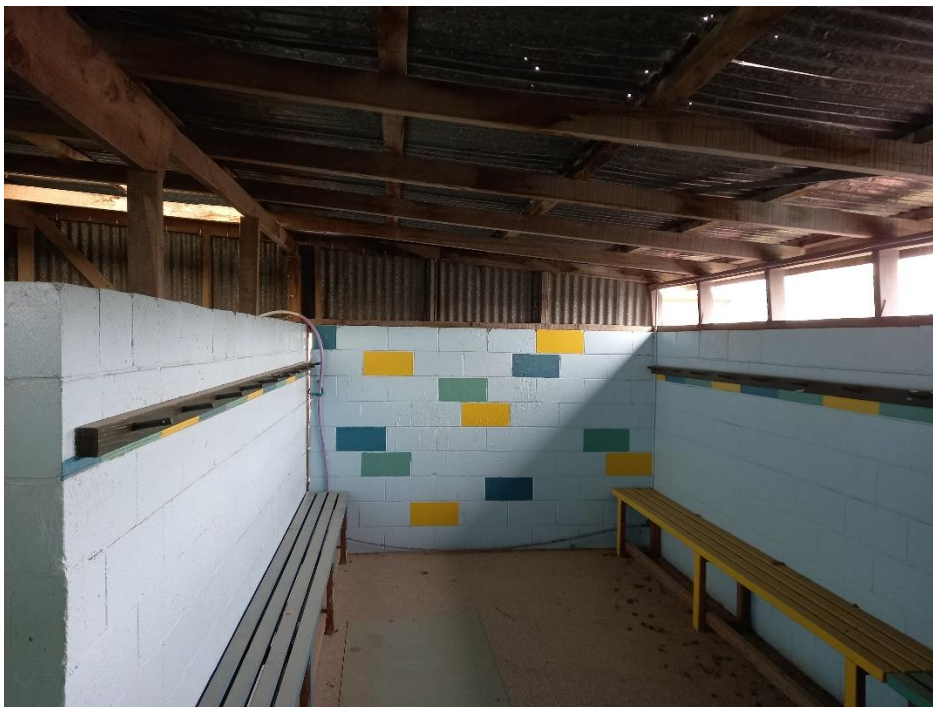
In the easternmost room of the female changing shed where the internal north-south wall meets the north and south external walls the open joint at the top of the wall of 35mm at both ends is visible to the outside and is a source of rainwater ingress to the internal.

View within the same female changing room looking toward the northern external wall showing the same 35mm open gap at the top where it joins the original structure to the left.

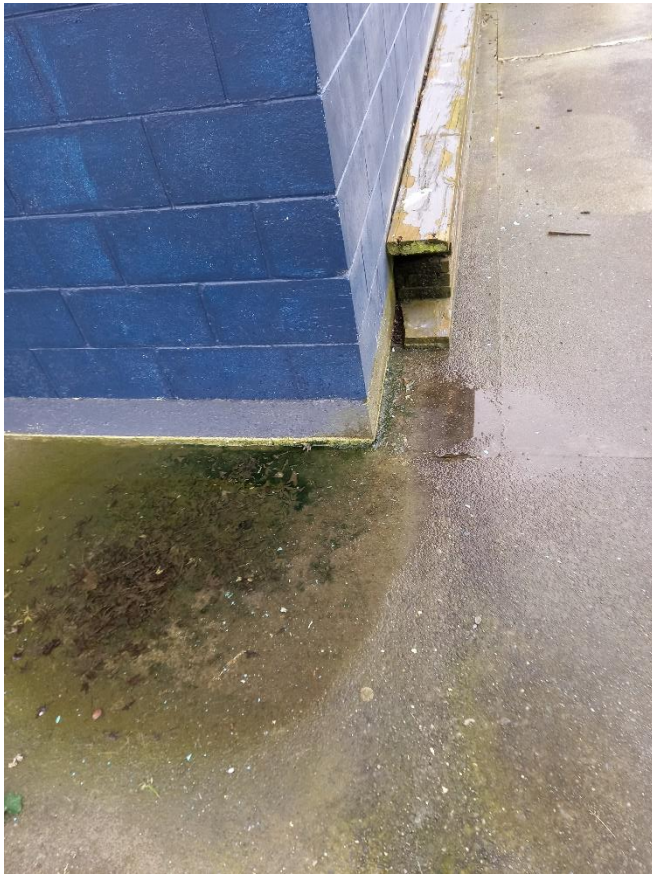
cracked and appears out of level across the crack pointing to settlement having occurred. The edge of the crack has been ground to a chamfer in the past to prevent a trip hazard, indicating vertical movement has occurred in the past. On the north elevation where the eastern addition blockwall joins the original, the same rotational movement found on the south elevation is repeated with a 35mm wide gap open to the inside was measured at the top of the wall. Wire ties between the joints was found.

View of south-east corner of building, surface water ponding and external slab cracked with level differences across the crack, all evidence of past settlement of the foundation.

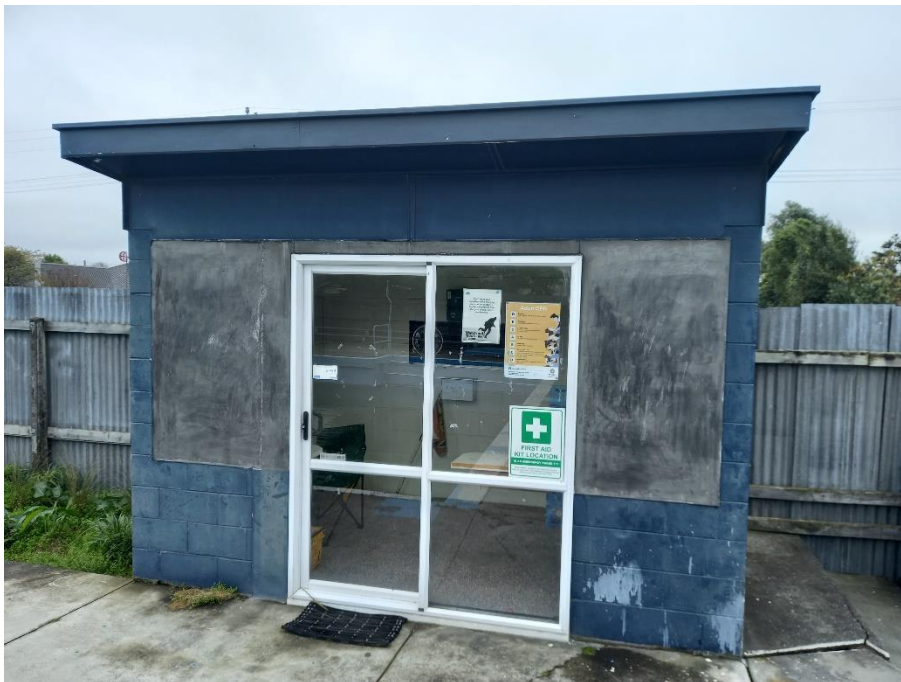
The External elevations of the office are 90mm hollow masonry blockwork with a concrete bond beam around the perimeter and a timber roof above. No visible defects were observed.

View of small office structure.
