# ARBORICULTURAL ASSESSMENT REPORT (Review 2015)

Client:	Mr E. Drewitt
Site:	30 Queens Drive, Ashburton, Canterbury
Scope:	Review & discussion of the visual tree assessment (VTA) for the Silver lime <i>Tilia tomentosa</i> growing in the rear of the property.
Author:	Ed Sard
Date:	2 <sup>ND</sup> July 2015 DRAFT

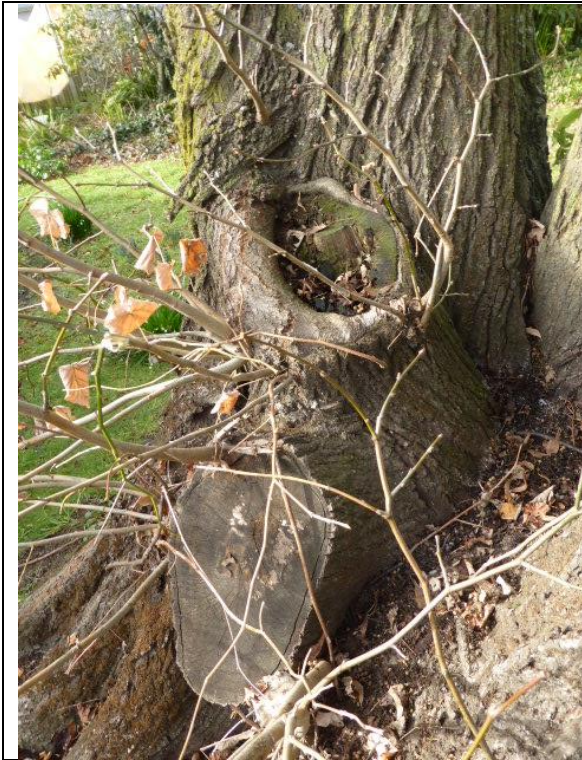
- 5.3 The structure of the tree consists of three main stems which emanate from the base of the tree. Stem #1 leans to the south-east and is closest to Mr Dewitt's house. Stem #2 orientates to the west and stem #3 orientates to the north-east. Two large pruning wounds were evident at the stem base, to the north-west, indicating historic stem removal.<sup>2</sup> These wounds were much smaller in diameter than the existing three stems. Included bark was noted at the attachment points of the three stems. Included bark is an internationally recognised and well documented structural weakness in trees.

Photo 1: previously removed stems

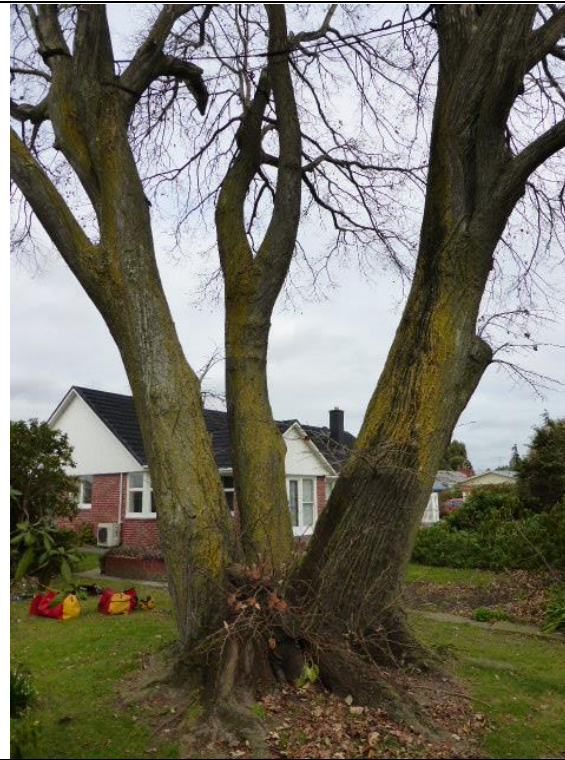
Photo 2: Orientation of the stems

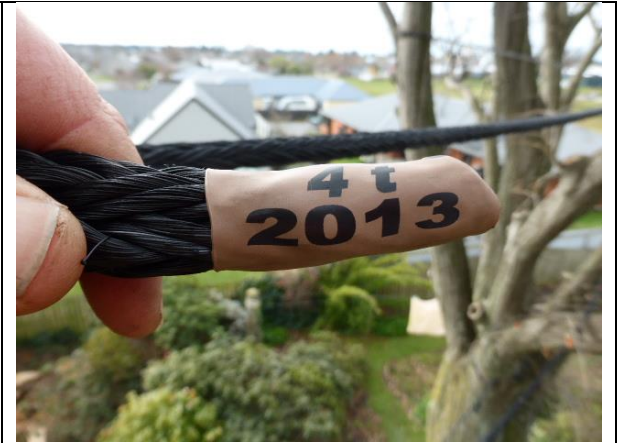
- 5.7 A non-invasive Cobra bracing system has been installed at approximately half the total height of the tree, connecting stems #1 and #2 and #1 and #3. Two Cobra bracing systems were evident, which have been installed at different times. The most recent installation was a 4 ton system in 2013 confirmed by the date end caps installed.<sup>3</sup> An earlier installation is present which is smaller in diameter than the 2013 system and is indicative of a 2 ton system.<sup>4</sup>

- 6.3 In 2013 a second Cobra bracing system has been installed which is noted as being a 4 ton system confirmed by the date end caps installed.<sup>10</sup> This system has been installed incorrectly with significant slack noted in both braces.<sup>11</sup> This is unlikely to have the desired effect of supporting the stems in the event of failure due the extent of travel before the slack is taken up.

Photo 3: Recently installed Cobra system

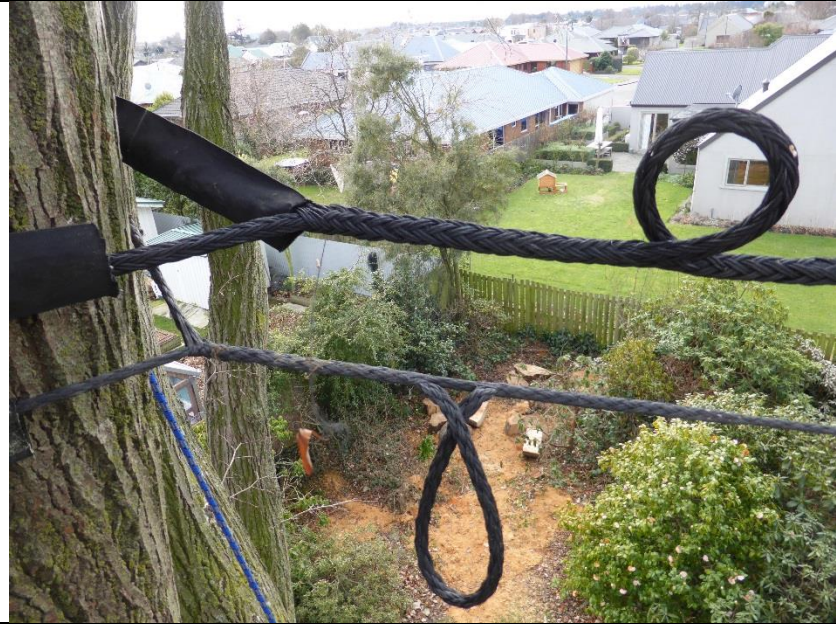
- 5.8 The earlier Cobra system connecting both stem #1 and #2 (east-west) and stem #1 and #3 (north-east – south-west) was noted has being at high tension. The system has been installed at natural forks in the branch structure. Incremental growth of the trees stems has partially included the points of attachment.<sup>5</sup> There is evidence of previous failure of a cobra brace between stem #1 and #2 with the remnants of the brace trees partially included.<sup>6</sup>

- 6.4 Due to the tension noted on the pre-existing braces, failure of these braces is considered likely. Mr Walter Fielding – Cotterell's report dated 21 January 2014 notes that when the recent Cobra system was installed in December 2013 one of the braces was found to be broken, this is likely to have been the brace between stems stem #1 and #2 (east-west) as noted in paragraph 5.8.

Photo 4: Recently installed 4 ton system on top. Previously installed in the bottom indicative of a 2 ton system. Note this brace is under high tension. Stump of the recently removed Oak visible to the rear boundary.

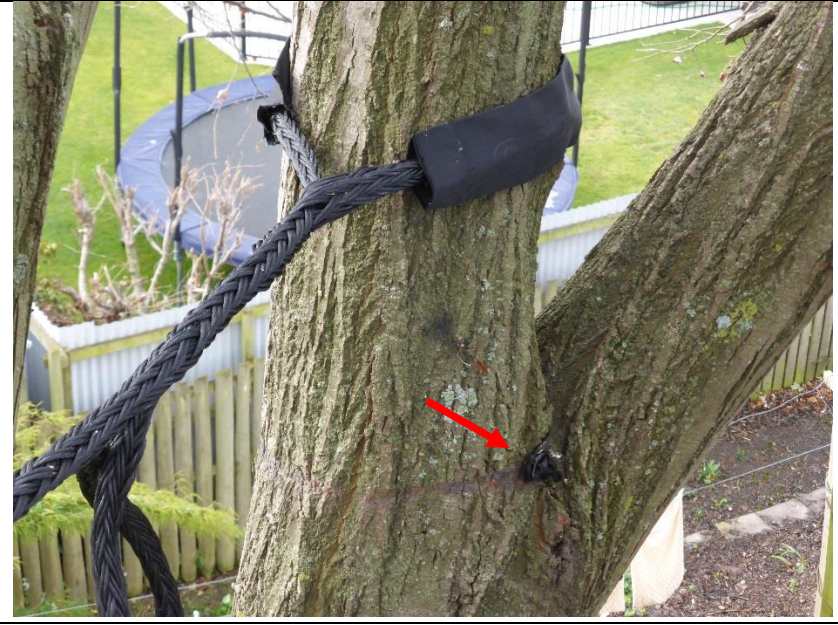
- 5.10 The installed braces connecting stems #1 and #2 are connected to the main stems at an approximate diameter >450mm.<sup>7</sup> The stems have a similar angle of lean and the tension between at the connecting points is likely to be similar.
- 5.11 The installed braces connecting stems #1 and #3 are connected via a secondary branch on stem #3 with an approx. diameter of 300mm and the main stem of #1 with an approx. diameter >450mm.<sup>8</sup> Significant end weight was noted on stem #1 which leans towards the property and is at a greater angle than stems #2 and #3. Due to the end weight noted the secondary branch attached of the Cobra system on stem #3 has been pulled into the adjacent secondary branch lateral with an approx. Diameter <200mm at the point of attachment.<sup>9</sup>

Photo 5: Previously failed cobra system partially included at the point of attachment.

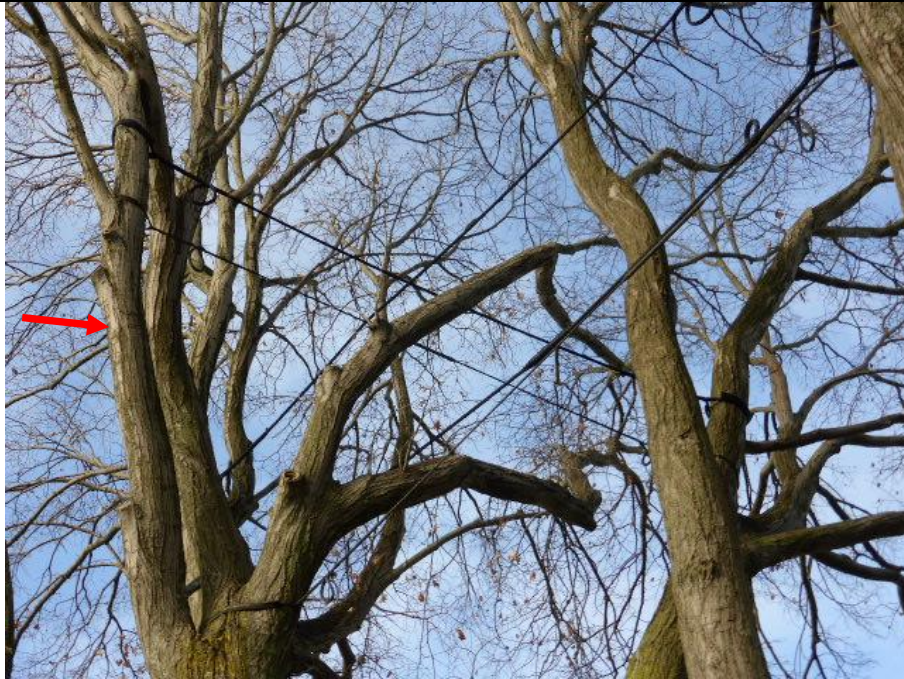
Photo 6: The installed braces connecting stems #1 and #3 are connected via a secondary branch on stem #3 with an approx. diameter of 300mm

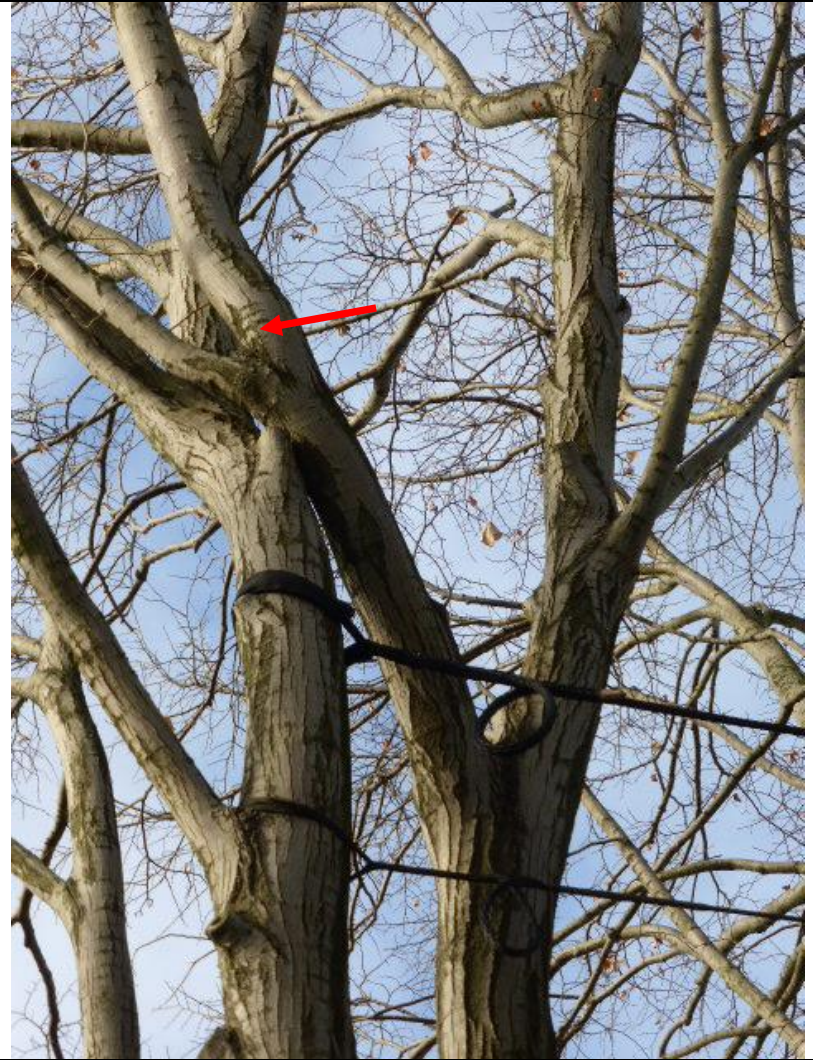
Photo 7: The secondary branch supporting Stem #1 has been pulled into the adjacent secondary branch lateral with an approx. Diameter <200mm

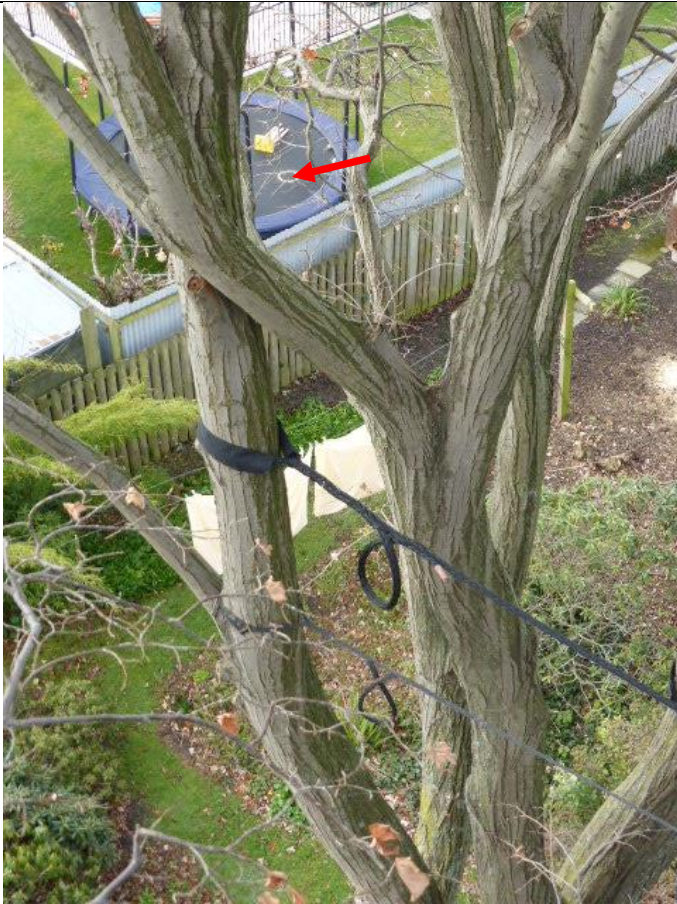
Photo 8: The secondary branch supporting Stem #1 has been pulled into the adjacent secondary branch lateral with an approx. Diameter <200mm

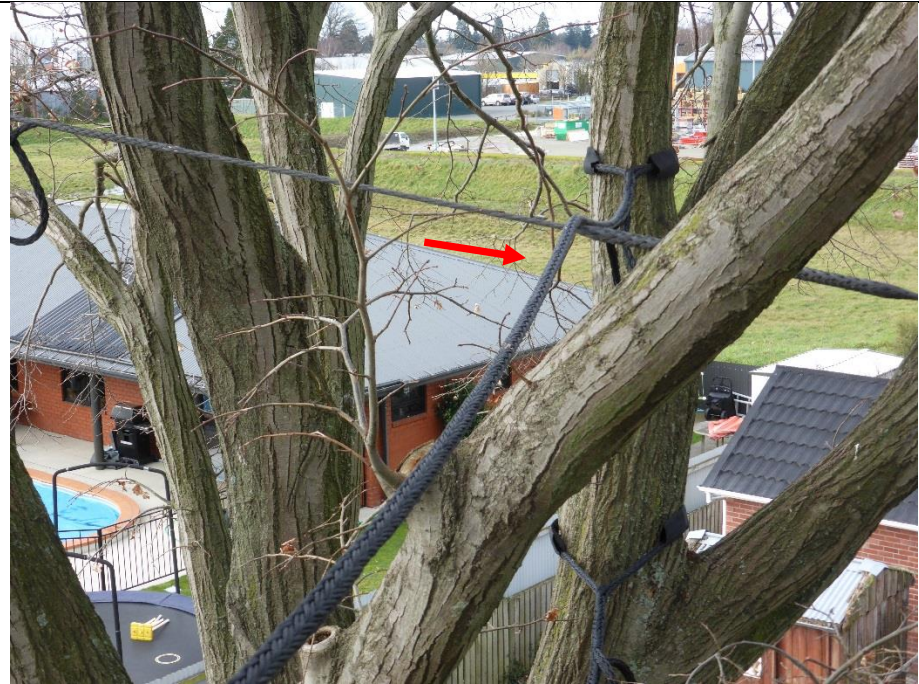
- 6.5 What is of most concern is the degree of lean of stem #1 towards Mr Drewitt's house and the inadequate attempt to mitigate the structural defect (included bark). The pre-existing brace is connected to a secondary branch, which in turn is supported by a lateral branch <200mm diameter which is supporting the entire weight of stem #1. With the pre-existing brace (indicative of a 2 ton system)

considered to be inadequate and the recently installed brace installed incorrectly with a large amount of slack, there is a high risk of stem failure.

Photo 9: Incorrectly installed 4 Ton Cobra brace with significant slack in the system note.

ISA matrices referenced in Appendix B. In view of the known structural defects identified within the tree, it is my opinion that removal of the tree is the only viable long term arboricultural solution to mitigate the risk posed by the tree.
