June 2022

# Ashburton District Council-

Playground Report  
2022

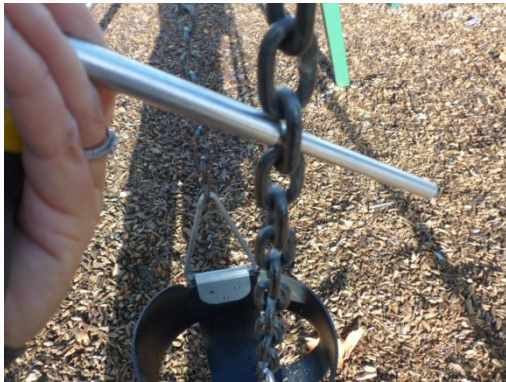
Finger entrapment in chains

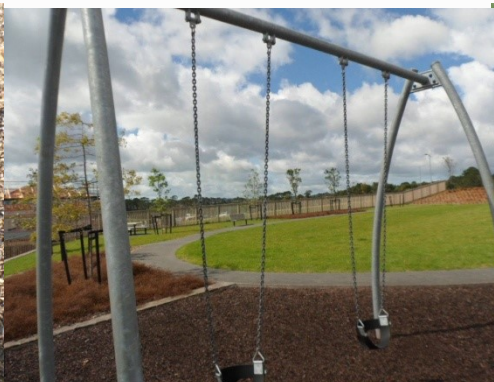
compliant chains

1. Purchase compliant chain. Compliant chain is available in NZ and is the most effective way to ensure there is no finger entrapment. The chain size must have an internal diameter of less than 8.6mm in any one direction.

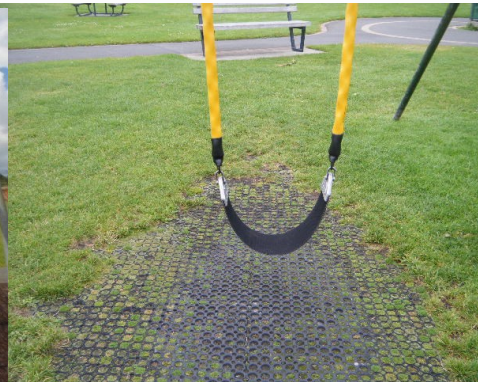
chain cover

2. Provide a swing suspension member that is not made of chain.
3. Provide a cover over the chain. This method is problematic, if the chain cover splits or comes away then the chain exposes finger entrapments. Further to this chain cover constantly gets cut, is broken, and has sharp edges. The chain underneath the cover cannot be inspected for wear. We are starting to see swing chain failure as a result of chain wearing and rusting under the chain cover. The Inspector recommends only using compliant chain and not purchasing items with chain cover on them.

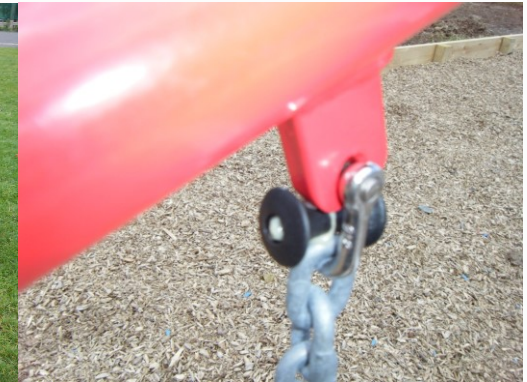
plug to fill entrapment gap in connections

4. There is a plug that can be installed on those connections that have a finger entrapment – as shown on the images
5. When swing suspensions are renewed ensure compliant chain is used.

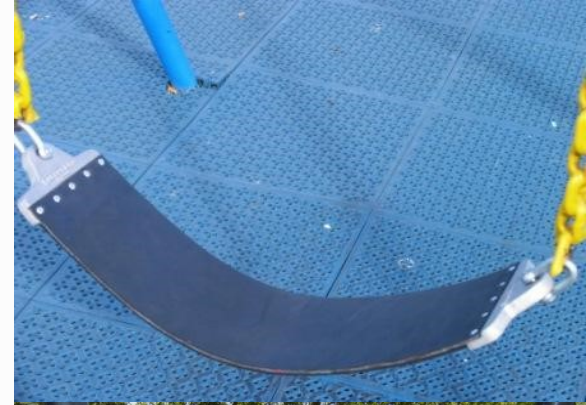
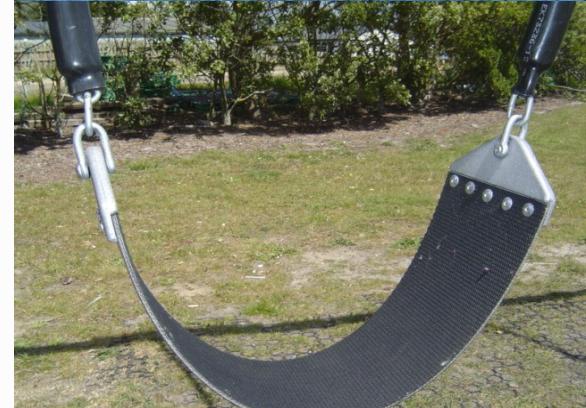
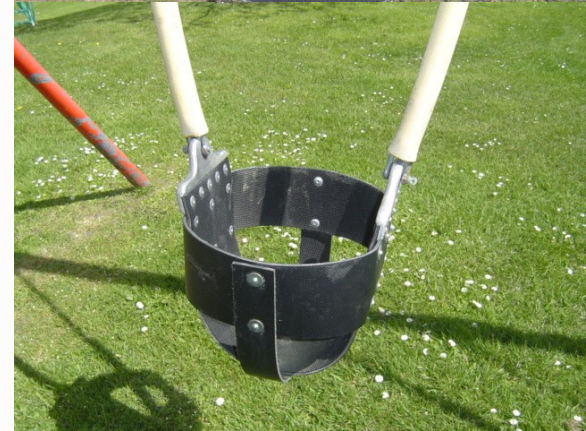
Swing seats: The type of swing seat being used by the city is wrought with problems, the metal plates lift and become sharp, the seat's rubbish perishes and allows water into the inner plate. This in turn rusts and breaks. The type of swing seat currently being used by the City requires frequent renewal. There are two alternative manufacturers in New Zealand making swing seats that have had the problems designed out of them. They get a considerable longer life out of these swing seats.

The Inspector recommends using an alternative seat to reduce maintenance replacements. A Company in Wellington is producing swing seats of a different design that does not have the problem of plates lifting. The swing seat is called 'Rubber bits' and trades under the name of Industrial conveyors Ltd, 12 Victoria Street, PO Box 30598, Petone. 04 568 6983 and fax 04 568 6536. Alternatively Dunedin District Council are making their own swing seats and may produce them for others.

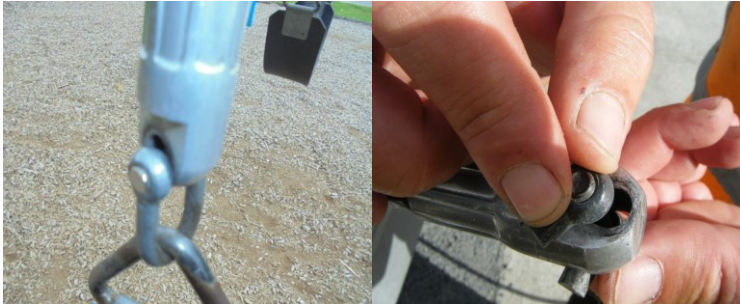
The District has a number of this type of swing connection. The swing connections wear and break at the lower end of connection. These swing connections need to be monitored and replaced as required.

Photo: swing connection and wear

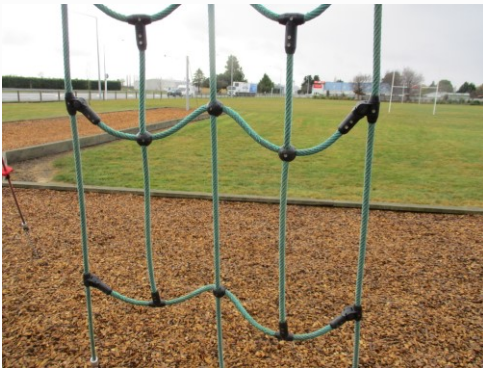
The HUCK type rope towers have plastic connections, the bolts within the connection rust and break. The cap comes off allowing the pin to come loose. The connecting eggs move allowing rope sizes to shift.

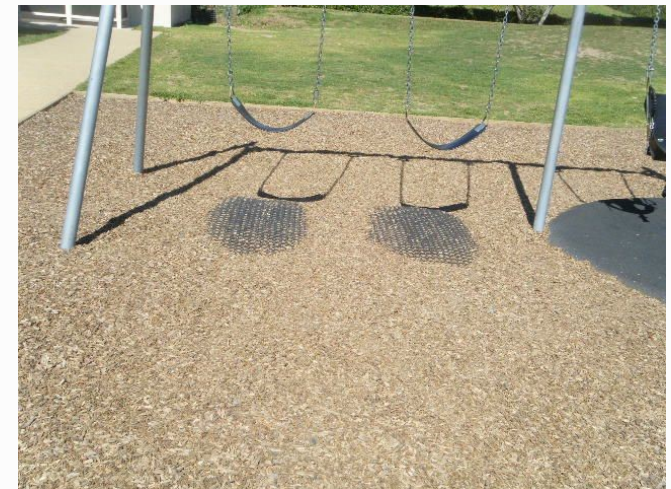
There was a constant problem with the high wear areas being badly scuffed out. In many cases the compliance and impact absorption qualities of the surface was compromised by the high scuff areas.

In order to rectify this issue it is recommended that scuff mats are installed under high wear areas.

Installation methodology is to place a pile of cushionfall at ground level.

Mats are laid over the top of the cushionfall and pegged in 8 places

The cushionfall is returned around the mat exposing only the top approx. 500x500mm.

The aim is that only an area of scuff mat is exposed with all the edges and corners well covered by cushionfall.
