Appendix V Preliminary Site Investigation (Contaminated Land)

Ashburton Chalmers Avenue Bridge Preliminary Site Investigation

PREPARED FOR Ashburton District Council | February 2022

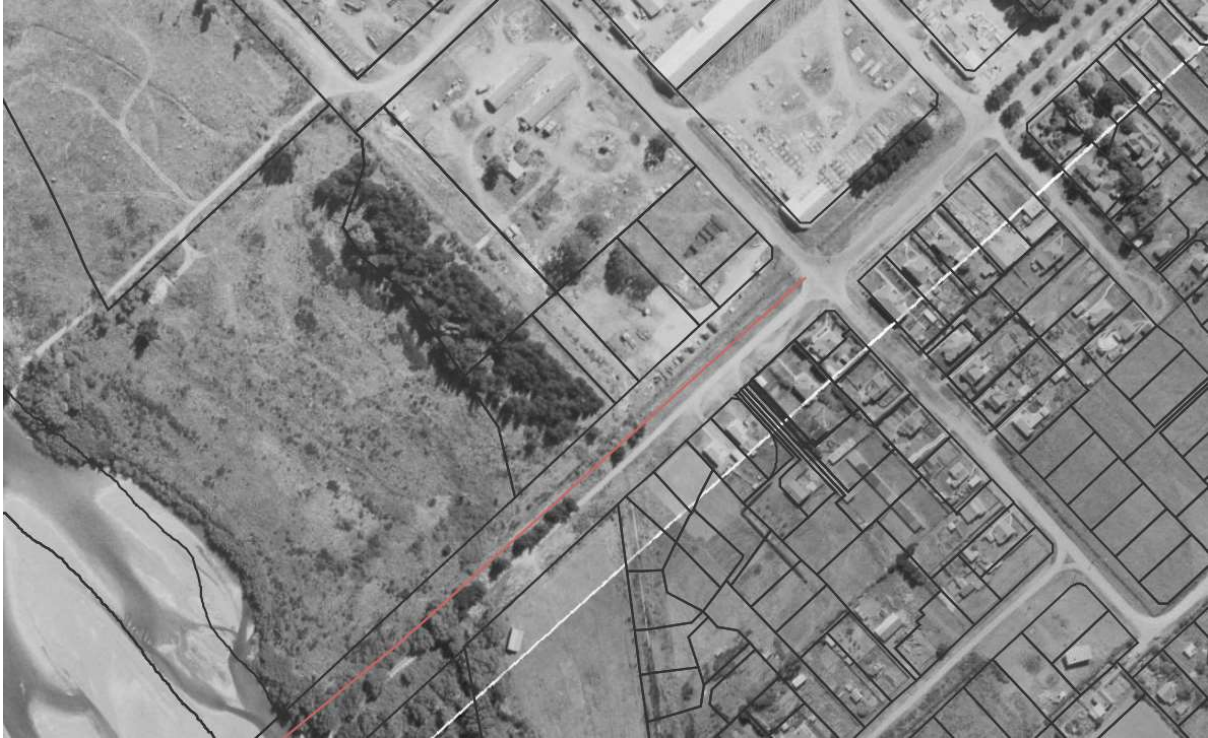
1955-1959	South of Chalmers Avenue is further developed residential. North of Chalmers Avenue looks to be used as a yard of some sort. Some sheds and stockpiles of material are visible. Land northeast of the corner of South Street and Chalmers Avenue is now developed industrial with a warehouse and stockpiles of material around the property, potentially timber from a treatment facility (HAIL A18). The borrow pit has now been filled in (HAIL G5) but has been assessed as being far enough from the project alignment to be highly unlikely to pose a risk to human health or the environment.	The 4wd track to the river's edge is more established. This area is generally unchanged from previous imagery.	East of Carters Terrace the alignment now crosses through an area of market gardening (HAIL A10) at what is now 61 Carters Terrace. Carters Creek has now been diverted to an established drain. The alignment passes through a small grouping of farm buildings at present day 119 Grove Street.

Figure 3: 1955-1959 Image showing development along the north part of Chalmers Avenue

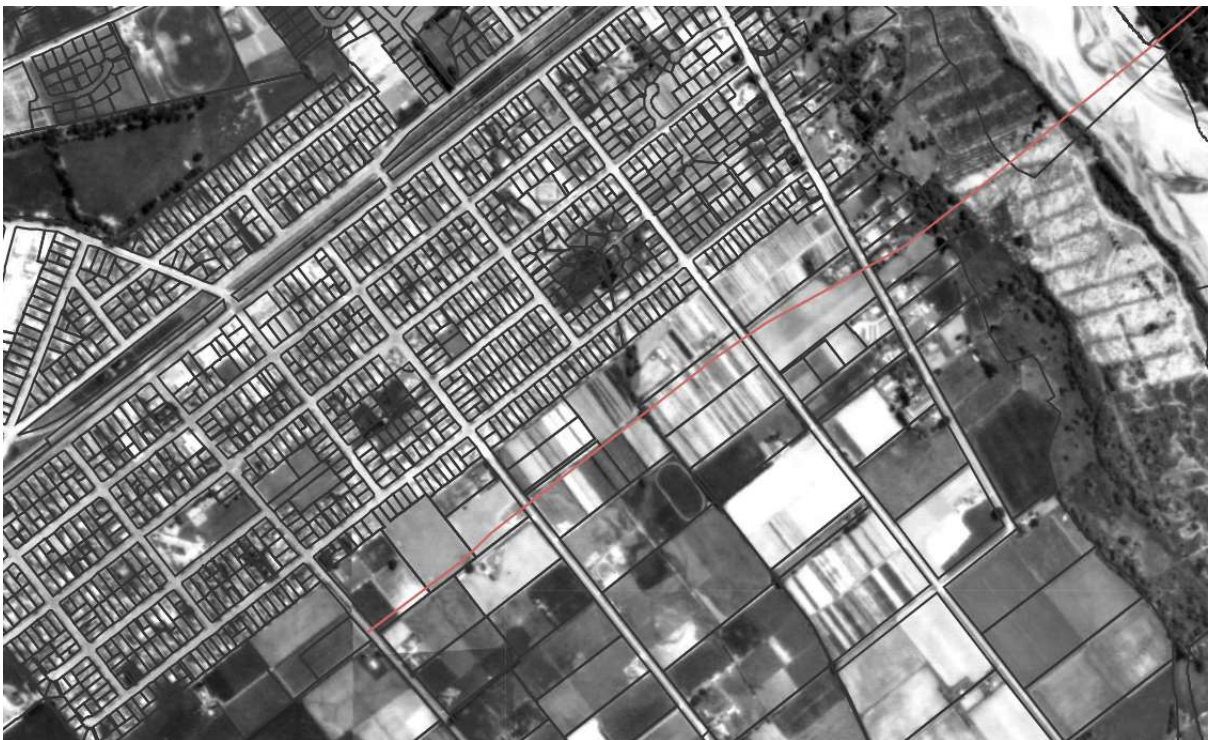
- HAIL A10 market gardens were found to historically have taken place across land between the west edge of the riparian zone lining the Ashburton River through to Johnstone Street.

Figure 4: 1985-1989 image showing market gardens between Wilkin Street and Johnstone Street

It is recommended that land between Carters Terrace and Johnstone Street and along Chalmers Avenue between 3 Chalmers Avenue and the intersection with South Street should be investigated as part of a Detailed Site Investigation.

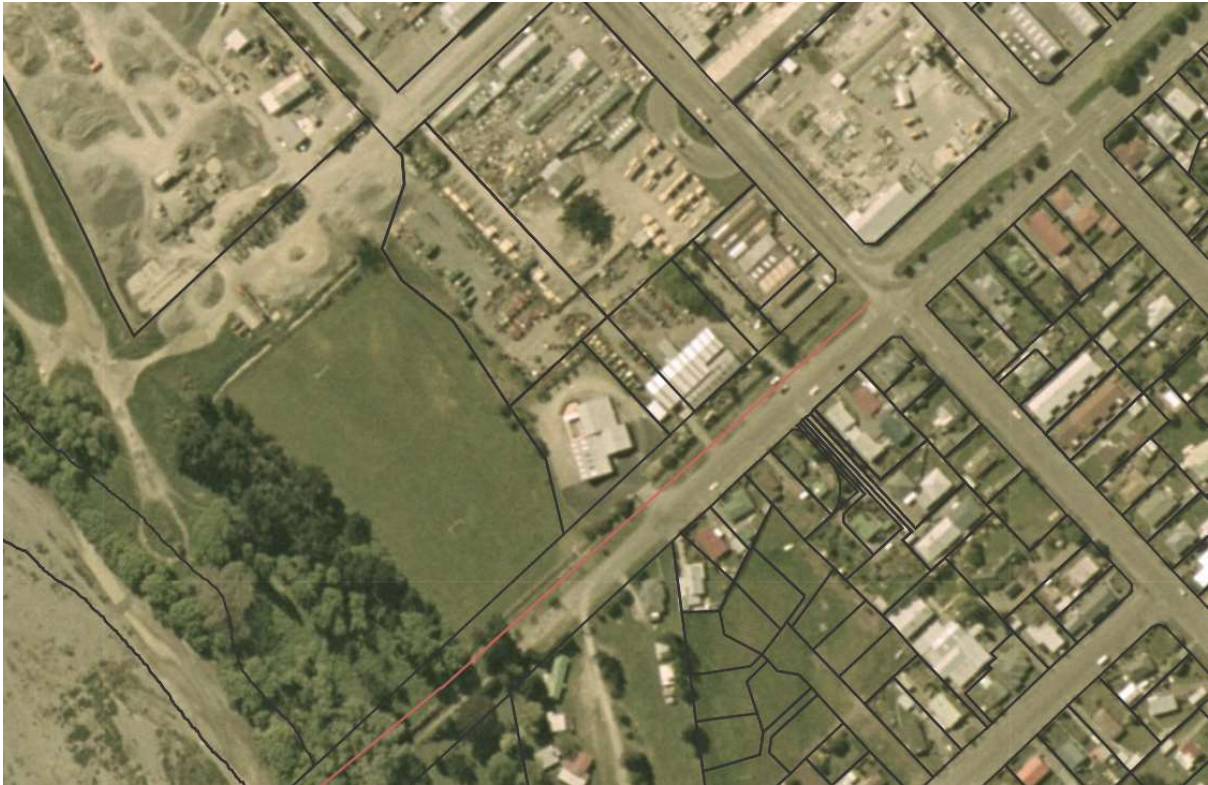
Figure 5: 2004-2010 image showing tractor dismantling yard and concrete manufacturing along Chalmers Avenue

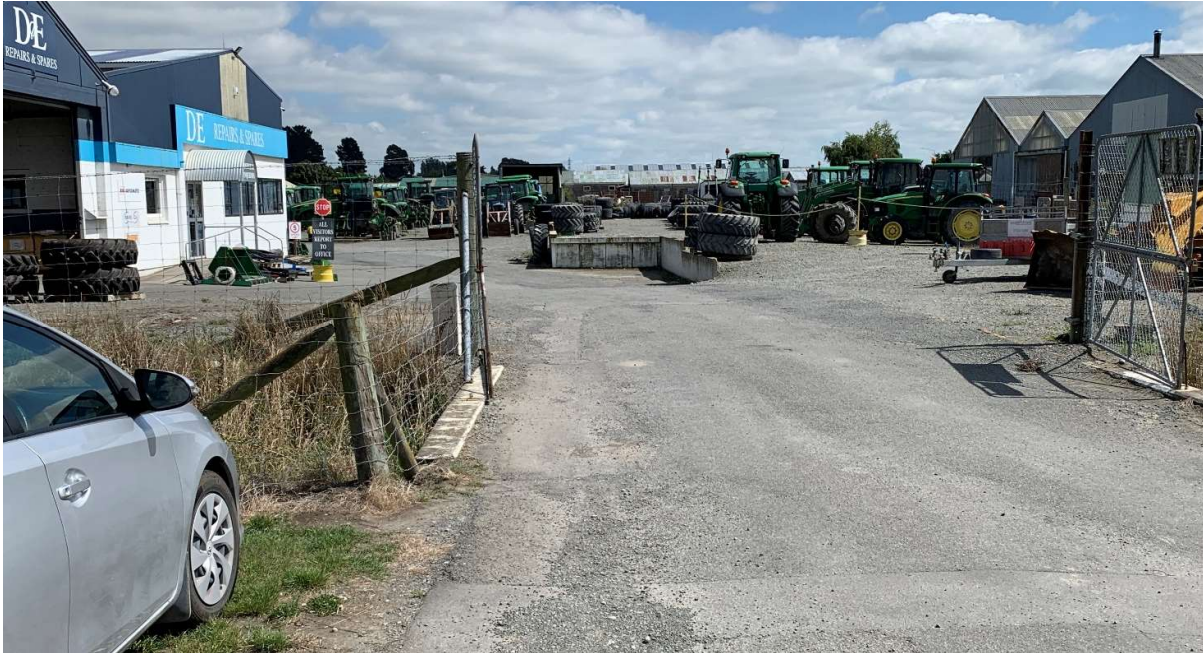
- Located at 5 Chalmers Avenue is D&E Repairs and Spares which is a tractor repair facility (HAIL F4). Many salvage tractors were present in the yard. Areas of visible staining were noted.

Figure 6: D&E tractor repair and sales. Note the bridge over the channel in foreground

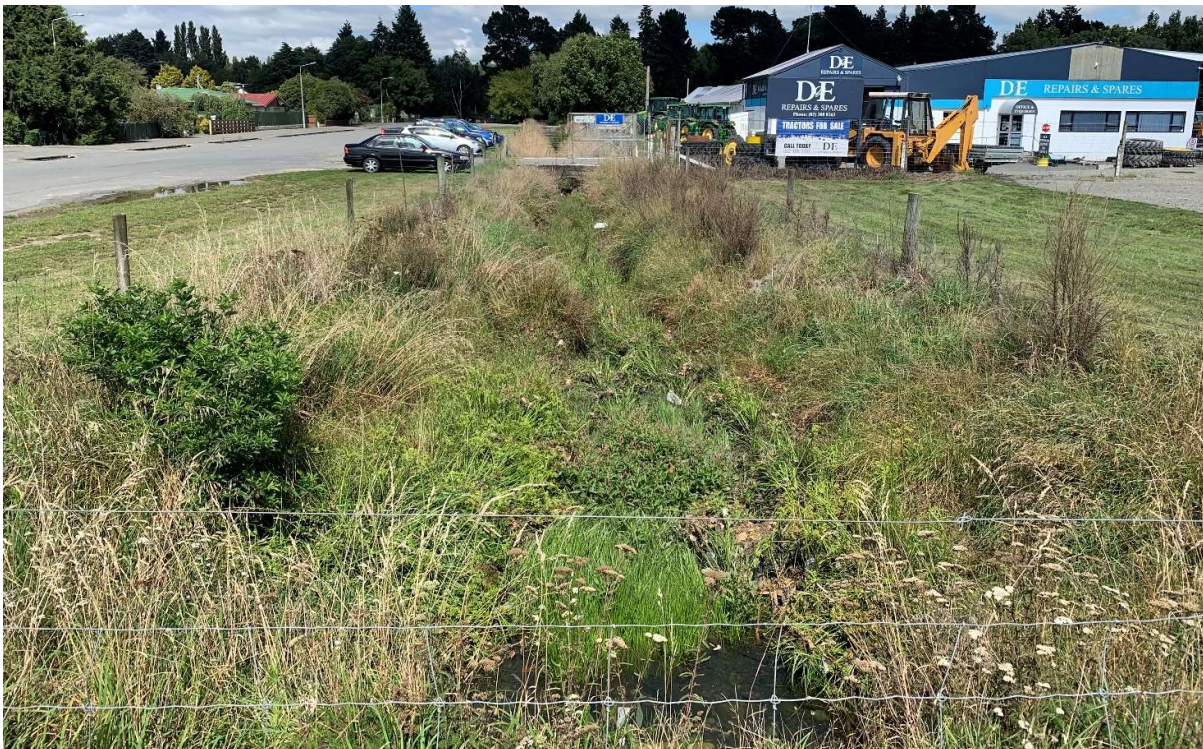
- An open drain runs east to west along the north side of Chalmers Avenue from the intersection with South Street. The drain is approximately 1.5m wide by 2m deep. It separates the HAIL sites to the north and Chalmers Avenue.

Figure 7: Channel running along north side of Chalmers Avenue

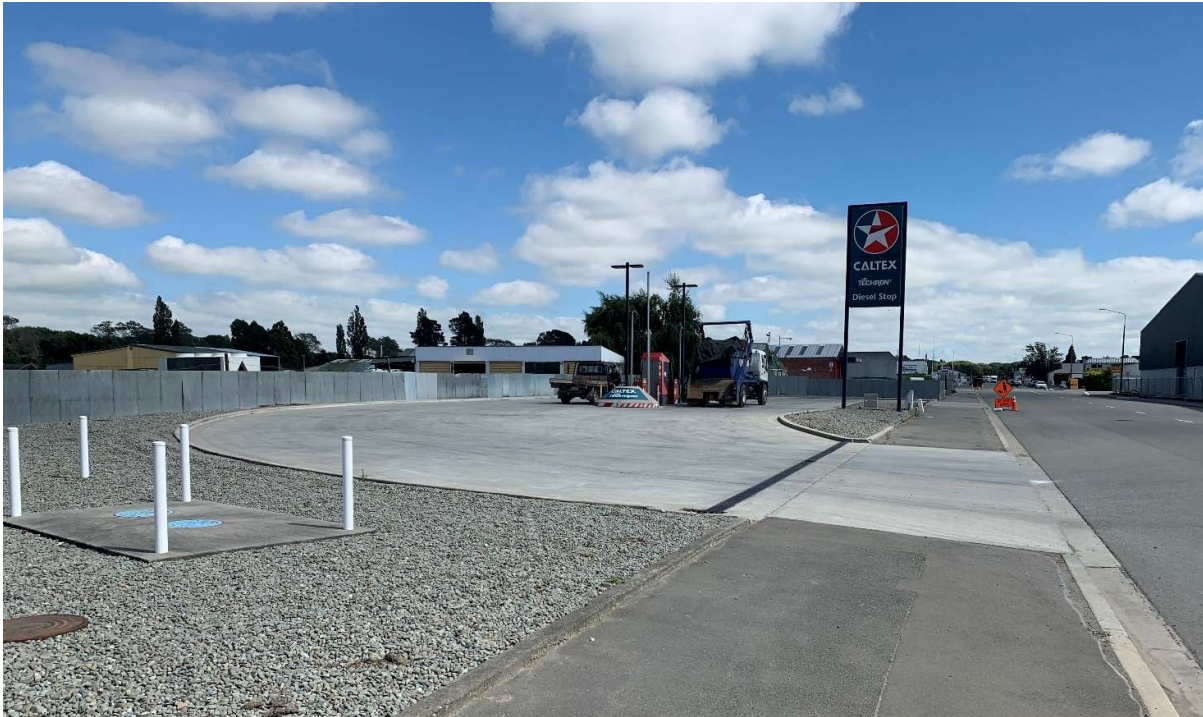
- The Luisetti building on the northeast corner of Chalmers Avenue and South Street is fully paved and tidy. No indication of HAIL activities noted.
- A Caltex Ashburton is located at 128 South Street 110m north of the site (HAIL F7). The site is modern and fully paved with no evidence of spillage or leaks.

Figure 8: Service station at 146 South Street

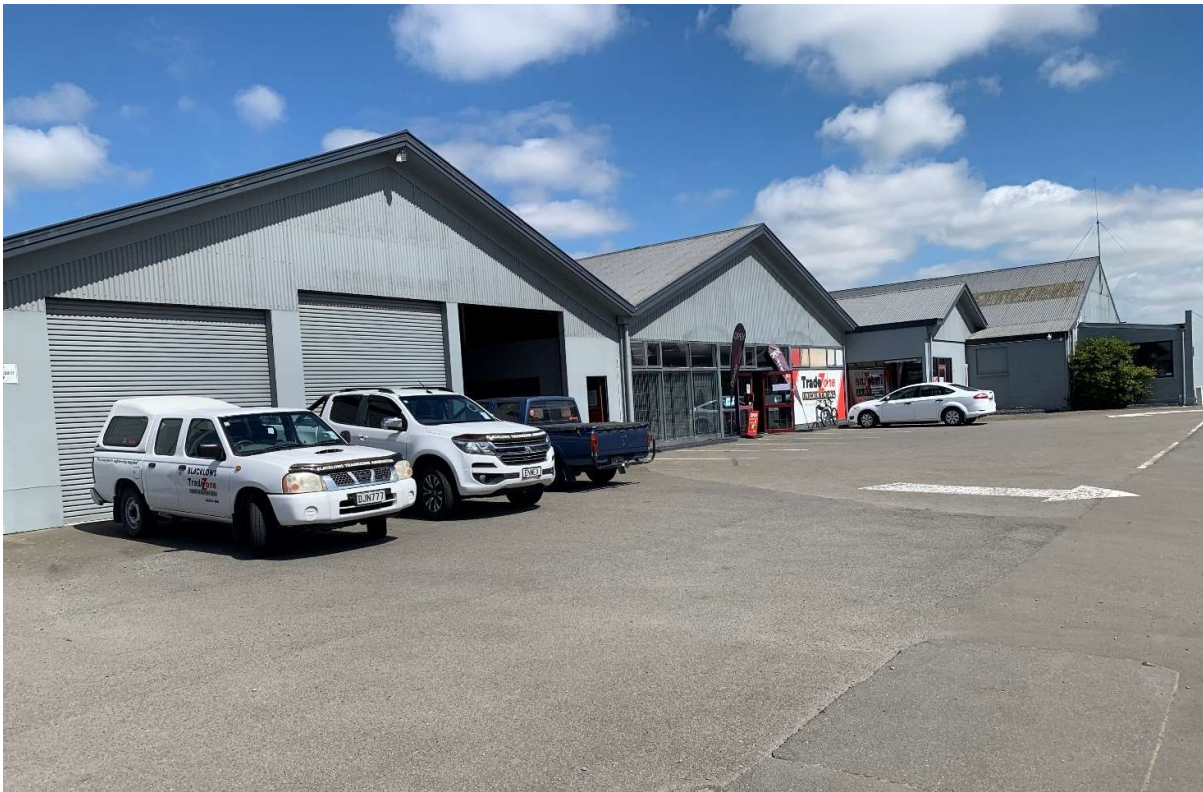
- On the northwest corner of South Street and Chalmers Avenue is Blacklows engineering supplies. Their website states they do engine reconditioning (HAIL F3). The site was predominantly paved with a small number of drums behind the shop. No evidence of spillage was noted.

Figure 9: 126 South Street showing the Blacklows facility
