Arboricultural Report

Damage to Protected Common Lime - 30 Queens Drive, Ashburton

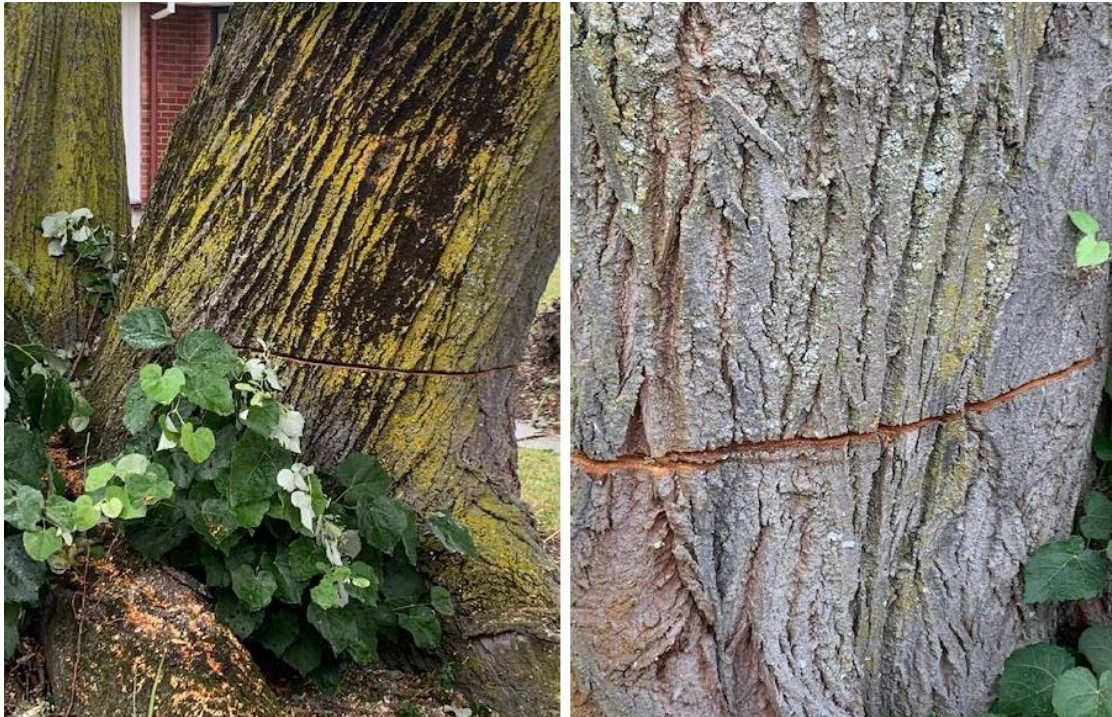
Image 1: Showing ring barked stems (supplied)

- 2.1 As can be seen on the attached inspection record and images, each of the three stems have sustained a chainsaw wound around a portion of their circumference. Stem A has had 64% of the circumference cut, Stem B 28% has been cut and Stem C has had 44% cut.

- 2.2 In my view, these percentages are not sufficiently high enough to cause the short-term death of the tree as satisfactory conductivity remains to ensure the roots receive starch and other assimilates from the canopy, and that the canopy is conversely provided the moisture it requires from the root system.

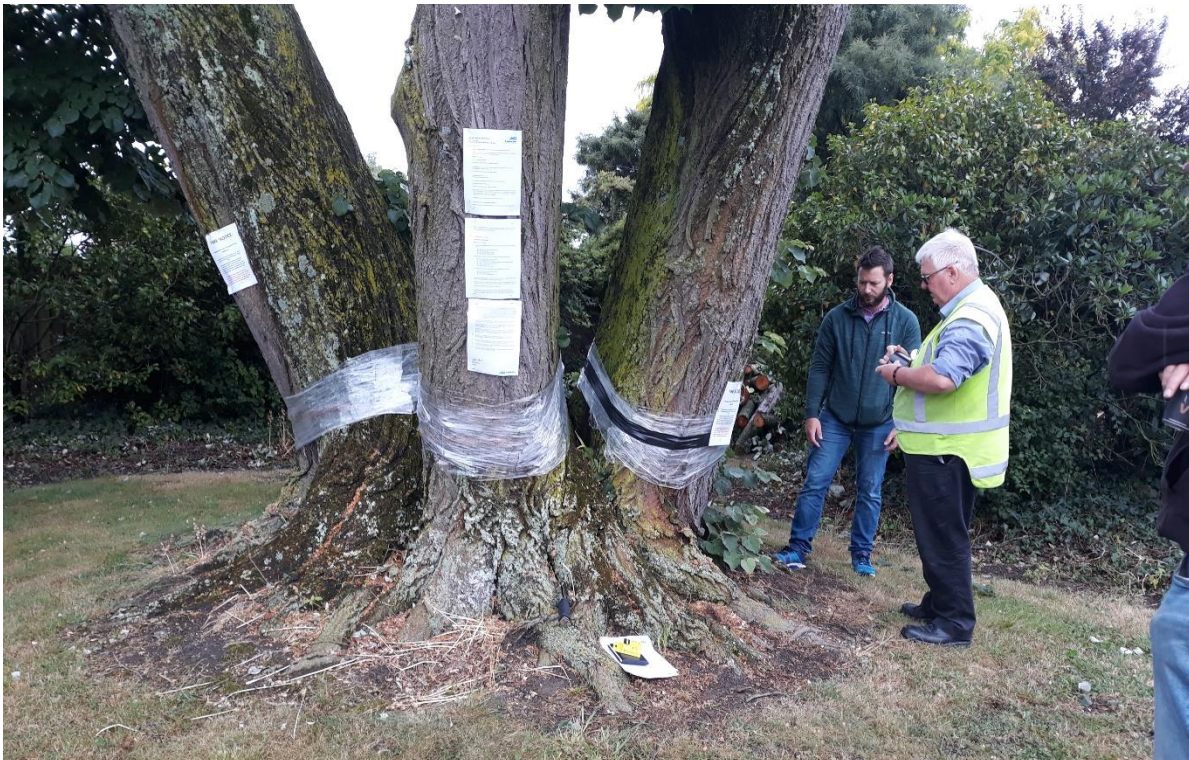
- 1.3 In an effort to mitigate the wounding that had occurred to the tree, the wounds had been packed with moist sphagnum moss under plastic as is the recommended practice in such events (image 2). This was done to ensure the cut cambium surfaces did not dry out to aid restoration of the tree's cambium.

Image 2: Showing initial treatment of wounds to damaged lime tree (supplied).

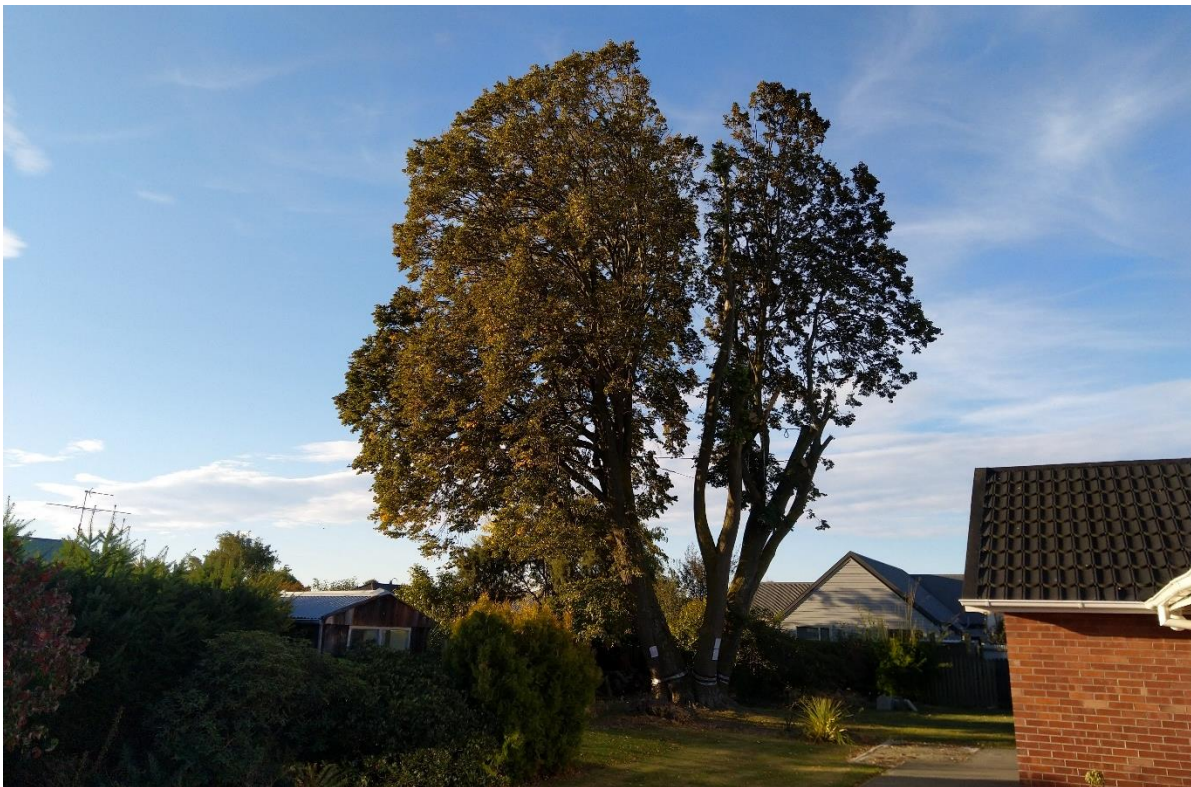
- 2.3 During my visit to the site in March I noted that the remaining canopy was unaffected by the ringbarking. By late April the canopy was still full and healthy, and some regrowth was observed arising from the truncated stems (see image. 3). If the cuts had been more severe then canopy death would have resulted.

Image 3: Showing canopy cover on April 29, 2021.

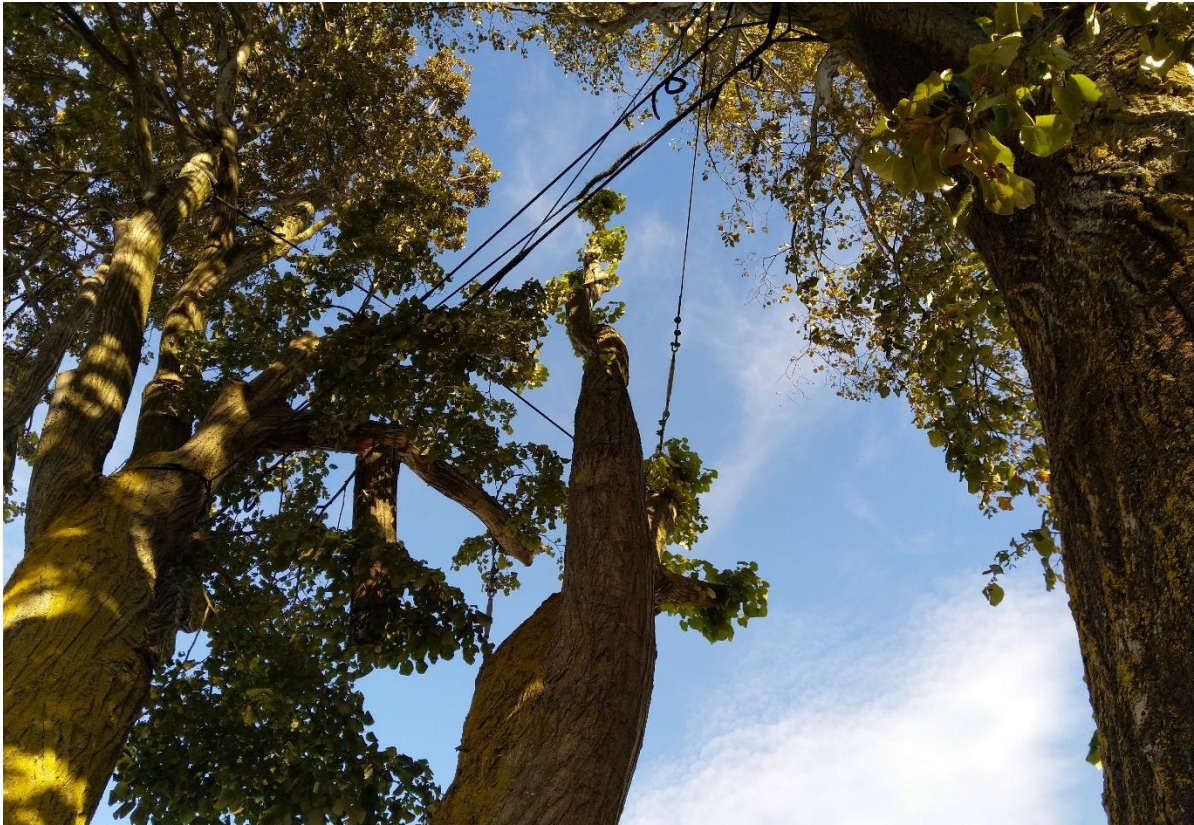
- 2.4 The tree has a cable support system installed in the canopy (image 4). One or two of the cables appears to have been cut during the partial removal of the tree however the canopy still appears to well supported. Further closer inspection of the support system will be required.

Image 4: Showing cable support system installed in the tree. Regrowth on the truncated stems can also be observed (April 29, 2021).

- 3.3 To that end a complete grown reduction will be required to balance the canopy. Additionally, the cable support system will require reassessment and corrective steps taken if necessary.

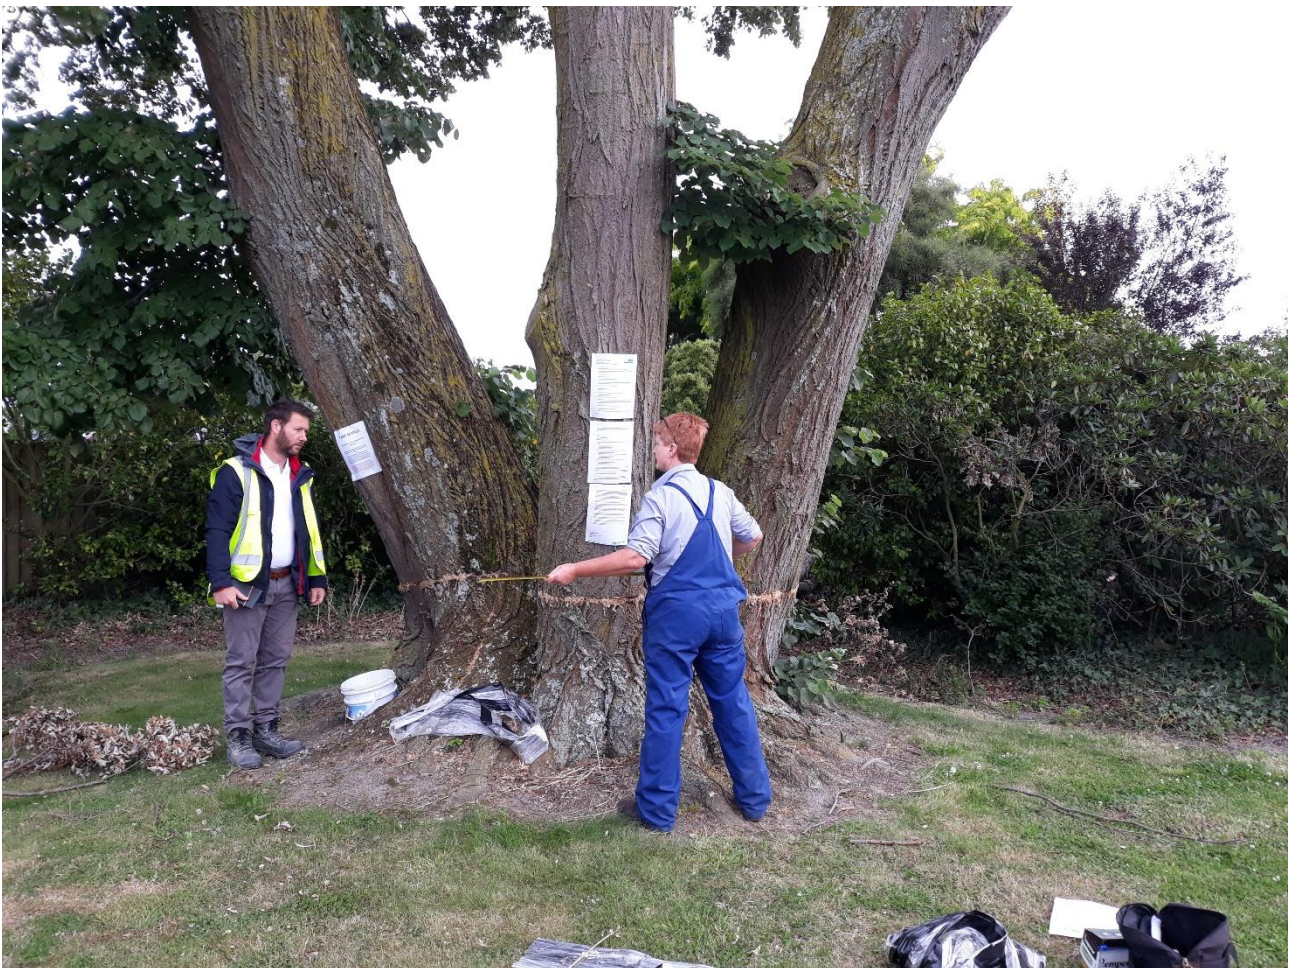
Figure 1 Tree as unwrapped looking from east to west saw cuts seen as where sphagnum moss has been inserted.

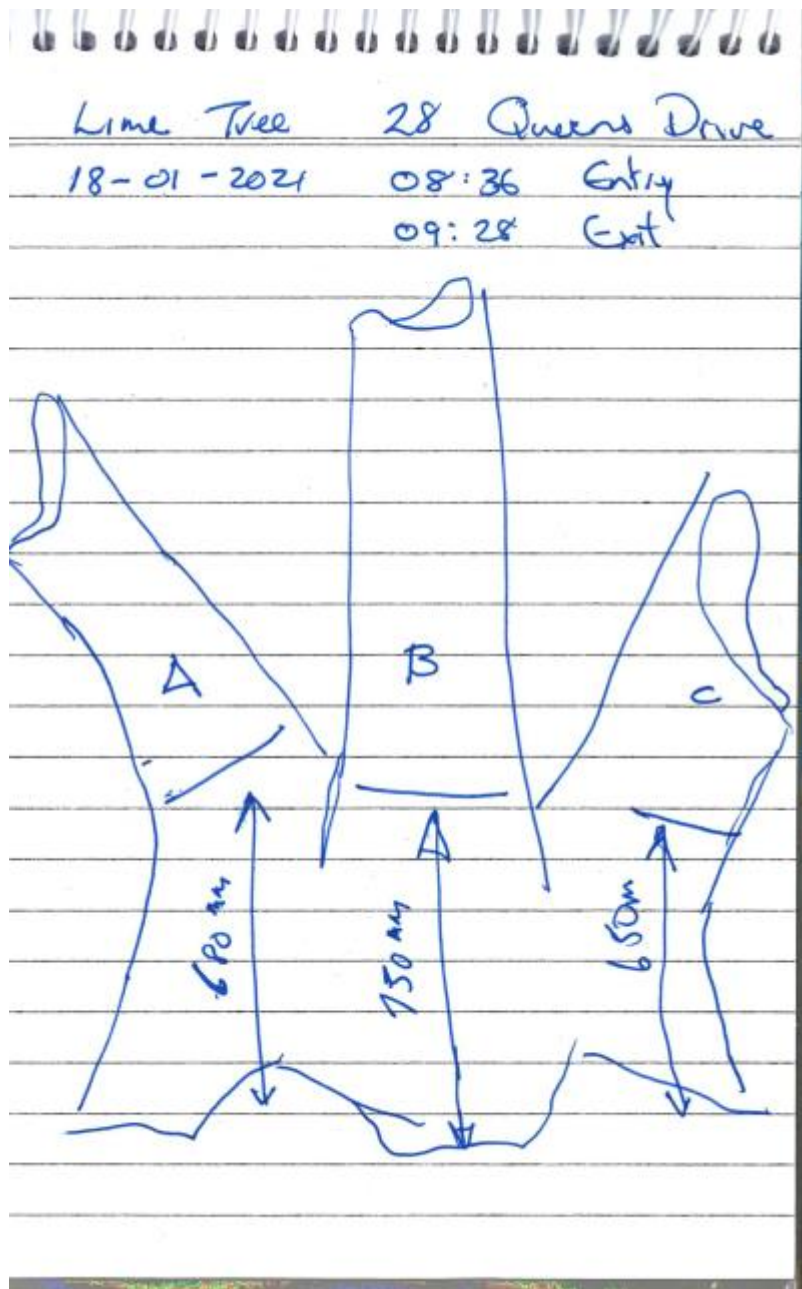
Figure 2 site note showing height of saw cuts and position on trunks looking from east to west.

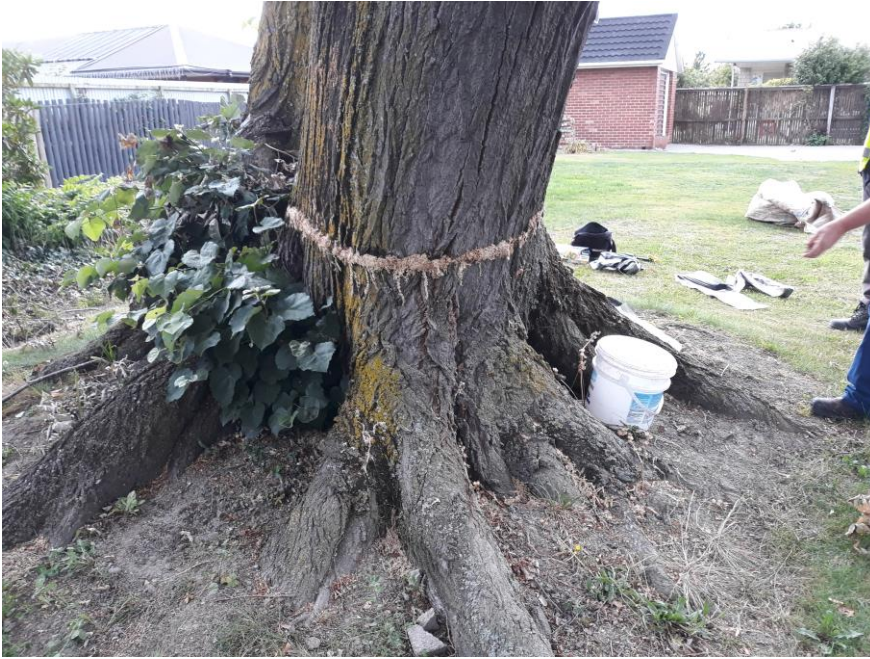
Figure 3 Trunk A 1400 mm cut 43 mm to 37 mm deep. Cut on front 650 mm 33 mm deep. Circumference 3200 mm.

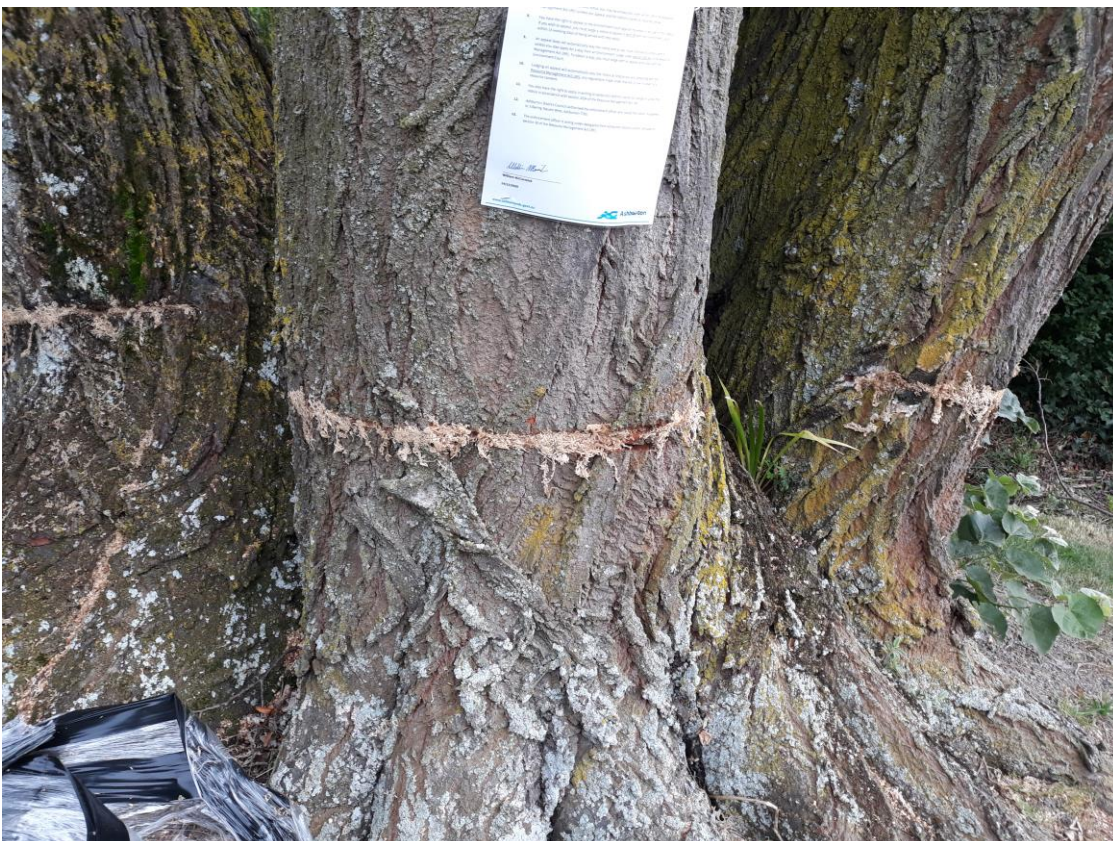
Figure 4 B saw cut 620 mm long and 62 mm deep. Circumference 2200 mm.

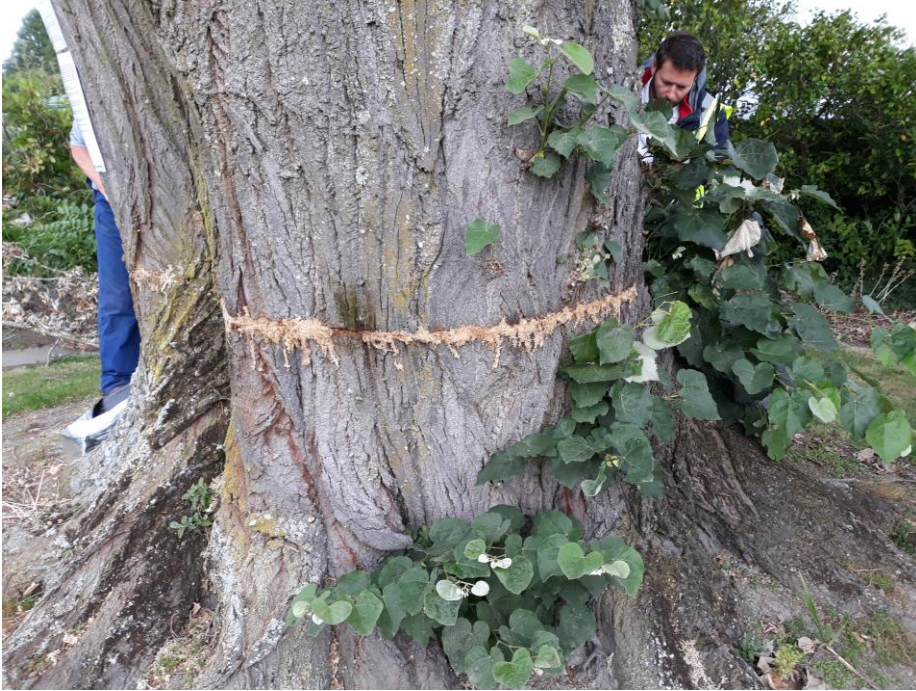
Figure 5 C saw cut 1300 mm and 34 mm deep. Circumference 2930 mm

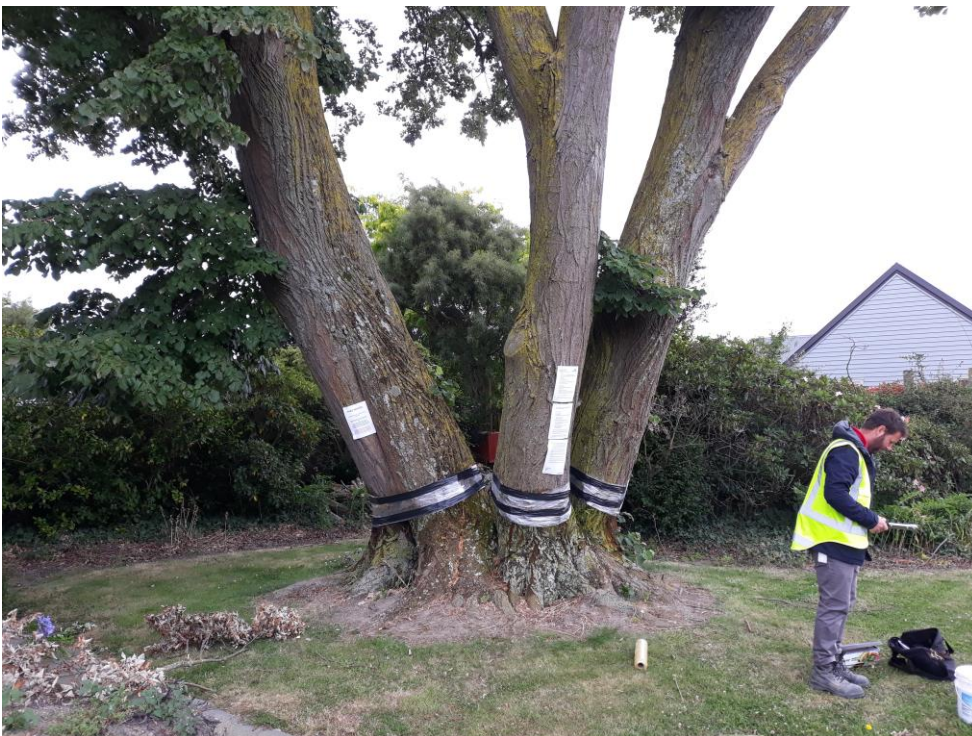
All cuts were checked no health issues showing and moss was wet and rewrapped.

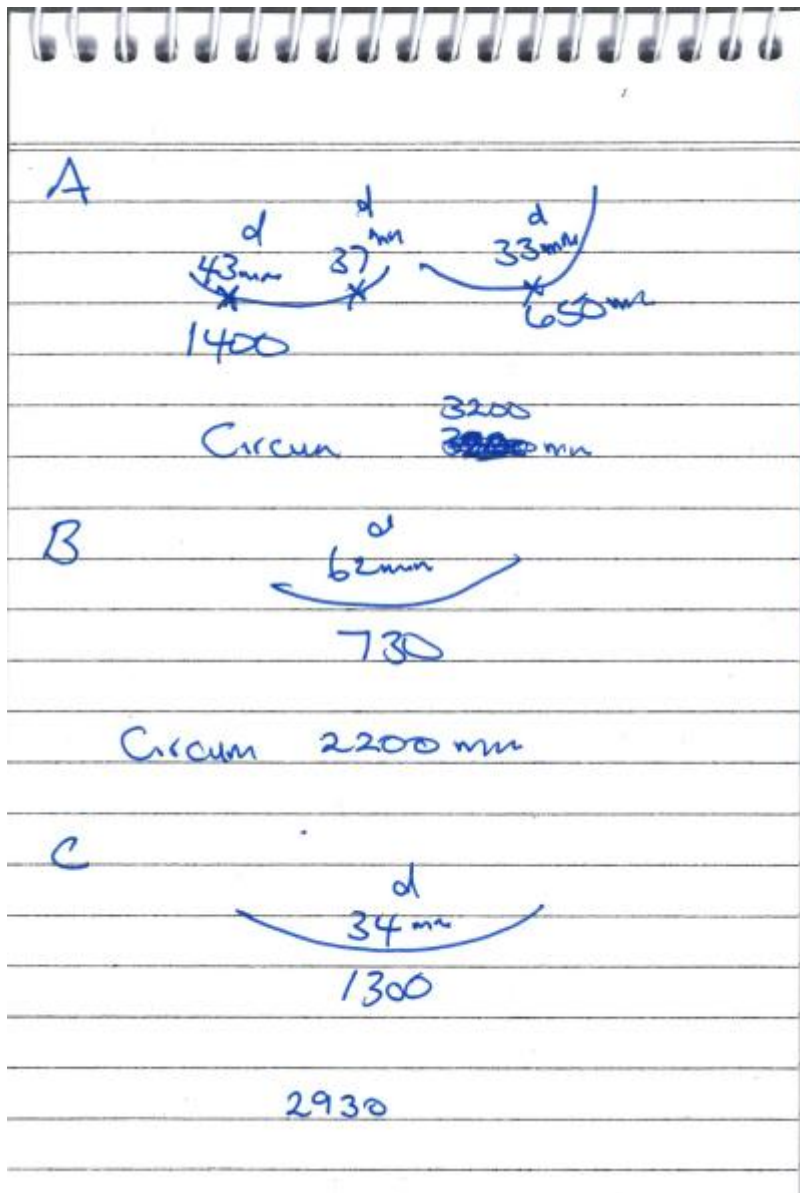
Figure 6 Site note of cut size and depths.

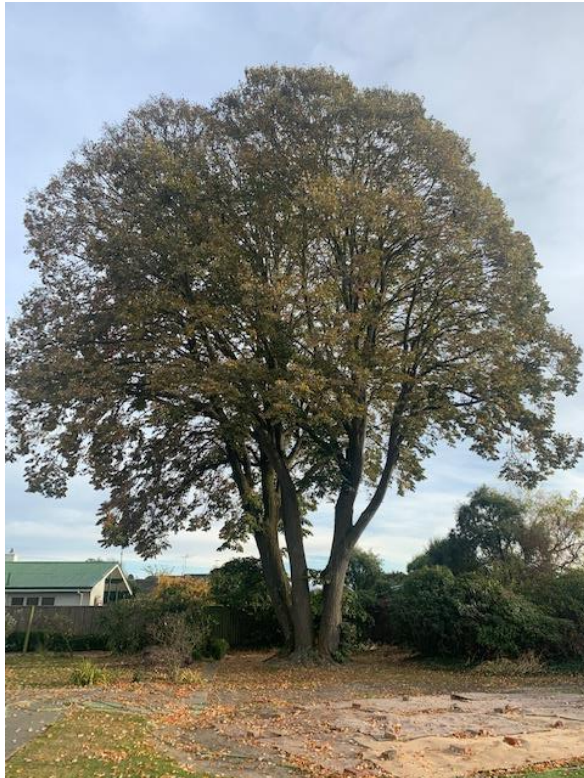
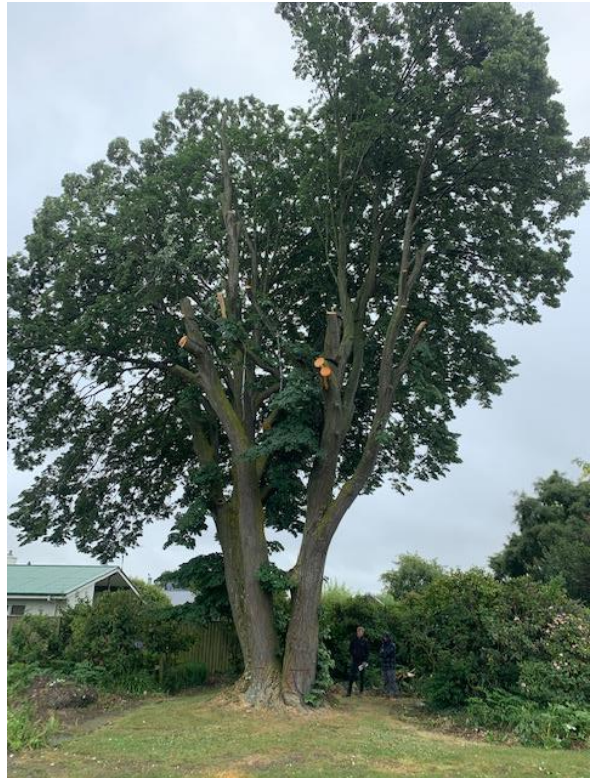
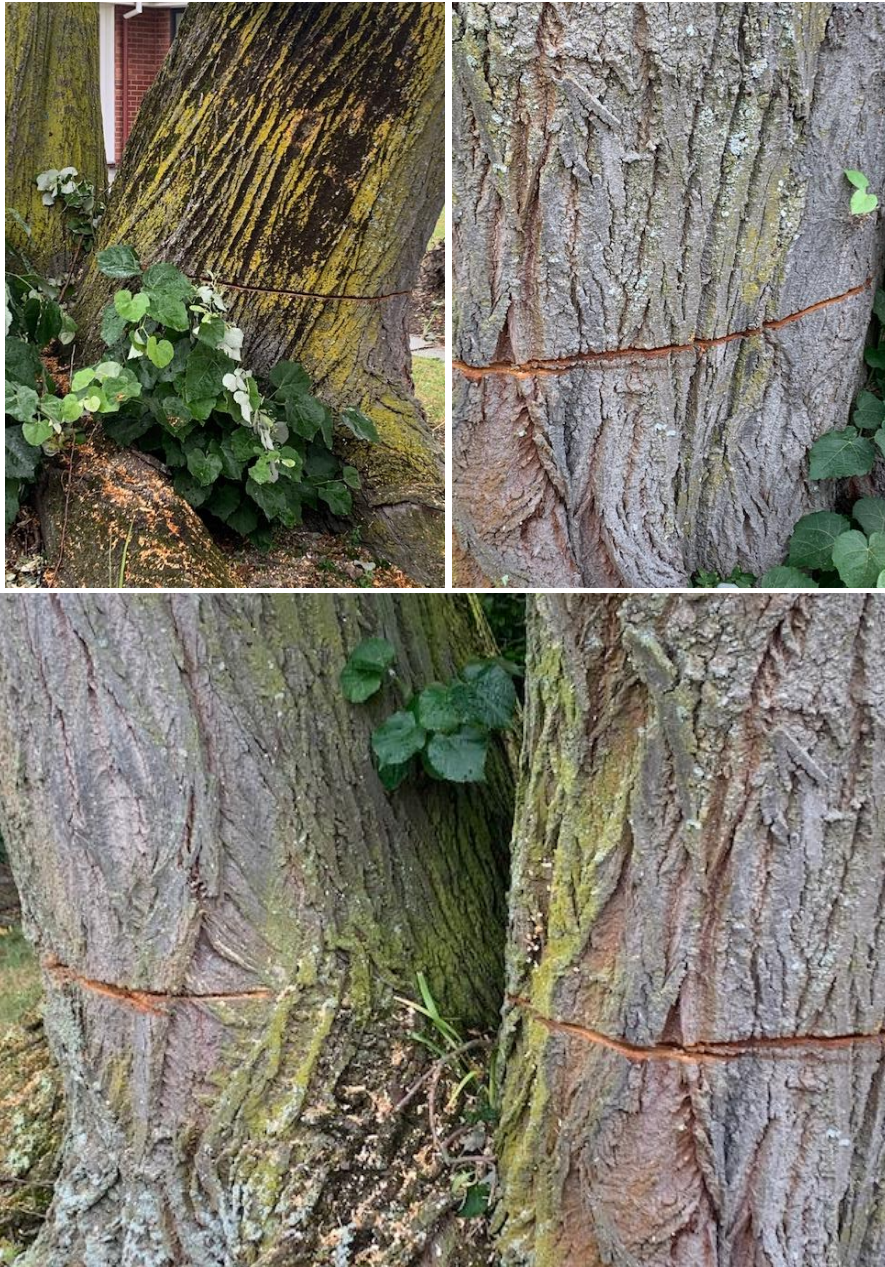
Here is a photo of the tree taken May 20 and again on 21 December 20.

Unfortunately work had already been undertaken leaving the tree significantly damaged and unbalanced. This work has affected the aesthetics of the tree and also possibly causing a health and safety issue due to the unbalanced weighting of the tree.

Not only has there been damage to the upper canopy, the tree has also been ring barked with a chainsaw – see pictures above. This is across most of the base of the stems but not

the whole base - therefore it is possible sap flow could continue to occur within the tree (this could be a slow process requiring regular monitoring).

I would recommend a full crown reduction to take all the wind loading out of the tree and to then monitor the trees health regularly for any dieback which may occur during the ring barking process.
