# Methven Springfield Water Supply Water Safety Plan

**Version 2.0: November 2017**

Andrew Guthrie  
Assets Manager  
Ashburton District Council

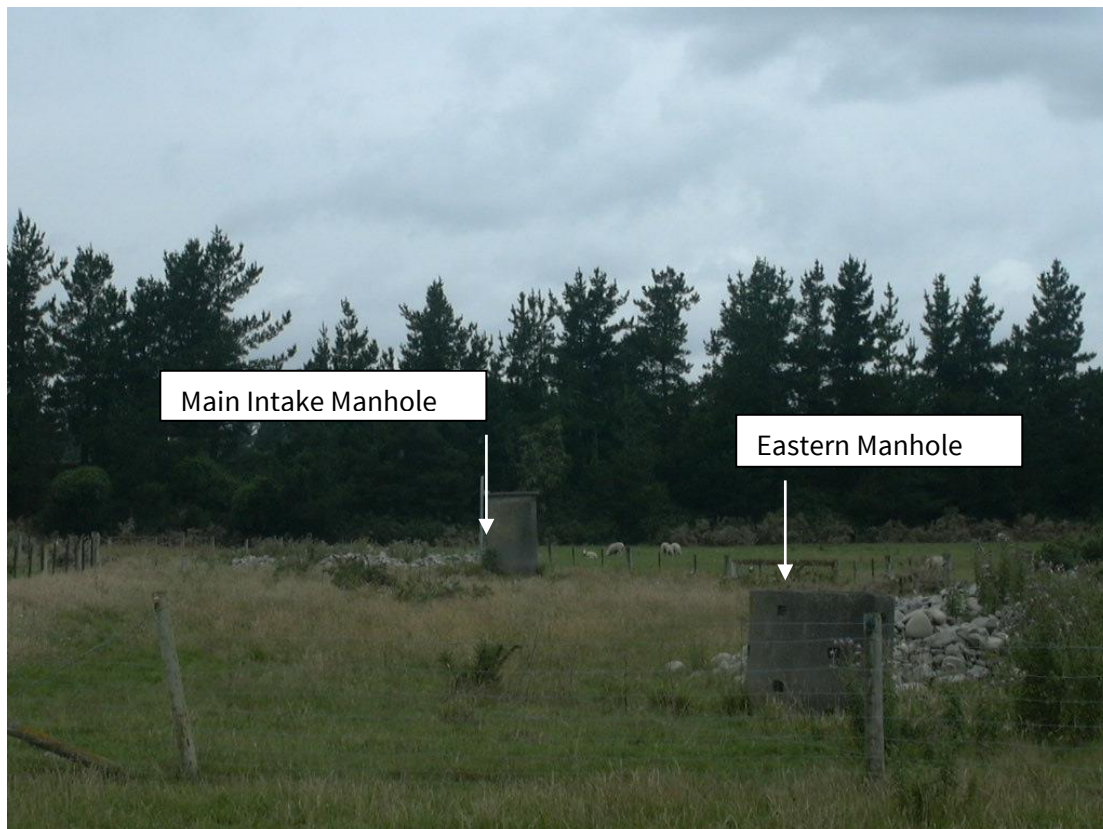
The eastern manhole is 103.2m from the main manhole and two 200mm diameter perforated Class C PVC pipes running in parallel join the two. The perforated pipe has 54 10mm holes per metre and has a level of 403.3m under the eastern manhole and a level of 402.05m under the main manhole.

The trenches that the laterals are laid in were filled with a 50mm deep bedding layer of 25mm pea shingle before the perforated pipe was laid. Another 200-300mm of pea shingle was then placed around and on top of the pipe. The cover was finished with a 100-150mm deep layer of 6mm chip.

*Photograph No 1 – Infiltration gallery, access chamber*

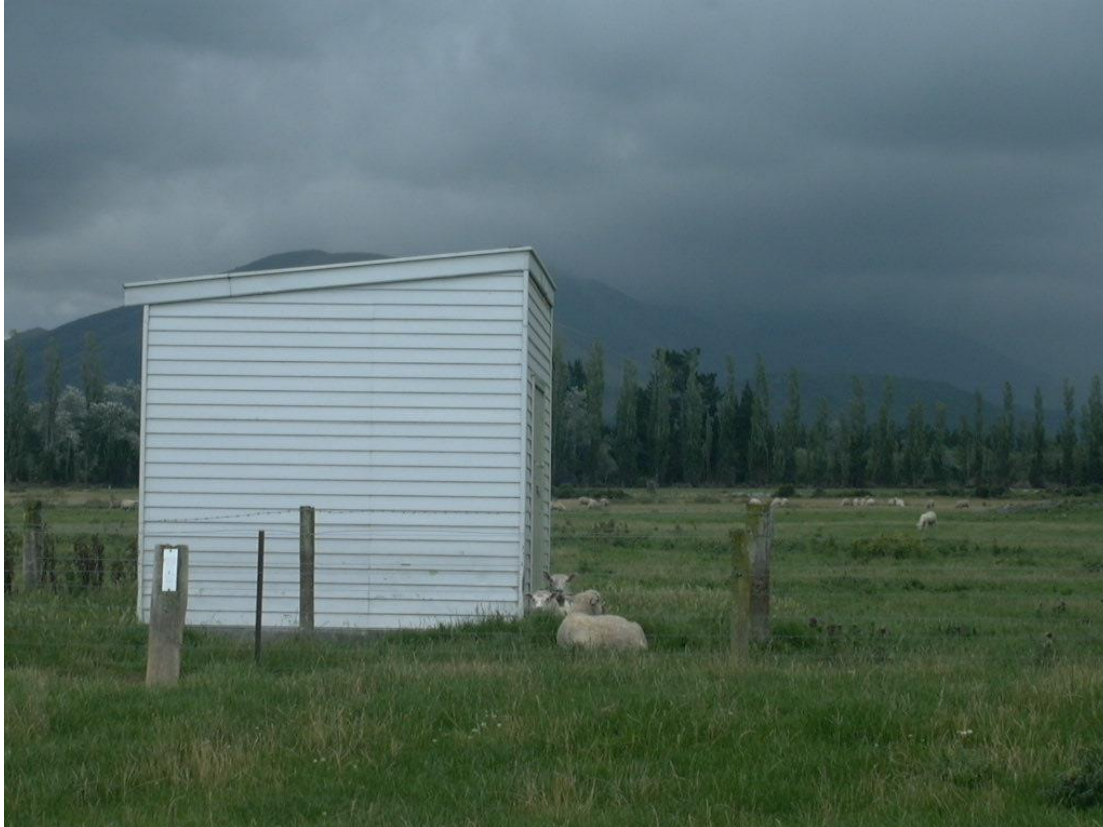
The Raw Water Trunk Main travels 460m south from the infiltration gallery to the old chlorination shed that is also located on private property. Inside the shed is an ABB electromagnetic flowmeter with a GPRS data logger. The trunk main is 200mm dia Class B PVC pipe.

*Photograph No 2 – Old chlorine shed on raw water trunkmain route*

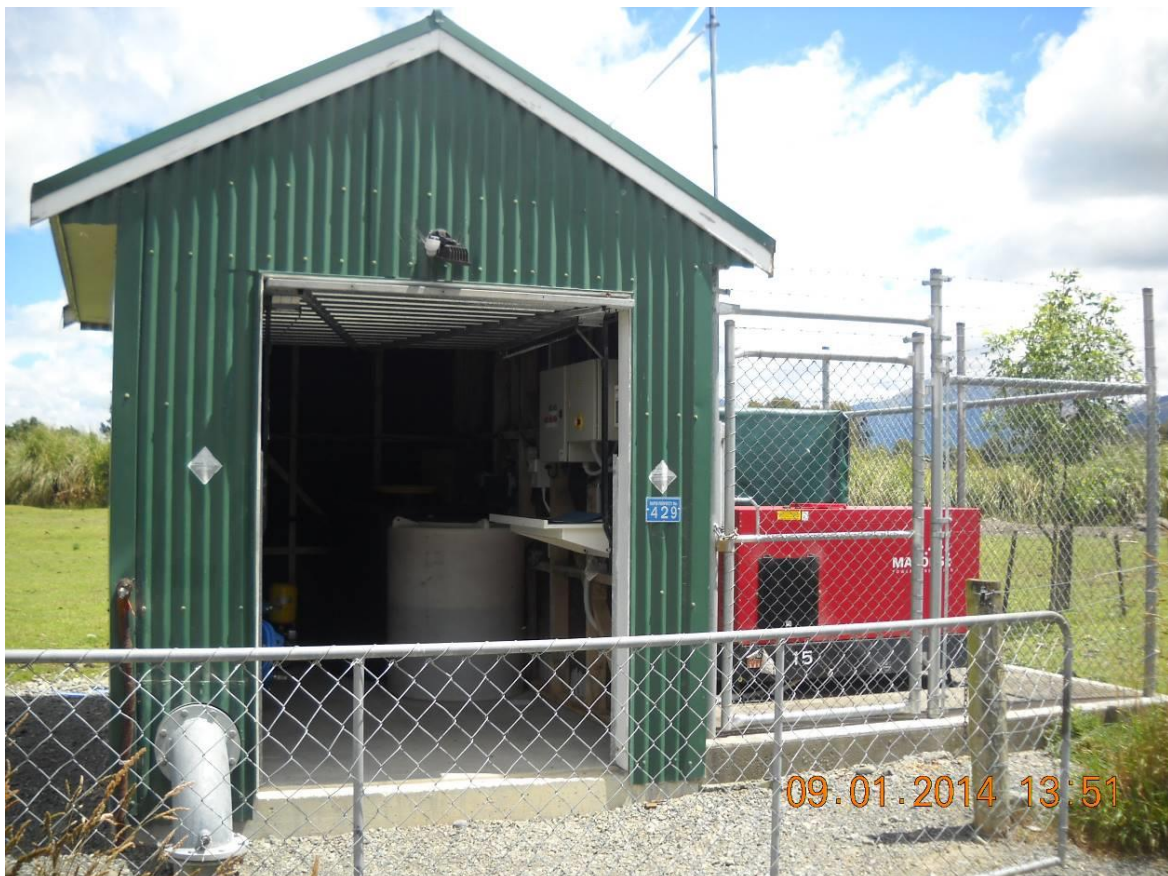
*Photograph No 3– Treatment shed with chlorine storage tank and back up generator visible.*

A standby power generator is installed and is sufficient to operate the treatment equipment in the event of a power supply interruption.

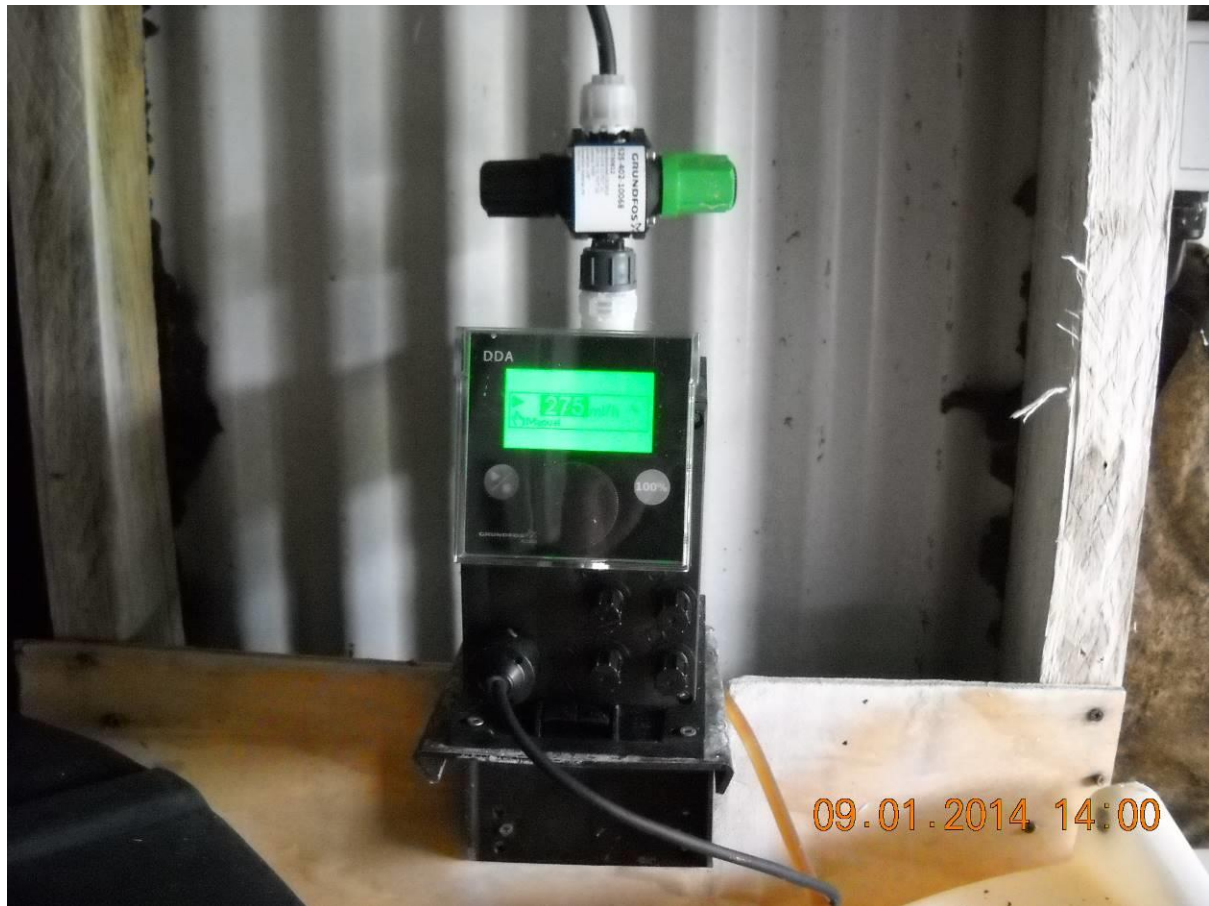
The raw water is dosed with 13.5% sodium hypochlorite solution at a fixed dose rate before passing through a (non-validated) UV disinfection system and then to the reticulation. There is no filtration of raw water at present. Pipework allows the system to be by-passed if necessary for maintenance. Water continually runs through the plant unless it is shut down for maintenance.

*Photograph No 4– Chlorine dosing pump*

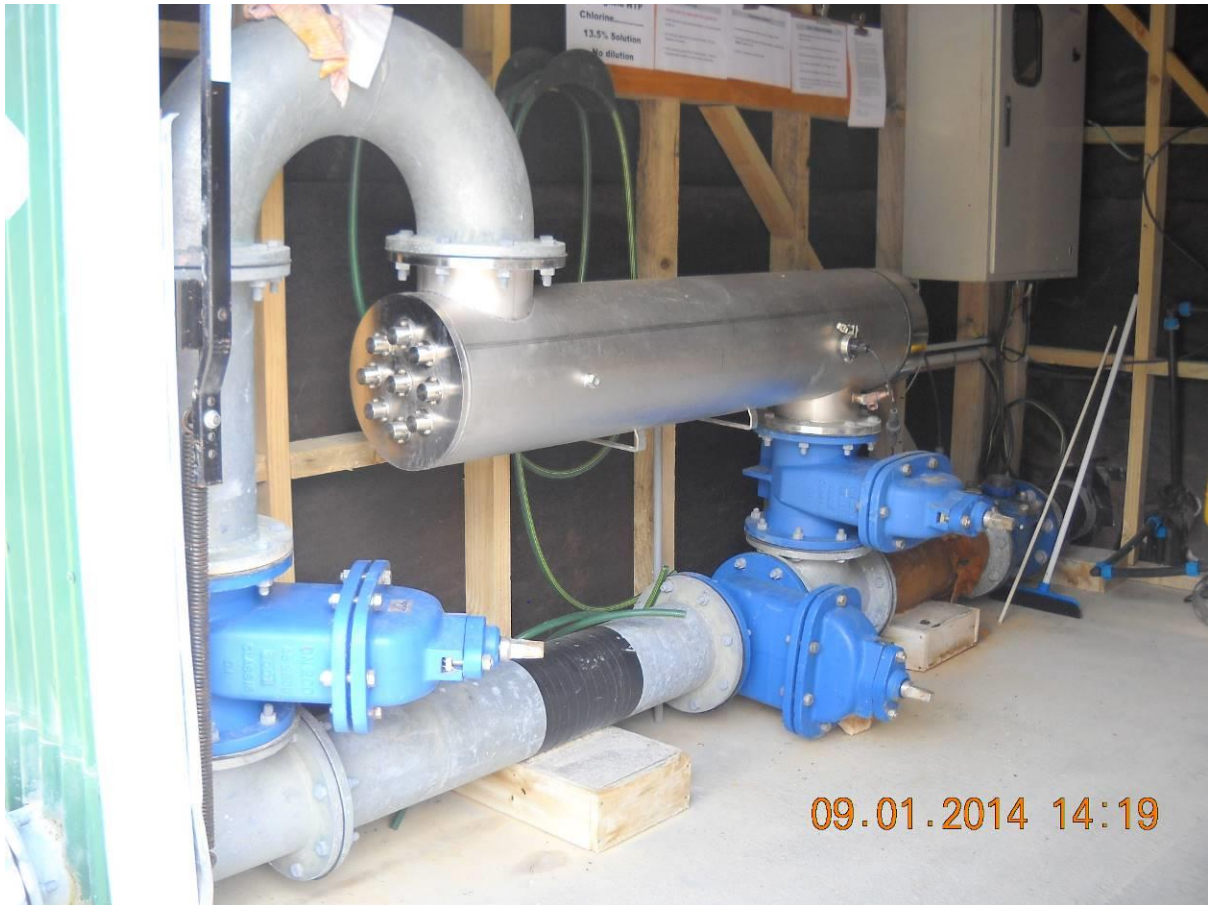
An analyser records ultraviolet transmissivity (UVT) of the water but this is not connected to telemetry and is recorded manually during inspections by the operator. The UVT analyser is calibrated when the tubes are replaced and when there is a fault with the unit or one of the tubes. SCADA is used to report power failure, high flow and UV fault to the operator by alarms. SCADA also records accumulated flow, instantaneous flow and pump run hours.

*Photograph No 5 – UV unit within treatment plant*
