28 July 2015

Job No.: 141111

RE: 229 WEST STREET, ASHBURTON – DETAILED SEISMIC ASSESSEMENT

229 WEST STREET, ASHBURTON CONCEPT STRENGTHENING

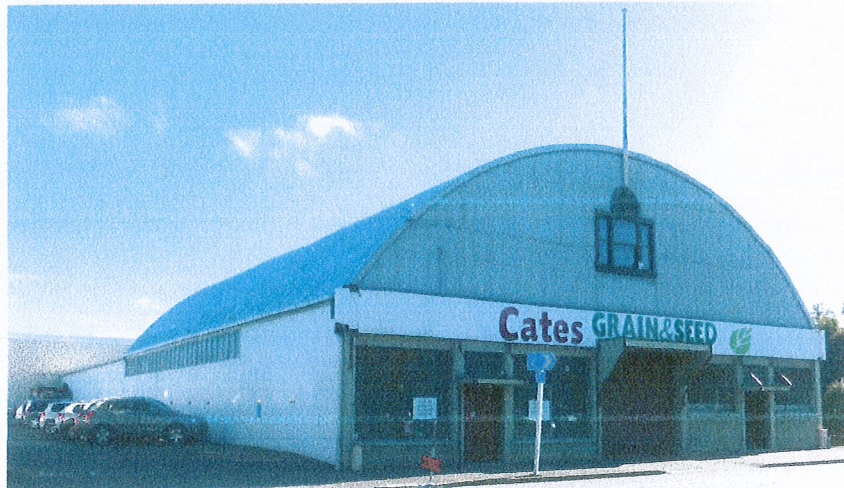
Photo 2: West street facade

Drawings show that the West Street facade was altered in the mid 1960's with the wall demolished below the first floor level with a new reinforced concrete frame constructed with brick infill along with new doors and windows. A new reinforced concrete block wall was also constructed on the south west wall to the front part of the building. Further additions to the north east were completed in the 1990's with the addition of a single storey office area.

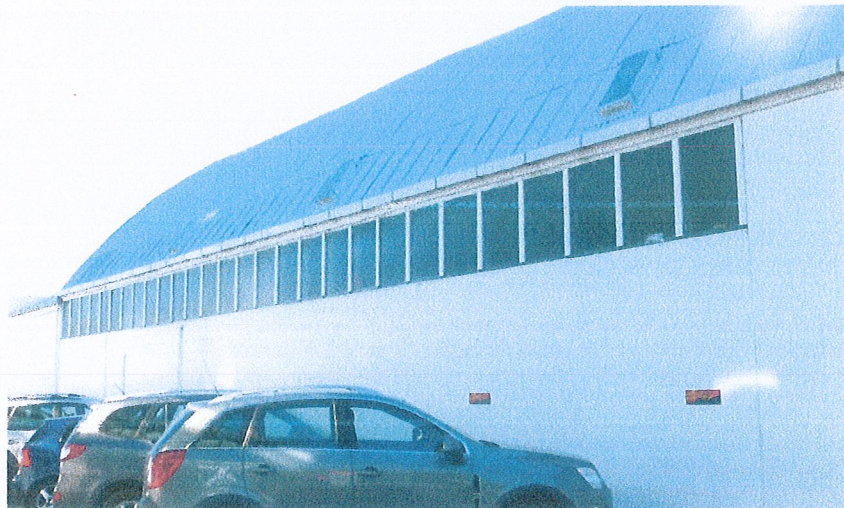
Photo 3: Windows above south west block wall

The drawings show that the south west block wall to the front part of the building is well connected to its foundations. The block wall further along was built on the existing foundation with only a nominal connection of the wall to the foundations. Being a relatively long length of wall it will have reasonable in plane strength. However the rear part of the wall has windows above so no effective connection to transfer lateral load from the roof to the wall.

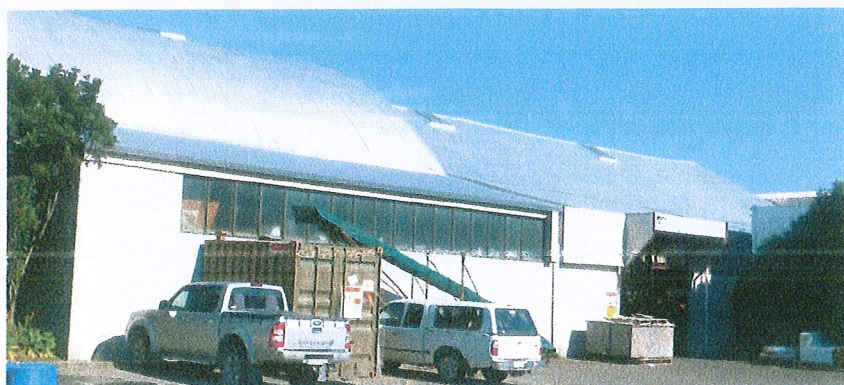
Photo 4: Windows above north east block wall

There are block walls along each side of the building which the drawings indicate are partially reinforced. The drawings show a nominal connection of the block walls to the foundations to the rear building where the walls were constructed on existing foundations. Being a relatively long length of wall, it will have reasonable in plane strength but minimal connection and structure to transfer the loads to the walls.

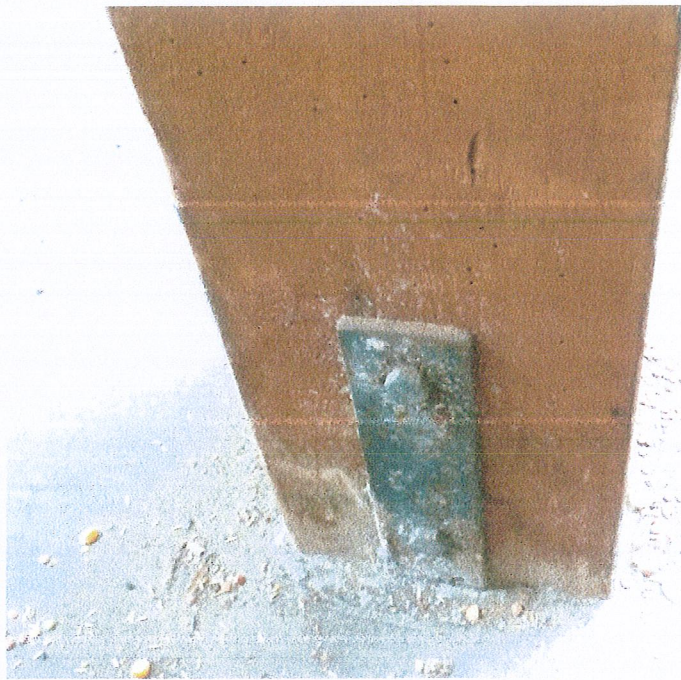
Photo 5: Post connection at base

A potential source of lateral load resistance is for the timber poles to cantilever from their base. We have assumed that the timber posts have fixed base connections with two steel plates extending from foundation and bolted to the post with two 12 dia bolts for this system. The lateral seismic capacity of the rear part of building in the longitudinal direction is approximately 20% NBS based on the above assumption. It was also assumed that the foundations have overturning capacity to, at least, match the capacity of base connections.

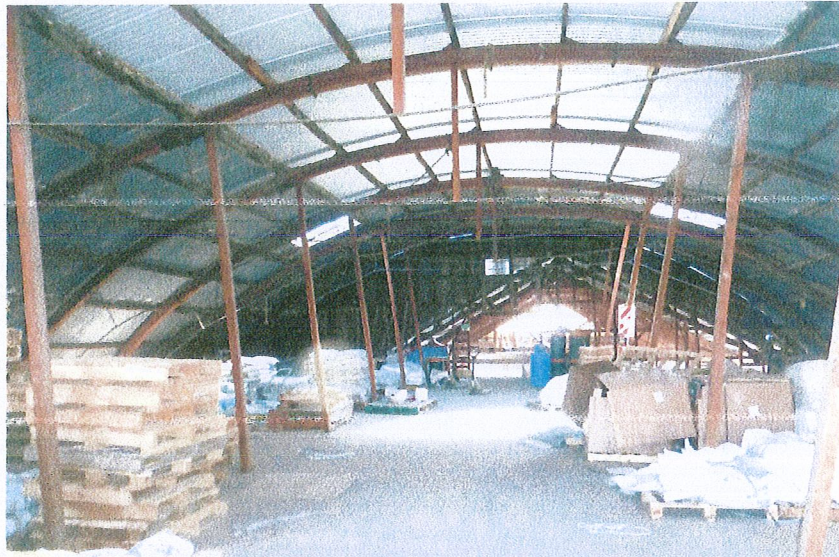
Photo 6: Front part of building (mezzanine)

It was observed that some of the timber members (posts, joists, framing) have been damaged over the time by borer. The posts to the rear part of the building have a lot of borer as do some of the mezzanine floor joists (about 1/3 of the joists appear to be affected). Wall framing to the front of the building along with some roof framing is also affected.

Lateral force-resisting system of the front part of building comprises timber floor structure supported by timber posts with timber knee braces. We have assumed that the curved laminated timber rafters have sufficient capacity to transfer the roof seismic loads to the mezzanine floor beams. The longitudinal block walls do not appear to be tied to the adjacent timber posts, which limits strength of the wall.

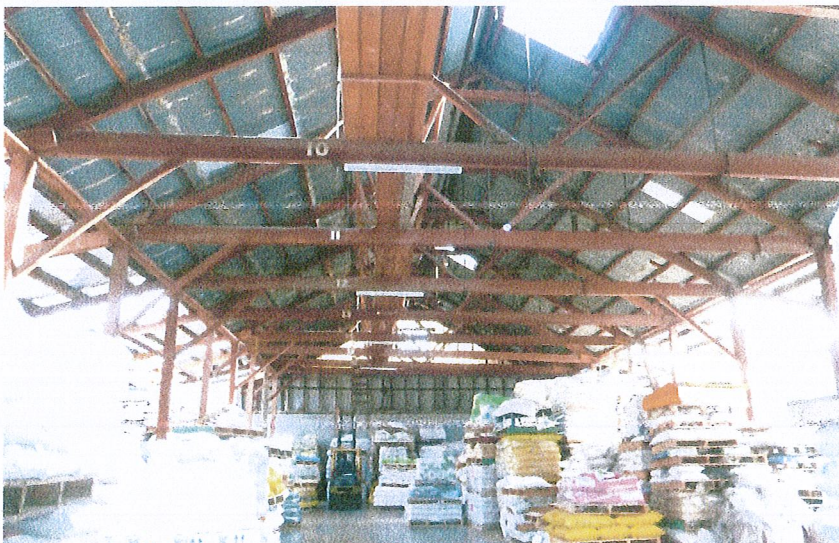
Photo 8: Rear part of building (addition)

Lateral force-resisting system of the rear part of building comprises timber trusses supported by timber posts with timber knee braces. It was noticed that several braces have been removed over the time, reducing the lateral capacity of the building. We have assumed that the connection capacity of the knee braces match the compression capacity of the braces.

The rear (north west) block wall does not extend up to the roof level. The timber framed wall structure above does not have a system to transfer the seismic forces from the roof to the block wall.

The calculated lateral seismic capacity of the rear part of building in the transverse direction is approximately 7% NBS.
