Heritage Item 21

WWII Hangar, Ashburton Airport

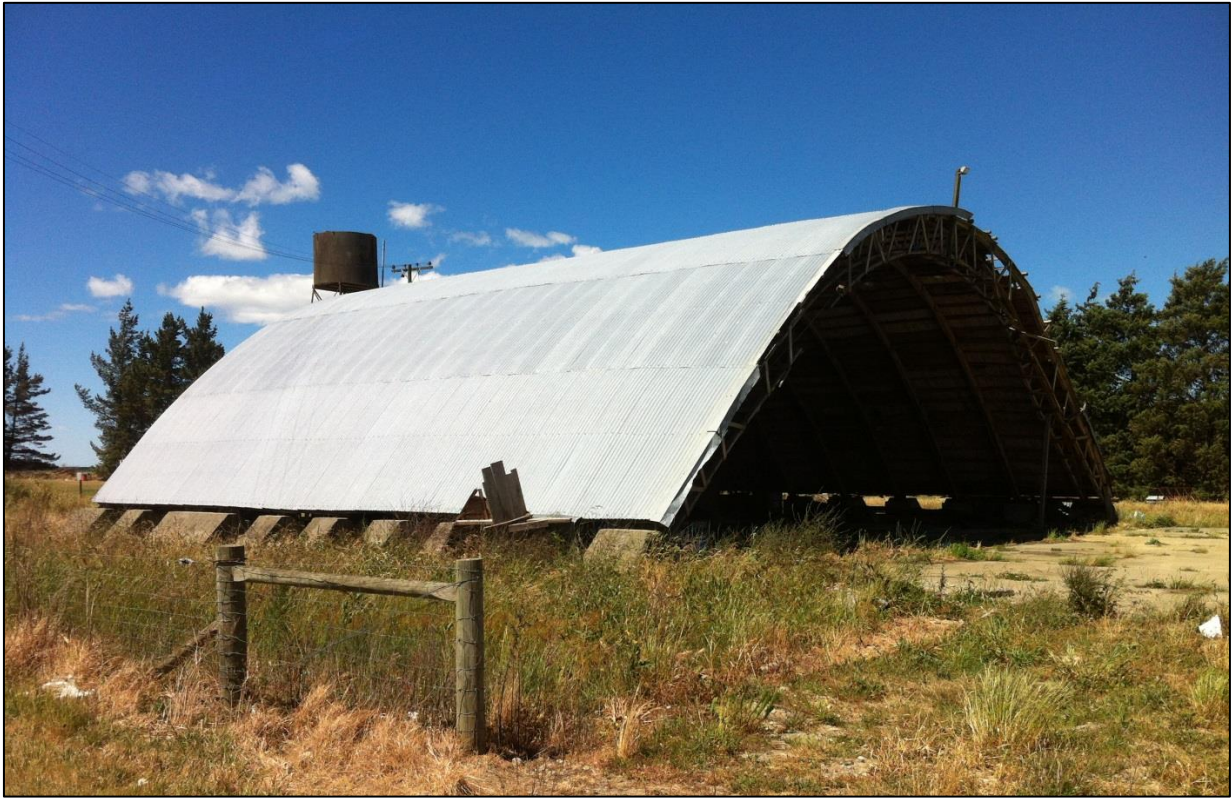
Detail	
Description:	<p>This item consists of a WW2 hangar located at Ashburton airport.</p> <p>Although unconfirmed, the hangar may be a local version of the steel-framed Over Blister hangar used, in various sizes, by the RAF in the UK. The original doors may have been canvas curtains which were then replaced by iron doors. These are now completely gone, having been removed following strong winds in 2013. The roof is now corrugated iron, however it would have originally have been constructed of timber covered with tarpaper. The rear wall was also constructed of timber covered with tarpaper – the timber is still in place with only remnants of the tarpaper attached at the joins.</p> <p>The hangar is a unique construction with light-weight box girder wooden trusses - there are four of these, one front, one back and two close together supporting a lifting beam. The intermediate trusses are just planks nailed together. The front truss appears to have been damaged, presumably by the weight of the replacement iron doors.</p> <p>The hangar is in a bad state of disrepair. The iron roof does not continue right to ground level and so the bottom section of internal timber is exposed and rotting. The timber on the rear wall, now missing its tarpaper, is also rotting with holes already appearing.</p>

Detail	
Condition:	This historic hangar is in a very bad state of disrepair. The roof is still watertight; however the interior woodwork is open to the elements due to having no doors which has left one whole side exposed. The tarpaper is nearly all missing from the back wall, leaving the timber exposed and rotting. The timber along the bottom of the sides is also rotting due to the iron roof not reaching the ground. The Aviation Museum is keen to purchase and restore this WW2 hangar, however have not been able to reach an agreement with the owner. Unless repairs are undertaken in the near future, much of this historic hangar will be lost.
Setting:	This hangar was originally one of many similar hangars located at the centre of this busy WW2 training camp. It is now the only one remaining and is set at the edge of the current airfield. This and the compass rose, tarmac and tie-downs are the last remnants of the WW2 history of this airfield. The setting is of high importance due to being the original location of the last remaining one of several WW2 hangars.
