Heritage Item 22

WWII Tarmac and Compass Rose, Ashburton Airport

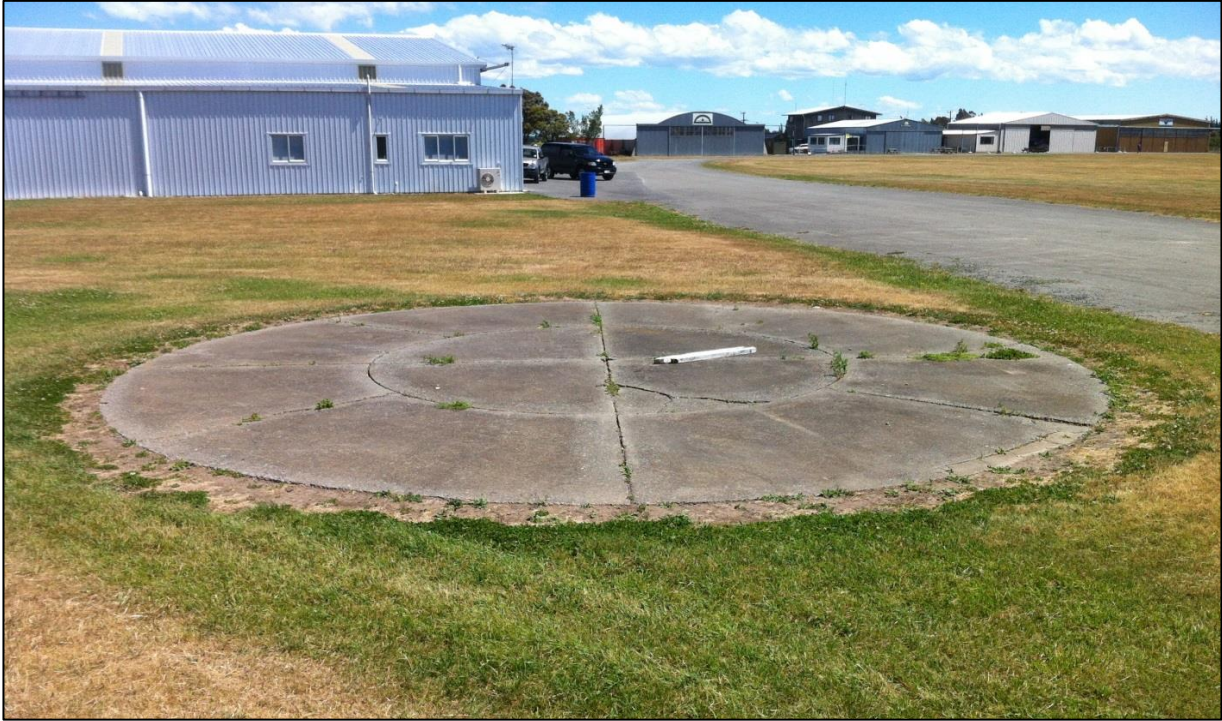
Detail	
Description:	<p>This item consists of a section of WW2 tarmac and a compass rose located at Ashburton airport.</p> <p>The tarmac is approximately 10m wide and runs for a distance of approximately 600m, running from the north-east to the south-west then turning on a 90 degree curve and heading towards the north east. The tarmac still retains the metal tie-downs which are positioned in the centre of the strip and appear about every 2 to 3m – these were used to secure the aircraft to protect them from becoming damaged in the area's notorious nor'west winds. The tarmac is in relatively good condition – it is no longer used for aircraft, but rather is used as a road for vehicles to access the hangars and other buildings dotted around the airfield.</p> <p>The compass rose is located to the east of the WW2 tarmac, approximately 120m to the north-west of the WW2 hangar. It is a circular area of concrete spanning approximately 8m in diameter and divided into sections. It is believed that the compass points of true north, south, east and west would have been identified by brass plates on the concrete, but these are no longer present. The compass rose was a functional tool whereby the aircraft was placed on the rose pointing to true north and from there, the magnetic north direction could be established and the individual readings for each plane altered. As magnetic north is a variable, these calculations needed were undertaken regularly.</p>

Detail	
Notable Features:	<p>As well as the WW2 tarmac and compass rose, the airfield is also home to an original WW2 hangar (heritage item H21)</p> <p>Compass rose; tarmac; tie downs; location.</p>
Condition:	<p>The tarmac is still in relatively good condition and is maintained and used as a vehicle access to hangars on the airfield. Ashburton airfield is a grass field and does not have a usable tarmac runway. Many of the metal tie-down rings are still evident – some in good condition, some broken or welded into the ground and some are missing.</p>
Setting:	<p>The compass rose is in average condition. The circular shape is still intact and the sections evident, however some of the concrete is becoming quite cracked with grass growing through the cracks and the cracked areas are starting to become uneven.</p> <p>The setting of the tarmac and compass rose are of high importance. During the WW2 years this was a large, incredibly busy airport and training camp which prepared and sent many pilots off to war. At that time the tarmac and compass rose where located centrally to all of the activity on the airfield. These items were practical and functional elements used on a daily basis. Today these items are unused but still form an important part of the airfield's history.</p>
