## ASHBURTON WATER MANAGEMENT ZONE COMMITTEE AGENDA

**DATE:** Tuesday 24 May 2022

<b>HUI/MEETING:</b> Ashburton Zone Committee	
<b>AGENDA ITEM NO:</b>	<b>KAUPAPA/SUBJECT:</b> Hekeao Community Wetland
<b>KAITUHI/AUTHOR:</b> Melanie Brooks	<b>WĀ/MEETING DATE:</b> 24 May 2022

**Report contents.**

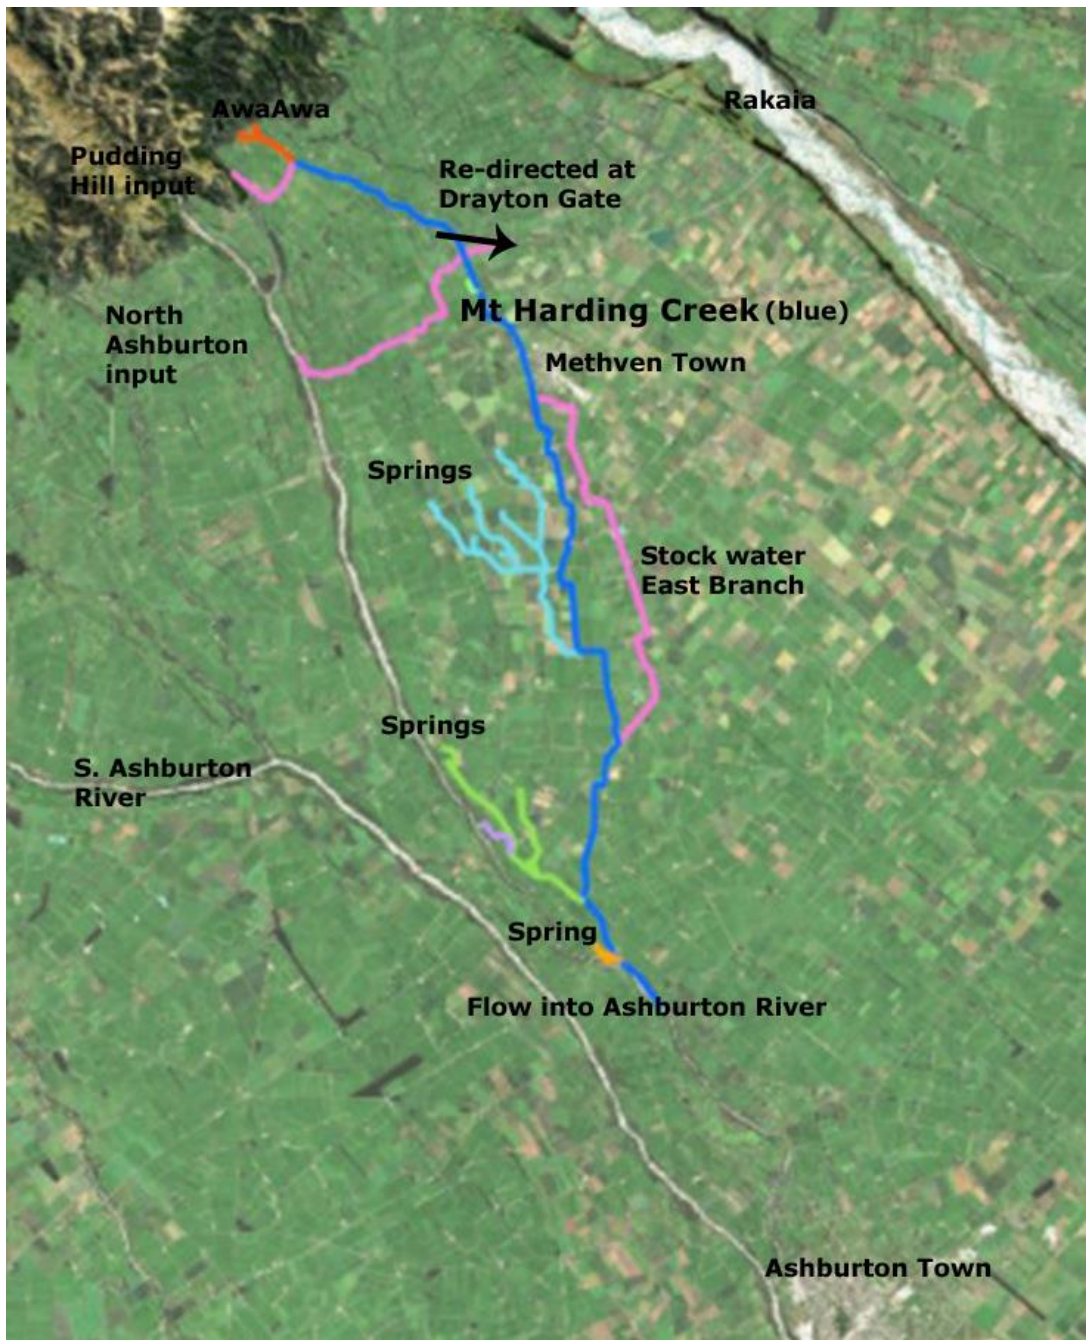
Map below shows the Creek and its tributaries, plus stock water connections in/out.

**Map key:** orange for headwater from AwaAwa reserve, darker blue for MtHarding Creek, pale blue for intermittent springs from West, green for spring fed tributary which feeds the lower reach, pink for Pudding Hill and Methven auxiliary stockwater schemes (ADC).

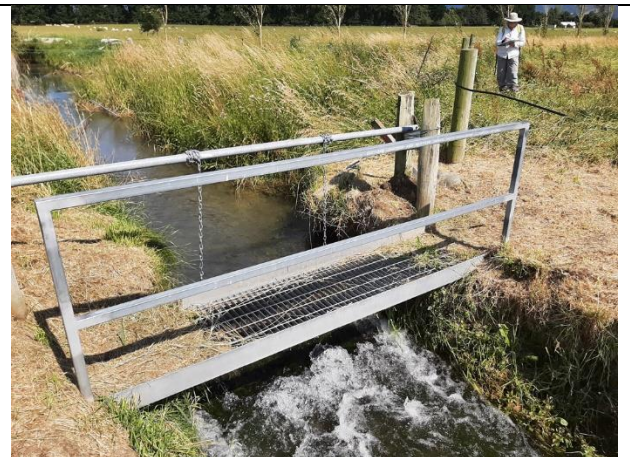
Above right. Drayton Gate. North Ashburton water arrives several metres West of here and largely replaces the flow from the north.

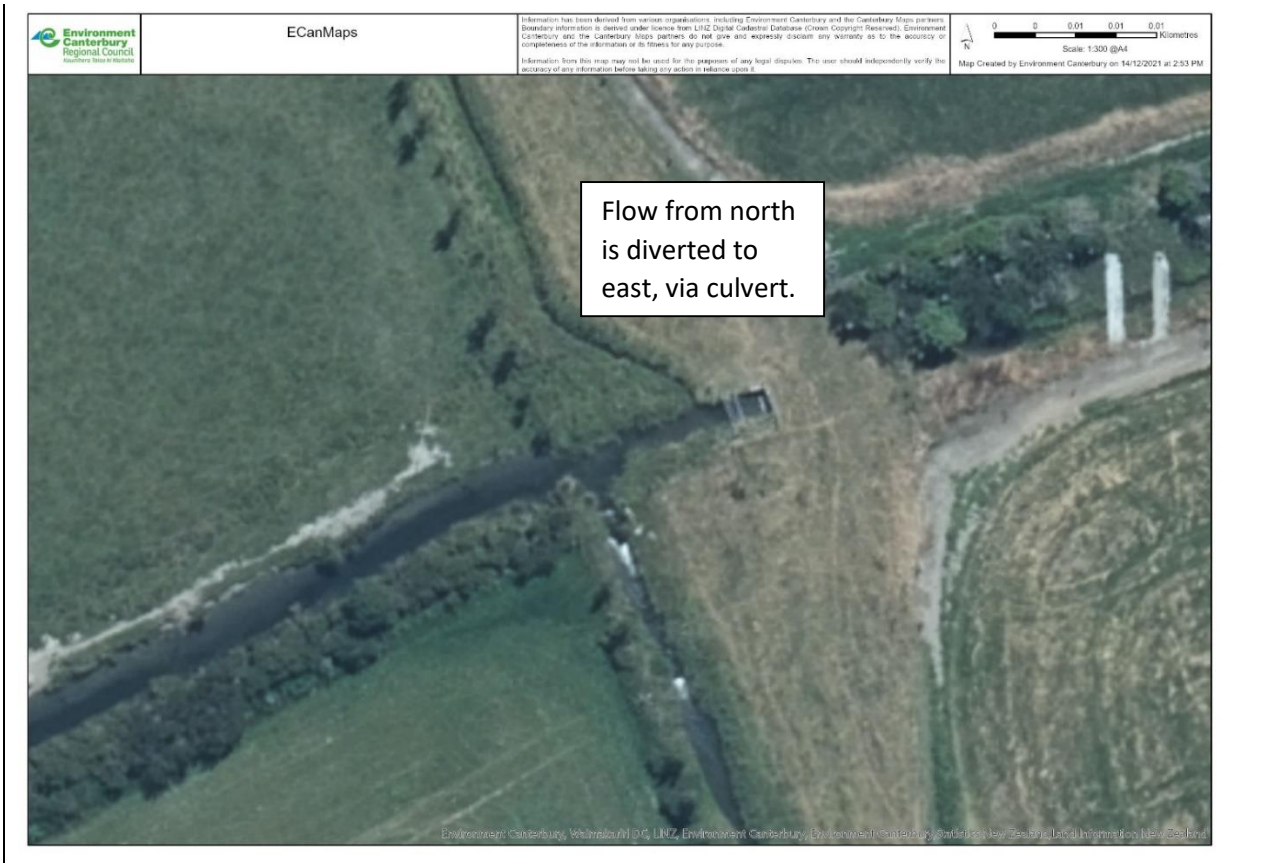
Aerial view of Drayton Gate. The Methven Auxiliary flow from North Ashburton River arrives from the West (left of photo) and is sent both East and south, substituting for water arriving from the north. See also a pair of photos in the section on eDNA water sampling, further below.

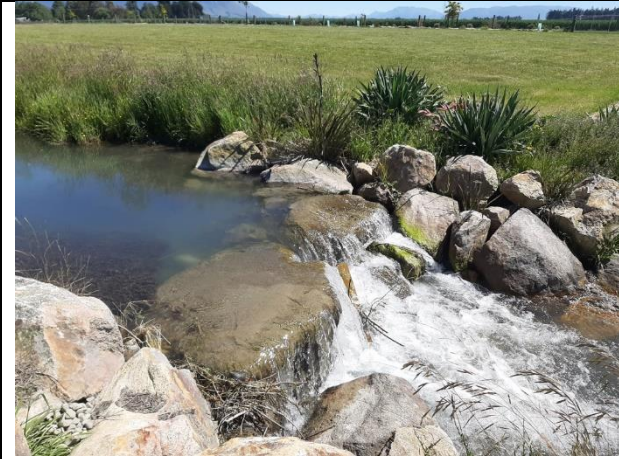
Rocks added to the stream bed at 'Thyme Stream', subdivision on Mt Harding Creek north west of Methven, beside new houses. Silt is settling from the slowed water behind these barriers.

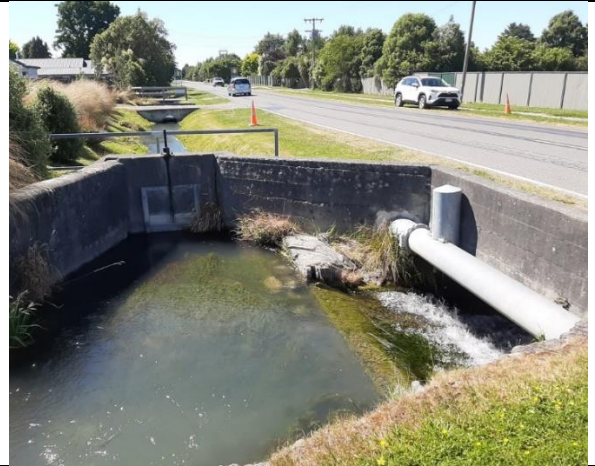
An Ashburton District Council-maintained stock water flow control point at the Creek's northern entry to Methven, flow arriving from the left. (photographed in December 2020). The flow East beside Forest Drive (receding vertically in this photo view) feeds to another stock water branch, and the flow to the right, passing under the road, continues over a concrete weir ledge as Mt.Harding Creek.

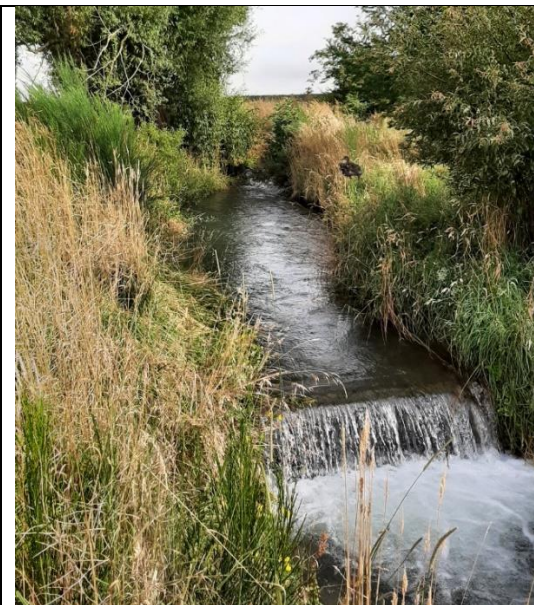
Example above of small in-stream step weir (photo 2 Feb 2021). There are many weir steps of around this size: see list in Appendix 2.

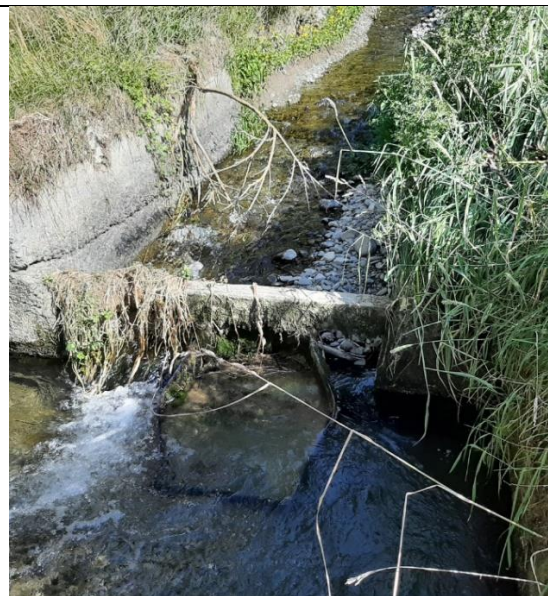
Remains of a larger concrete structure near Drayton Road. (26 January 2021).

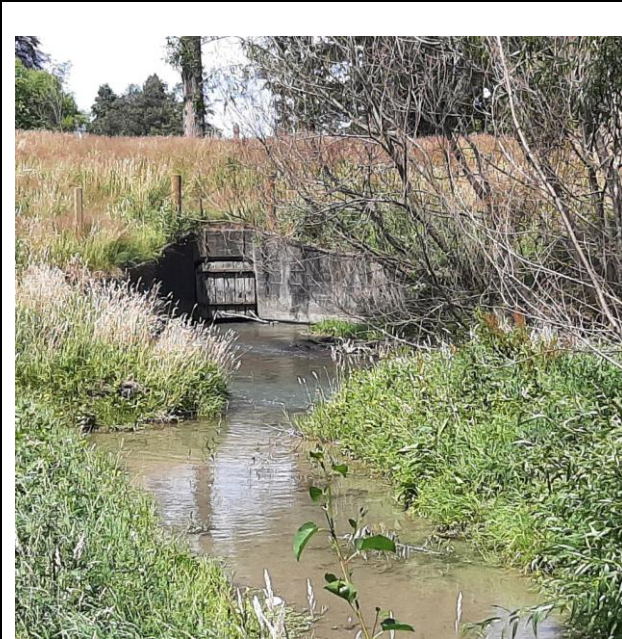
Entry to siphon for Mt Harding Creek under the Rangitata Diversion Race, north of Methven near original Mt Harding homestead.

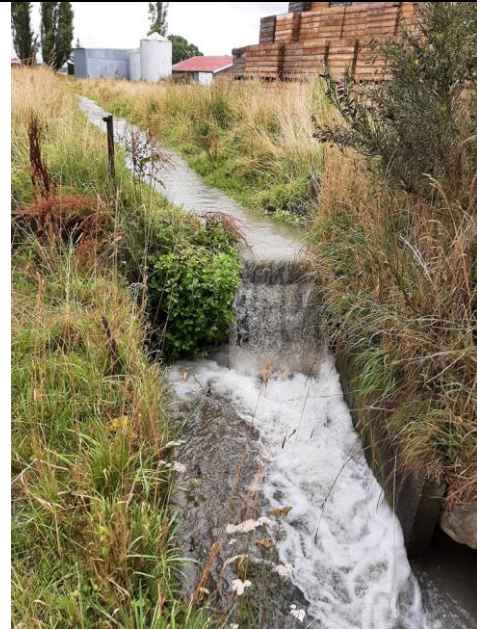
Steeper weir within the Creek on J McKay's farm near SH77 represents a fish passage barrier (16 Feb 2021)

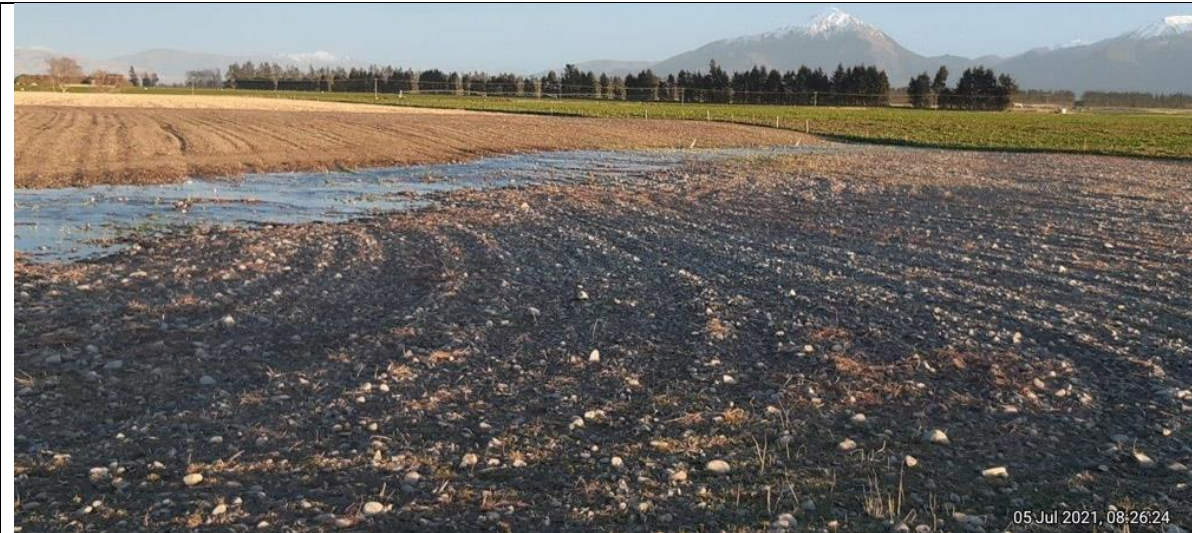
5 July 2021 flow across 2507/2347 Methven Highway paddocks when ground water level rose after winter rainfall (view west). Herons seen visiting.

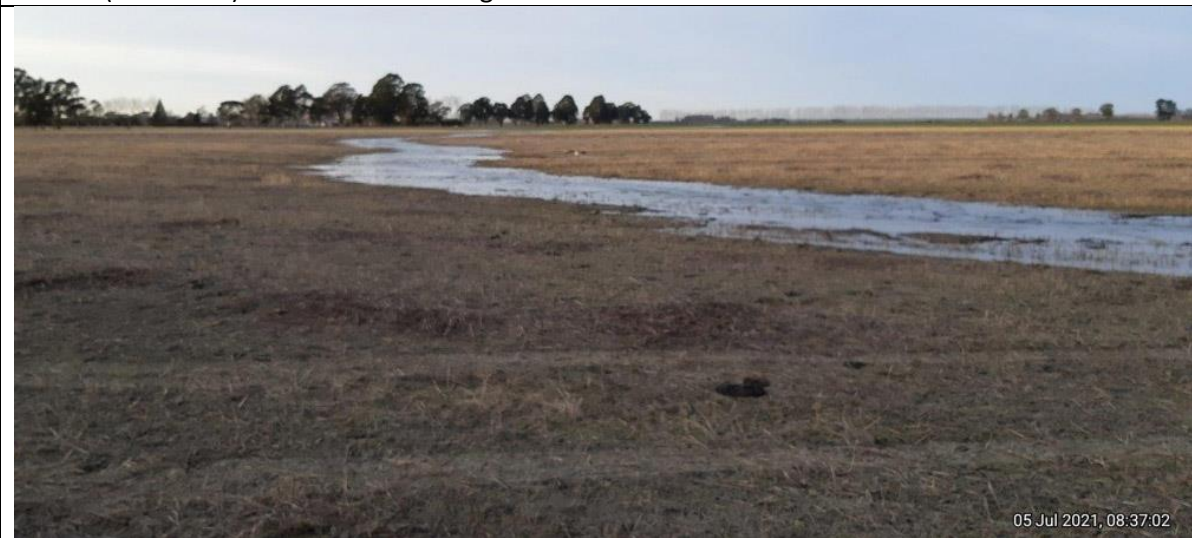
(above) Same farm, looking east. These natural flows are western tributaries of Mt Harding Creek.

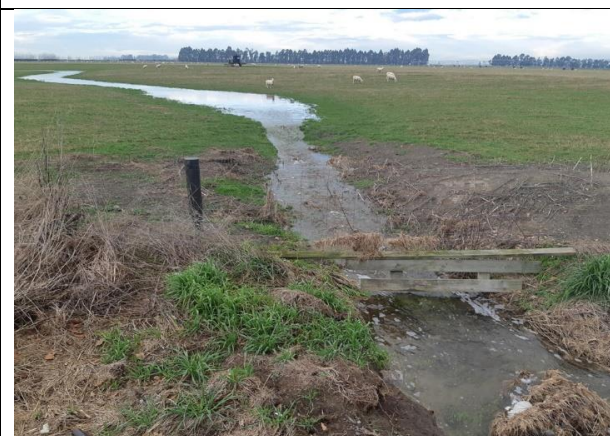
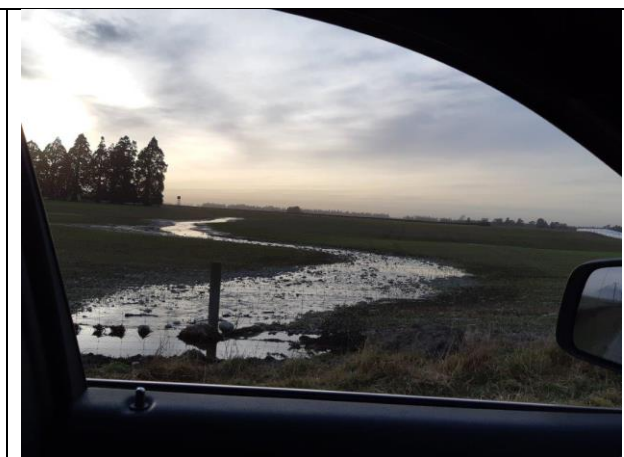
Above left: Spring-fed flow running across 2378 Methven Highway paddocks, June 2021. Above right: roadside view of spring-fed flow across 228 Reynolds Rd paddocks, June 2021. Both were contributing to Mt Harding Creek volume downstream.

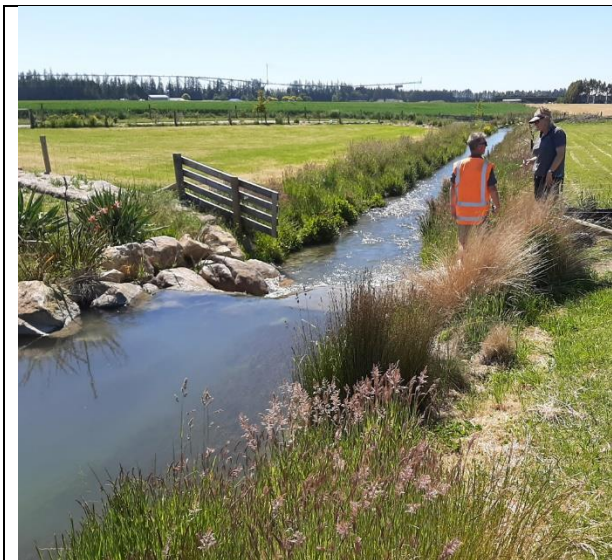
‘Thyme Stream’ landscaping of Creek at new subdivision. Work has included addition of rocks to the stream channel where the resulting flat water behind rock piles acts as a silt trap.

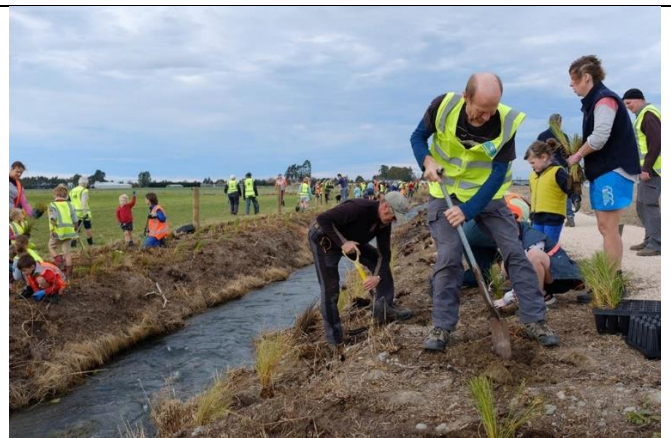
A public planting event in 2021 at the Creek-side walkway , organised by Methven Lions Club, attracted a large attendance to ‘Thyme Stream,’ and soon ran out of plants.

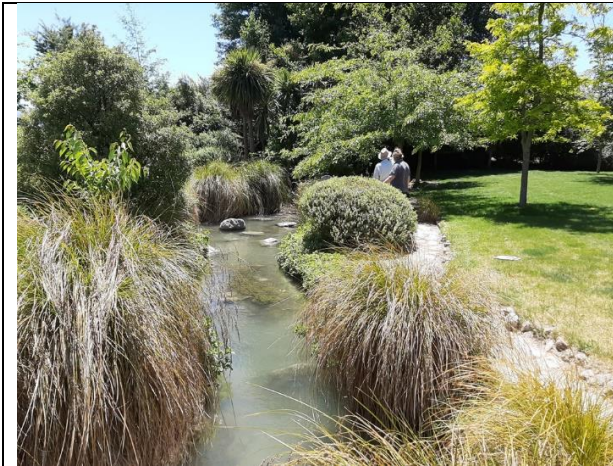
Mt Harding Creek crossing a Methven garden. Previous sightings of koura and trout here – but not recently. Silt levels in this water have risen, recently brought by North Ashburton water.

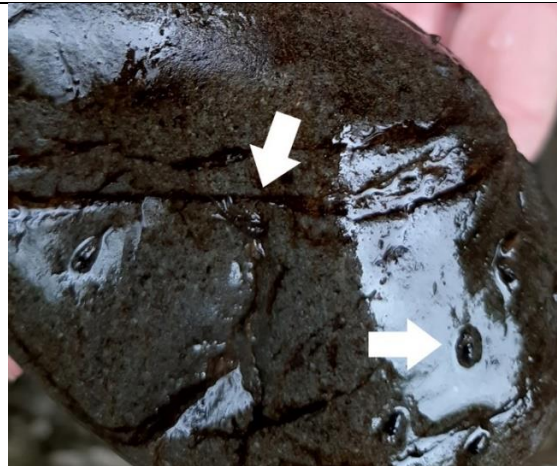
Caddis fly larvae under a stone on bed of upper Mt Harding Creek – indicators of reasonable water quality. No Dobson fly larvae or mayfly larvae seen, however, (which would have indicated higher water quality).

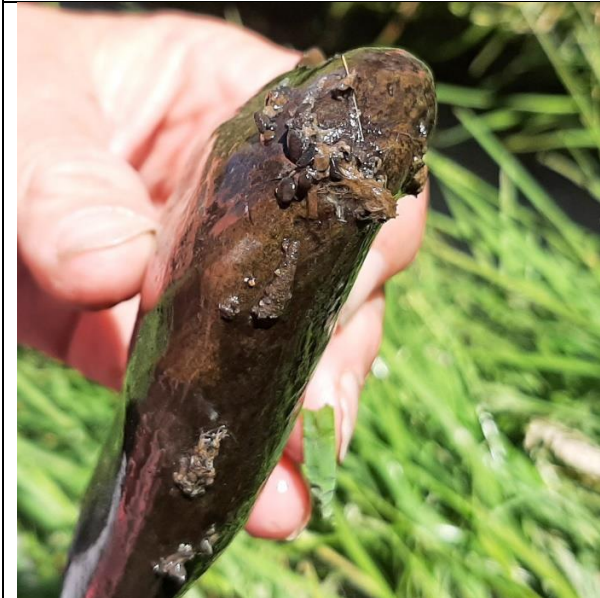
Cased caddis larvae on a stone lifted from Mt Harding Creek, on McKay's farm.

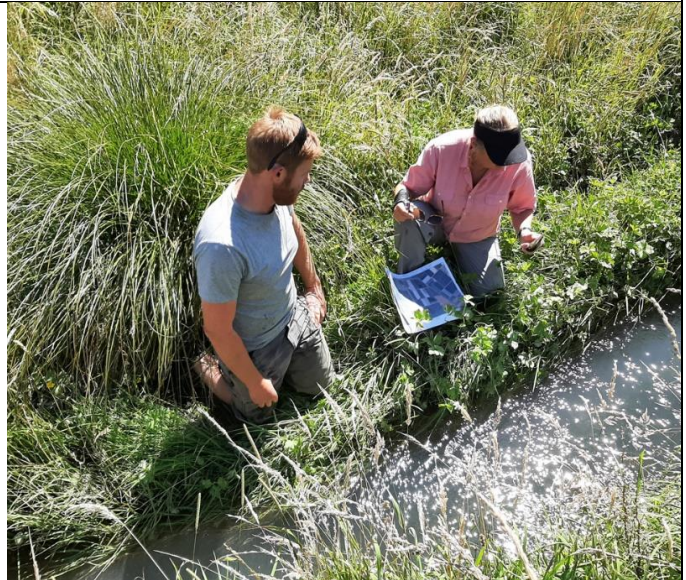
One of the creek locations where Carex has naturally established. Good set-back depth from McKay's arable-farmed land.

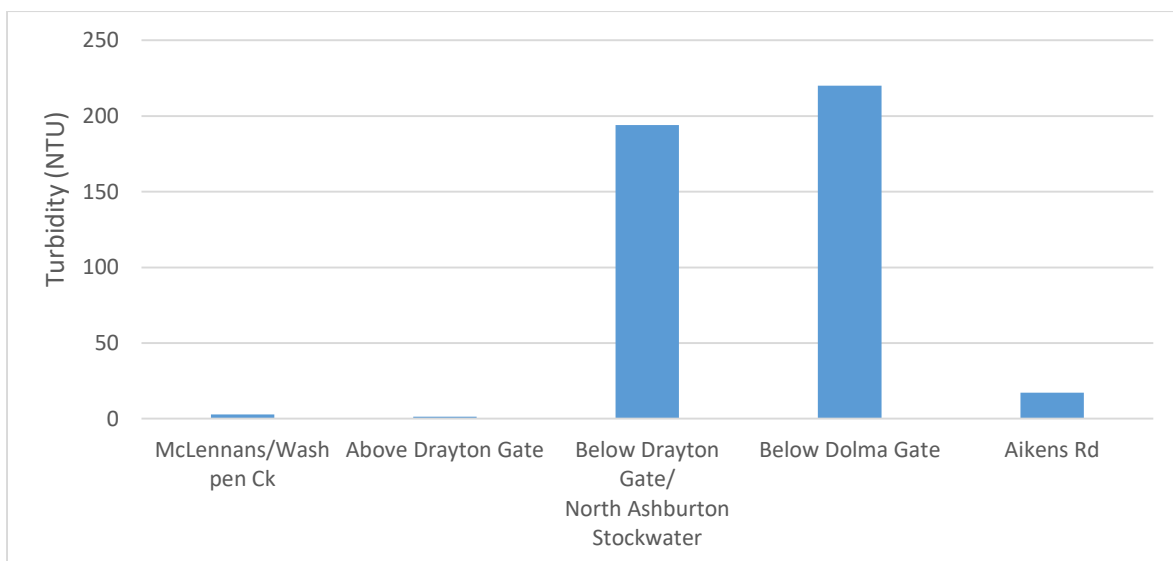
Turbidity was measured to indicate changes in water clarity seen and photographed through the catchment. Low concentrations of turbidity were observed at the upper two sites of Washpen Creek and Mt Harding Creek Above Drayton Gate. Turbidity increased for Mt Harding Creek with the inclusion of stock water sourced from the North Branch of the Ashburton River at the Drayton Gate. The North Branch was dirty for a long period of time due to a slip in the foothills during the May/June 2021 floods. Mt Harding Creek continued to have elevated turbidity concentrations downstream of this discharge at sites below Drayton Gate and Dolma Gate. Further downstream at Aikens Road, turbidity concentrations showed a decrease. Suspended sediment had likely settled out from the North Branch source by this site, and the Creek bed was again pebbly. There was also flow dilution from additional flow from spring sources to the West with low turbidity concentrations.

Figure 2: Turbidity concentrations for Mt Harding Creek

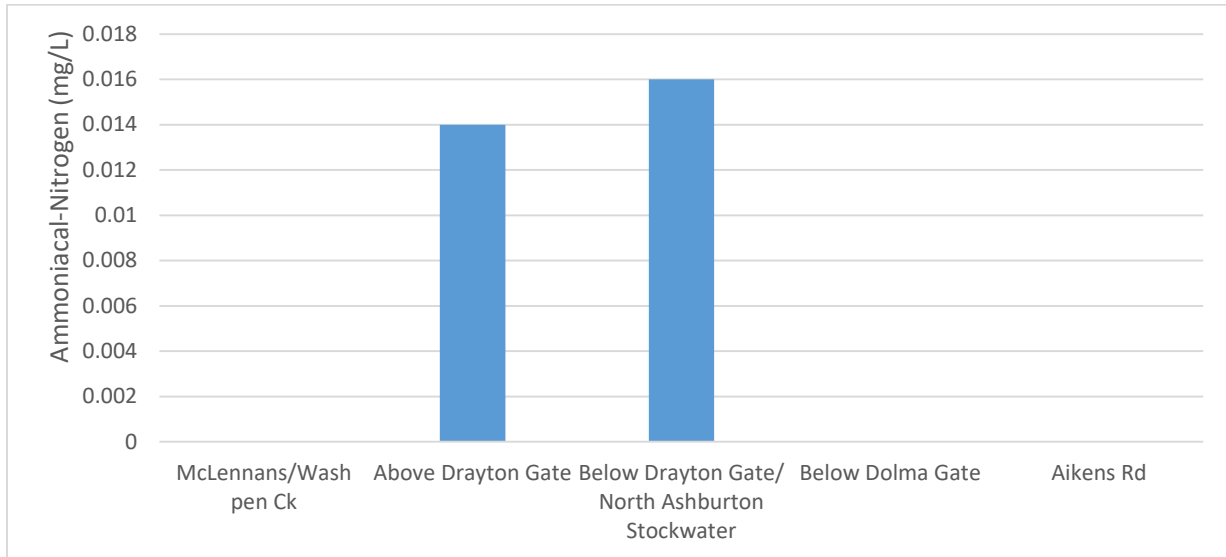
Total ammoniacal-nitrogen was below detection threshold for Washpen Creek, and at the lower two Mt Harding Creek sites below the Dolma Gate and at Aikens Road. By comparison, the two sites above and below the Drayton Gate had elevated ammoniacal-nitrogen concentrations. Stock were observed close to the unfenced stock race channel on this sampling date and may have been a localised source of ammoniacal-nitrogen via urination.

Figure 3: Total ammoniacal-nitrogen concentrations for Mt Harding Creek

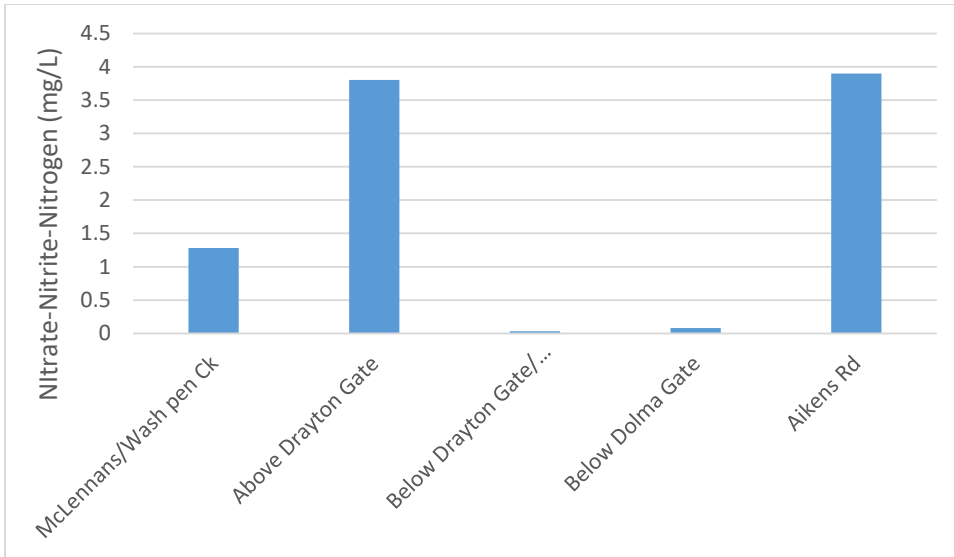
Nitrogen (measured as NNN) varies throughout the catchment and likely responds to the dominant source of flow at a site. The upper site called “Washpen Creek” flows out of Awa Awa Rata Reserve/MacLennans Bush, before flowing through a small farm/lifestyle block and a dairy farm where there is some groundwater drain interception. It is potentially influenced by septic tanks in the Reserve and nearby dwellings (Future testing of Ecoli bacteria sources could shed light on this), as well as nutrient leaching from livestock pastures. NNN concentrations more than double between the Washpen Creek site and the next site above Drayton Gate. At Drayton Gate, the NNN concentrations drop to low levels as the sampled water flow switches to the stock water sourced from the North Branch of the Ashburton River. NNN concentrations remain low at the Dolma Gate site, before increasing downstream at the Aikens Road dairy farm site. Between Dolma Gate and Aikens Road there are several intermittently flowing spring-fed streams that flow into Mt Harding Creek that would influence NNN concentrations. NNN concentrations are generally higher in spring-fed streams due to the source of flow coming from groundwater influenced by nitrate leaching over extensive farmed areas.

Figure four: NNN concentrations for Mt Harding Creek

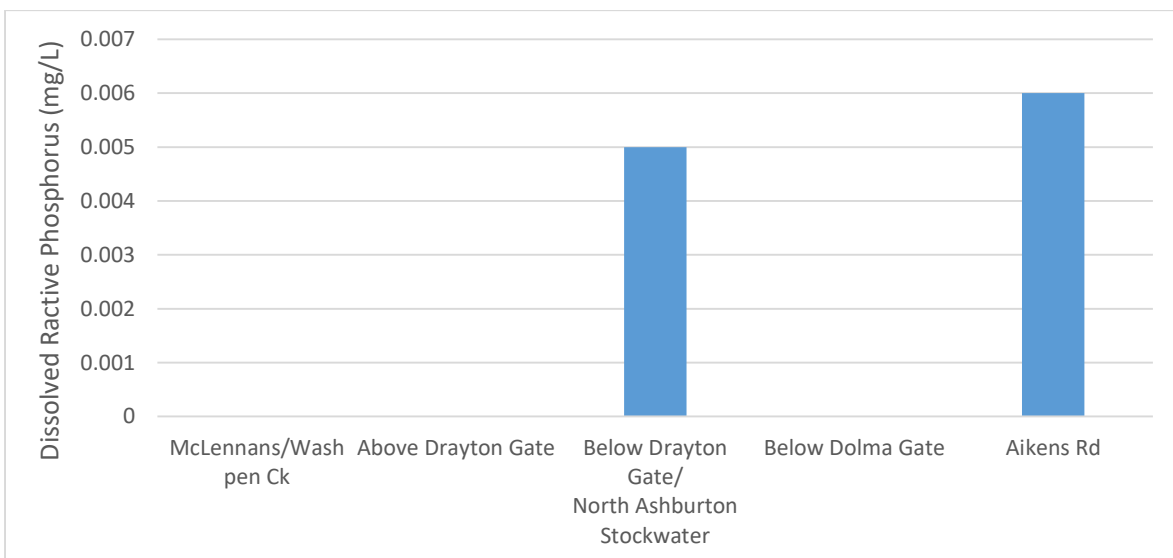
Dissolved reactive phosphorus (DRP) concentrations were below the level of detection for Washpen Creek, the point above Drayton Gate and Below Dolma Gate. Additionally, the DRP concentrations observed for Below Drayton Gate and at Aikens Road were at low levels. This suggests that relatively little urban pollution such as soluble detergent residues containing phosphates from Methven is reaching the Creek, though there may be some urban storm water road surface wash input (which typically containing chemicals such as hydrocarbons and zinc: but this was not lab tested). Animal manure, fertilisers and human sewage are also significant sources of phosphorus. Some urban streams near Timaru, for example, show much higher levels of DRP than found here.

Figure 5: DRP concentrations for Mt Harding Creek

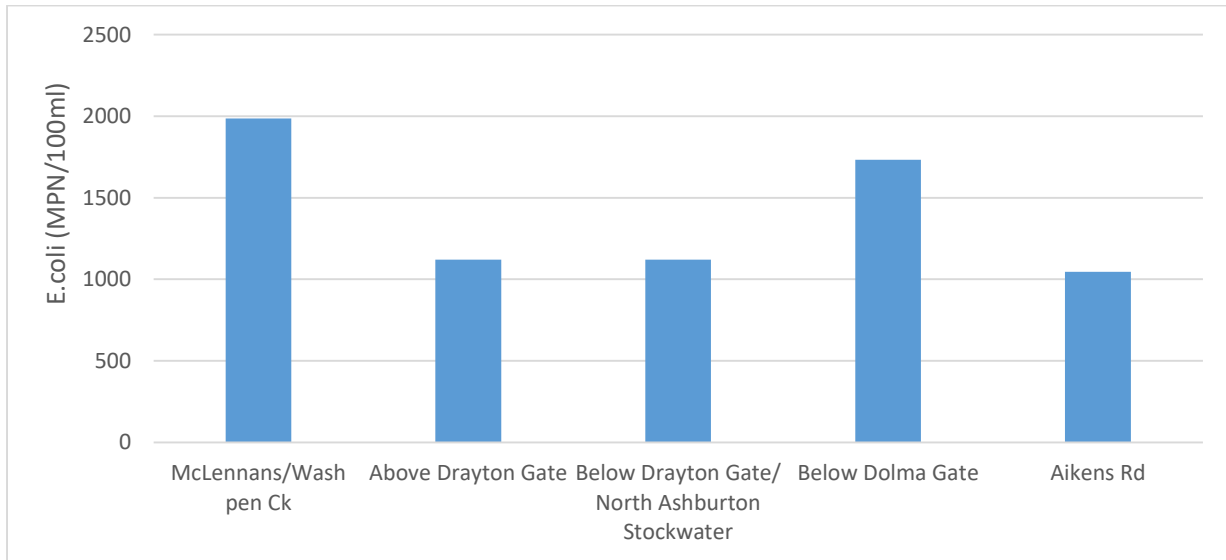
Mt Harding Creek exceeded 1000 MPN/100mL. Concentrations were greatest for Washpen Creek and the site below Dolma Gate, both of which had adjacent livestock. These concentrations likely reflected faecal sources located nearby these sites on the day of, and immediately prior to sampling. Potential sources include but are not limited to stock access or surface water/sub-surface drain run-off from land where stock have been grazing (e.g. tile drains), and/or leaking septic tanks releasing human DNA and observed waterfowl such as ducks, pukeko and swans.

Figure 6: E.coli concentrations for Mt Harding Creek

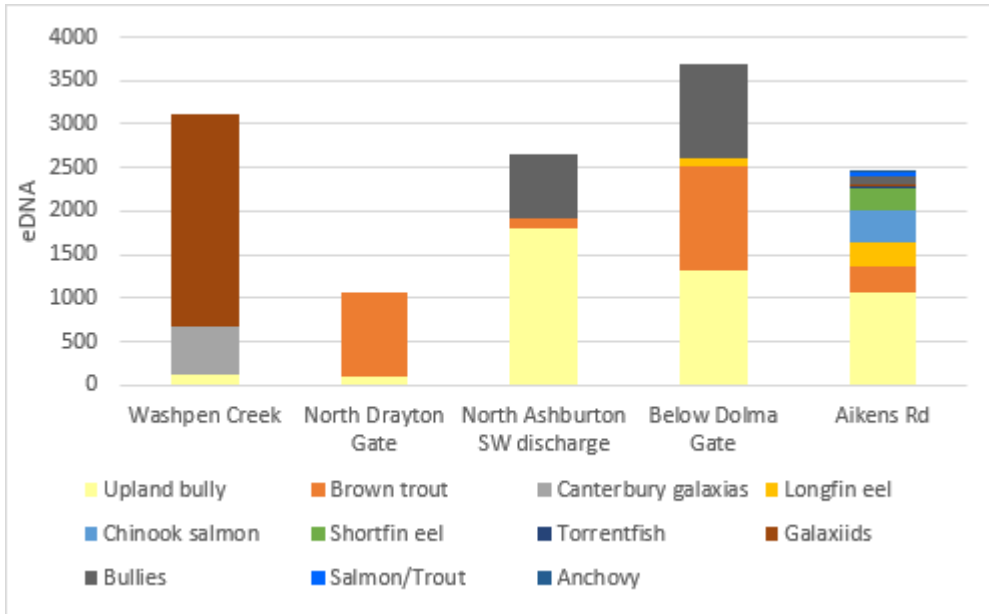
eDNA monitoring identified that the Washpen Creek sample was dominated by DNA from native Galaxiid species, and identified Canterbury Galaxiids specifically. (See figure 7 below) This was the only site where Brown Trout DNA was not observed. Brown Trout predate on smaller fish such as galaxiids and the absence of Brown Trout is possibly linked to detected presence of galaxiids at this site. Sites below Washpen Creek were dominated by DNA from Brown Trout and Bullies. The Aikens Rd site showed the most diversity with traces of DNA from upland bullies, brown trout, long-fin and short fin eels, chinook salmon and Torrentfish. This site is located near the confluence of the North Branch of the Ashburton River where there may be recruitment of fish upstream from this river and there is also a fish hatchery on one of the nearby spring-fed tributaries. Faecal matter was detected from farm livestock, humans and birds.

Figure 7: evidence of fish present upstream of each eDNA sampling site.

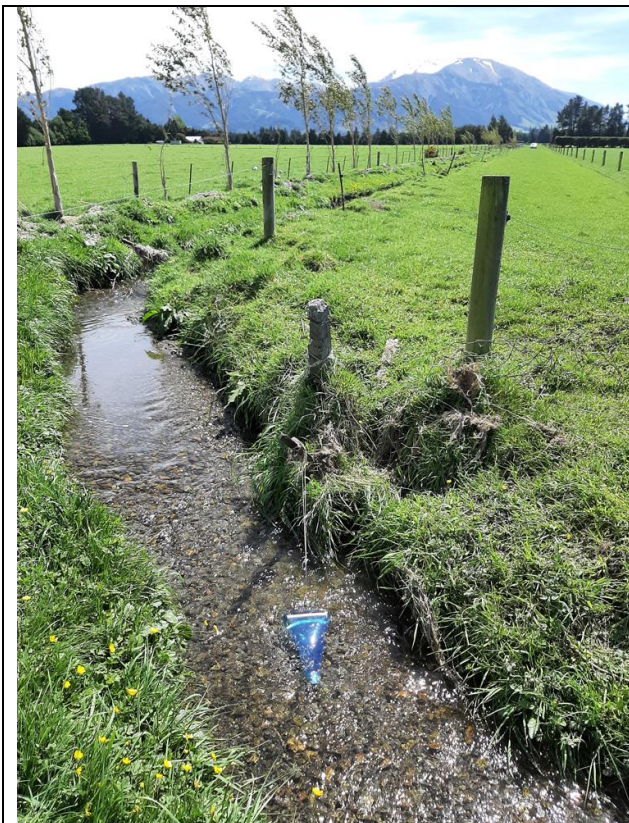
Tethered blue bag is a Wilderlab E-DNA collector in the (clear) water arriving from north of Drayton gate, fed by the Washpen and Pudding Hill water. At Drayton Gate this water is swept eastwards into a stock water flow and lost to Mt Harding Creek. The 'Creek' water south of here thus changes biologically and chemically.

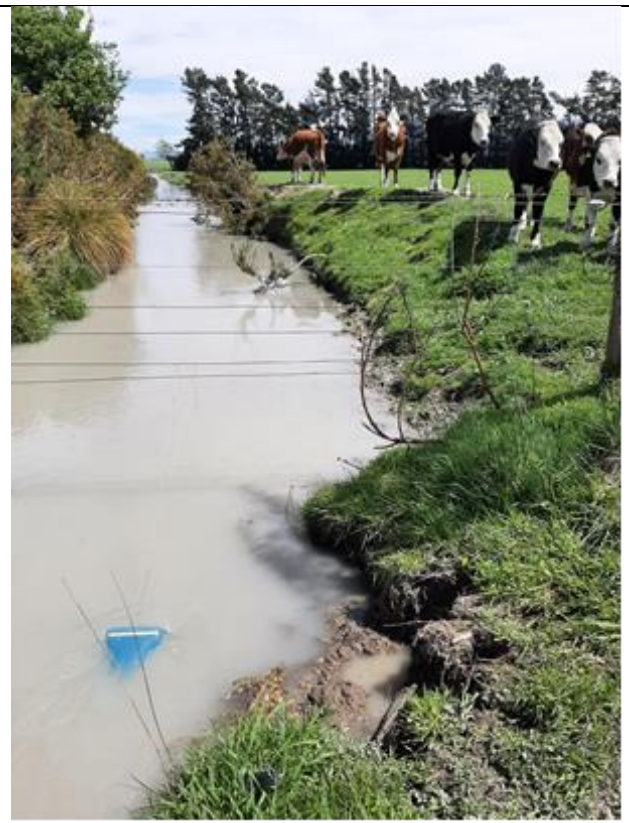
Blue bag here, installed on the same day only 10 metres south of the one shown at the left. It is in the larger volume of (then silt-laden) water arriving from North Ashburton River sourced stock water race, at the west. This water is sent south at the Drayton gate, into the former Mt Harding creek channel, replacing a clear flow arriving from north.

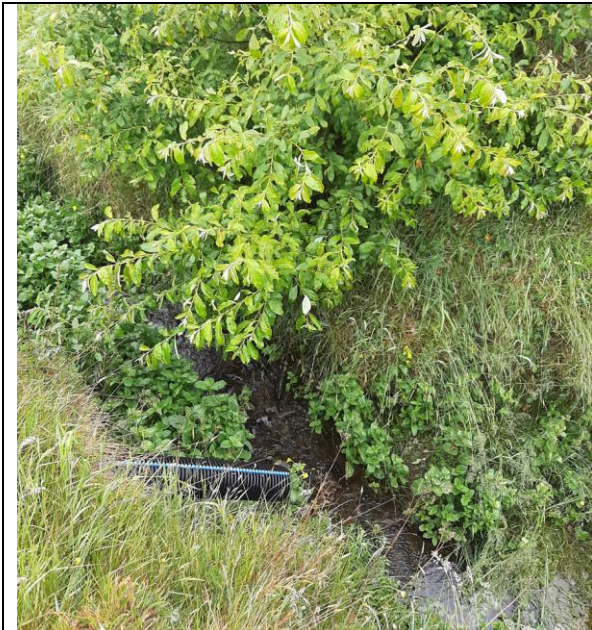
A small proportion of farms are likely to be contributing ‘hot spot’ water pollution through their farming practices, as observed on both dairy and arable farms. From experience elsewhere, this could be mitigated by larger setbacks from the waterway and planting within the setback areas with wetland species (e.g. Carex sedges, toi-toi, flaxes) in hollows at the paddock Creek-side margins. In at least one case adjacent dairy paddock sub-surface drainage was being piped direct to the creek without any opportunity to intercept/filter out nitrates, phosphates and silt (see photo at left, below).

Picture above left: *Novaflo*-type plastic drain pipe installed to drain dairy paddock sub-soil direct to Washpen Creek (in upper Mt Harding catchment, where our water testing showed high levels of nitrates and detectable phosphates).

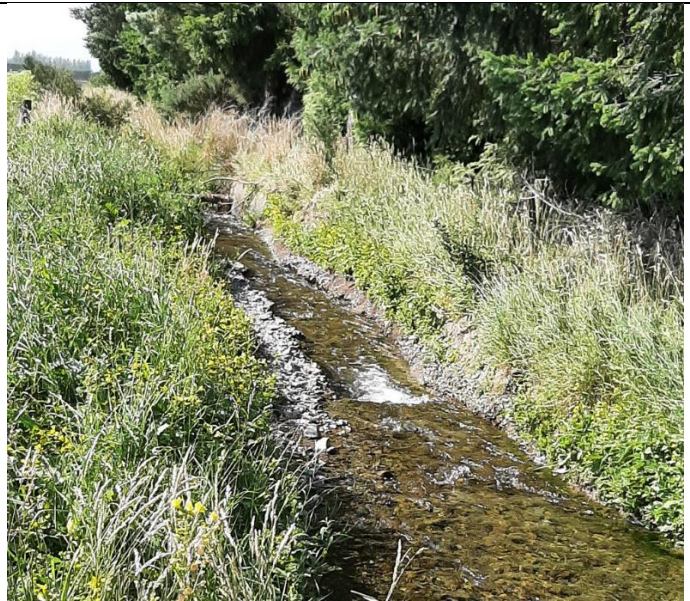
Above right: shingle bed in the Mt Harding Creek below Methven on an arable farm, with adequate set back to cultivated land. Summer weed growth in the waterway includes Monkey Musk (yellow flower seen here) as an indicator of available nutrients plus inadequate shade. Trees on the North bank could potentially provide extra shade here.

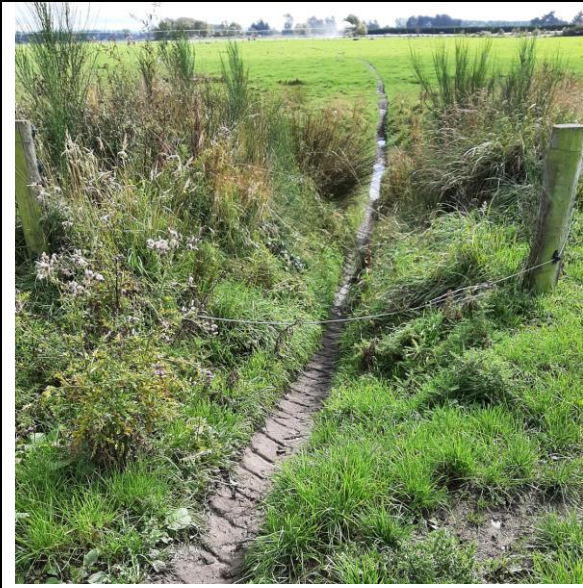
The quality of crossing over the creek for travelling irrigators was variable for the Mt Harding Creek Catchment. On two dairy farms, centre pivot irrigators are crossing either Mt Harding Creek or its spring-fed tributary without bridges to support their wheels, which creates muddy ruts sloping in from both sides, running surface pollution directly from the paddock into the waterway. There were also good examples seen, such as concrete bridges aligned for passage of irrigator wheels, installed above the creek.

Pivot irrigator wheel crossing a spring-fed tributary of the creek, on a dairy farm. This provides a stormwater path for silt to enter the waterway.

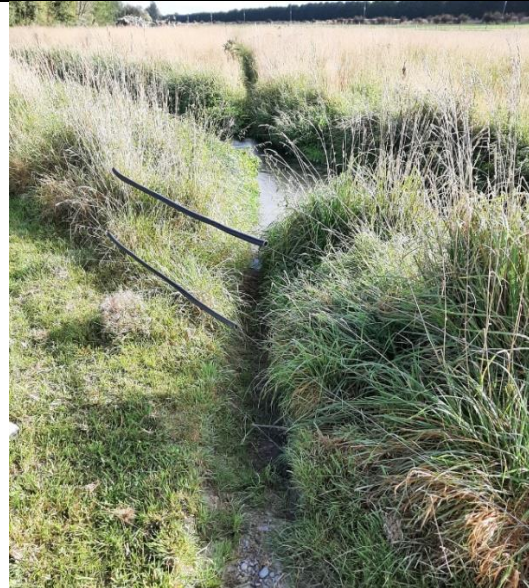
Pivot irrigator wheel track from another dairy farm, crossing Mt Harding Creek. (The insulated fence wires dip down when wheels pass over, at that point.)

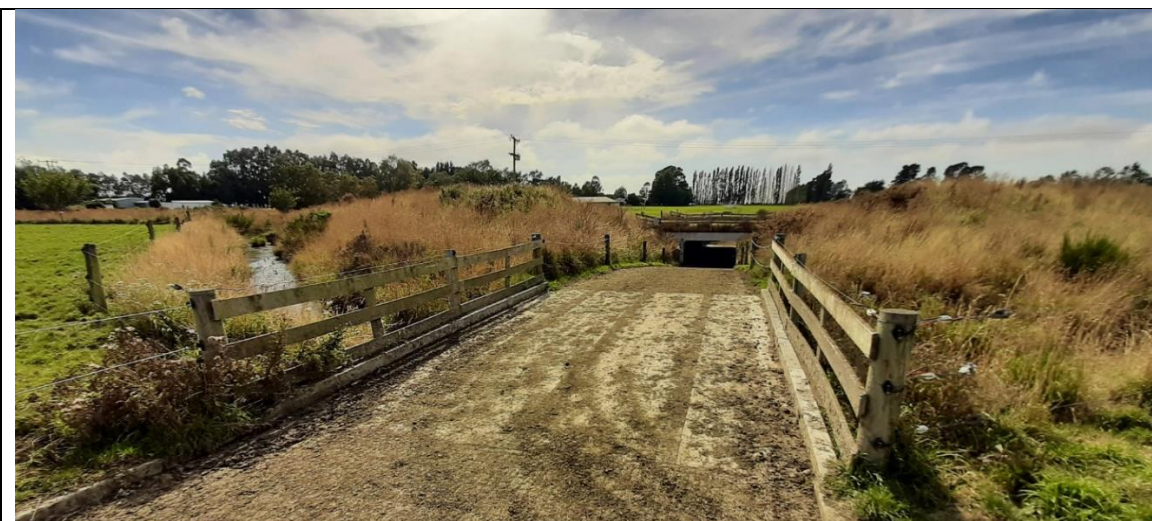
An example of 'good practice' stream stock-bridging on a dairy farm, where fencing prevents stock access to Mt Harding Creek and the bridge approaches are either level or sloping away from the water, and its concrete track edges are raised (bunded) to help manage animal manure and urine.

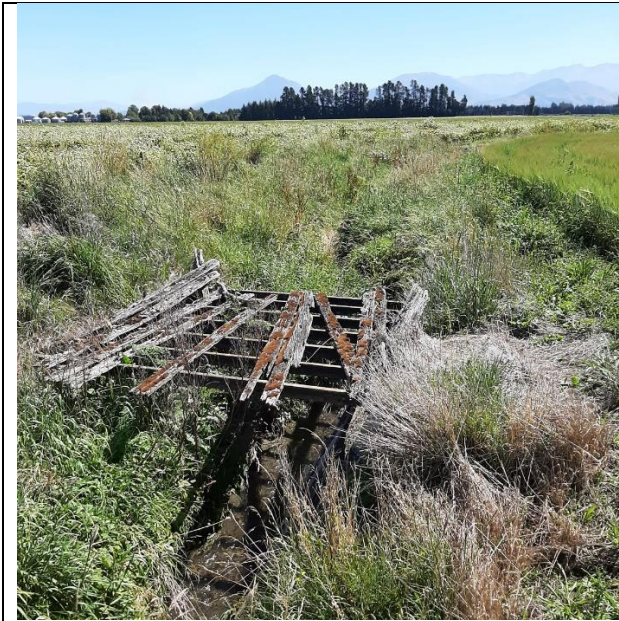
We encourage landowners to clean up their sections of the creek and expect that it would not take them long. We are aware of at least three dis-used timber and iron bridges which could potentially be dismantled before they collapse into the creek and cause blockage. Some boundary fences across the creek are similarly ‘informal’ and likely to collect flood debris.

Informal bridge example over the creek

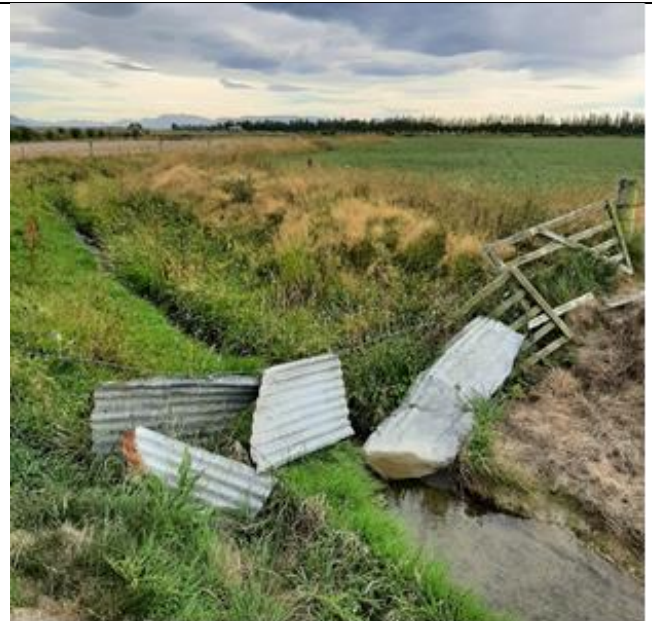
Ad-hoc fencing example at a farm boundary Creek crossing.

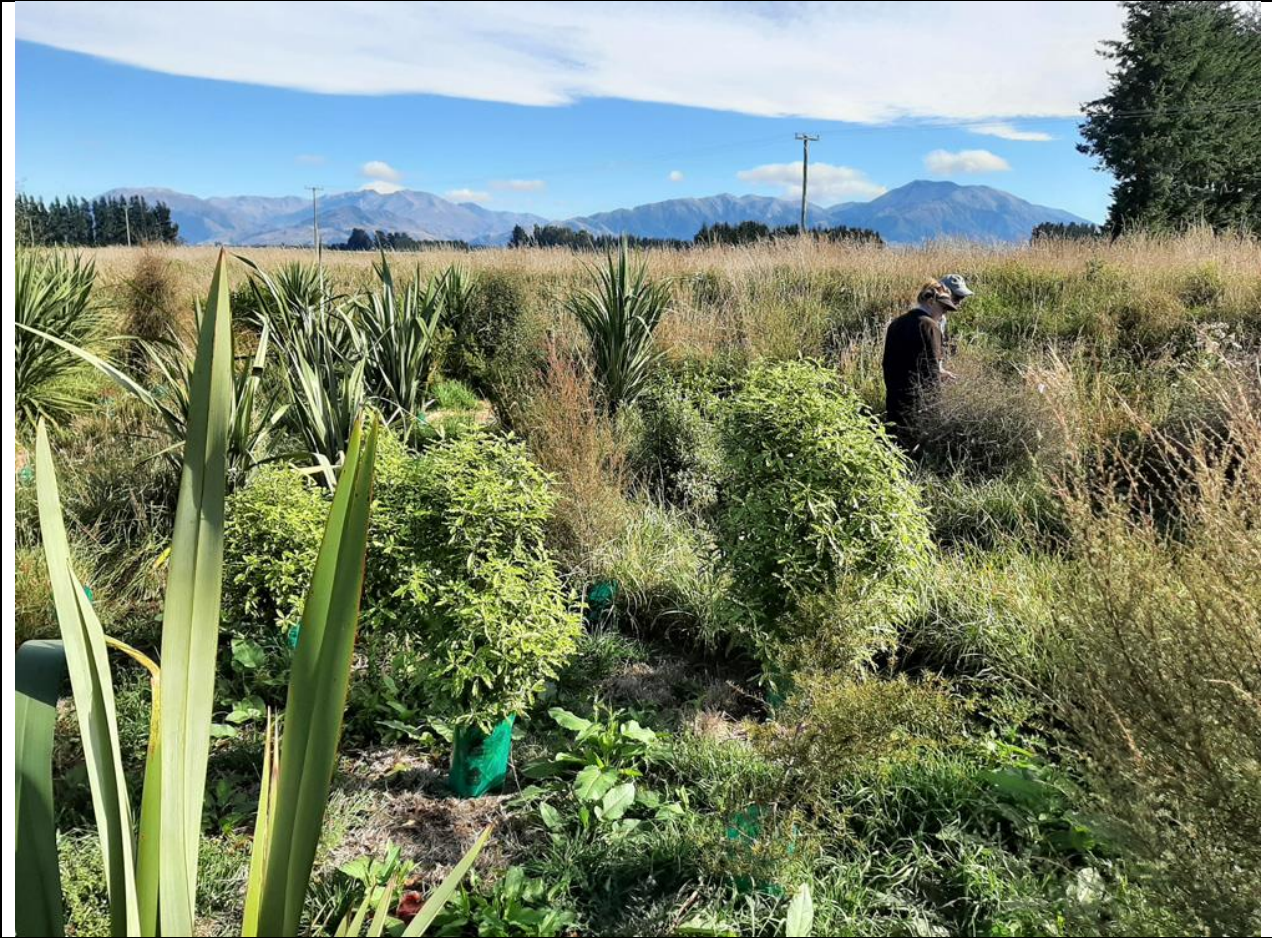
This planting on G. Lilley's farmland, within the catchment, which received grant support from Environment Canterbury, featured on an open day with additional plantings added in October 2021.

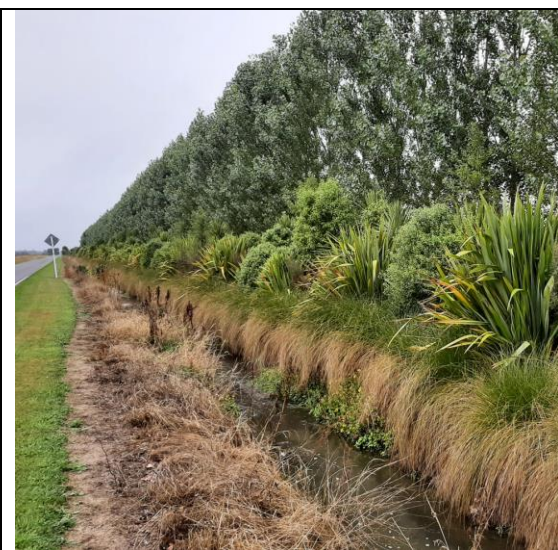
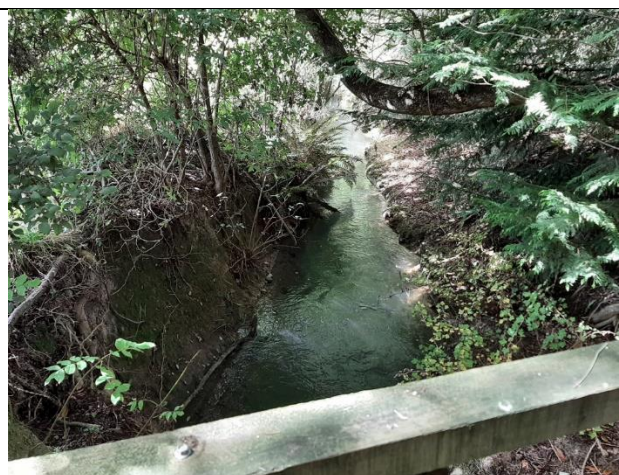
A shaded section of the Creek within an arable farm, with a mix of natives and exotics on both banks. (viewed from private footbridge)

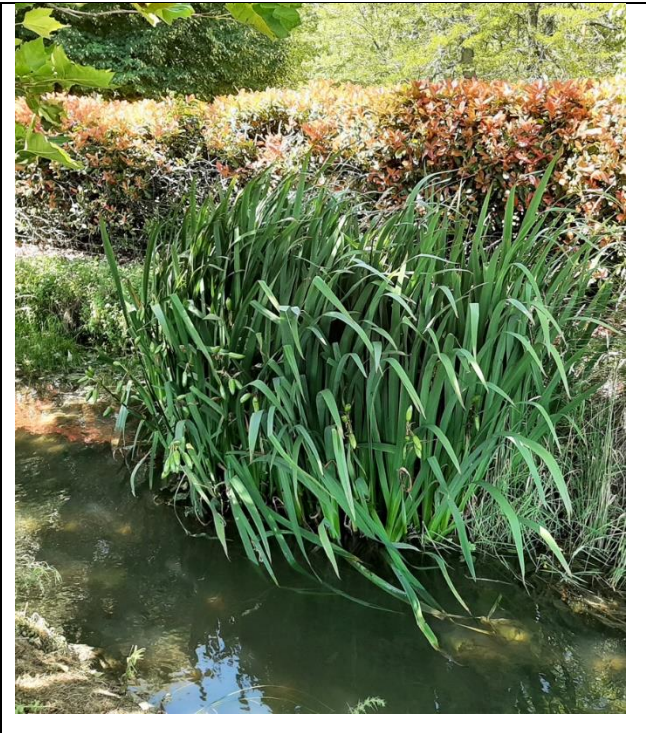
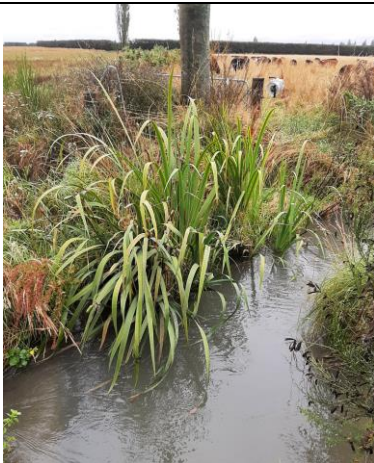
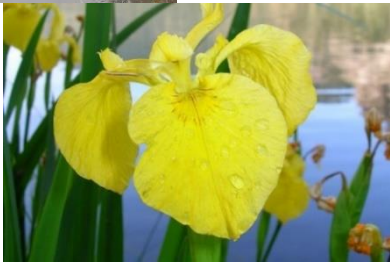
<p>Yellow Flag iris (<i>Iris pseudacorus</i>) pictured within the creek, on the roadside at Methven. It's an invasive weed, to be removed. It spreads downstream by floating seeds and broken pieces of rhizome.</p>	<p>Further clumps of iris have spread downstream of Methven. Physical removal is made difficult by need to extract all the rhizomes. Targeted poisoning is proposed. (Flower pictured, to aid ID.)</p>

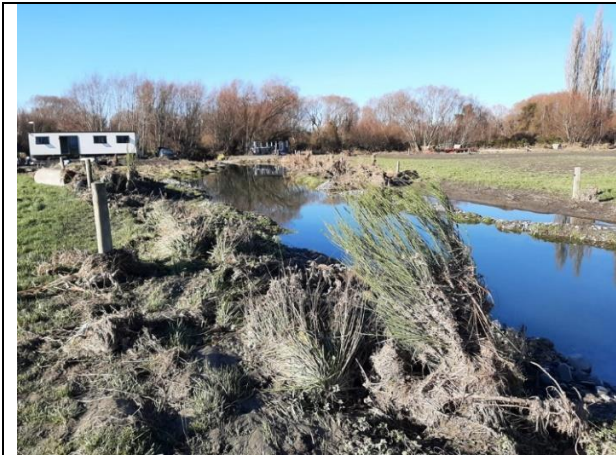
Above: June 2021, soon after North Ashburton River flood break-out entered an intermittent spring-fed watercourse on H. Rooney's Farm.

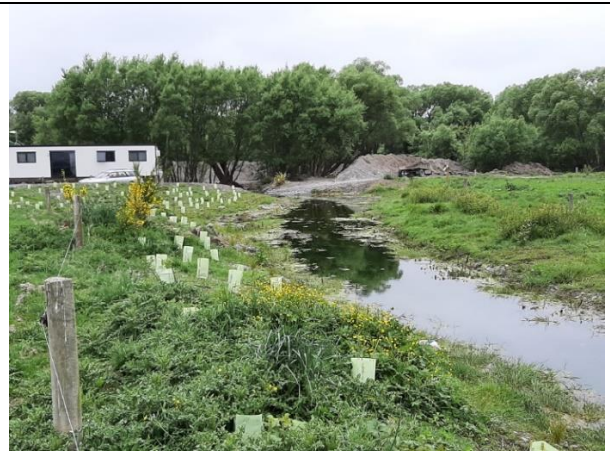
Above: Same location in November 2021, where the spring water is still flowing. Banks already replanted with natives (Fonterra assisted project).
