## ASHBURTON WATER MANAGEMENT ZONE COMMITTEE AGENDA

**DATE:** Tuesday 24 May 2022

<b>HUI/MEETING:</b> Ashburton Zone Committee	
<b>AGENDA ITEM NO:</b>	<b>KAUPAPA/SUBJECT:</b> Hekeao Community Wetland
<b>KAITUHI/AUTHOR:</b> Melanie Brooks	<b>WĀ/MEETING DATE:</b> 24 May 2022

**Report contents.**

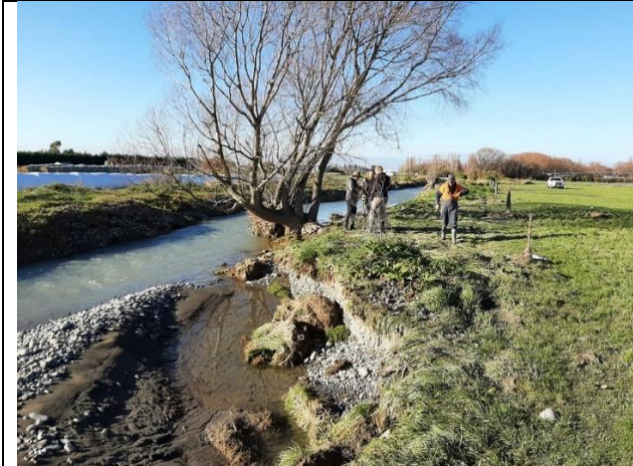
Above: June 2021, Looking downstream from right bank: flood damage to Mt Harding Creek at H Rooney's farm. The true left bank was scheduled for riparian planting (visible here, with white-wrapped baleage line beyond).

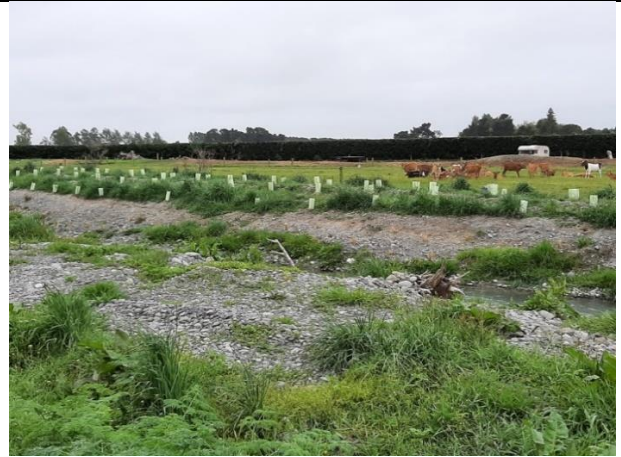
Above: Same section of creek, but looking upstream, December 2021. Native plants in place on the left bank, above re-graded shingle. Recovery from flood is under way. Fonterra assisted with project funding.

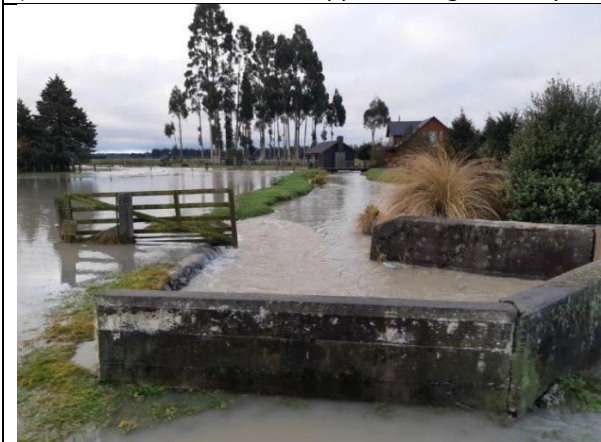
Mt Harding Creek 2021 flood across land north west of Methven, at the ADC Gate supplying Methven Auxiliary, on Forest Drive.

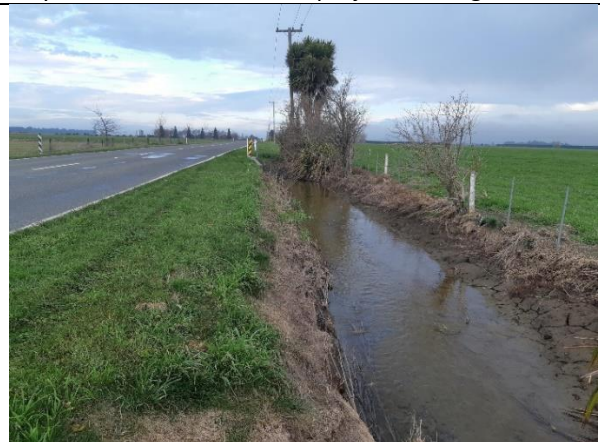
Post flood - spring fed flow south of Methven at SH77. Often this tributary bed is dry.
