**Soil Contamination Risk  
Preliminary Site Investigation Report**

**8 Glassworks Road, Ashburton, Canterbury**

July 2025

**Client:** Malteurop Group

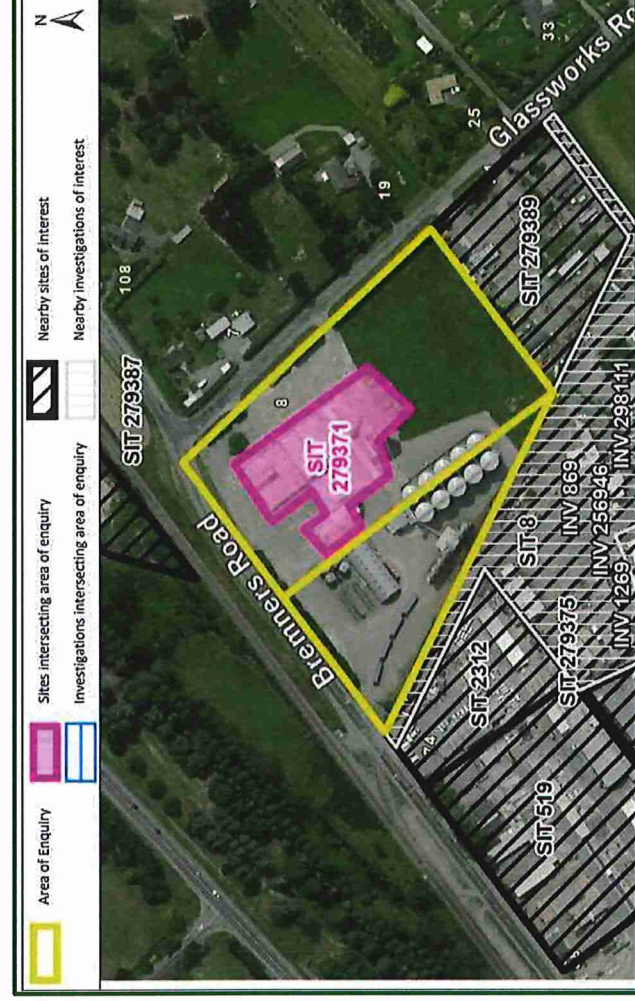
Figure 3 – Listed area (pink) in relation to the site (yellow)

Information available from the ECan GIS database shows part of the site is listed on the Listed Land Use Register (LLUR) for land use activities and industries associated with the Hazardous Activities and Industries List (HAIL). Part of the site is listed as 'HAIL 1 – any other land'. A note in the LLUR statement indicates the site was occupied by the Ashburton Glassworks from the 1940's onwards and contained furnaces for the manufacture of glass which were likely powered by coal. The site is categorised as 'verified HAIL, not investigated'. **Figure 3** below shows the listed area in relation to the site.

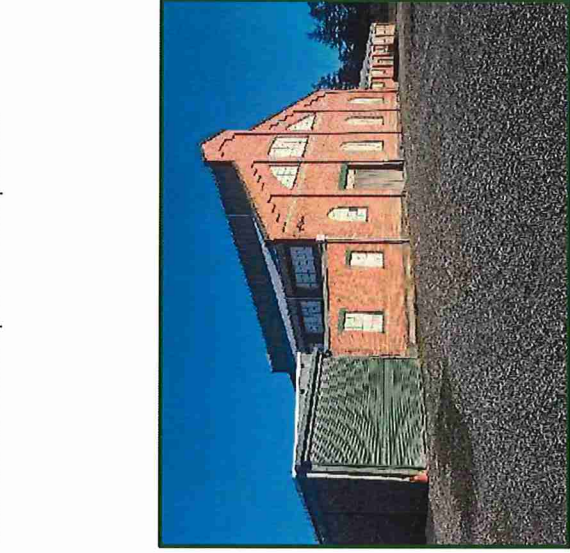
brick or iron clad, with corrugated iron roofing. The buildings are currently used for seed/grain storage by Malteurop and other general storage. There were no obvious signs of asbestos containing materials on the exterior of the buildings. The subterranean channels noted in **Section 8** above are visible throughout the building and cause significant issues with vermin as discussed by the client representative. The chimney itself was fully encapsulated. The client representative noted the significant unknowns with regard to the chimney and how deep underground it extends. He also noted that it is unclear how the site functioned in relation to coal storage areas and transport across the site. However, train tracks do extend into the building adjacent to the chimney and likely transported the coal directly to the chimney. There was no evidence of coal storage at the site.

Photo 1 – Historic Building with brick cladding

Historical aerial photographs show multiple buildings on site in the pre1940's. Due to the era of construction, the use of lead paint based is considered likely. Asbestos corrugated roof sheeting was noted in heritage articles as part of the construction material used on the historic buildings. Any intentional removal or natural deterioration over time may have resulted in contamination of the surrounding soils.

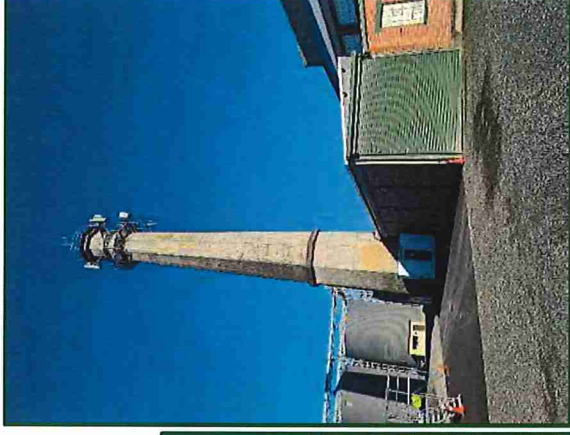
Photo 2 – Chimney

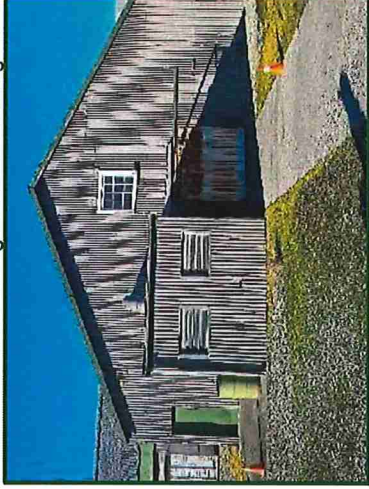
Photo 3 – Historic building with iron cladding

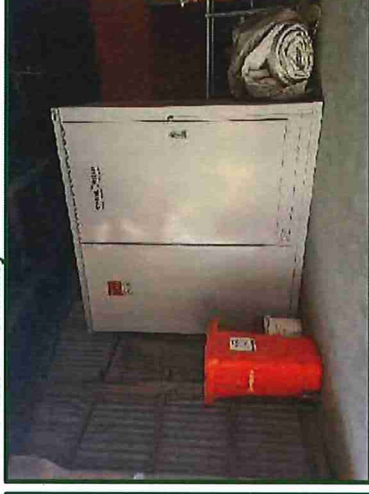
A modern hazardous substances storage shed and a lubricant drum with a pump are located within the building. A modern transformer was present outside the building. All are situated on a concrete base with no visible spills or leaks present.

Photo 4 – Hazardous substances storage shed

During the site inspection two air compressors, a hazardous substances storage shed and a lubricant drum with a pump were identified. There is likely to be minor fuel and chemical storage occurring elsewhere on site, not identified during the site inspection. One of the air compressors located in the control room appeared to have leaked and black staining was present on the surrounding surface. In general, the fuel and chemical storage occurring on site is very low risk as it is occurring within buildings on sealed surfaces.

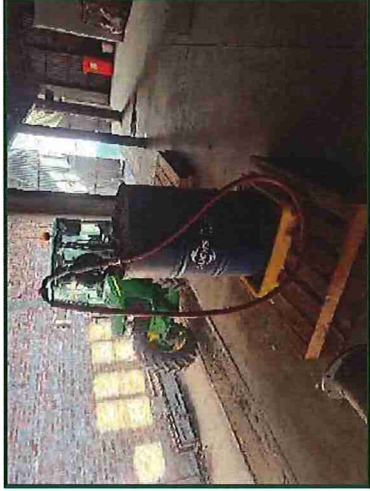
Photo 5 – Lubricant drum with pump

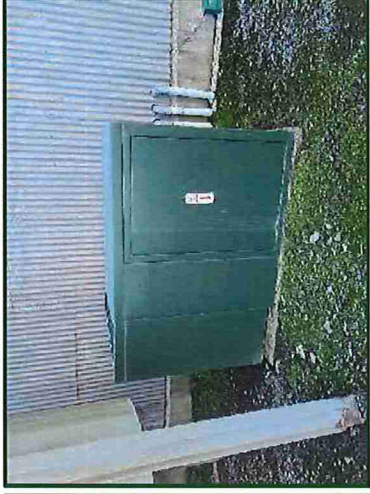
Photo 6 - Transformer

A modern transformer was identified during the site inspection. Based on the likely era of construction the use of polychlorinated biphenyls (PCBs) is considered unlikely. Contaminants of concern include heavy metals and hydrocarbons. However, the site inspection did not find any signs of oil leakages and the transformer is located on a concrete base, surrounded by hard sealed surfaces.

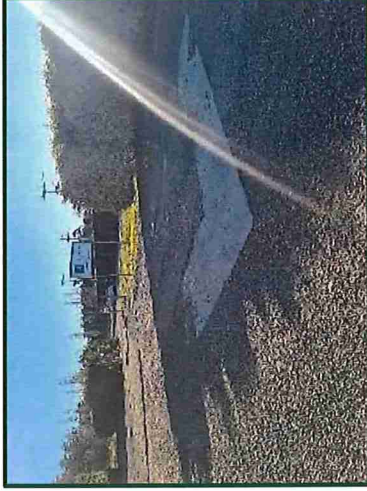
Along the northeastern boundary of the site is a concrete pad from a former weighbridge. Concrete edging is also present from the former inground water storage pool used for fire protection.

Photo 7 – Former weighbridge – concrete pad

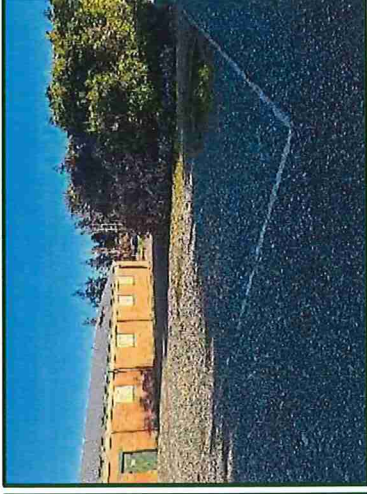
Photo 8 – Former pool for fire protection – concrete edging

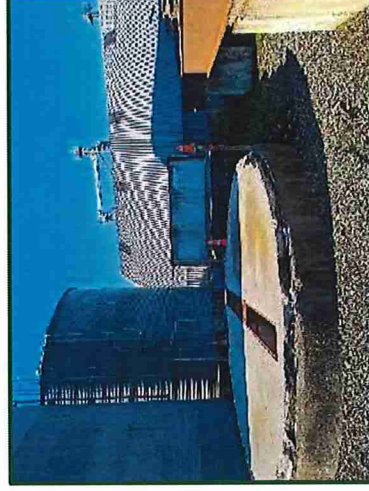
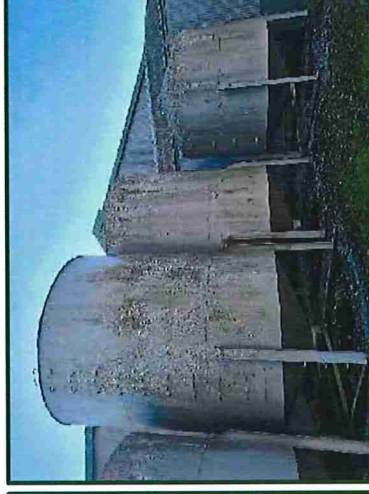
To the west of the historic building there are six decommissioned silos, with an additional two concrete pads for silos which have already been removed.

Photo 9 & 10 – Decommissioned silos

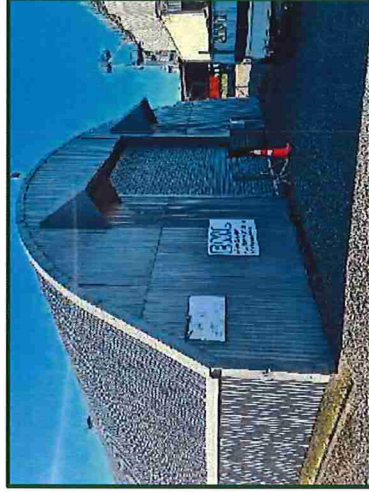
The western section of the site consists of a long-corrugated iron workshop occupied by EML, a steel supply and custom engineering business. Outside the workshop there is general workshop storage and several oil drums which appear to be used for the burning of waste materials.

Photo 11 – EML Workshop

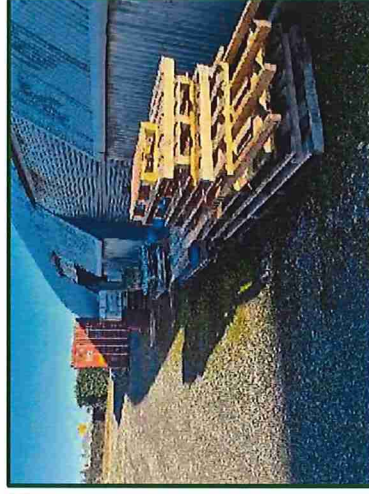
Photo 12 – Storage

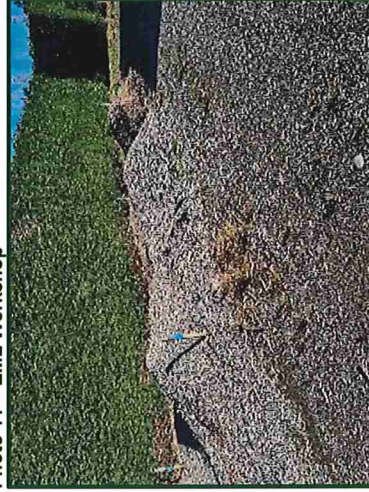
A pegged-out area in the western corner of the site has been allocated for lease to a telecommunications provider. In this area there is a long mound of visually clean gravels adjacent to a mound of soil containing waste material with ash and charcoal.

Photo 13 – Pegged area for telecommunications

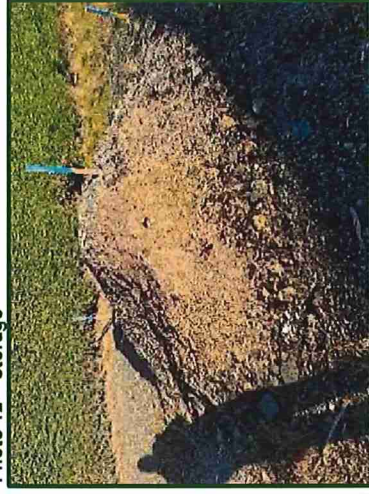
Photo 14 – Soil with visible ash and charcoal

A large burn pit, waste disposal of ash and a drum used for burning waste materials were identified during the site inspection. The burn pit is visible on aerial photographs from the early 2000's onwards and wooden pallets are visible in recent aerial photographs as well as during the site inspection. Burning of anthropogenic materials can cause contamination of the underlying soils.

Contaminants of concern include heavy metals, asbestos, other contaminants depending on the material burnt.

There is a potential risk to construction workers where soil disturbance works are proposed. It is recommended that a Detailed Site Investigation be undertaken in areas of the site where soil disturbance activities are to be undertaken.

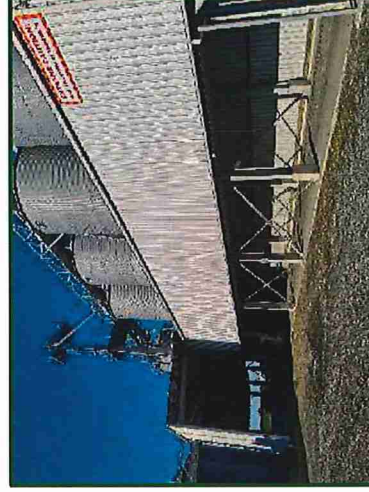
At the southern end, eight smaller silos are present with rail shunting infrastructure used for malt storage and distribution. An air compressor is situated on a concrete base to the south side of these silos. Ten large barley silos are also located in this area, accompanied by a concrete block clad control room, to the north. Black staining was observed on the floor of the control room surrounding an air compressor. There were no cracks in the concrete base of the control room.

Photo 15 – Silos with rail shunting

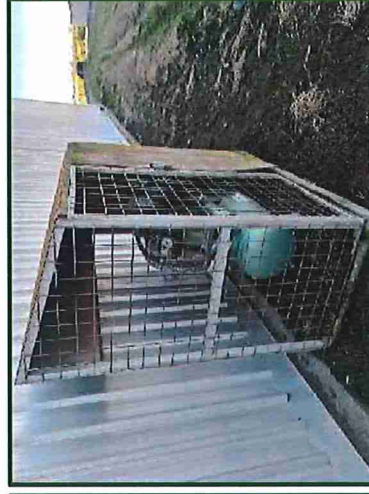
Photo 16 – Air compressor

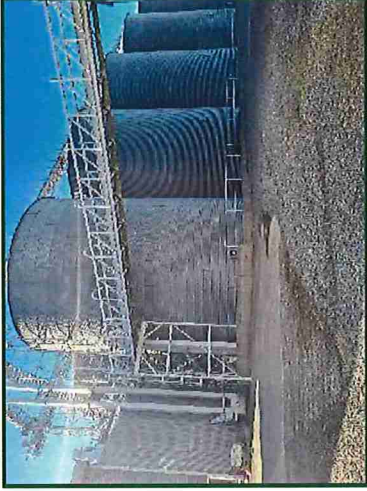
Photo 16 – Barley Silos

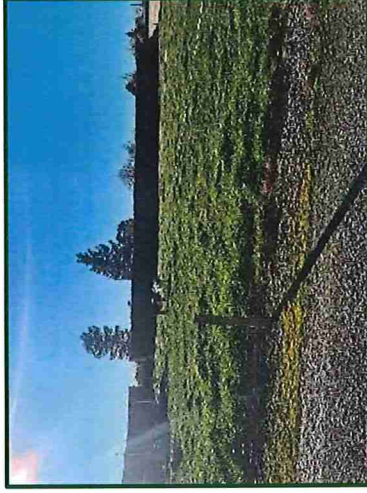
In the southern corner of the site, there is a large, grassed area used for grazing, a burn pit containing timber, steel and green waste was noted.

Photo 18 – Grassed area

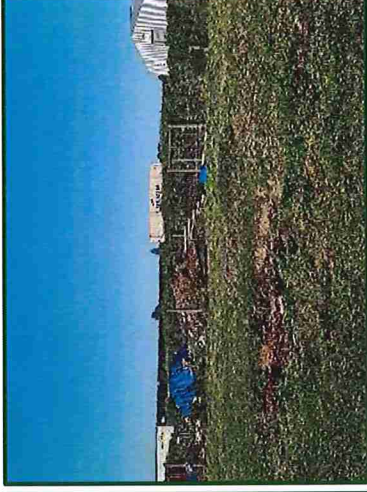
Photo 19 – Burn pit containing timber, steel and green waste
