# INFRASTRUCTURE SERVICING REPORT

TM30625 / Farm Road, Ashburton /  
CONISTON PARK LIMITED

**Title:** Infrastructure Servicing Report

**Project No** TIM 30625

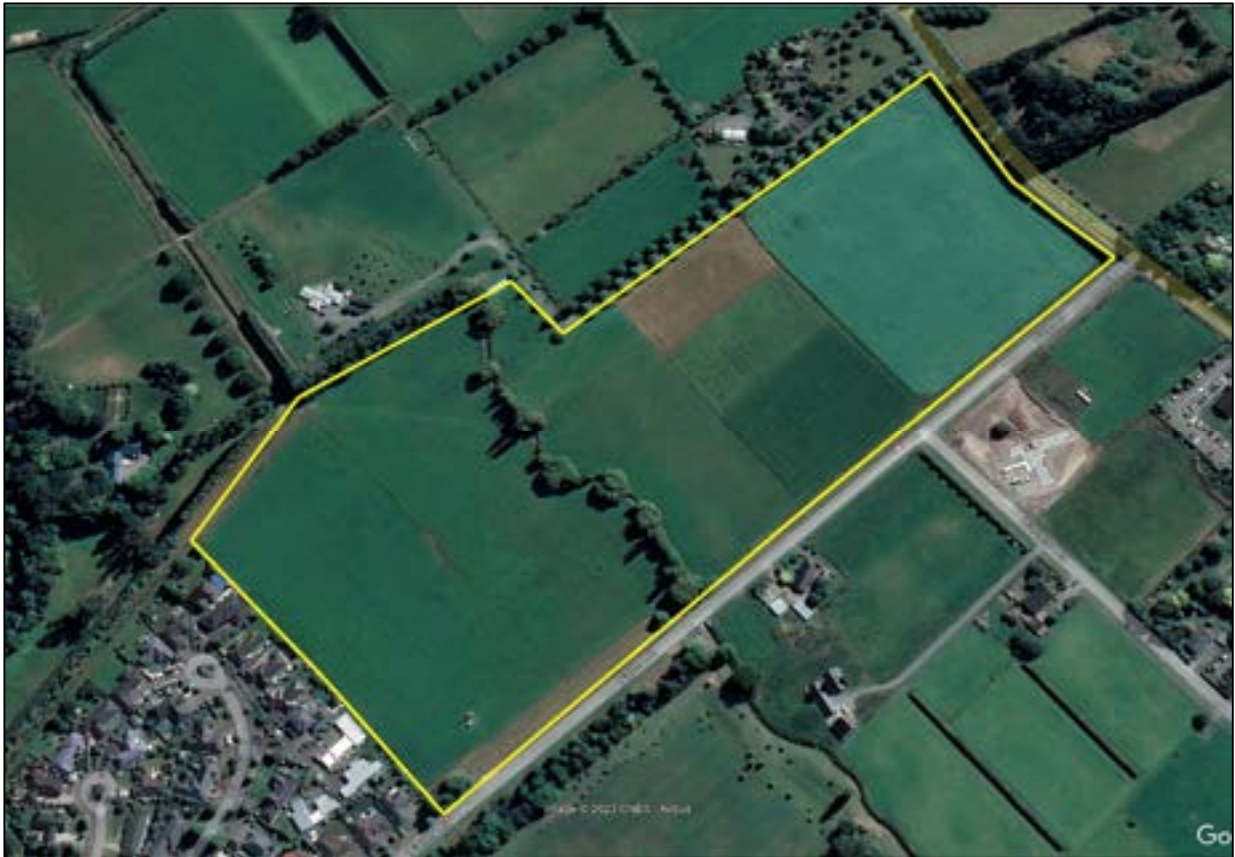
The site is located in Allenton, Ashburton, approximately 2.6 km northwest of State Highway 1, 1.7 km northeast of the Ashburton River and 0.7 km southwest of the Ashburton River North Branch. The land parcels (Lot 4 DP 320165 and Lot 8 DP 311232) occupy a total area of 16.32 ha and are hereon known as “the site” outlined in yellow shown in Figure 1.

**Figure 1: The Proposed Development Outline in Yellow**

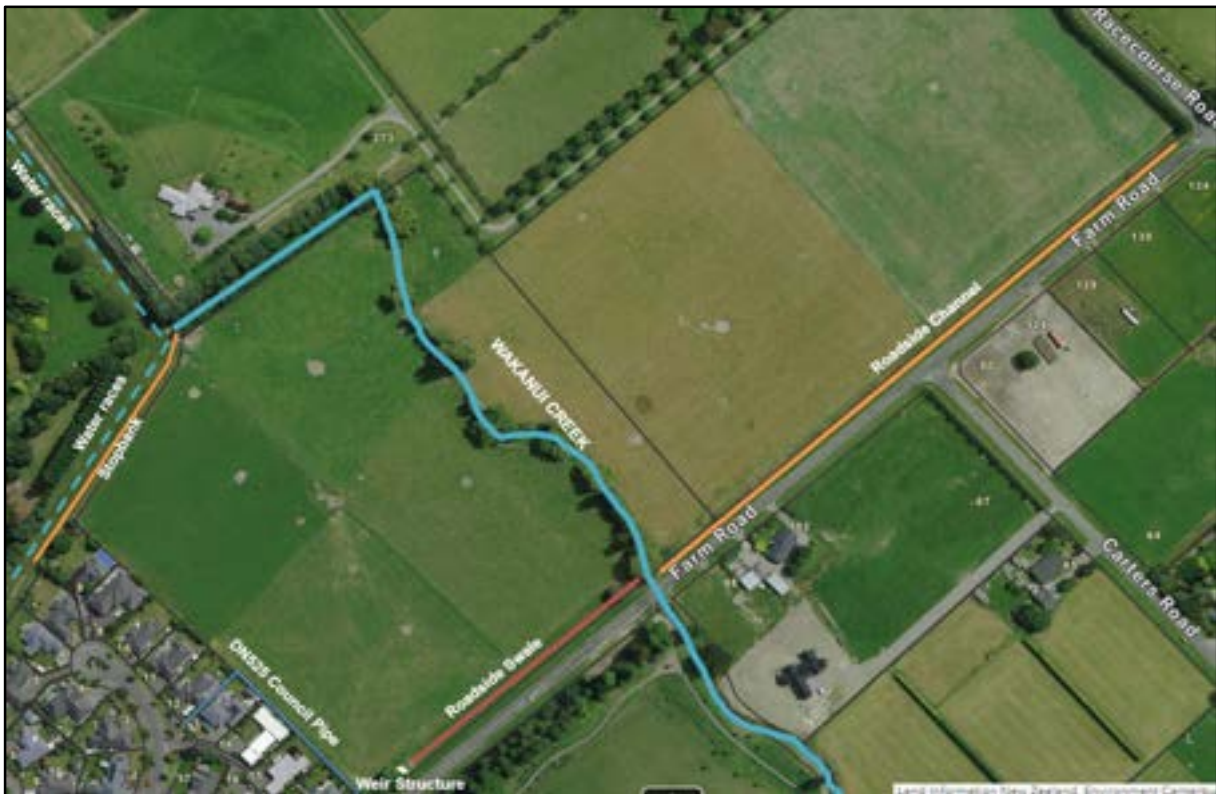
The land is predominantly flat across the site. According to Google Earth and Canterbury Maps the site elevation of 111m to 113m above the mean sea level across the site.

**Figure 2: Topography of the site**

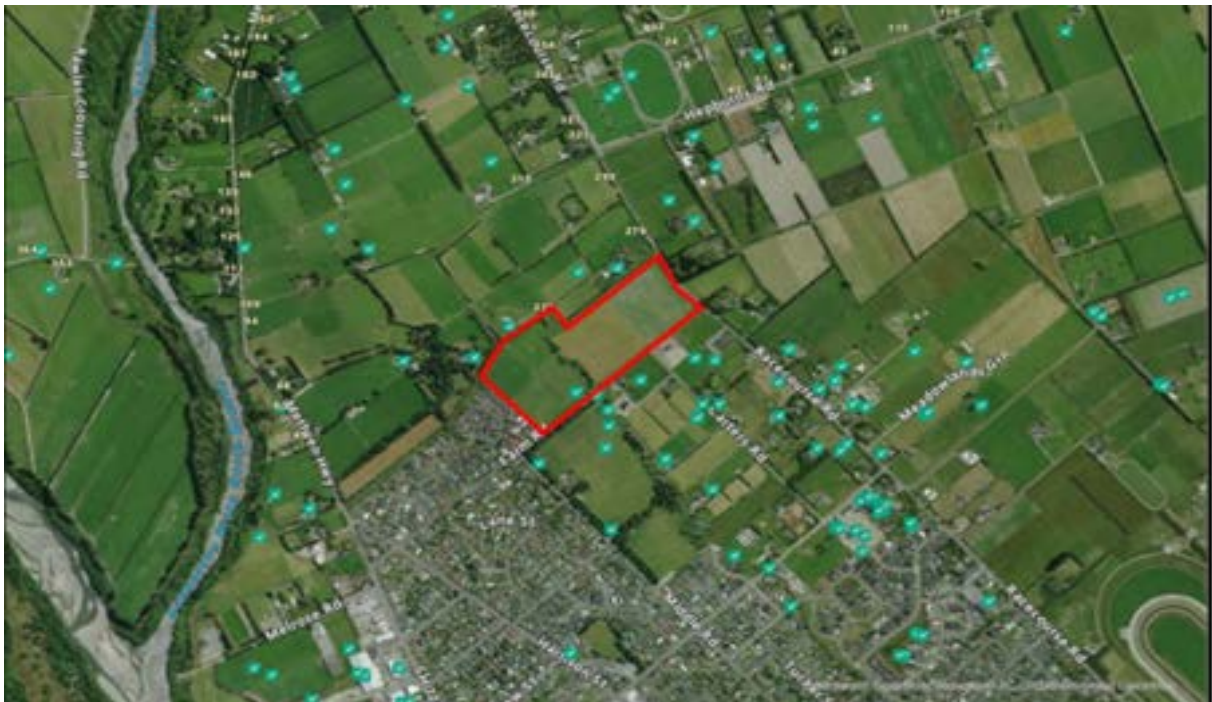
There are 24 off-site registered active consents to take groundwater and four active discharge consents off-site within a 500m radius of the site. The piezometric contours accessed via Canterbury Maps indicate that groundwater flow in the area is generally to the southeast.

**Figure 3: Nearby consents obtained from Canterbury Maps, February 2023**

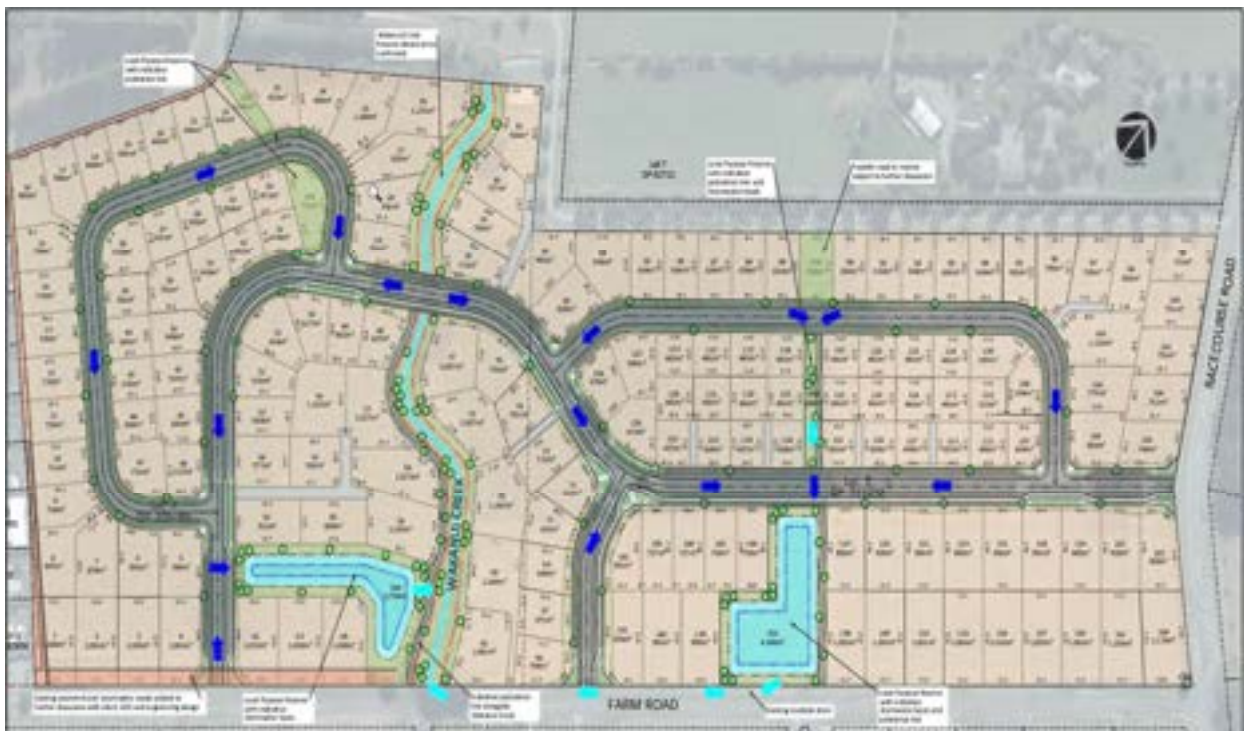
The proposed concept scheme plan for the Coniston Park subdivision shows approximately 167 proposed low-medium density residential lots, associated roading, stormwater reserve and recreational reserve area surrounding Wakanui Creek as shown in Figure 5 and **Appendix C – Concept Scheme and Design Plans**.

Figure 5: Concept Scheme Plan (Plan 30625-PL01)

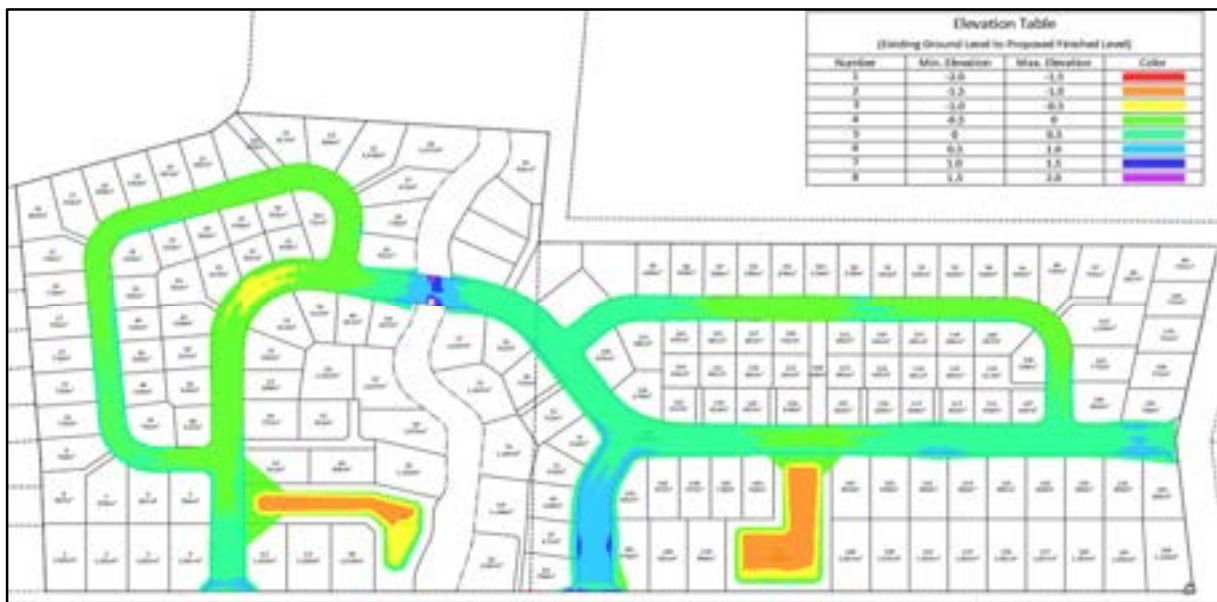
In Figure 6, the major cut-excitation area will be the construction of two proposed stormwater soakage basins with 1.5m depth from existing ground level. The major fill-excitation area will be formation of the road and upgrading the existing crossing to road crossing across Wakanui Creek.

**Figure 6: Excavation (Cut and Fill) Heat Map**

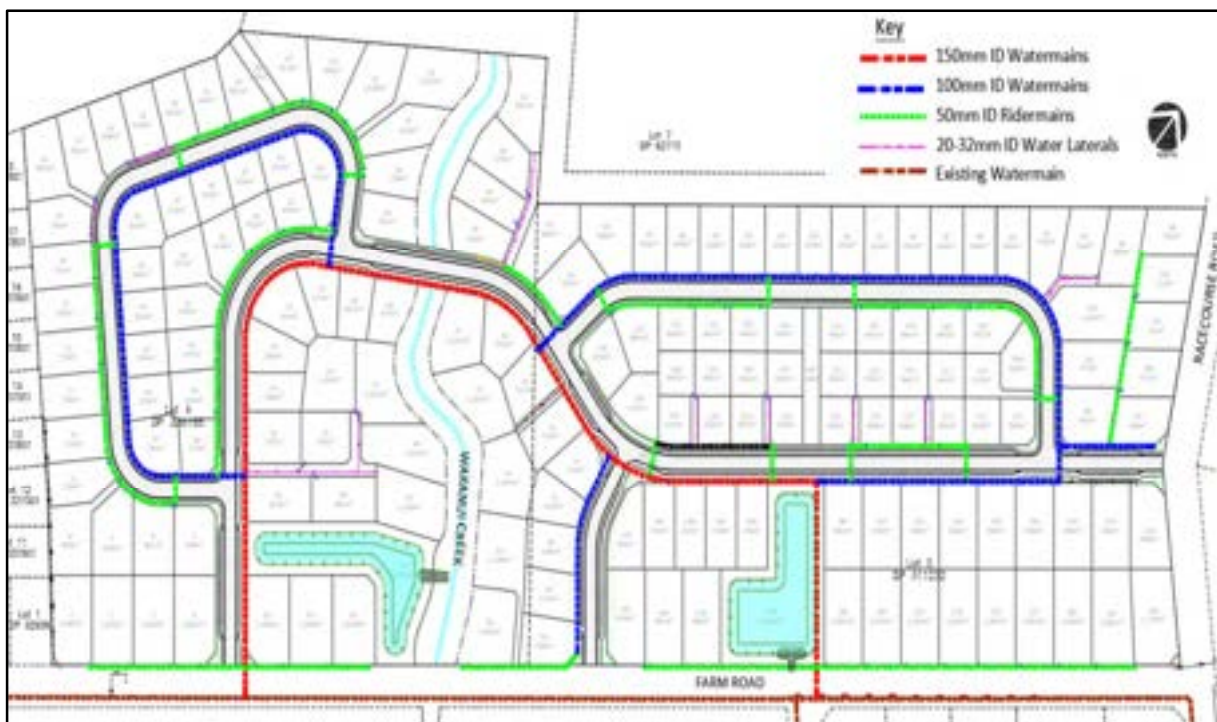
It is proposed the site will have two new connections to the public watermain along Farm Road that is extended into the West side of the site and loop back to the public watermain at the East side of the site. This will ring-main the site providing a “two-feed system” with a minimum pipe size of 150mm internal diameter.

**Figure 7: Proposed conceptual watermain connection and network within the site**

If the public water network were to be extended in the future to the North of Racecourse Road, the 100mm internal diameter watermain in the road reserved has been considered in the design to allow future connection to provide additional water network capacity, resilience and security of water supply to the site.

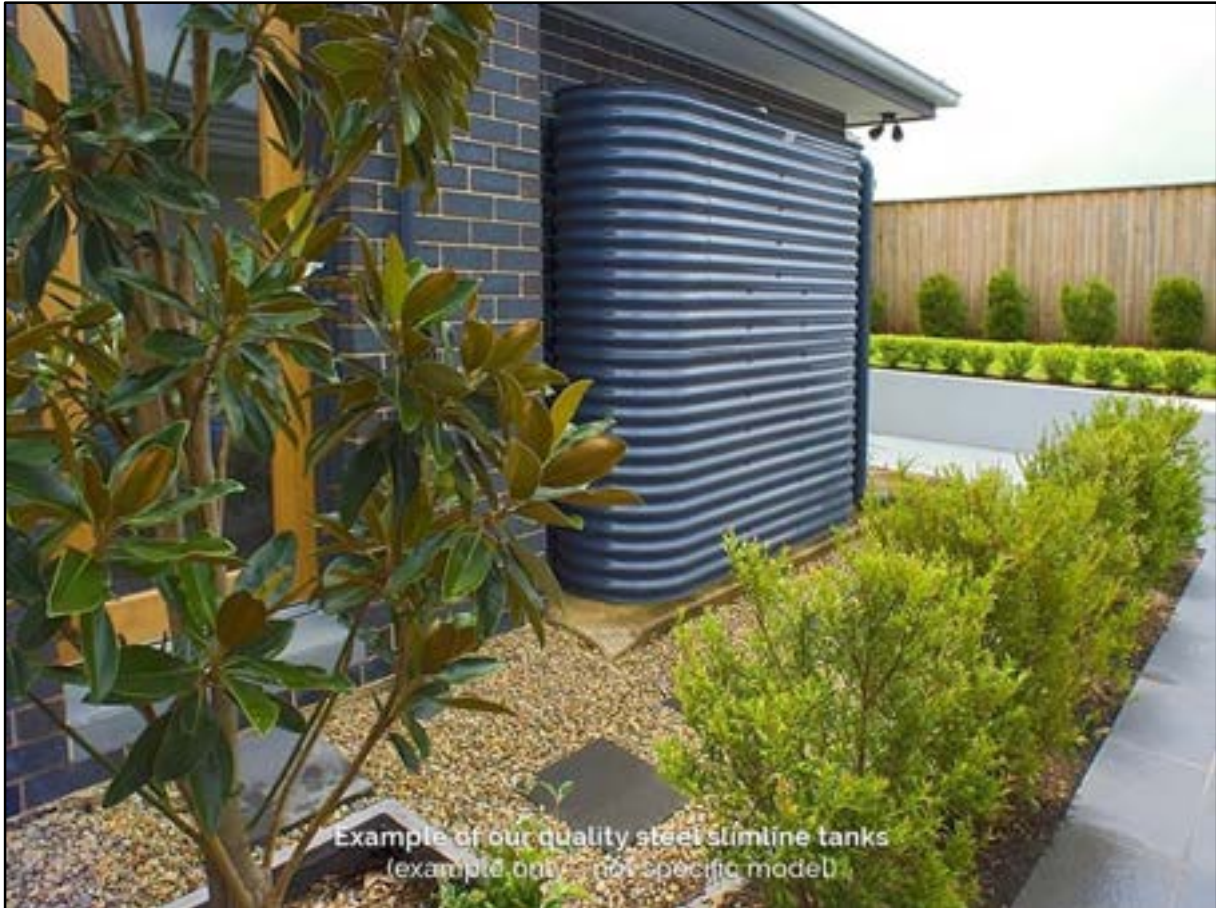
To minimise reticulation and global attenuation sizes, it is proposed that each allotment will be required to install a rain tank of a minimum 5000L storage. The tank will have 24mm discharge orifice size to provide stormwater attenuation prior to discharge to the stormwater reticulation or into the Wakanui Creek. Example of a 5000L slim line rain tank is shown in Figure 17.

**Figure 17: 5000L slimline rain tank**

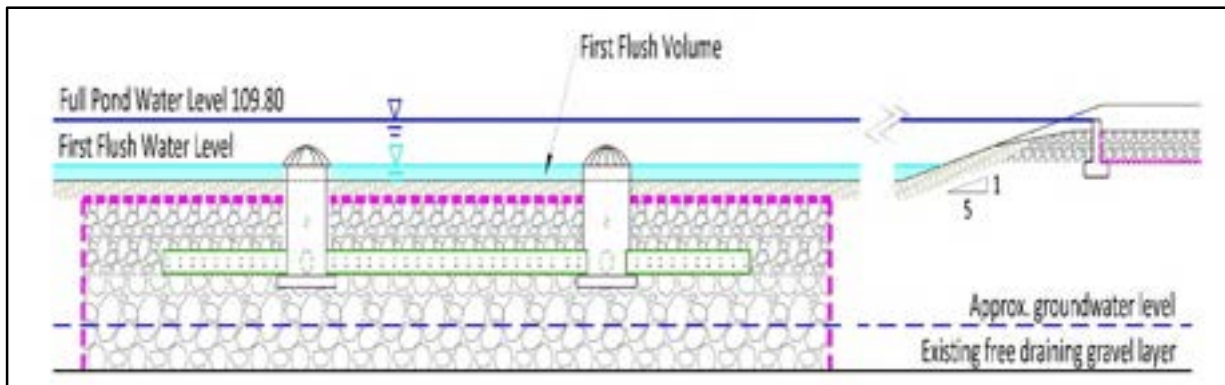
The conceptual infiltration/soakage basin plan is shown in Figure 19. The first flush volume shown as highlighted blue area will be collected and treated within the soakage basin by sedimentation and filtration. The solid blue line is the maximum pond water level for attenuation and any discharge to the overflow weir is the pre-development discharge flow to Wakanui Creek.

**Figure 19: Conceptual infiltration basin cross section**

The soakage basins are designed to discharge additional flows from the site into the ground. High factor of safety was used to each soakage basin to account for long-term creep effectiveness reduction of soakage, groundwater influences to soakage rate and capacity. From **Appendix D – Infiltration Test Memorandum Report**, infiltration rate for each soakage basin can be derived as shown in Table 22.

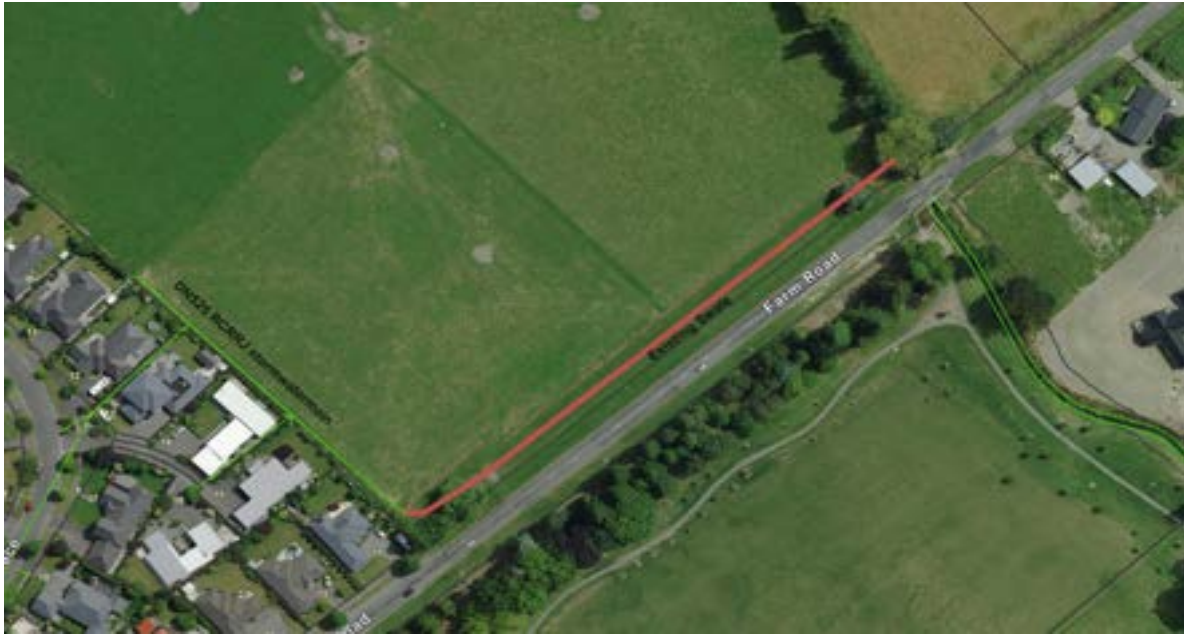
There is an existing stormwater swale at the Western side of Farm Road within the site which collects and convey stormwater discharge from the existing DN525 concrete (RCRRJ) stormwater main to Wakanui Creek as shown in Figure 20.

**Figure 20: Existing DN525 Pipe (Green line) and Swale (Red line)**

The site has multiple road frontages from allotments and road access crossing to the existing swale. Coniston Park Ltd ideally would like to convert the existing swale into a pipe network with similar pipe diameter to the upstream network in order to maximise the development area and provide better accessibility direct onto Farm Road. Existing and/or proposed easement(s) will need to be confirmed to protect the relevant infrastructure/pipeline.

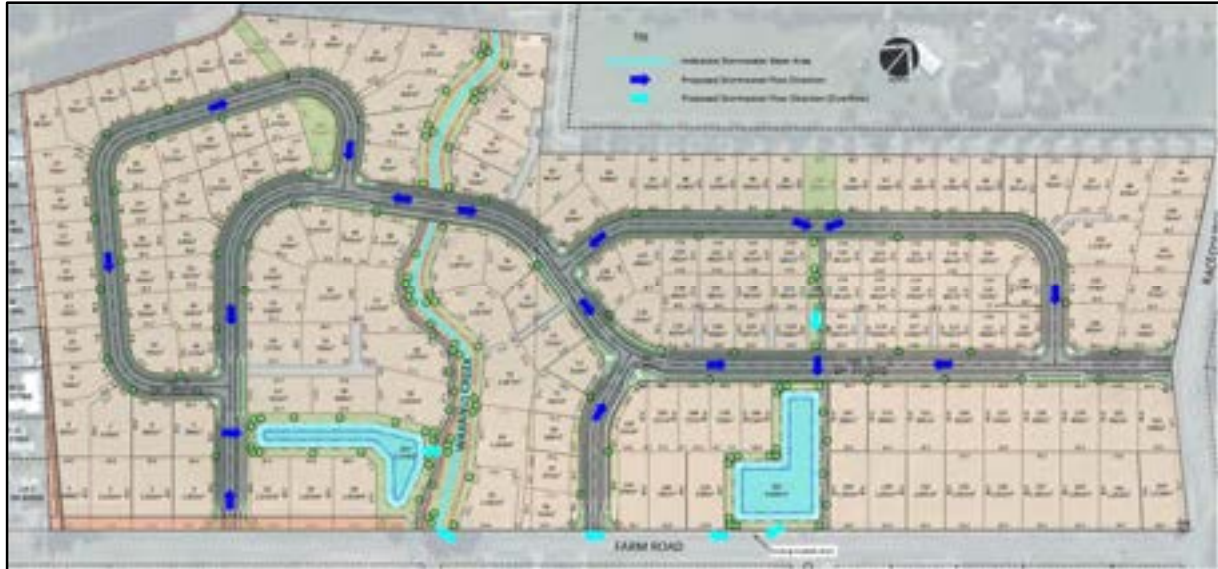
For events greater than the stormwater reticulation design event, excess surface runoff within the site will be conveyed within the road carriageway via road carriageway and swales to the soakage basin. Within this period, the soakage basin will be full and any excess stormwater will overflow to Wakanui Creek. The secondary flow path is shown in dark and light blue arrows as shown in Figure 25.

**Figure 25: Stormwater Secondary Flow Path**

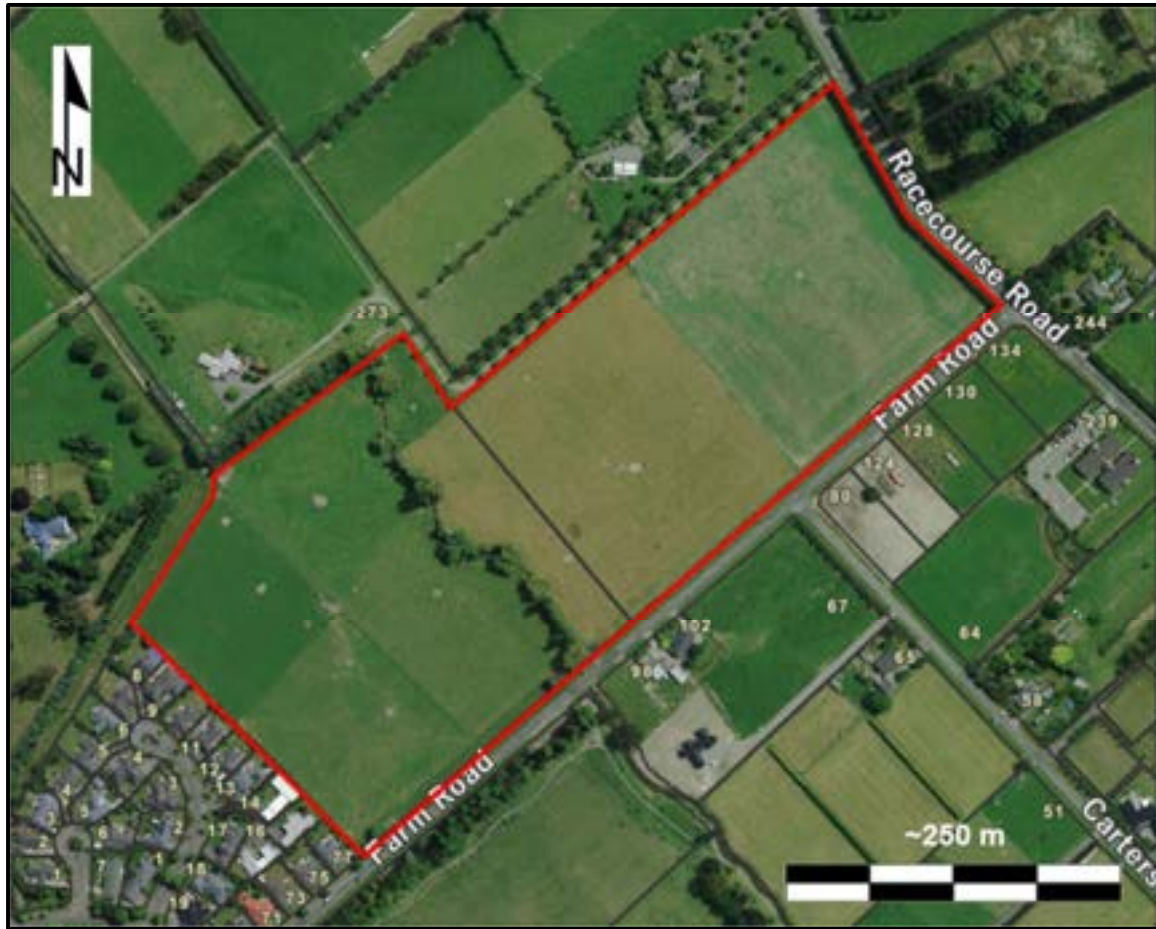
The site is located 750 m east from the northern branch of the Ashburton River (Hakatere), at its nearest point and is surrounded by rural-residential properties to the north, east, and south. Wakanui Creek flows southeast through the centre of the site. A developed residential subdivision is located immediately beyond the south-western site boundary.

Figure 1: Site Layout, Lot 4 DP 320165 & Lot 8 DP 311232, are indicated by the red outline (Latest aerial imagery obtained from Canterbury Maps).

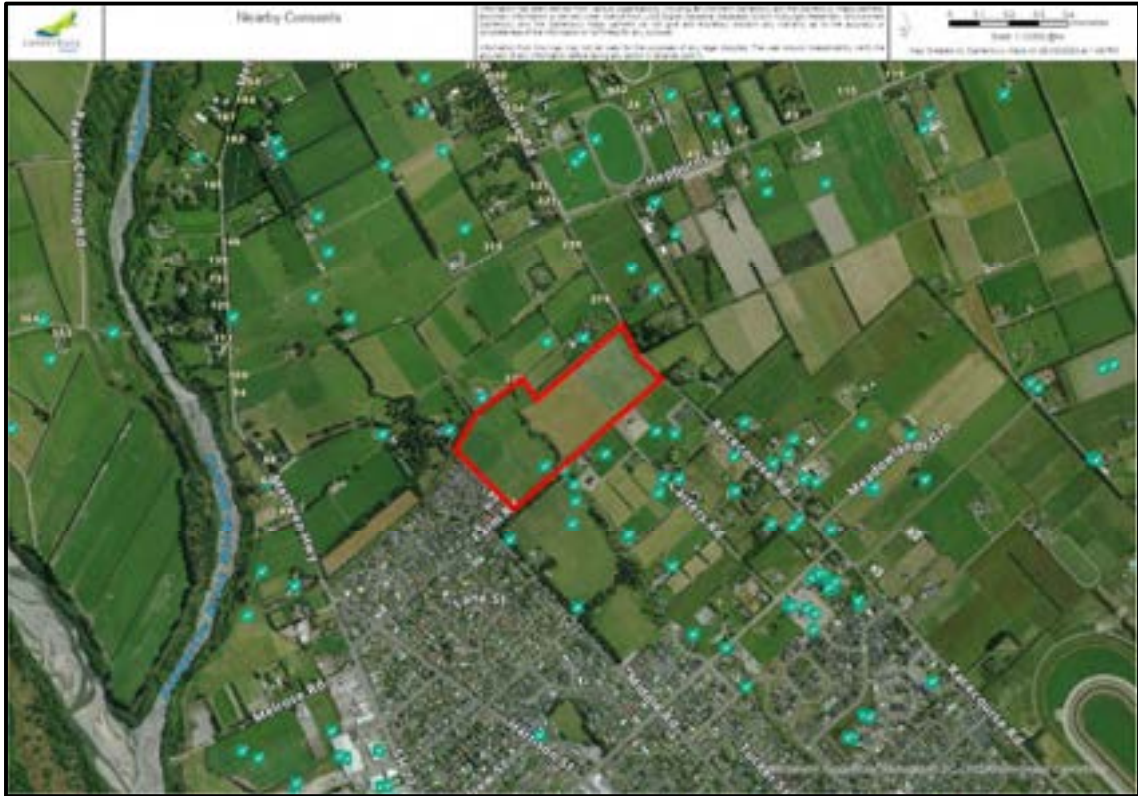
Figure 4: Nearby Consents listed in Table 3, obtained from Canterbury Maps, February 2023.

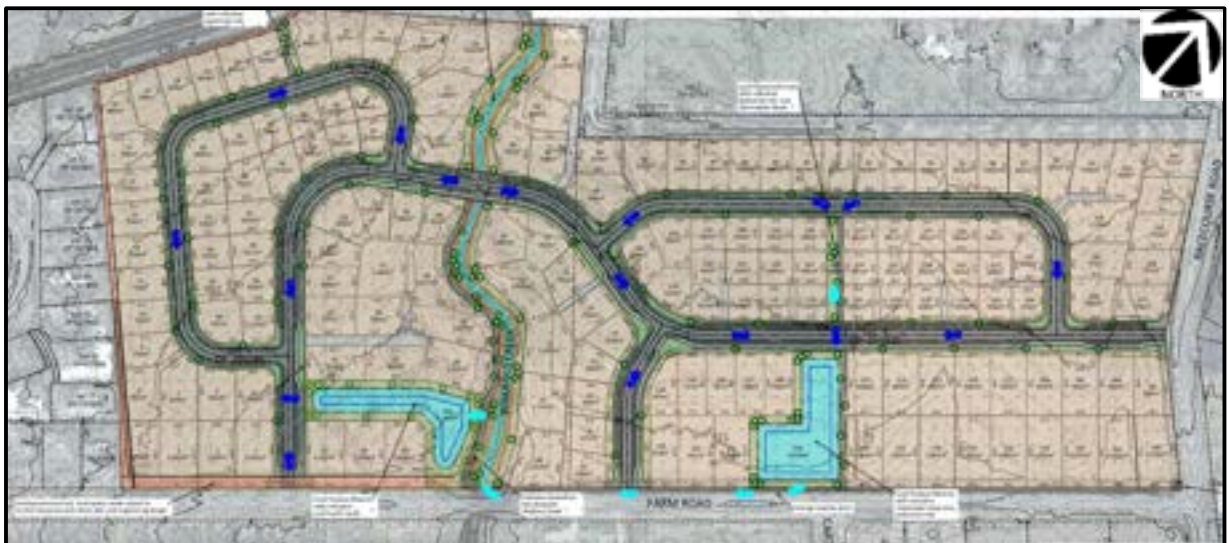
Development for 147 low density residential properties with associated stormwater ponds and infrastructure are proposed for the site. The lots will be served by a new internal road network off the existing Farm Road in the south. An initial scheme plan is shown in Figure 5 and **Appendix A**.

**Figure 5: Excerpt plan for the proposed Coniston Park subdivision.**

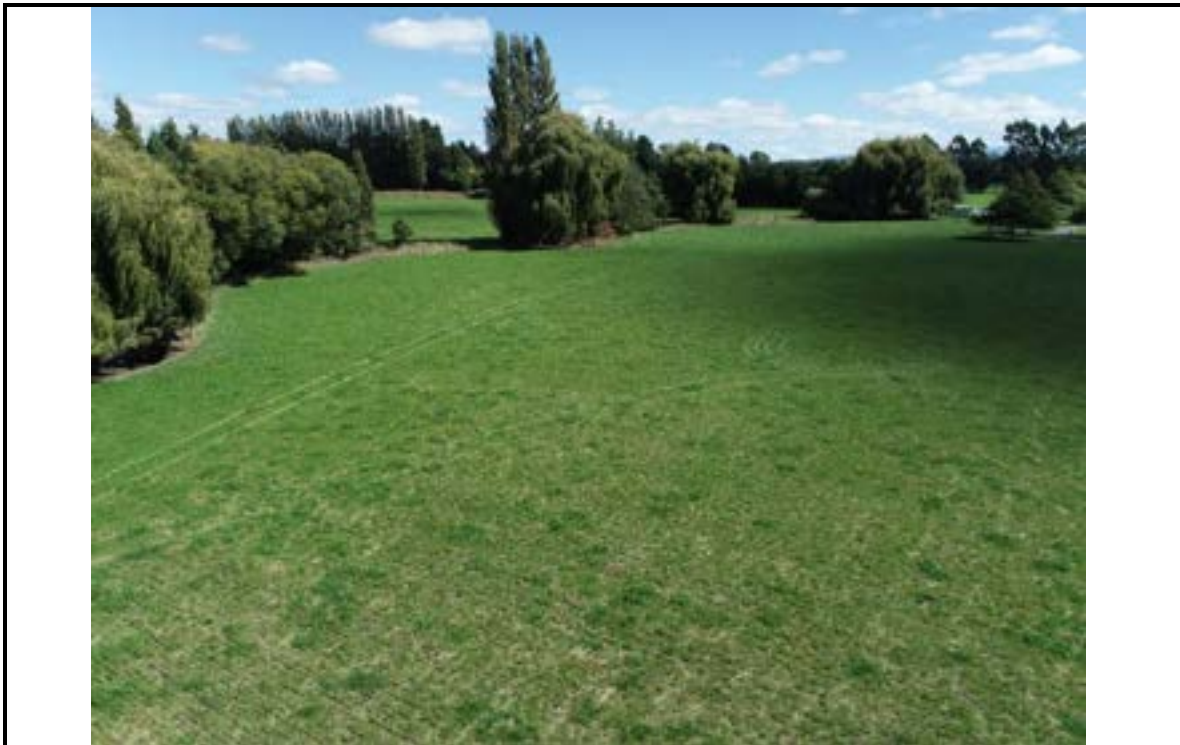
**Photograph 1:**

General site conditions looking at the centre of the site to the northeast. Wakanui Creek can be seen by the line of green vegetation. Bails of hay are in the top right hand corner.

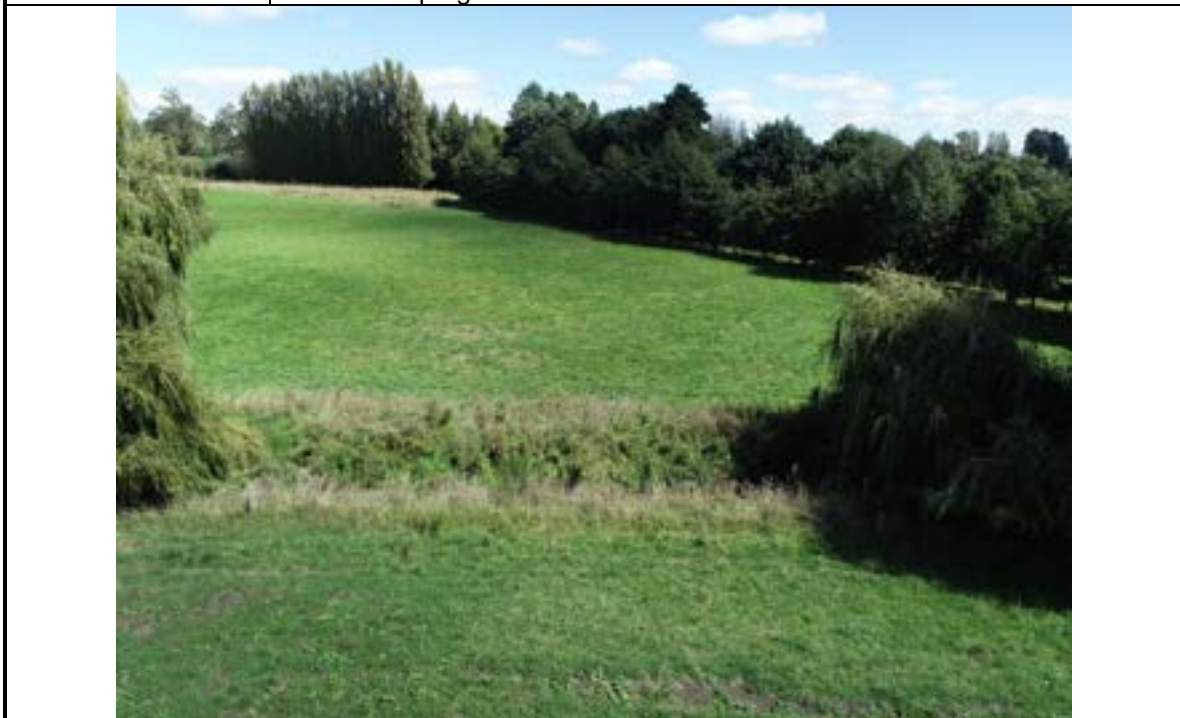
**Photograph 2:**

Aerial photo showing the northeast boundary of the site, which is relatively flat alluvial ground. Wakanui Creek flows through the site following the tree line (oak trees) to the north and flows in a general southeast direction and then loops to the front of the photo that you can see between the willows. There is an unnamed drainage channel that follows the poplar trees and heads north.

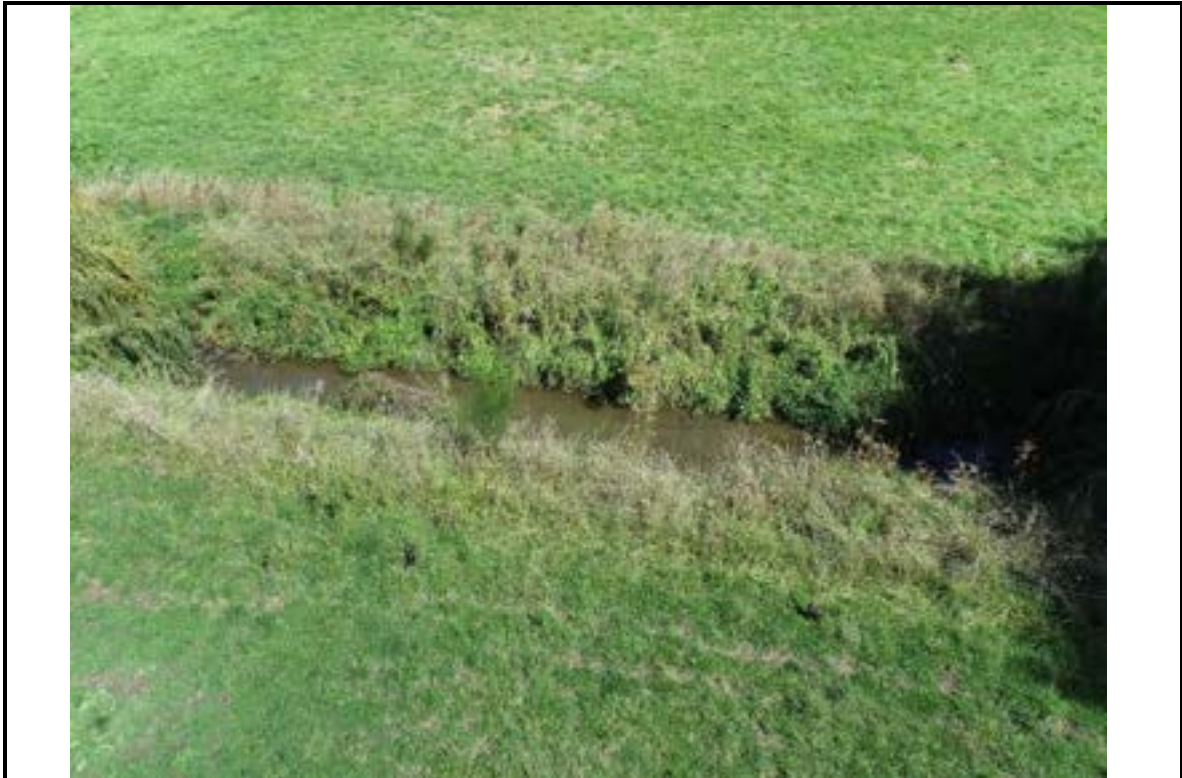
**Photograph 3:**

Aerial photo (31/01/2023) showing Wakanui Creek.

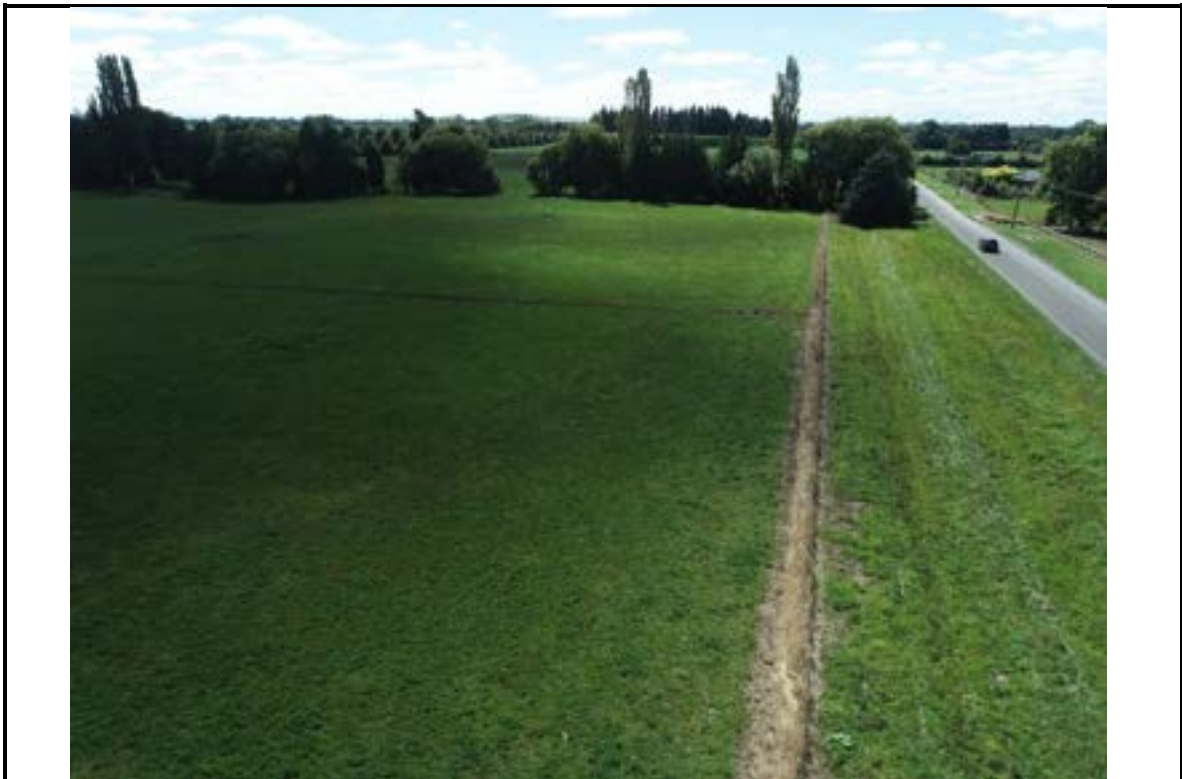
**Photograph 4:**

Aerial photo of the site from the southeast corner looking northeast. Farm road can be seen on the right. Wakanui Creek crosses the road just ahead of that car in the distance and pops out the other side.

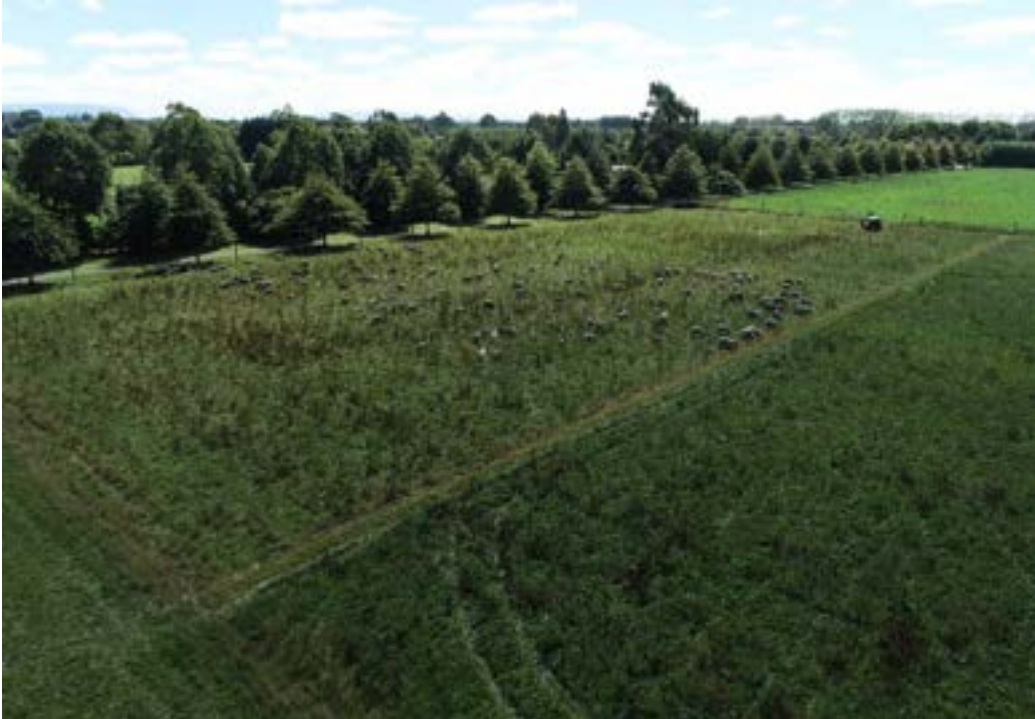
**Photograph 5:**

Aerial photo of the northwest boundary paddocks, looking north. The northernmost paddock is used for brassica crops. The tree lined driveway is the neighbours. Racecourse road is at the top right corner.

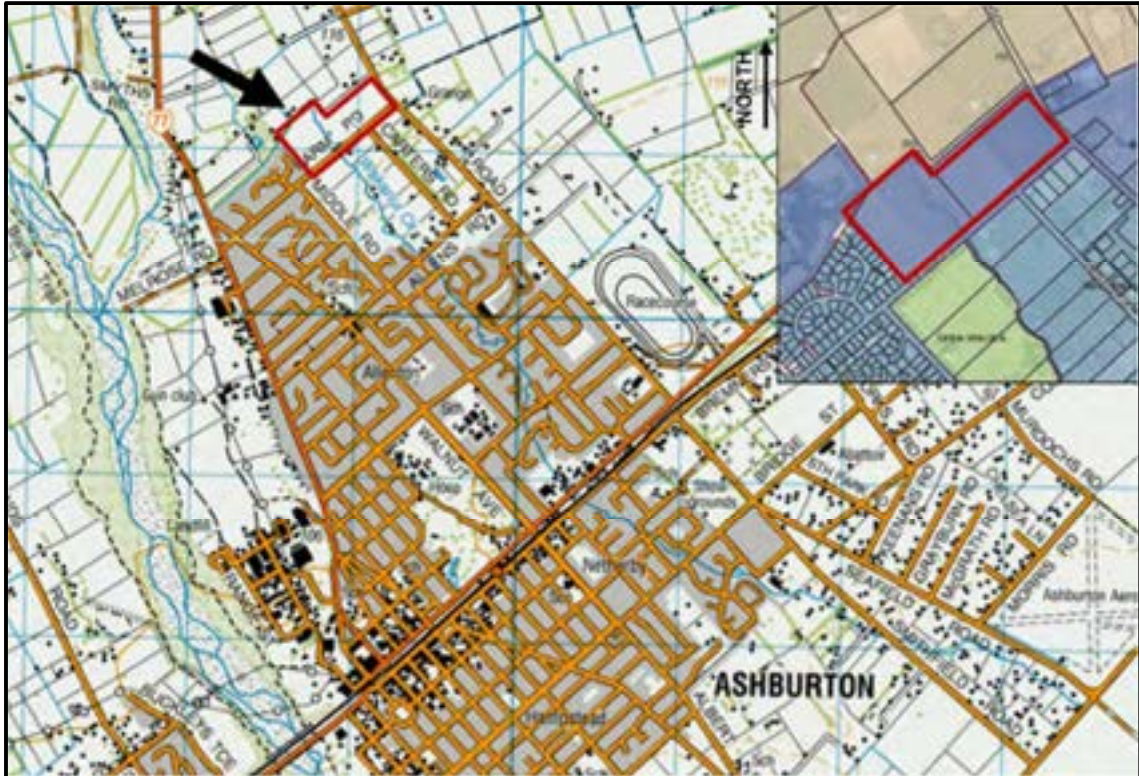
The site is located in Allenton, Ashburton, approximately 2.6 km northwest of State Highway 1, 1.7 km northeast of the Ashburton River and 0.7 km southeast of the Ashburton River North Branch (Figure 1). The land parcels (Lot 4 & Lot 8) occupy a total area of 16.32 ha and are hereon known as “the site”.

**Figure 1: Location of the site shown in red. Figure cropped from Topo50 Maps<sup>3</sup>.  
Insert shows Ashburton District Council District Plan zone 'Residential D' (purple).**

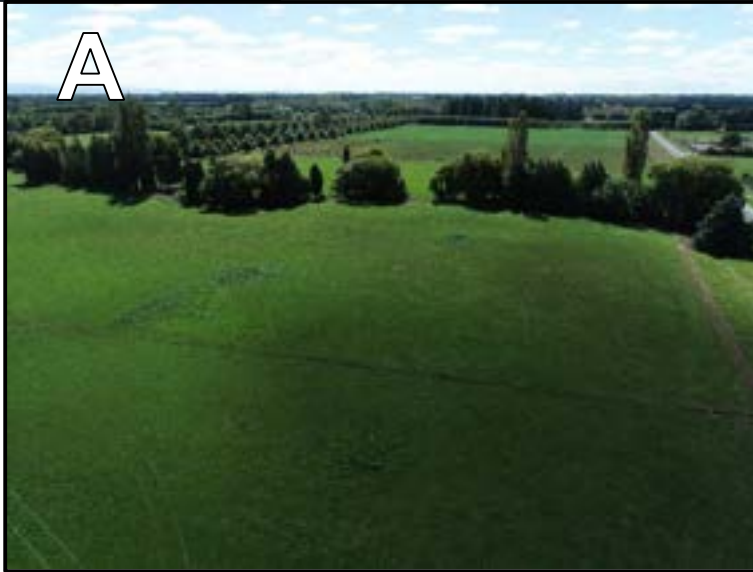
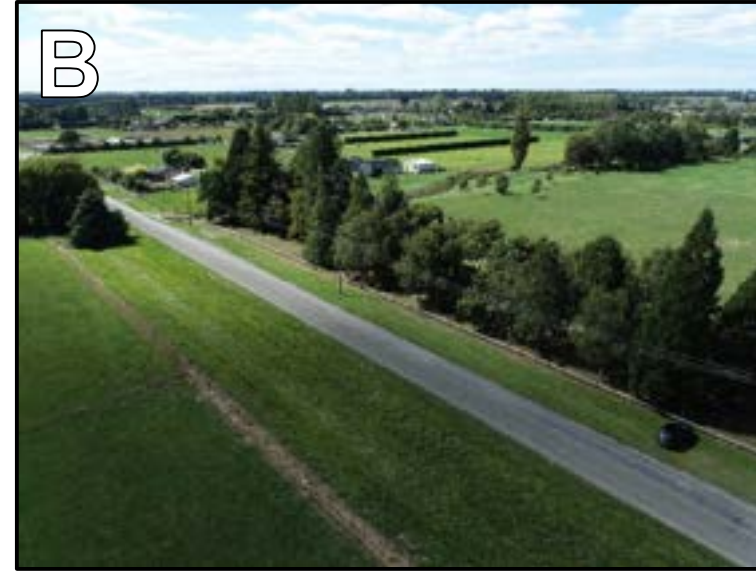
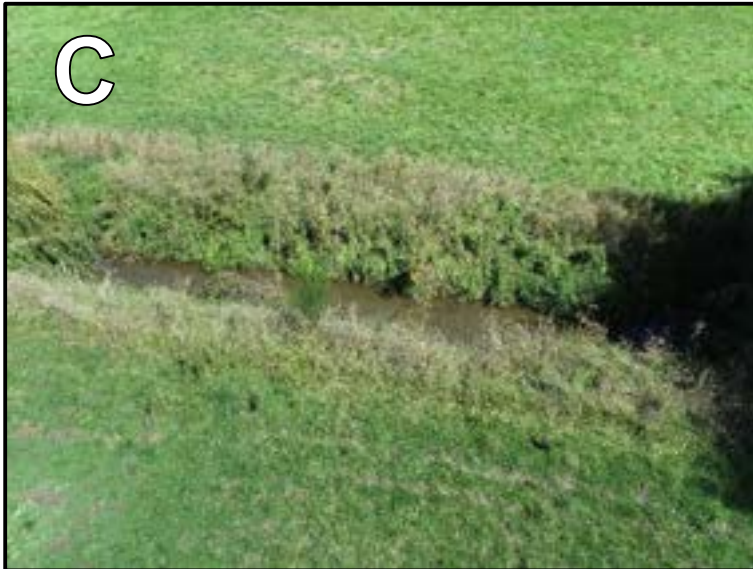
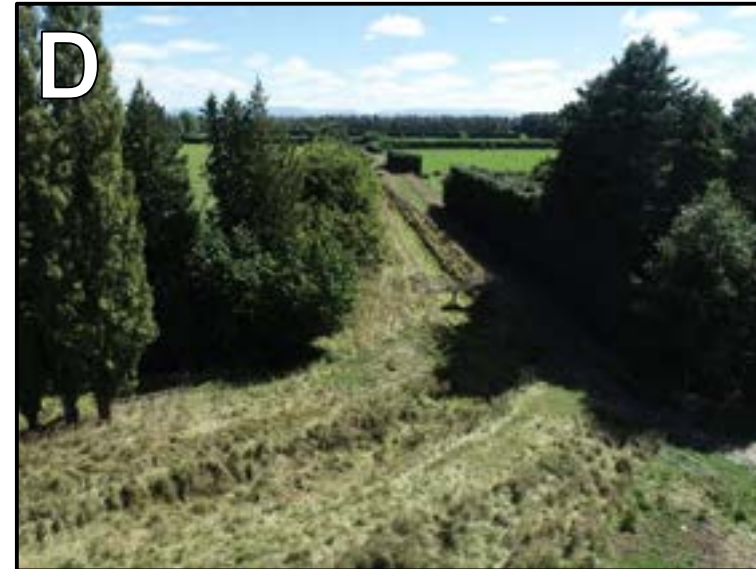
The currently grassed farmland site is bounded by Farm Road to the southeast and Racecourse Road to the northeast, residential lots to the southwest and similar rural–residential farmland to the northwest. The site is undeveloped, relatively flat with a history of farming land use (Figure 2A & 2B).

Near the centre of the northwest boundary, a watercourse, known as Wakanui Creek, enters the site at an acute angle and crosses in a northwest-southeast direction where it is lined by large mature trees (Figure 2A). The channel is approximately 3 – 6 m wide and incised 0.5 – 1.0 m deep and was flowing (southeast) at the time of this investigation (Figure 2C). The watercourse is classified on the Environment Canterbury (ECan) River Network<sup>1</sup> as a “*spring-fed plains watercourse*”; however, based on aerial imagery<sup>2</sup> it appears to now be mainly fed from the Ashburton River North Branch via a small channel, some 1.4 km northwest of the site, and from modified active water races. The channel exits at the southeast of the site where it crosses developed and undeveloped land in a southeast direction (parallel to Ashburton River) before reaching the coast approximately 20.0 km southeast of the site.

Near the westernmost end of the site (Lot 4), parallel to the northwest boundary, is a dry water race confined by stop banks and crossed by bridges (Figure 2D). The water race source runs through farmland in the northwest before passing the site and heading southwest to the Ashburton River North Branch. A roadside swale also exists between, and parallel to, the southeast boundary and Farm Road (Figure 2B).

**Figure 2: Photographs of the site: A) View across site looking northeast showing tree lined Wakanui Creek; B) View along Farm Road including roadside swale, looking east; C) Aerial oblique view of incised Wakanui Creek through the site; D) View of dry water race north of the site, looking northwest.**

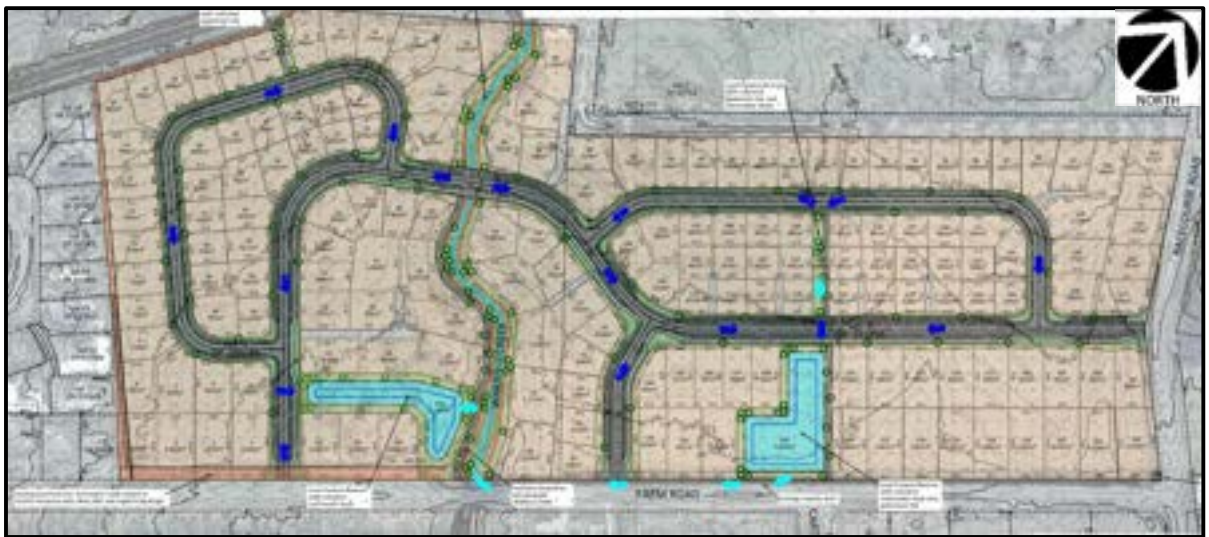
**Figure 3: Coniston Park development scheme plan by Davis Ogilvie showing proposed lot and road layout, subject to change.**

The draft scheme plan for the Coniston Park subdivision by WSP shows approximately 141 proposed low– medium density residential lots (650 – 928 m<sup>2</sup>), associated roading and a recreational reserve area surrounding Wakanui Creek. The latest draft scheme plan of the proposed development is shown in Figure 3.

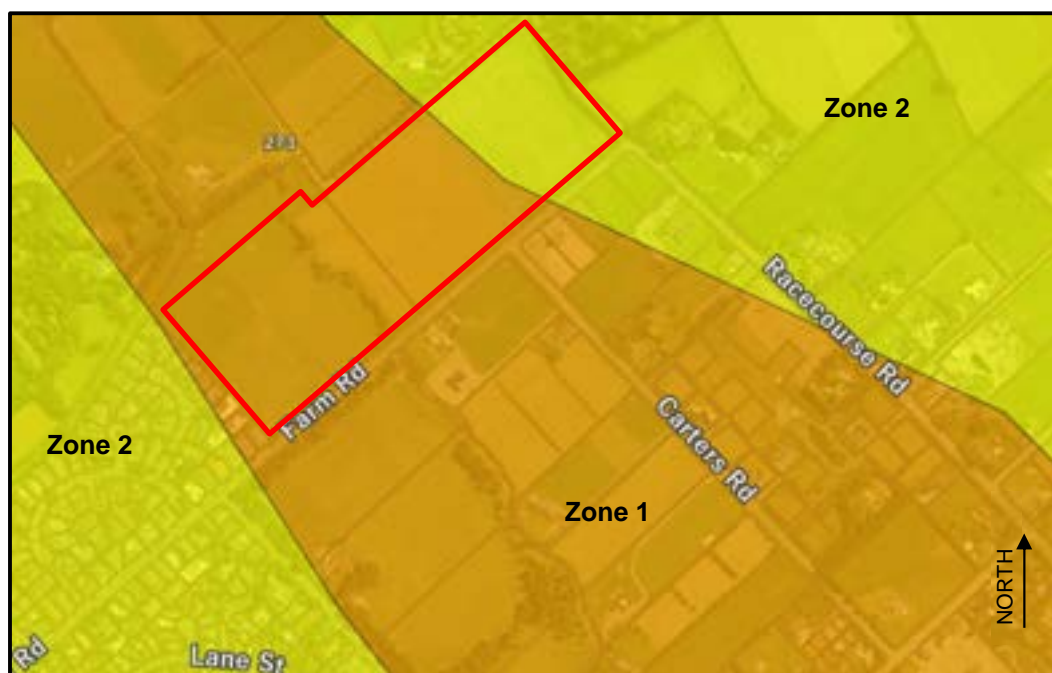
The northeast end of the site is within a lower risk zone (very low [liquefaction] potential ('Zone 2')) whereby there may be a "very small risk of liquefaction of local, isolated areas" It is noted that "much of this zone [2] has a water table at considerable depth, and liquefaction would require a combination of perched water table as well as loose sand."

Figure 4: Image showing Liquefaction potential in Ashburton District from the 'Ashburton District Engineering Lifelines Project'. Zone 1 is shown in (orange – low risk) and Zone 2 in yellow (very low risk). The approximate site boundaries are highlighted in red.
