# INFRASTRUCTURE SERVICING REPORT

TM30625 / Farm Road, Ashburton /  
CONISTON PARK LIMITED

**Title:** Infrastructure Servicing Report

**Project No** TIM 30625

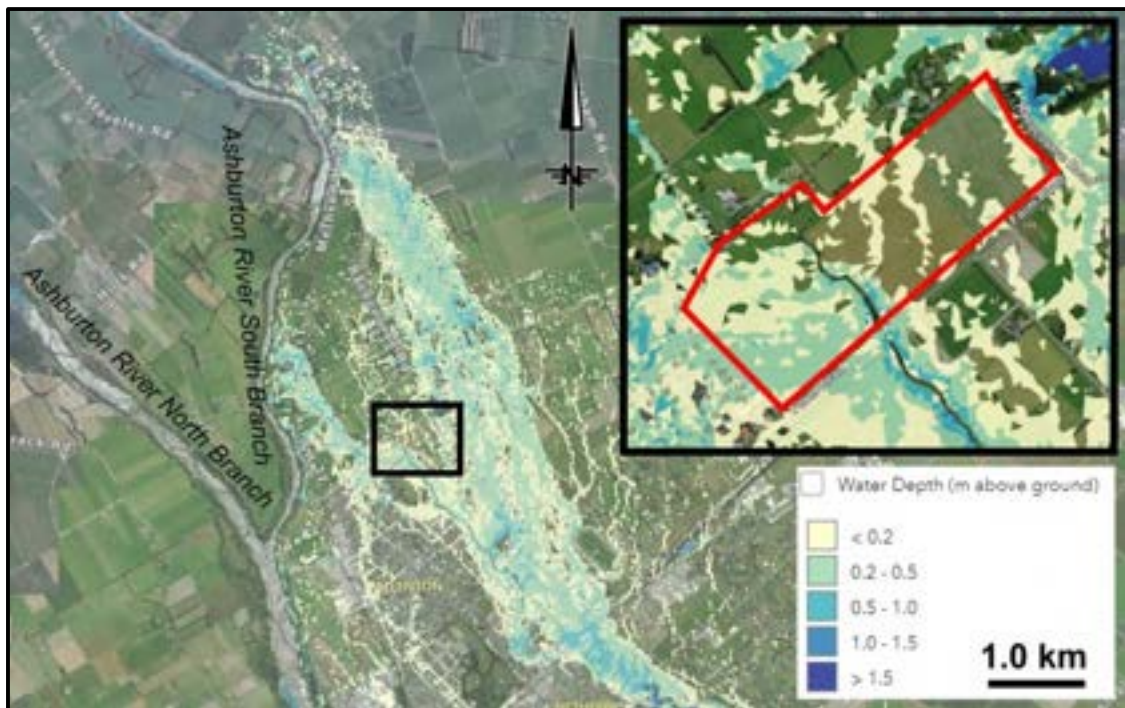
**Figure 5: Image showing modelled North Branch break-out events and expected water depths from the Ashburton/Tinwald Flood Hazard Investigation (2015). *Insert* shows the site defined by red boundary.**

It is recommended that finished floor level requirements are confirmed with ECan and ADC at the subdivision stage.

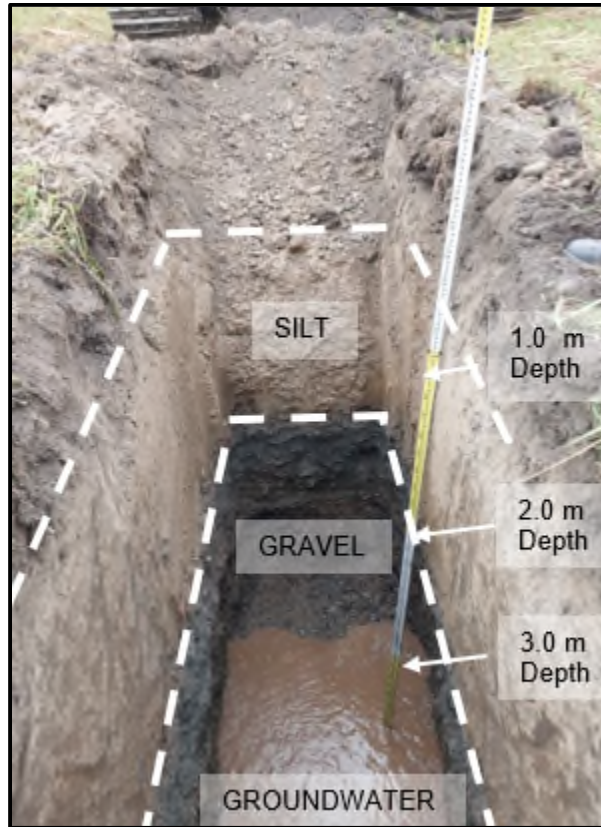
**Figure 6: View of the typical subsoil profile (TP10) at Farm Road to approximately 3.7 m below existing ground level (EGL). Photo date: 13 March 2023.**

A consistent soil profile was revealed by the investigation, consisting of up to 0.4 m of topsoil overlying silt with varying amounts of clay and sand to between 1.4 – 3.7 m. The silt was underlain by sandy gravel to a maximum of 5.5 m below EGL, the maximum depth of the investigation. An example of a typical soil profile revealed by the TPs is shown in Figure 6.

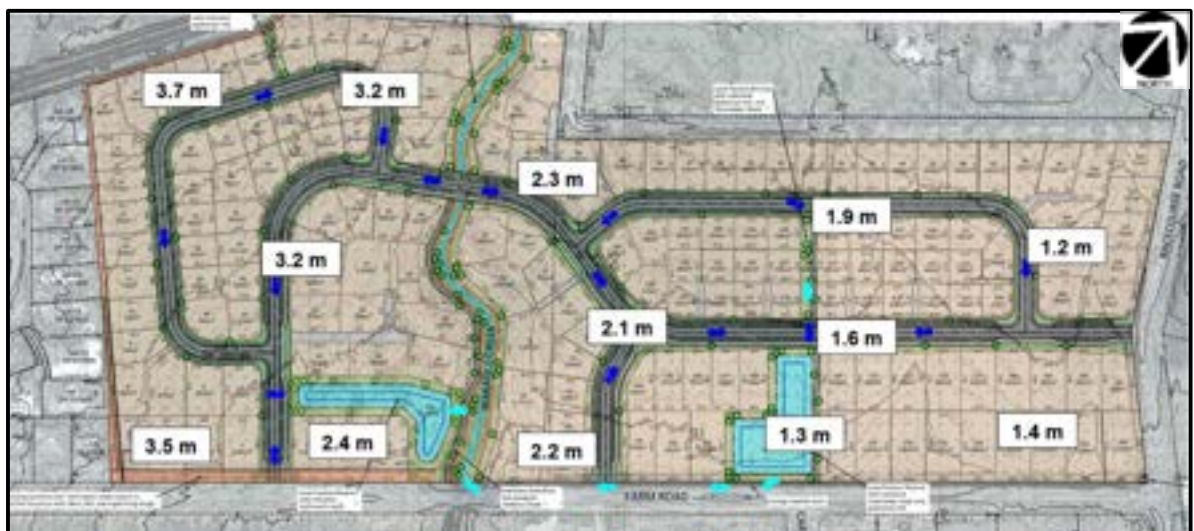
The variation in depths to gravel encountered across the site (from below existing, pre-development ground level) is illustrated in Figure 7.

**Figure 7: Annotated site concept plan showing summarised depths to gravel in meters below existing ground level.**

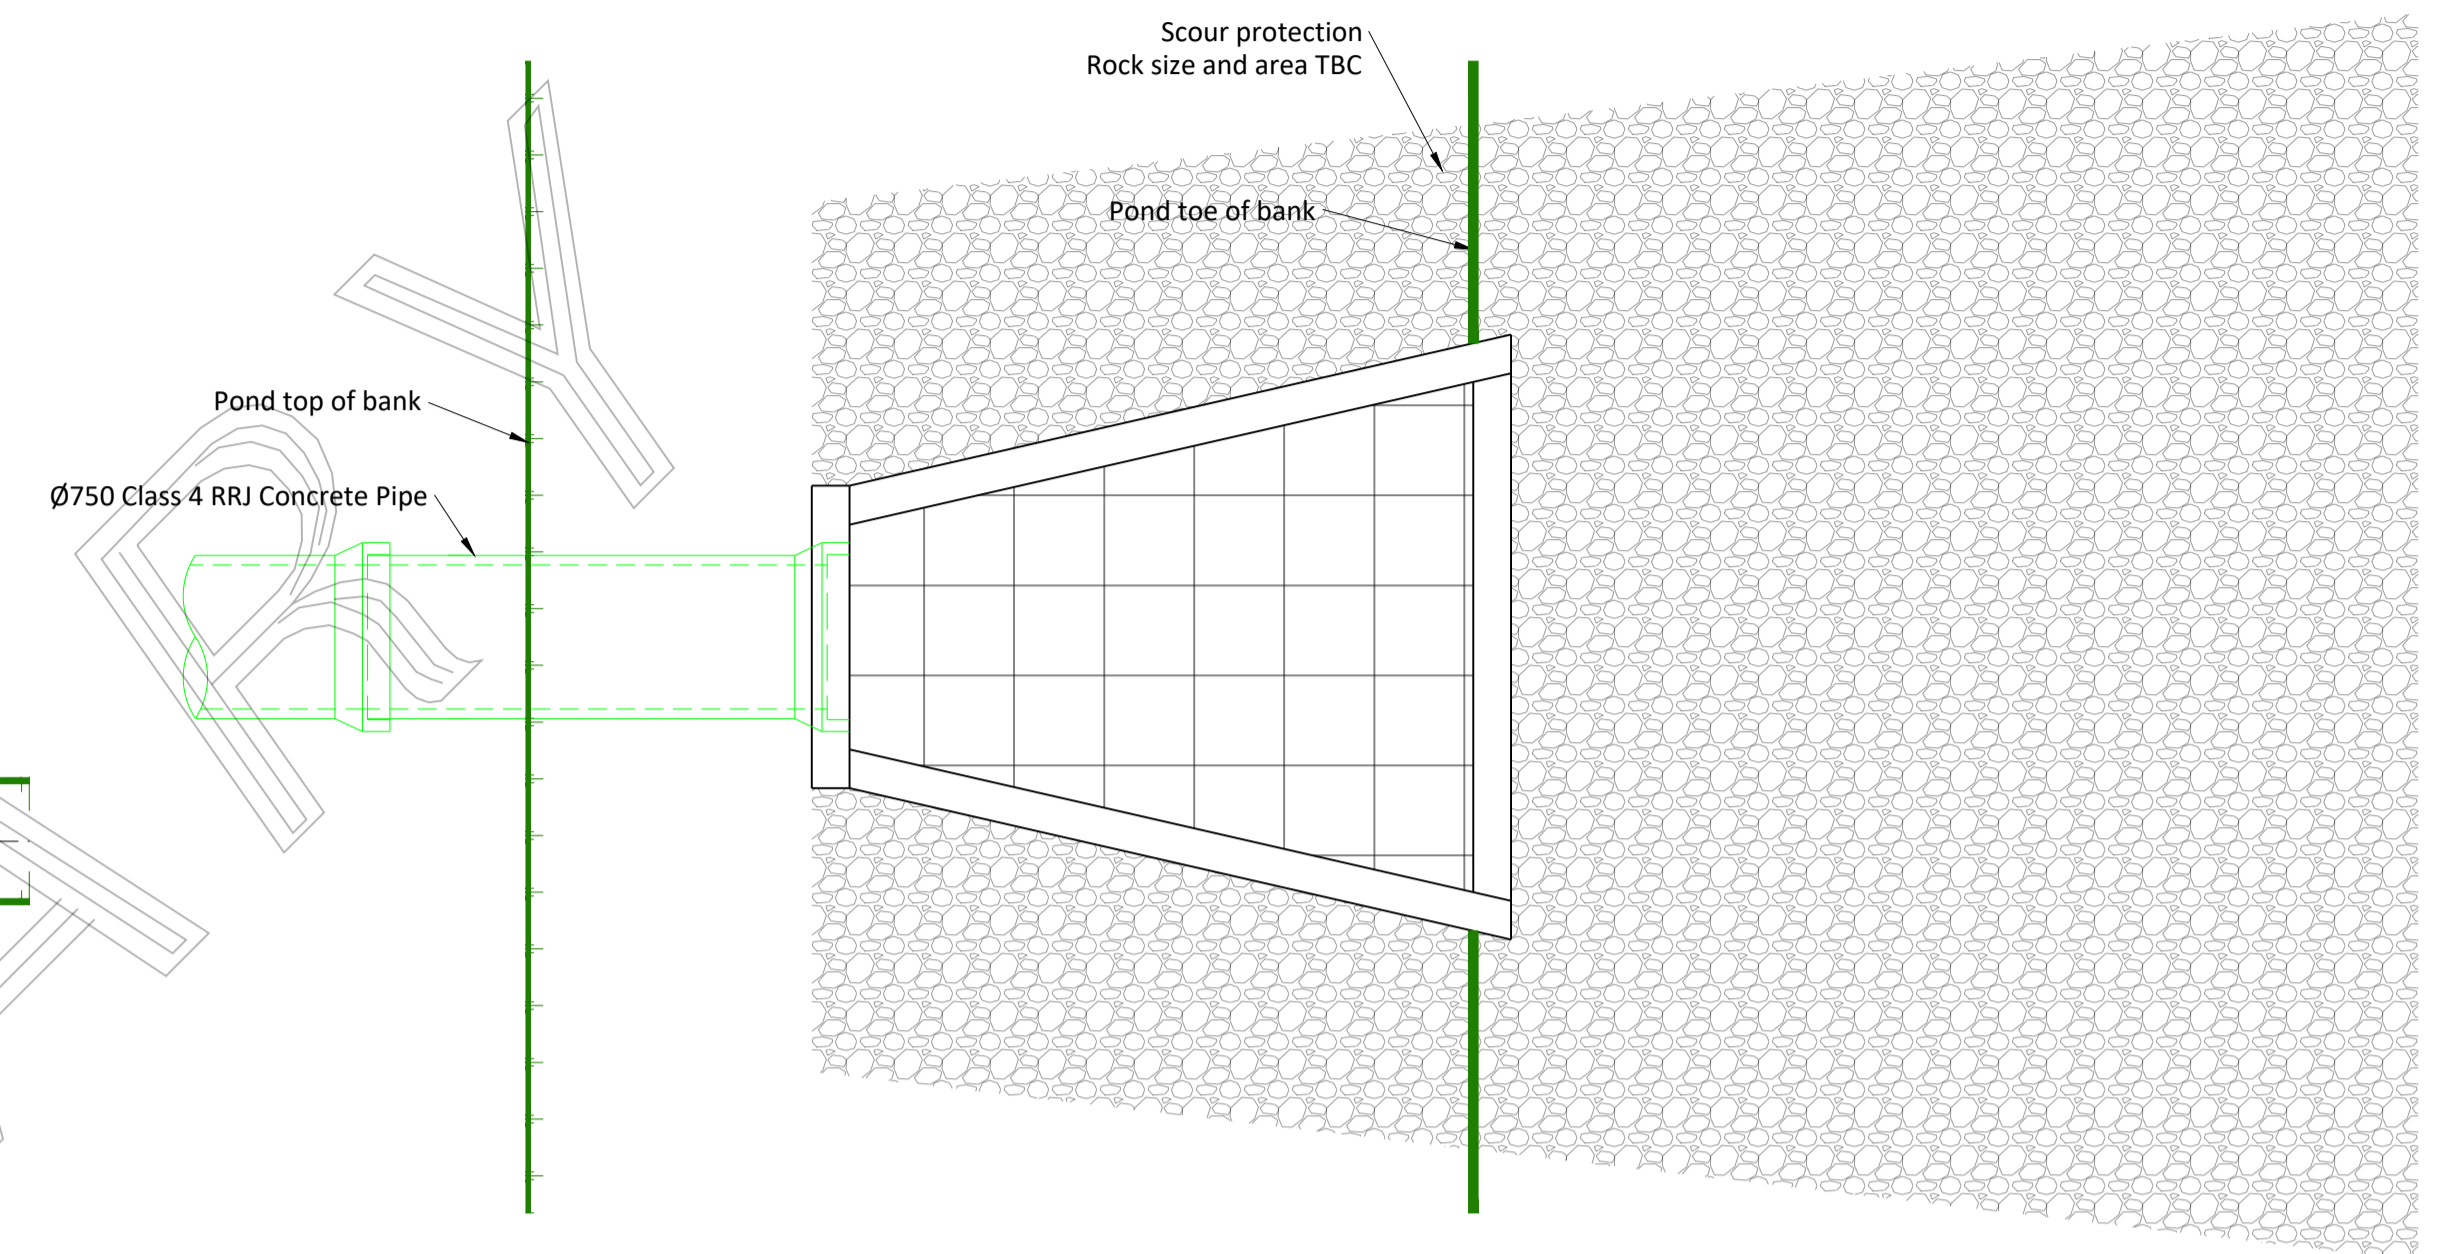
**INLET STRUCTURE PLAN VIEW**  
Scale 1:40

**INLET STRUCTURE SIDE ELEVATION**  
Scale 1:40

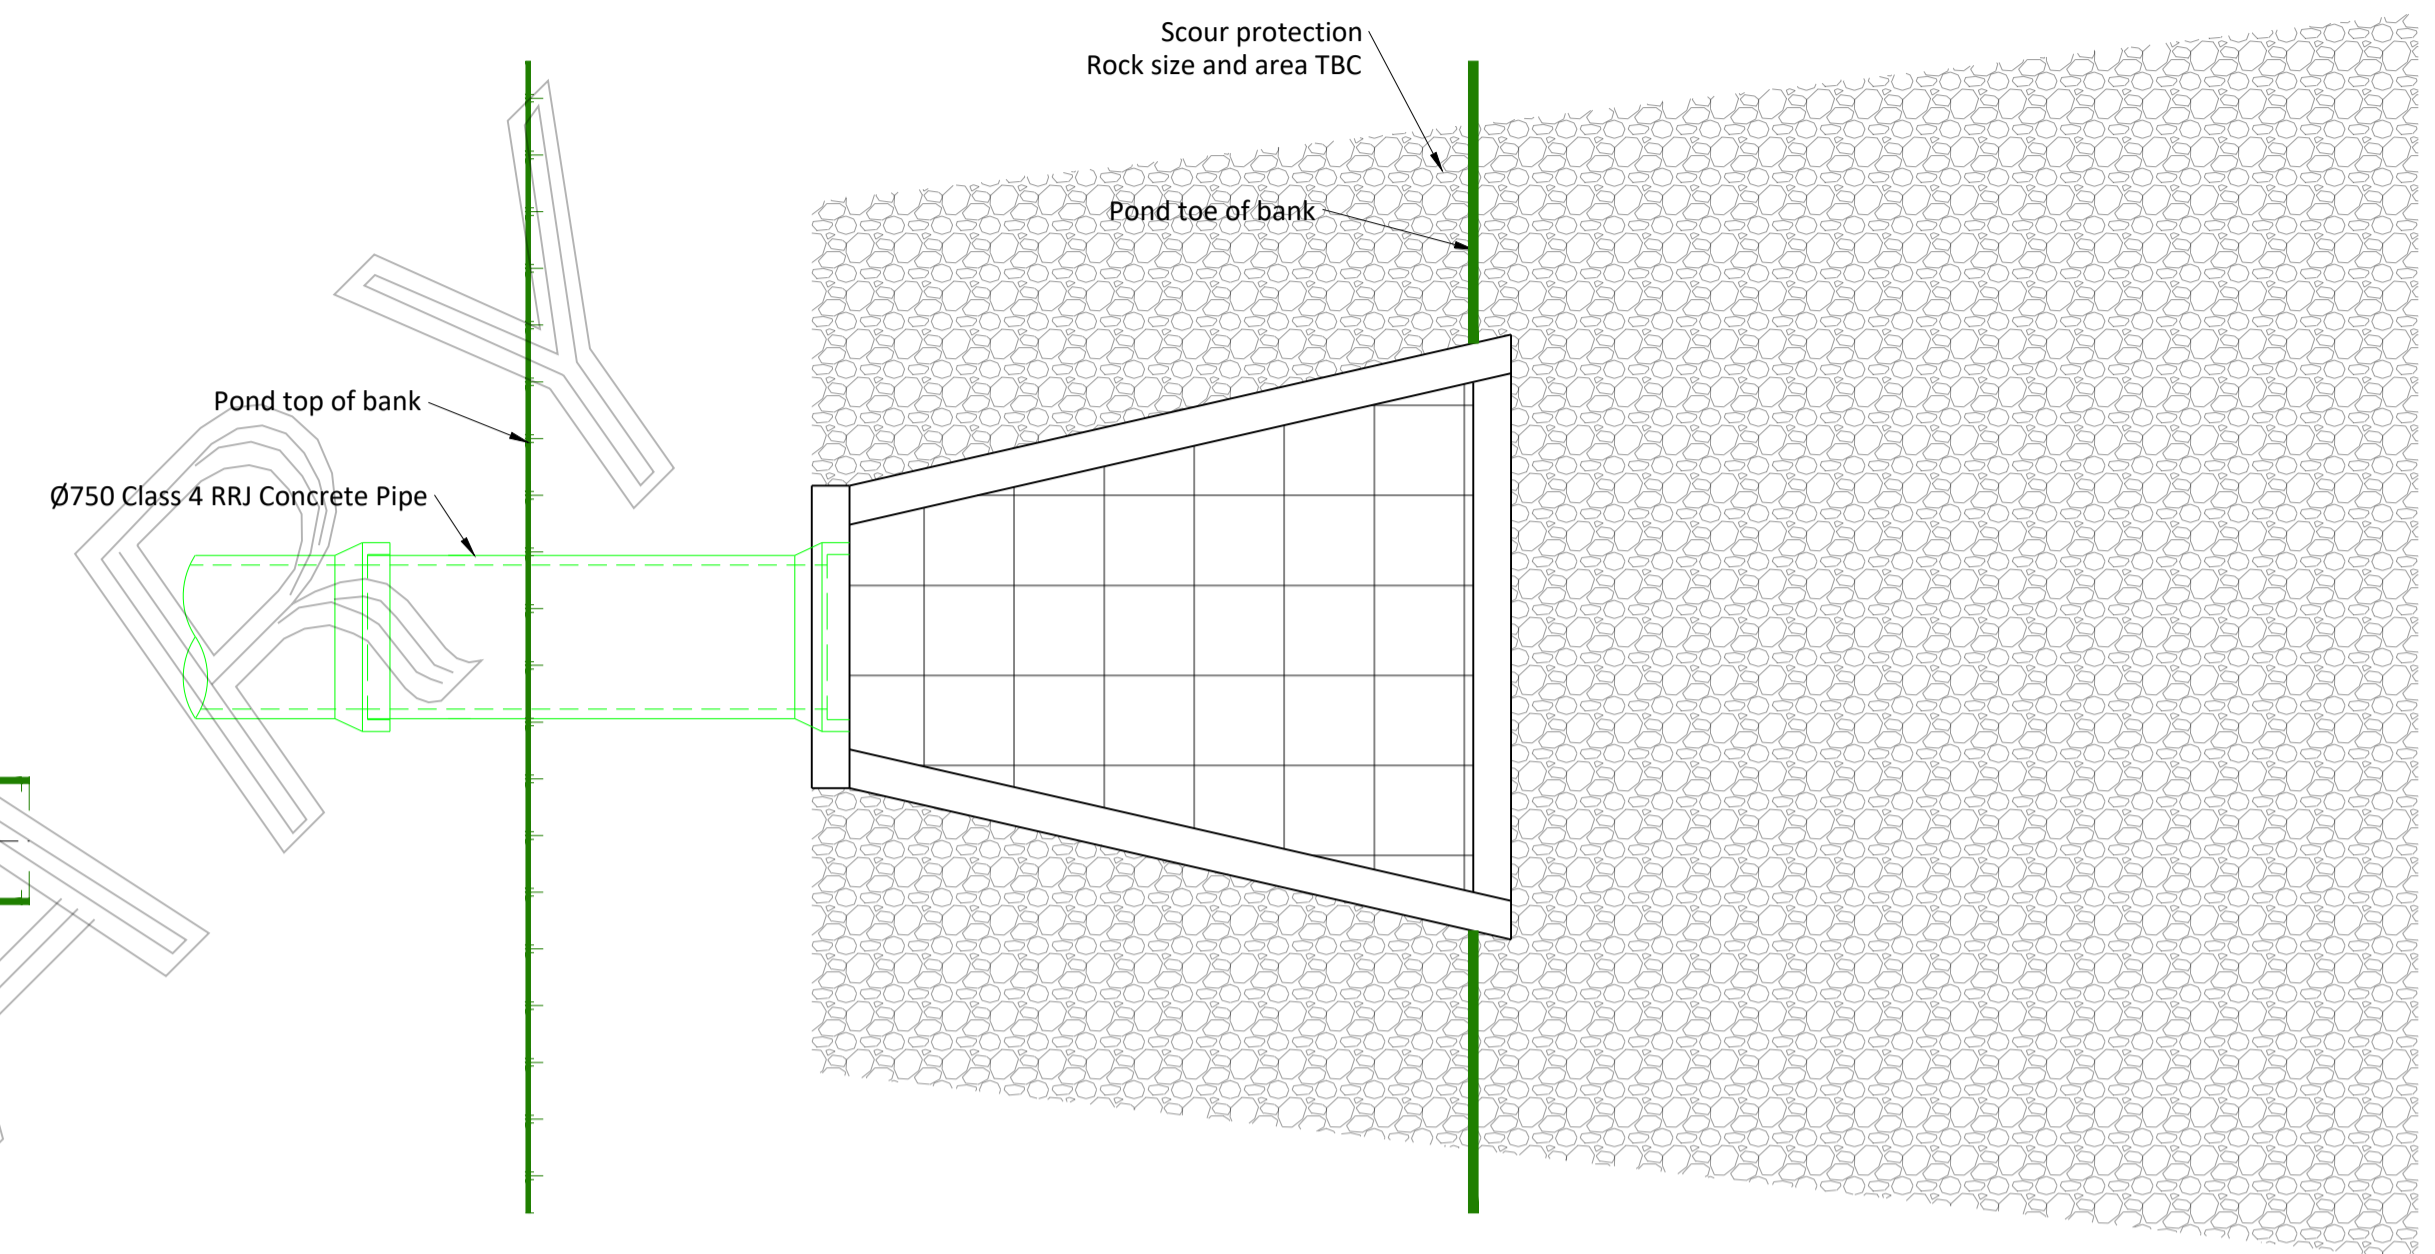
**INLET STRUCTURE PLAN VIEW**  
Scale 1:40

**INLET STRUCTURE SIDE ELEVATION**  
Scale 1:40

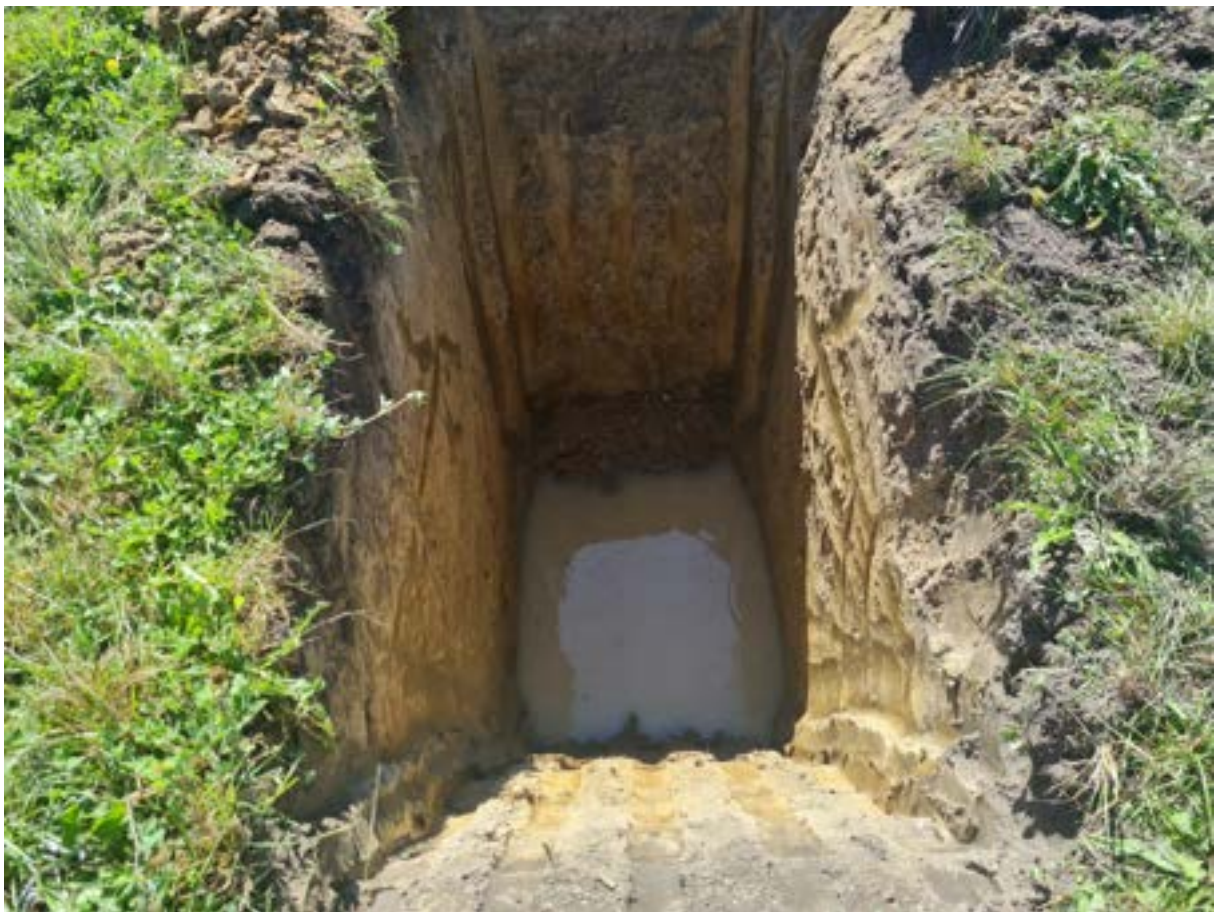
Groundwater: observed

Groundwater depth in the pit: TBC

**Photo - Test Pit 02**

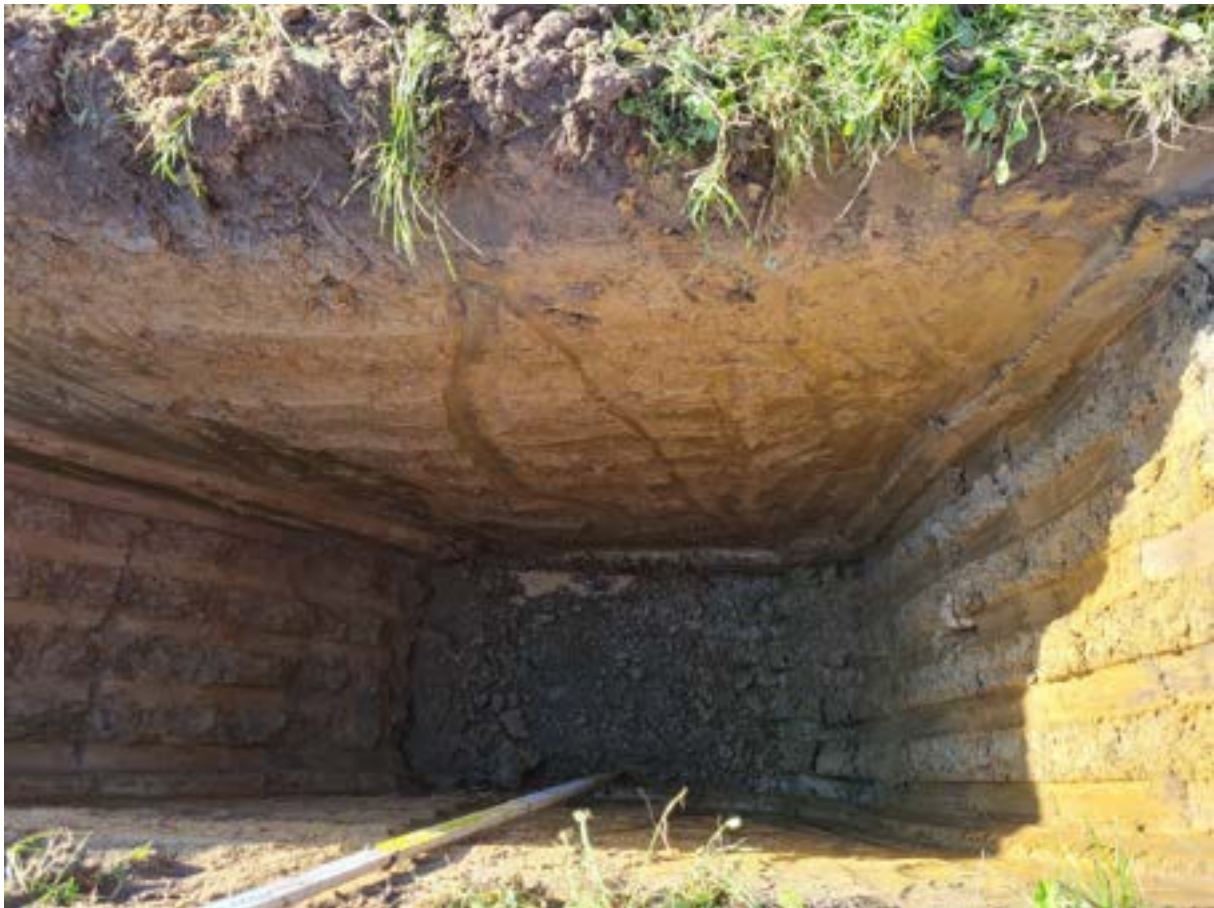
**Photo – Test Pit 06**

Groundwater depth in the pit: 100mm

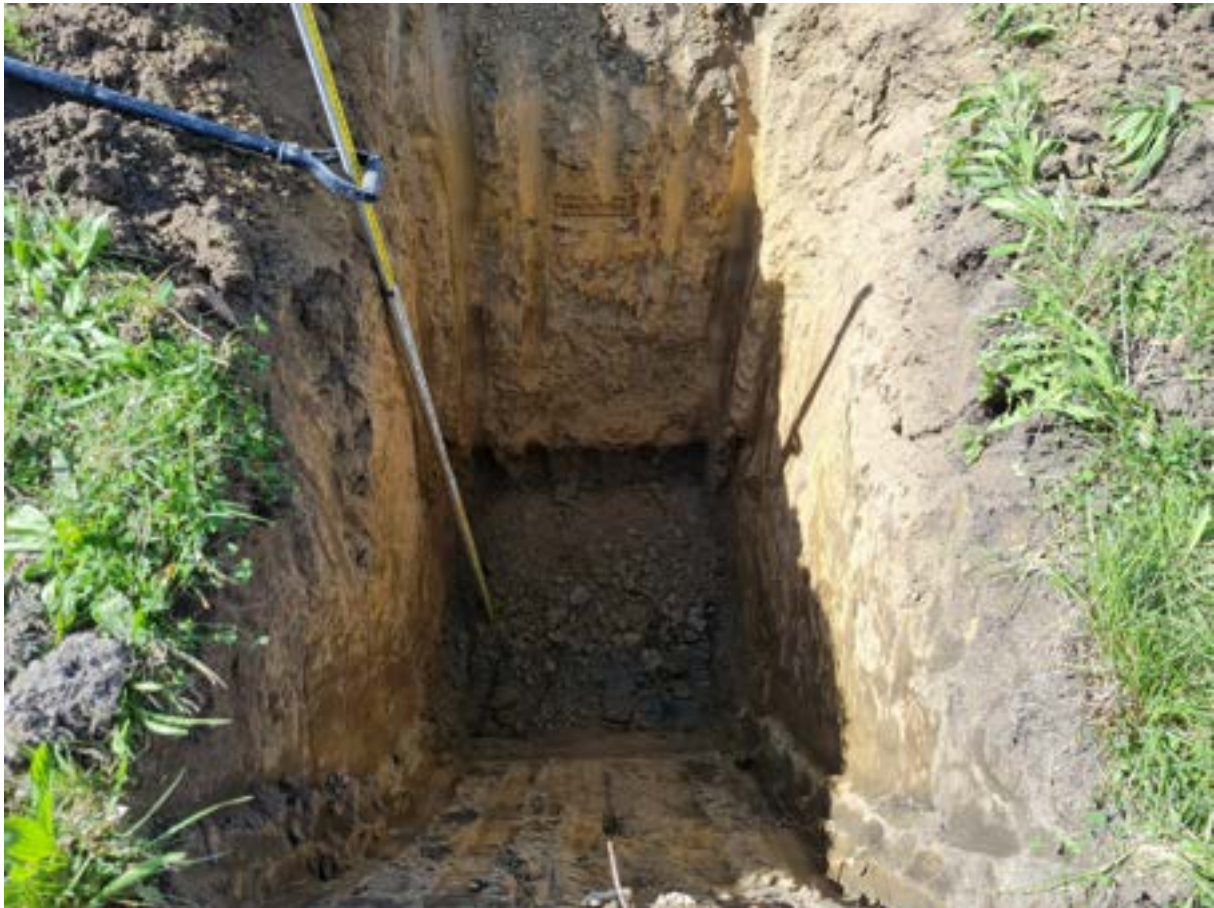
Total water drop during the test period: 150mm

Groundwater: no

**Photo – Test Pit 09**

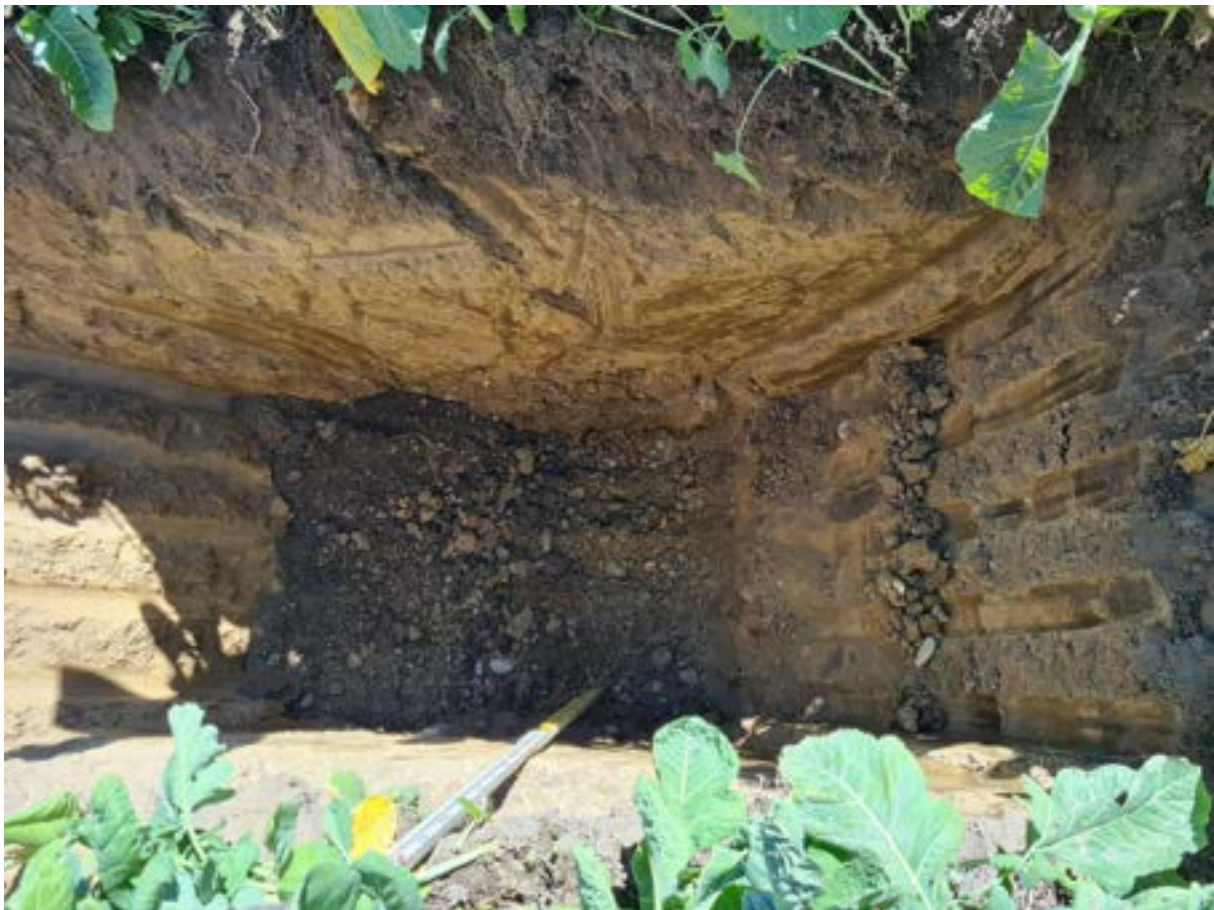
Total water drop during the test period: 1200mm

Groundwater: no

**Photo – Test Pit 12**

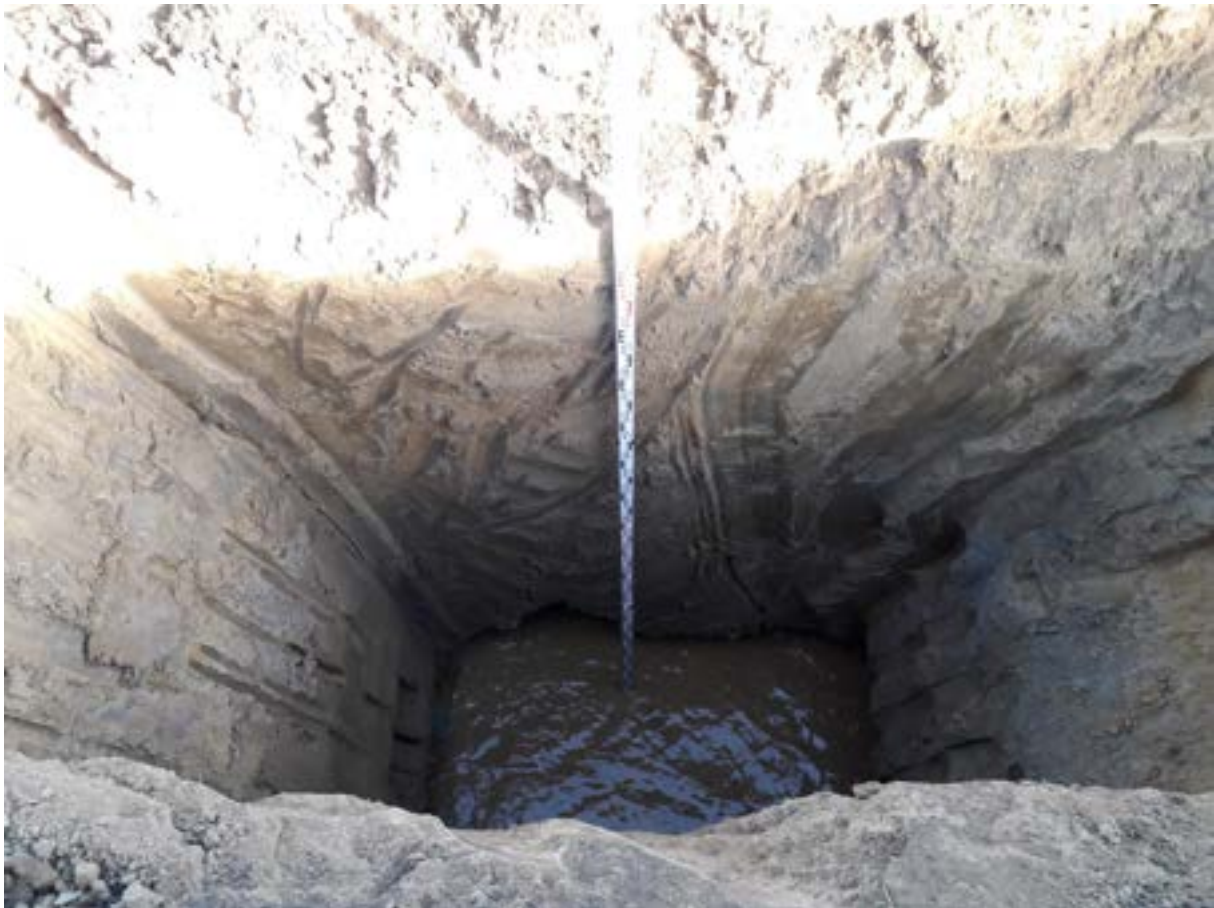
Groundwater: observed

Groundwater depth in the pit: TBC

**Photo – Soakage Test Pit 1**

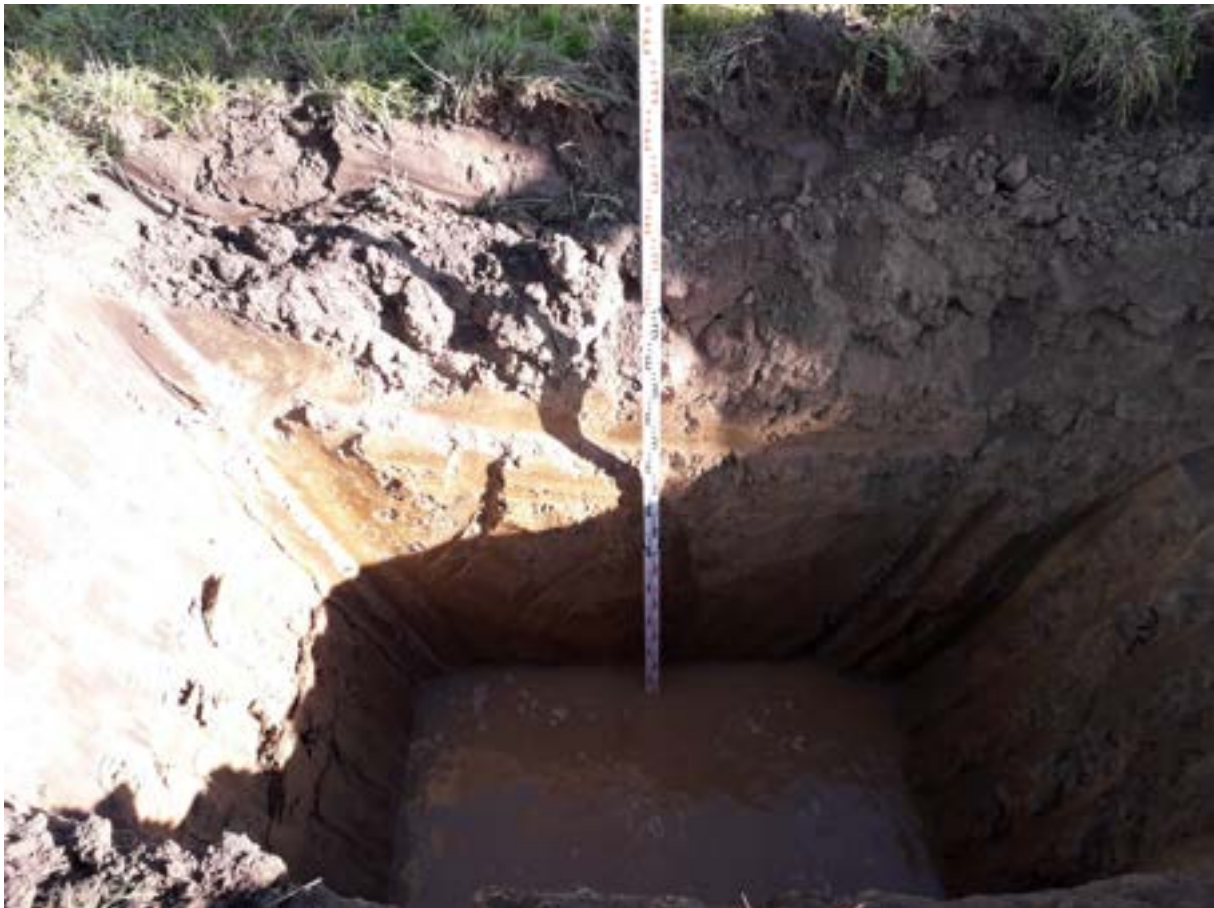
**Photo – Soakage Test Pit 2**

Groundwater depth in the pit: 1600mm

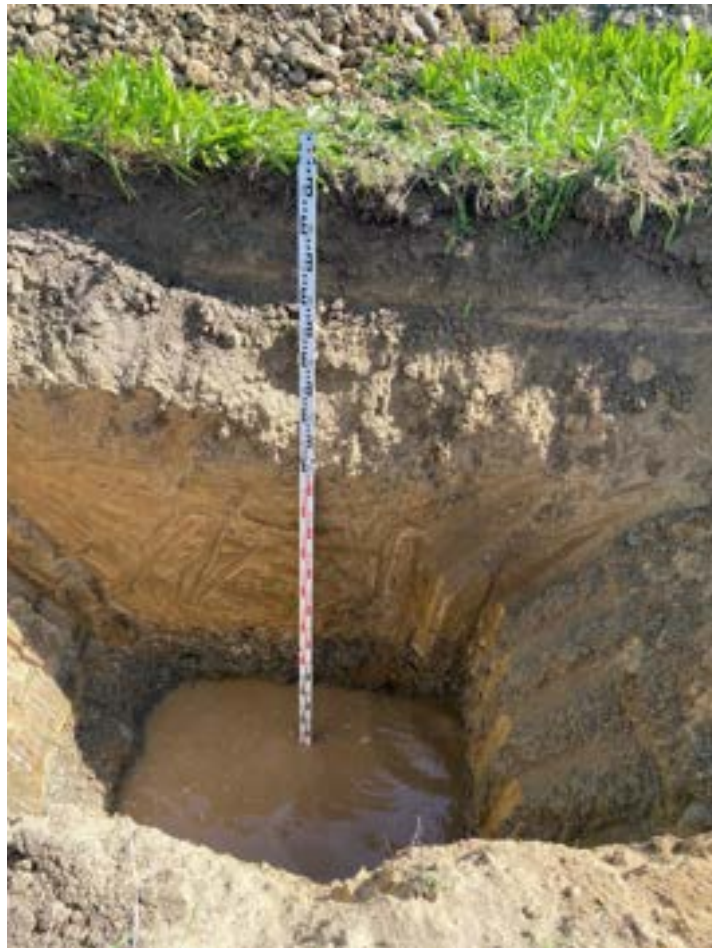
Groundwater: observed

Groundwater depth in the pit: TBC

**Photo – Soakage Test Pit 3**

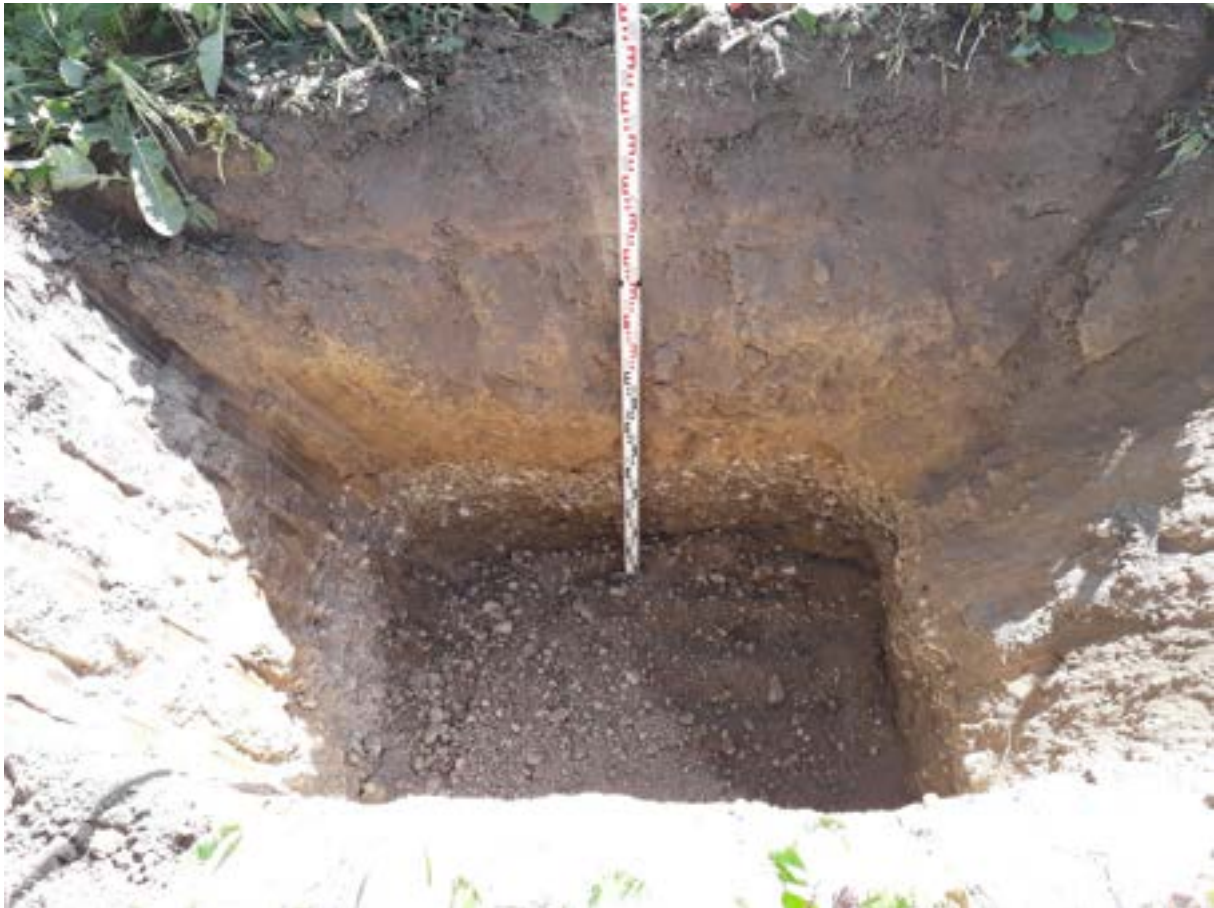
Total water drop during the test period: 1310mm

Groundwater: no

**Photo – Soakage Test Pit 4**

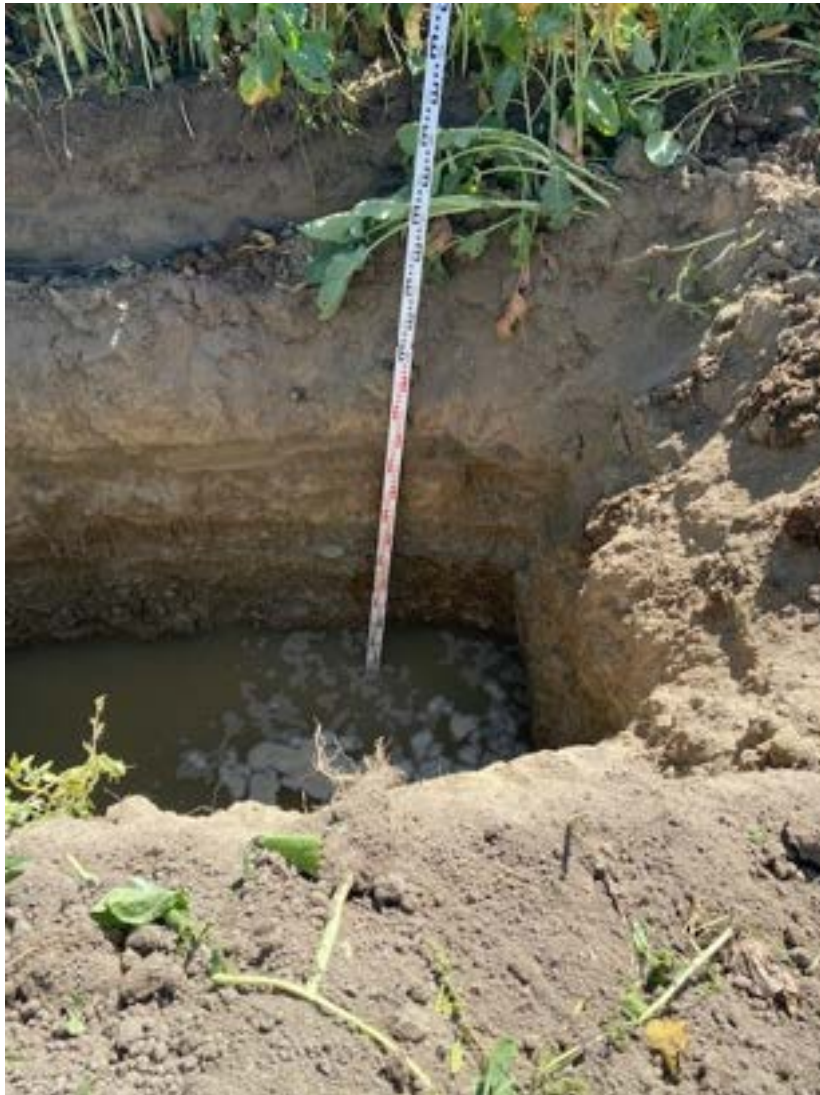
Total water drop during the test period: 1170mm

Groundwater: no

**Photo – Soakage Test Pit 5**

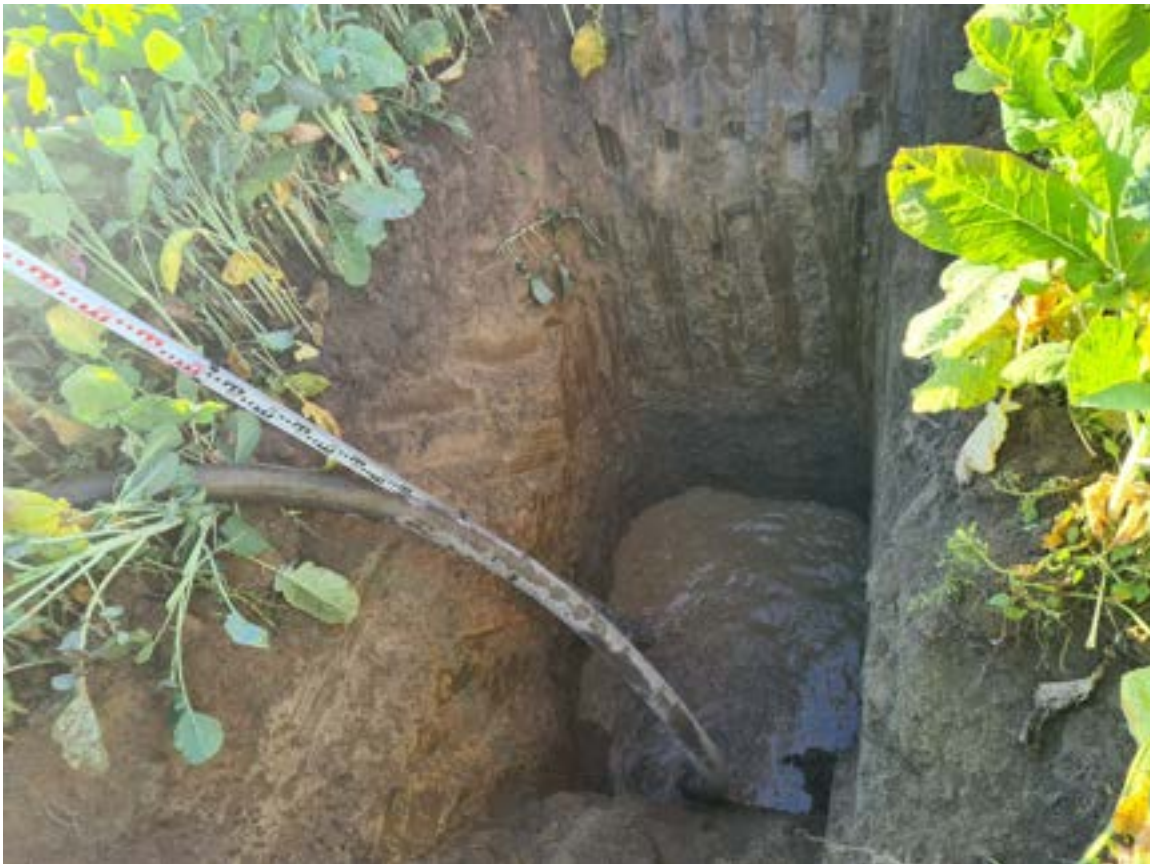
Total water drop during the test period: 600mm

Groundwater: no

**Photo – Soakage Test Pit 6**

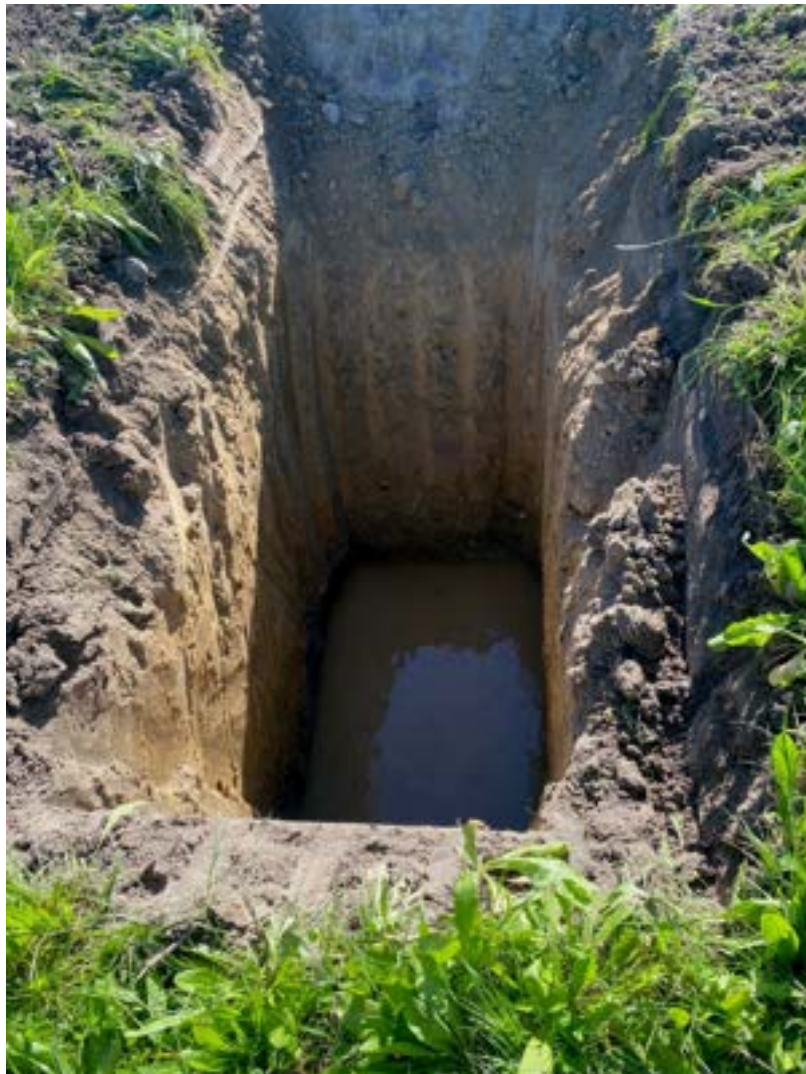
Groundwater: observed

Groundwater depth in the pit: 650mm

**Photo – Soakage Test Pit 7**

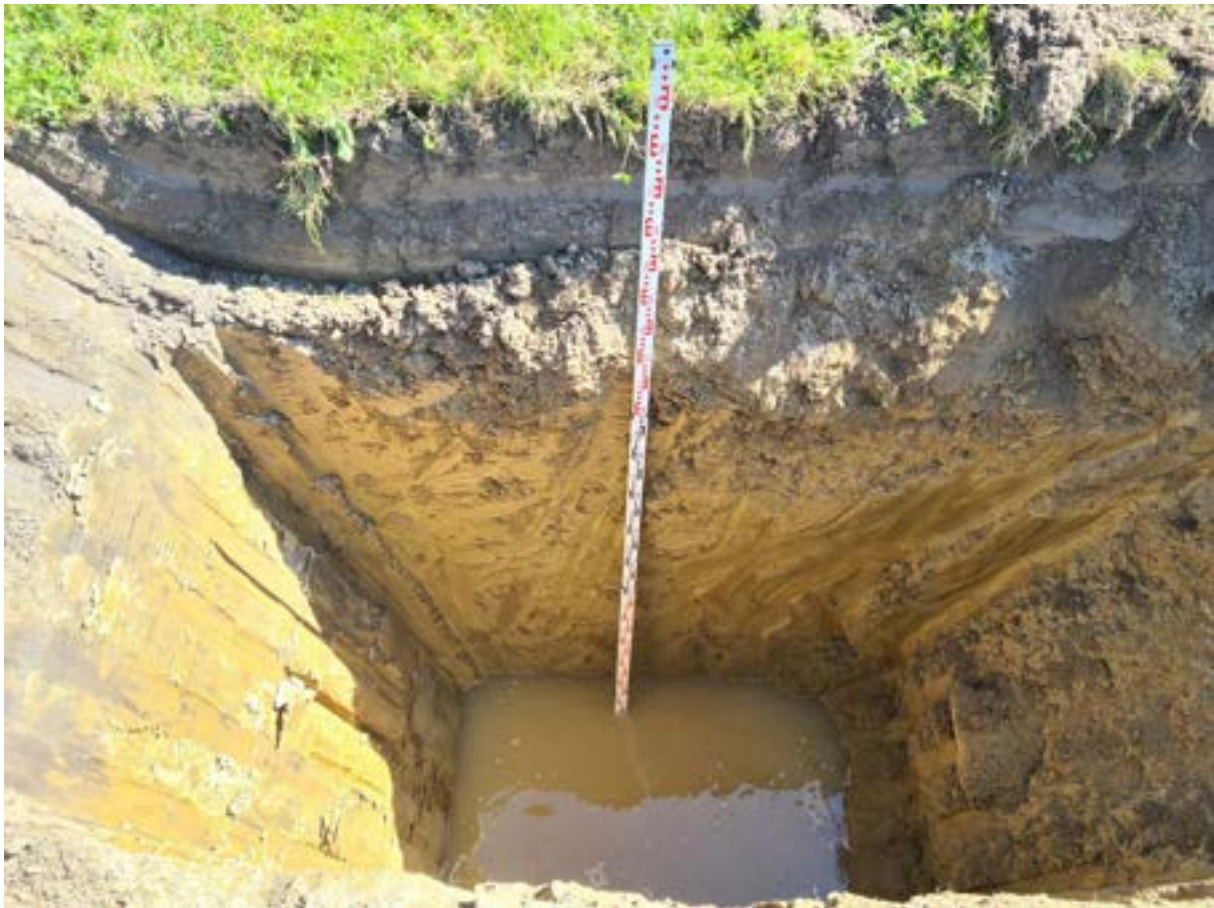
Groundwater: observed

Groundwater depth in the pit: 900mm

**Photo – Soakage Test Pit 8**

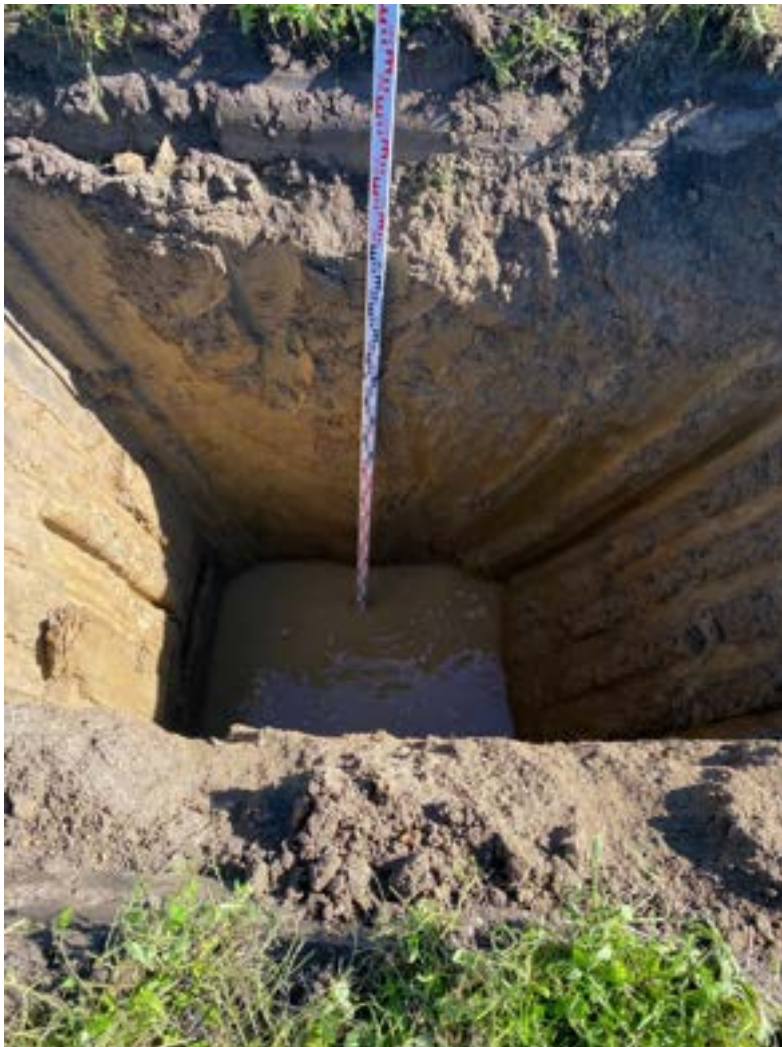
Groundwater: observed

Groundwater depth in the pit: 740mm

**Photo – Soakage Test Pit 9**
