Application for Subdivision Consent

AJ Developments (2016) Ltd

4 Wilkin St, Tinwald

Date Produced - December 2022

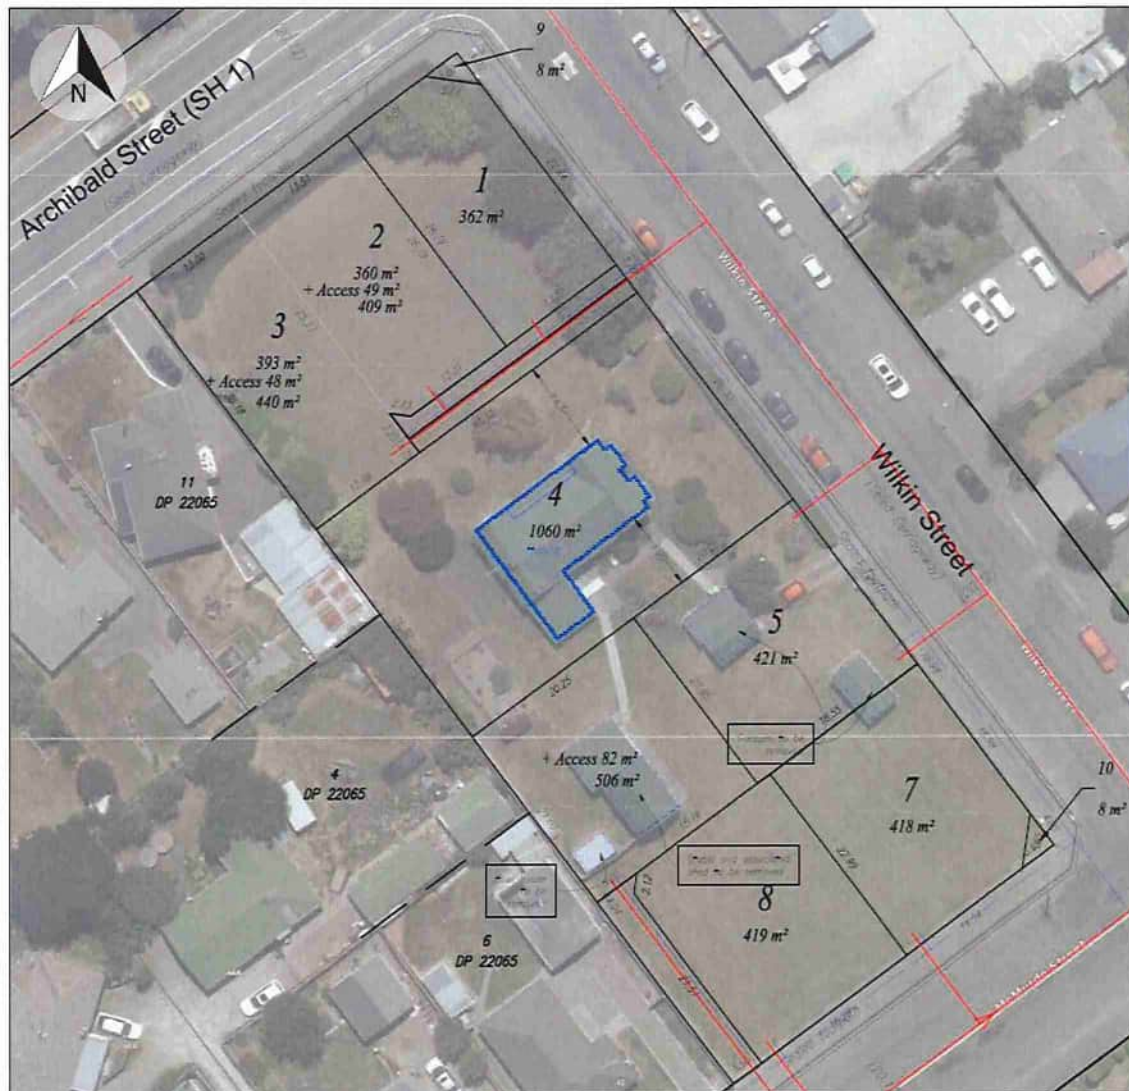
The wider property of 4 Wilkin Street will be subdivided into ten (10) separate lots (Figure 2). Lots 1-3 and 5-8 will be subject to residential development, on the northwest and southeast ends of the property respectively. Lot 4 will contain the extant 19th century cottage in the centre of the wider property. Lots 9 and 10 are small (8m²) corners of land at the northern and south-eastern corners of the site, which will be vested to the Ashburton district Council as road reserve.

Figure 2. Proposed plans for the subdivision of 4 Wilkin Street. Provided by client.

Three residential dwellings are proposed to be constructed on the northwest third of the project area (Lots 1-3 in Figure 2), with four more proposed in the southeast third (Lots 5-8 in Figure 2) (Figure 4 and Figure 5). Earthworks will be required for the land remediation and service installation in these areas.

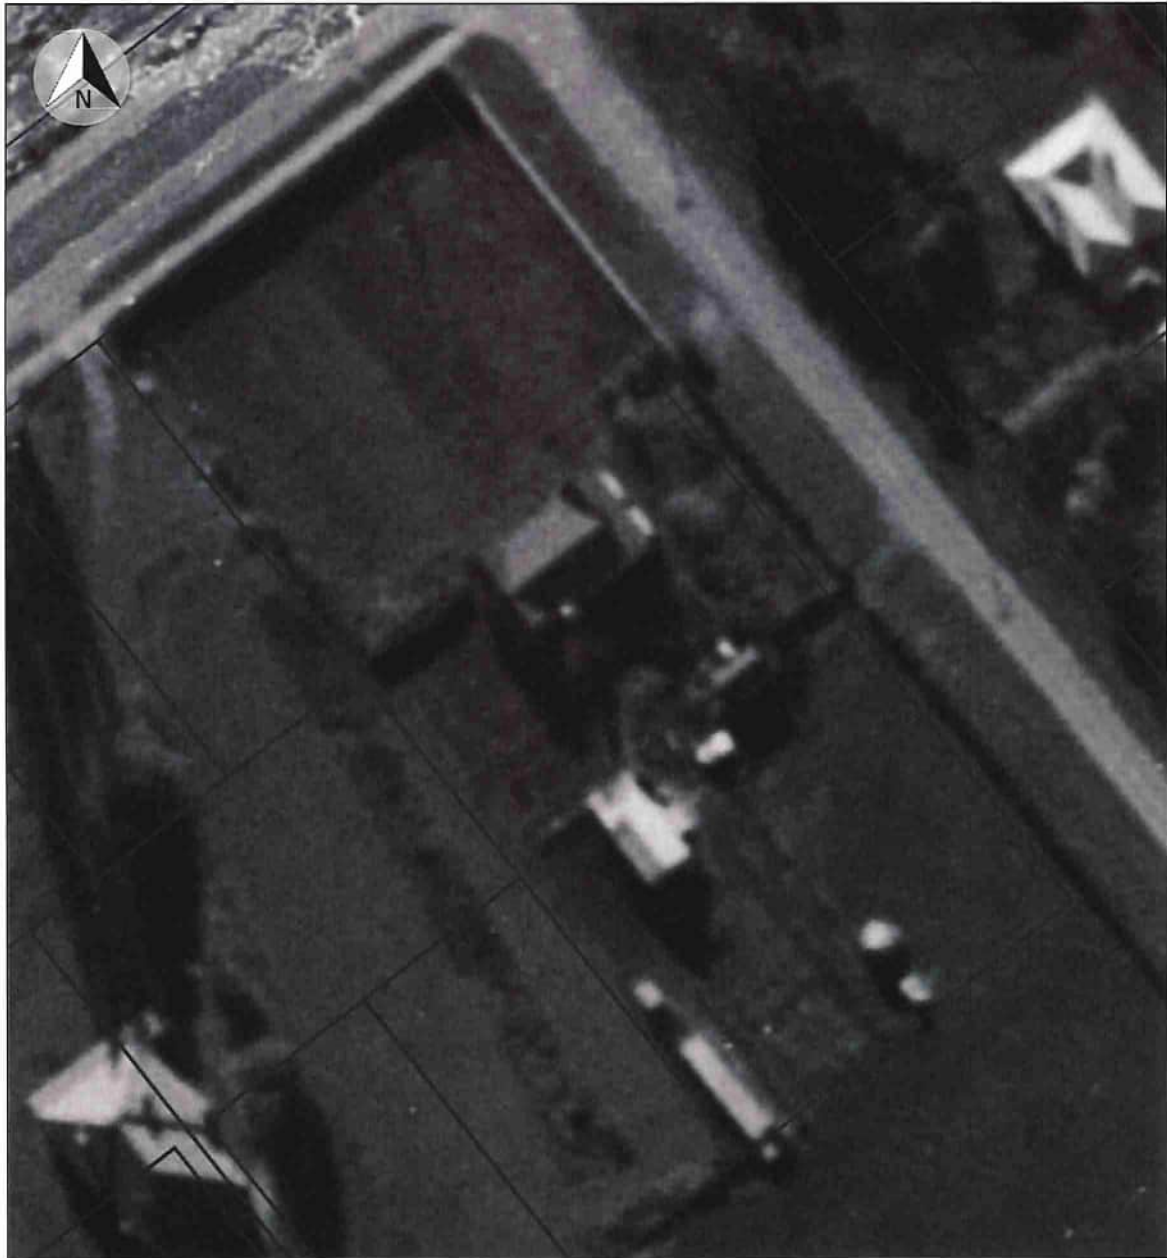
Several smaller outbuildings are visible at the southern property boundary in the 1941 aerial image (Figure 8). These buildings include Shed 1 and Shed 3, which are currently extant on the property. A building that has since been demolished is located on the southern boundary of the section.

Figure 8. 1941 aerial image of 4 Wilkin Street. Source: Retrolens

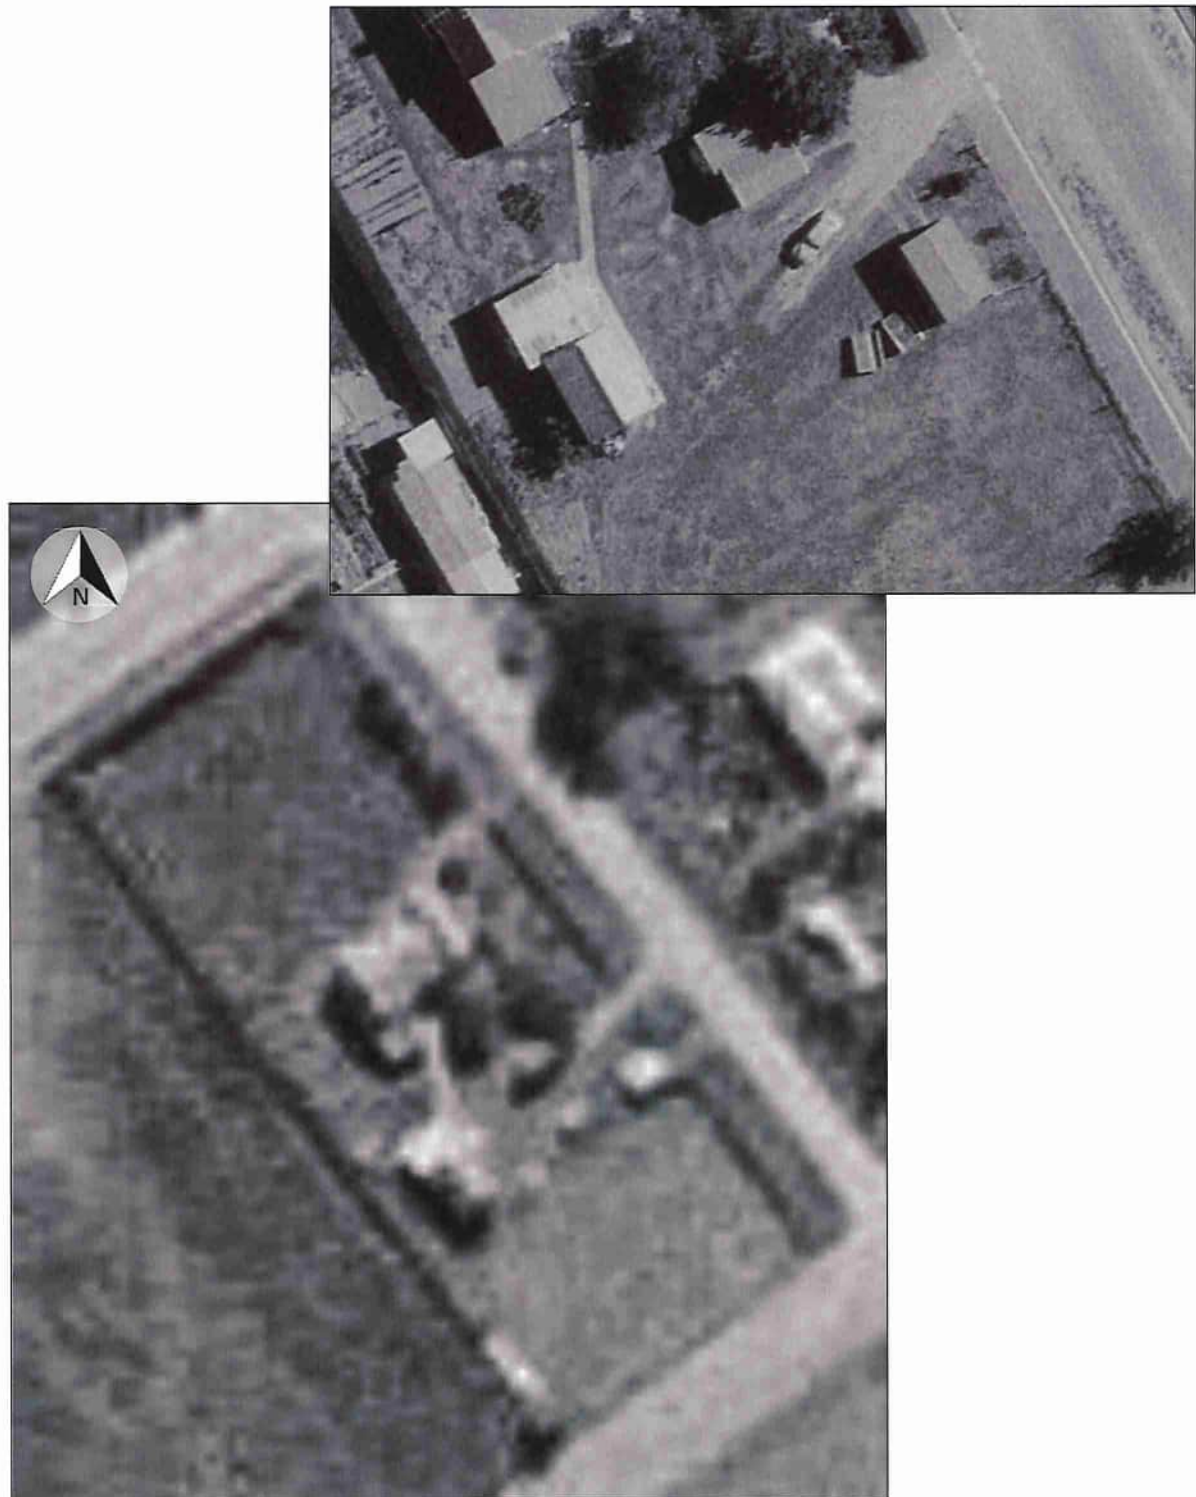
An aerial photograph from 1960 shows the construction of Shed 2. Whilst the quality of this image was poor and it was therefore difficult to precisely identify specific features, another photograph from 1976 shows the property with the same layout of structures (Figure 9).

Figure 9. Aerial images from 1960 and 1976 (inset) showing the construction of Shed 2. Source: Retrolens.

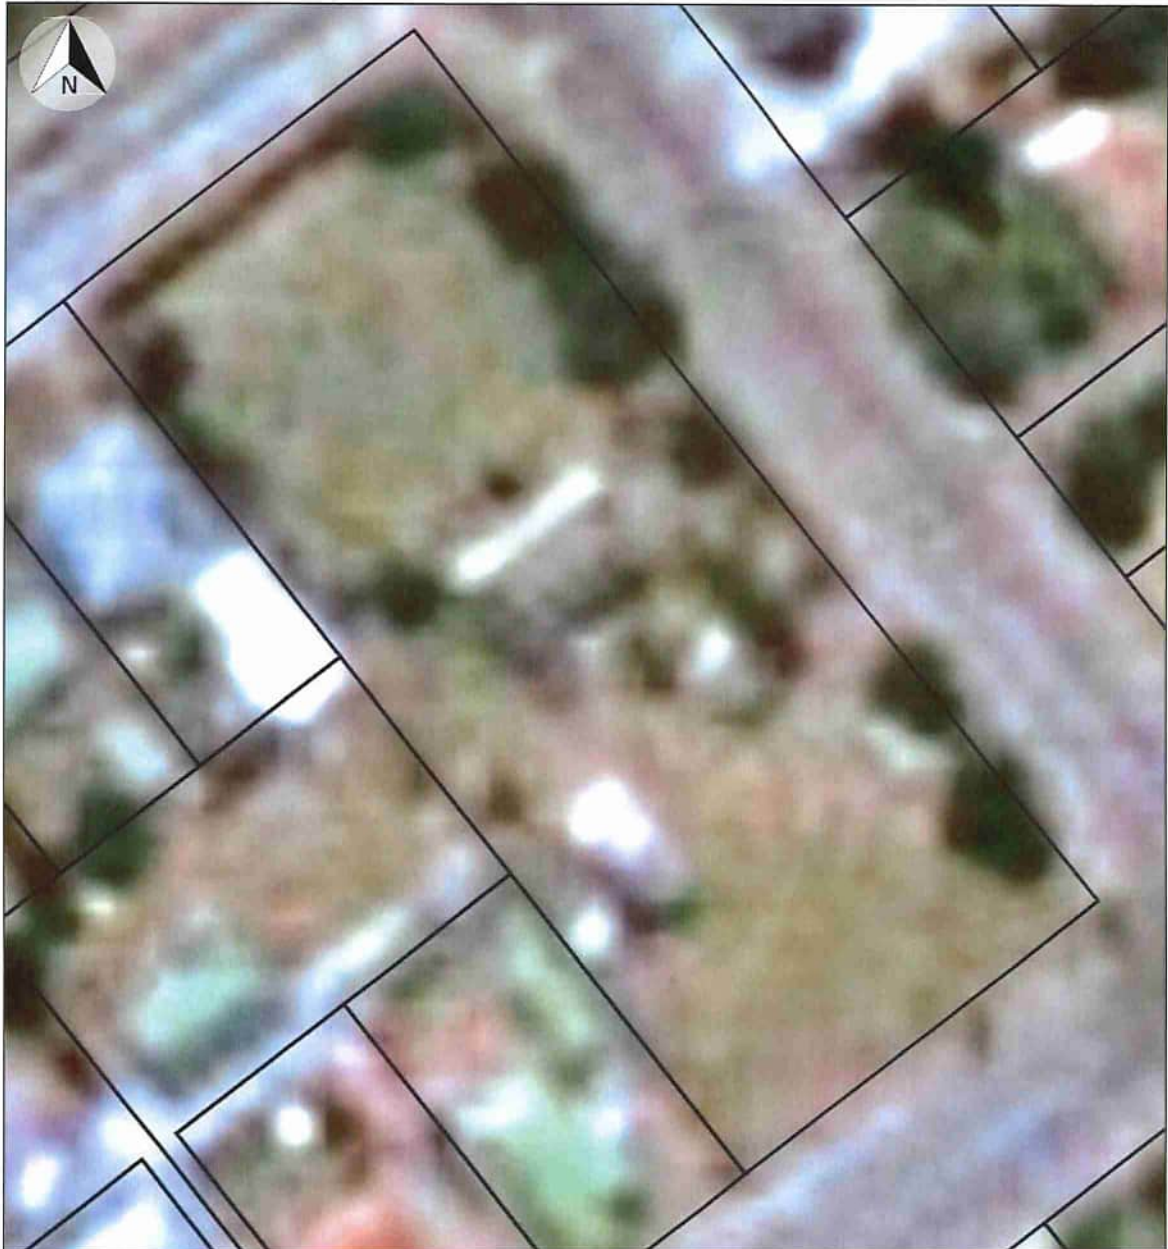
A poor quality aerial photograph from 2000-2004 shows that the shed on the southern corner of the property has been demolished (Figure 10). As the shed was present in photographs from 1998 it was demolished at some stage in the preceding 2-6 years. At this stage the outbuildings at 4 Wilkin Street are in their current day layout.

Figure 10. 2000-2004 aerial image showing 4 Wilkin Street, with the southerly shed now demolished. Source: Retrolens.

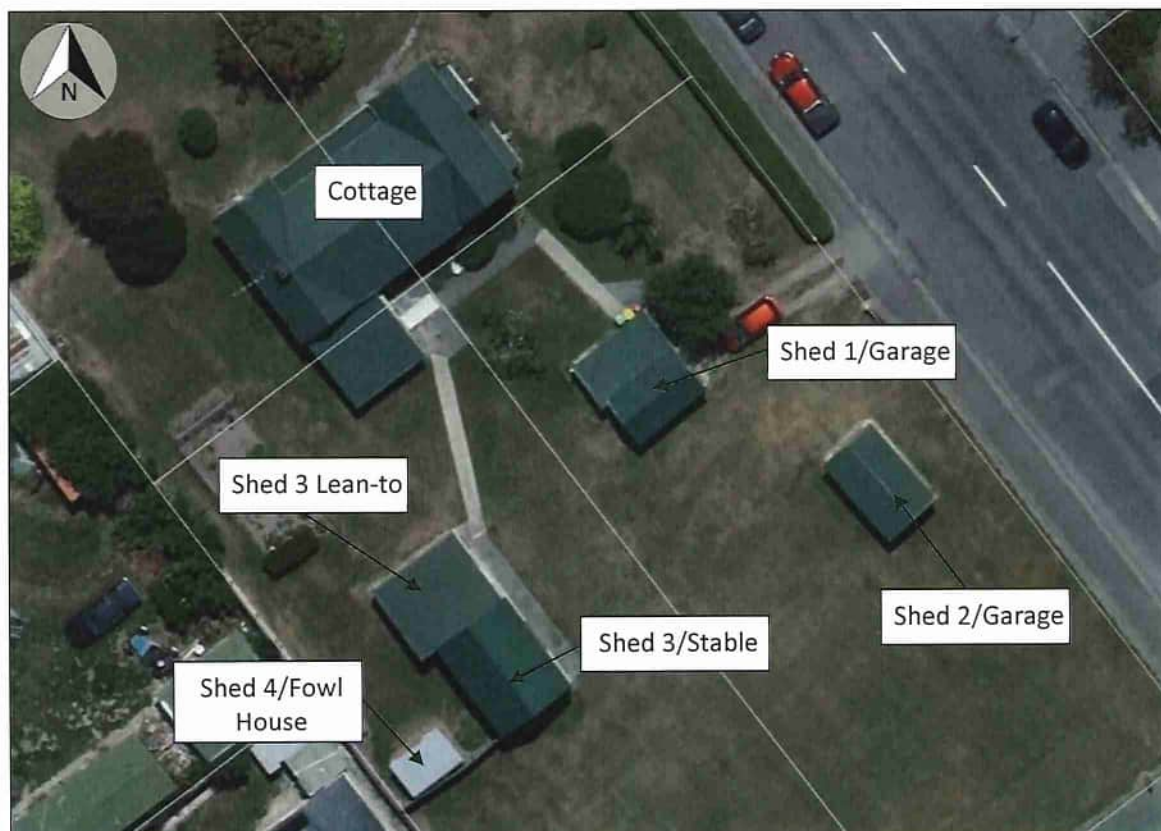
Figure 12 indicates the location and nomenclature of the extant buildings.

Figure 12. Nomenclature of buildings at 4 Wilkin Street.

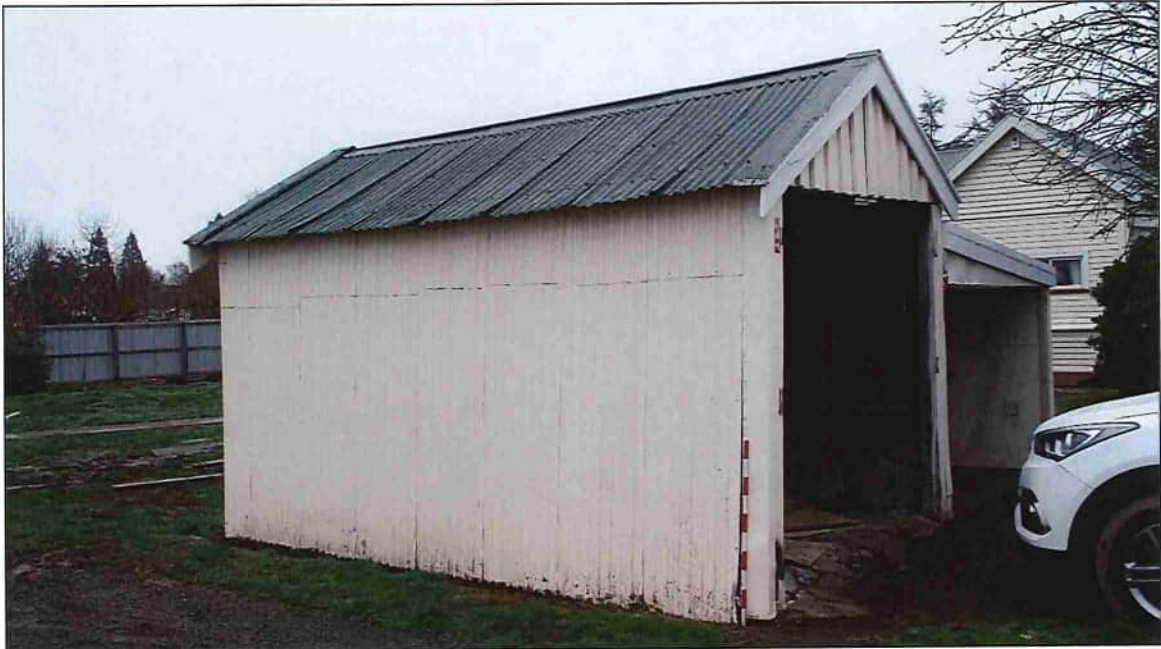
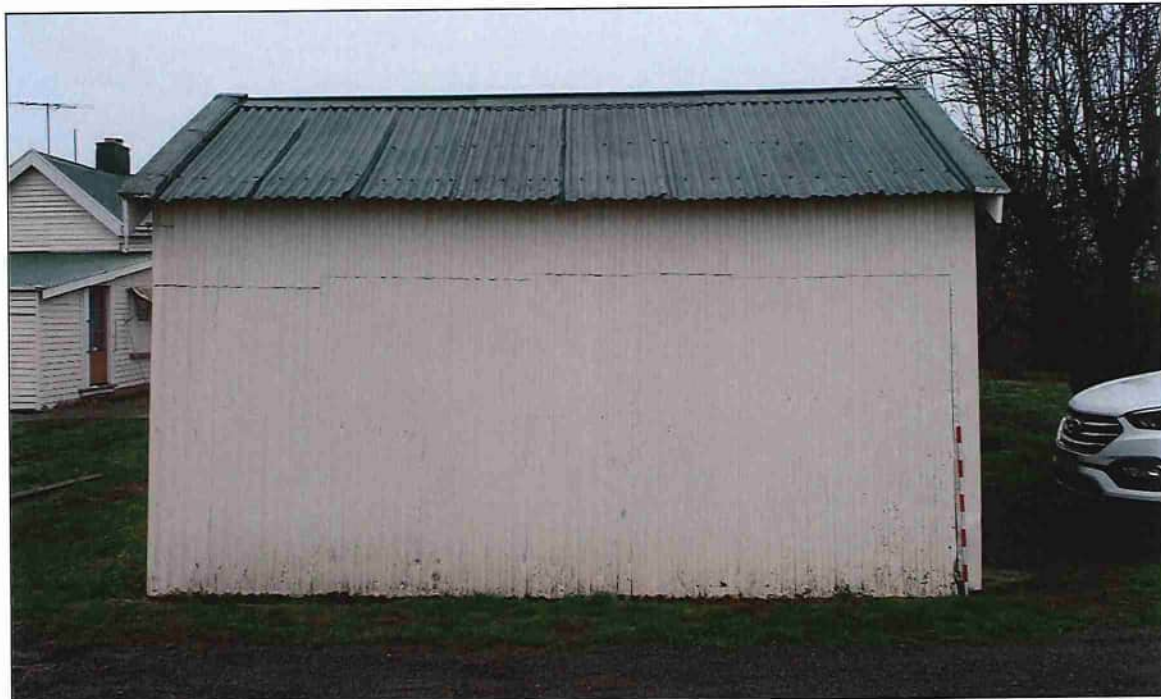
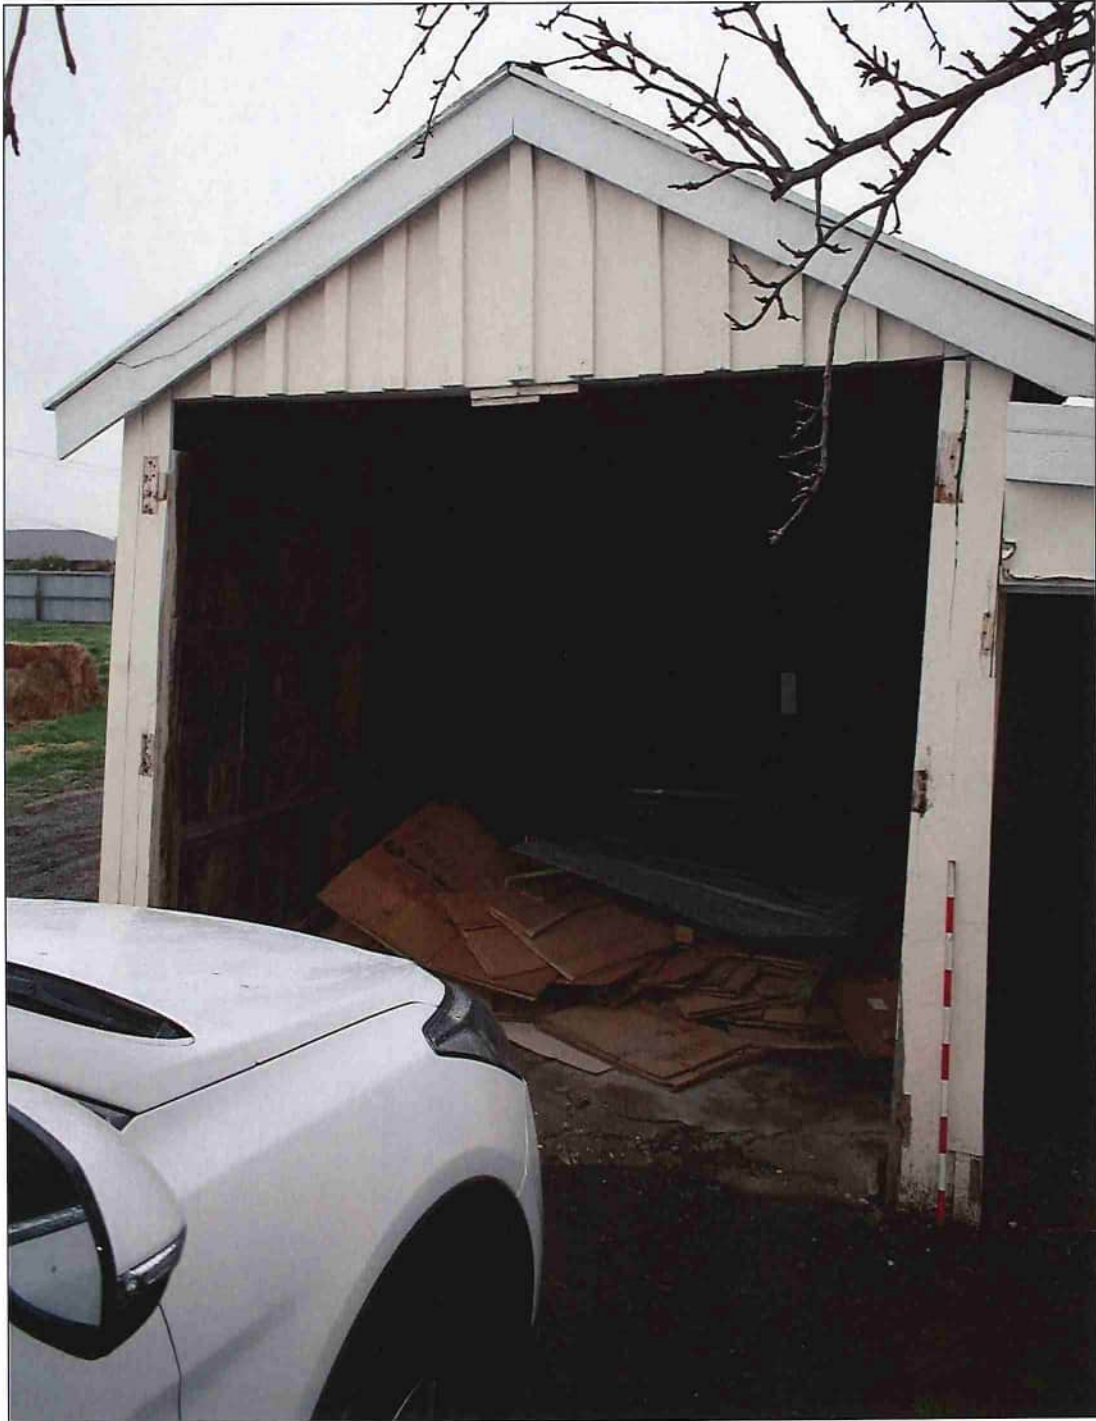
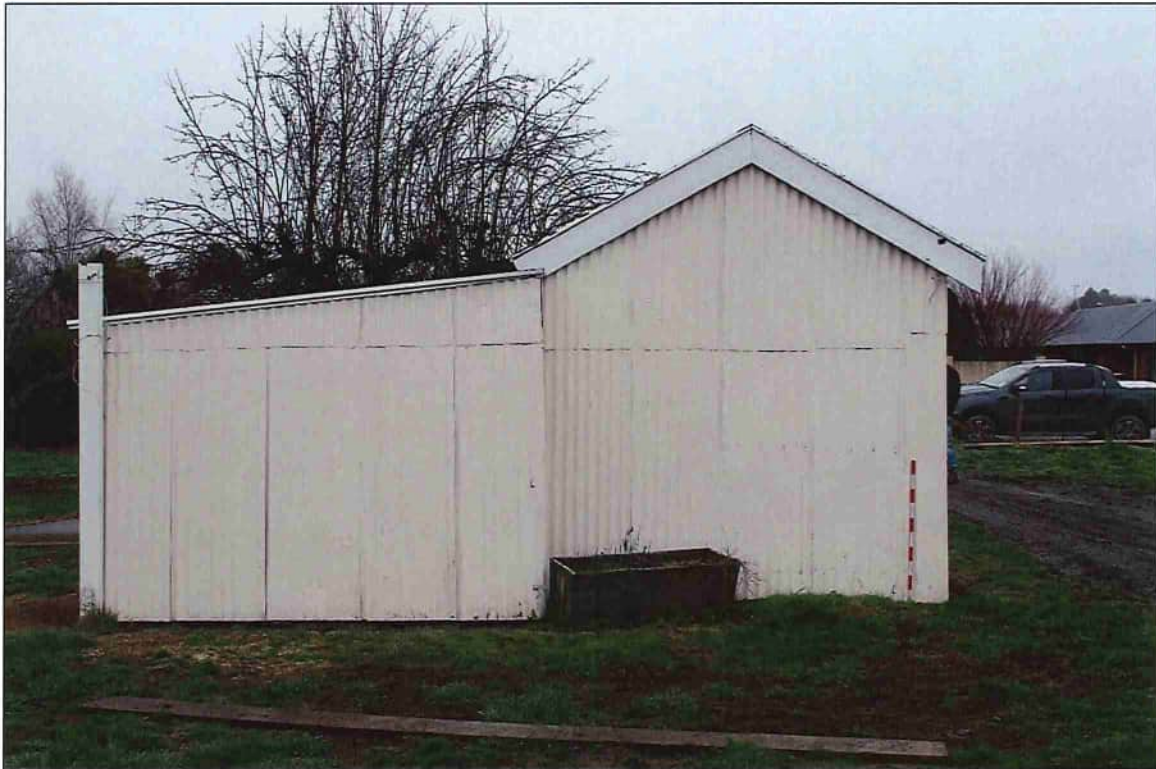
Figure 13. Shed 1, looking west. Scale = 10 cm increments.

Figure 14. Shed 1, southeast elevation. Scale = 10 cm increments.

Figure 15. Shed 1 main structure, northeast elevation. Scale = 10 cm increments

Figure 16. Shed 1, southwest elevation. Scale = 10 cm increments.

The framing of the main structure is clad with sarking boards on the outside. These are then covered with corrugated iron on the southeast and southwest elevations. The northeast and northwest elevations are clad in what appear to be pine boards, probably added in the 20th century. The structure of the ceiling is not visible. The main structure has a concrete floor, probably added in the 20th century.

The identified 19th century outbuilding (Shed 1/garage) is proposed to be demolished during the project works. It is likely that this building is the buggy shed described in the 1896 advertisement of sale. This building is structurally unsound and is considered unsalvageable. Under Section 42(3) of the *Heritage New Zealand Pouhere Taonga Act 2014* (HNZPTA) the demolition of this building will require an archaeological authority with associated building recording conditions. As the remaining outbuildings are 20th century in age there are no archaeological requirements associated with their demolition. However, if the timing of demolition works for all the outbuildings coincide, it is suggested that the attending archaeologist also be able to monitor the demolition of the other outbuildings to further record information pertaining to their ages and use.

Shed 1 is currently in a poor condition and is likely being supported by the 20th century lean-to on its northwest elevation. Retention of the shed is not possible while also meeting the project objectives. It is considered that the shed is in such poor condition that any attempt retain and relocate it on the site will result in its demolition.

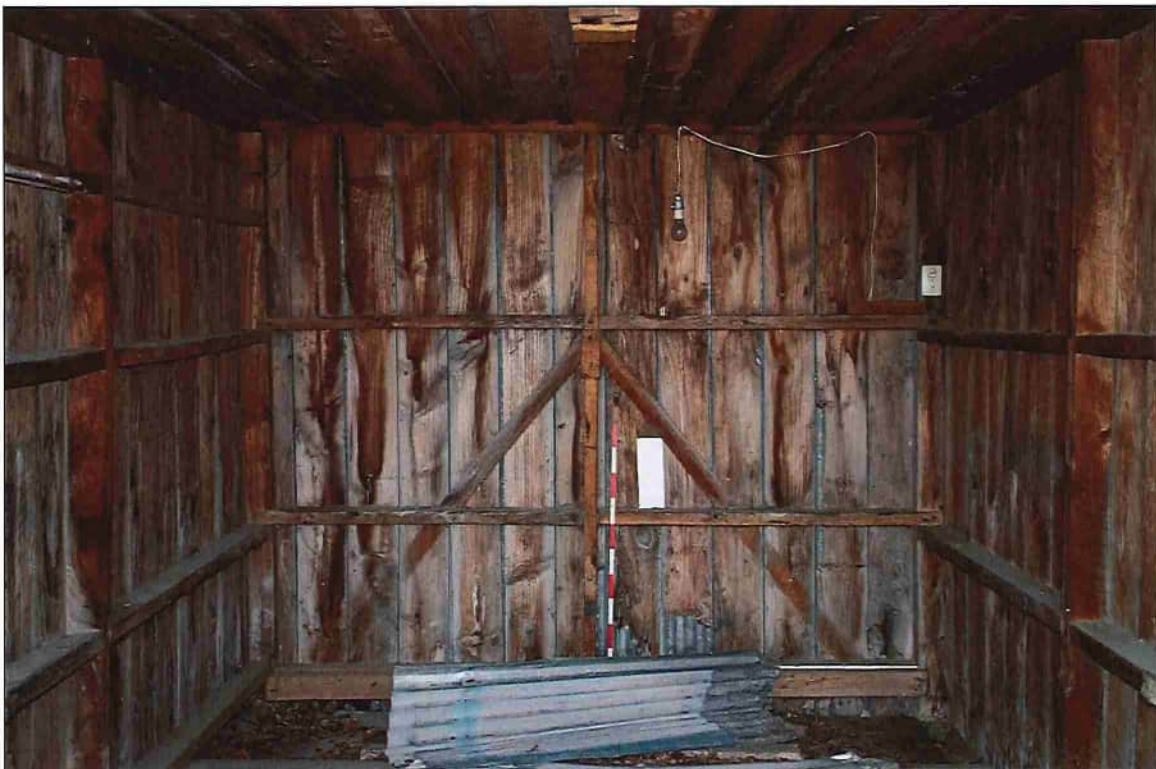
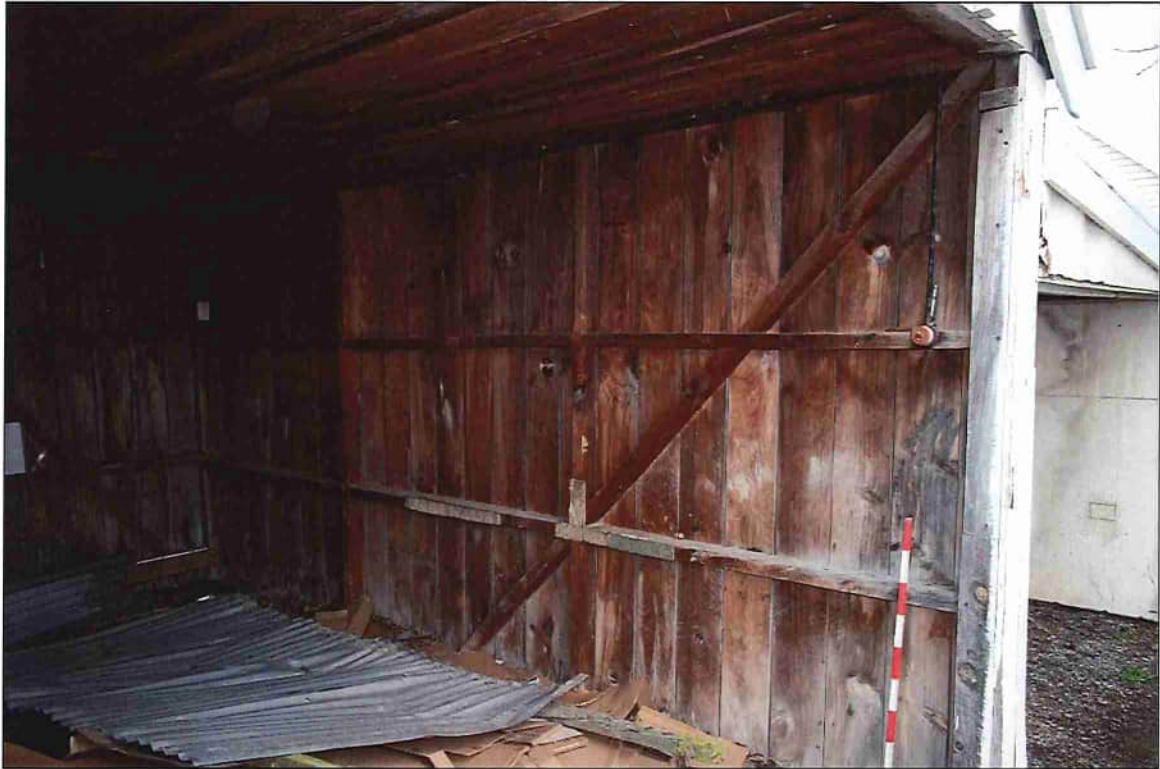
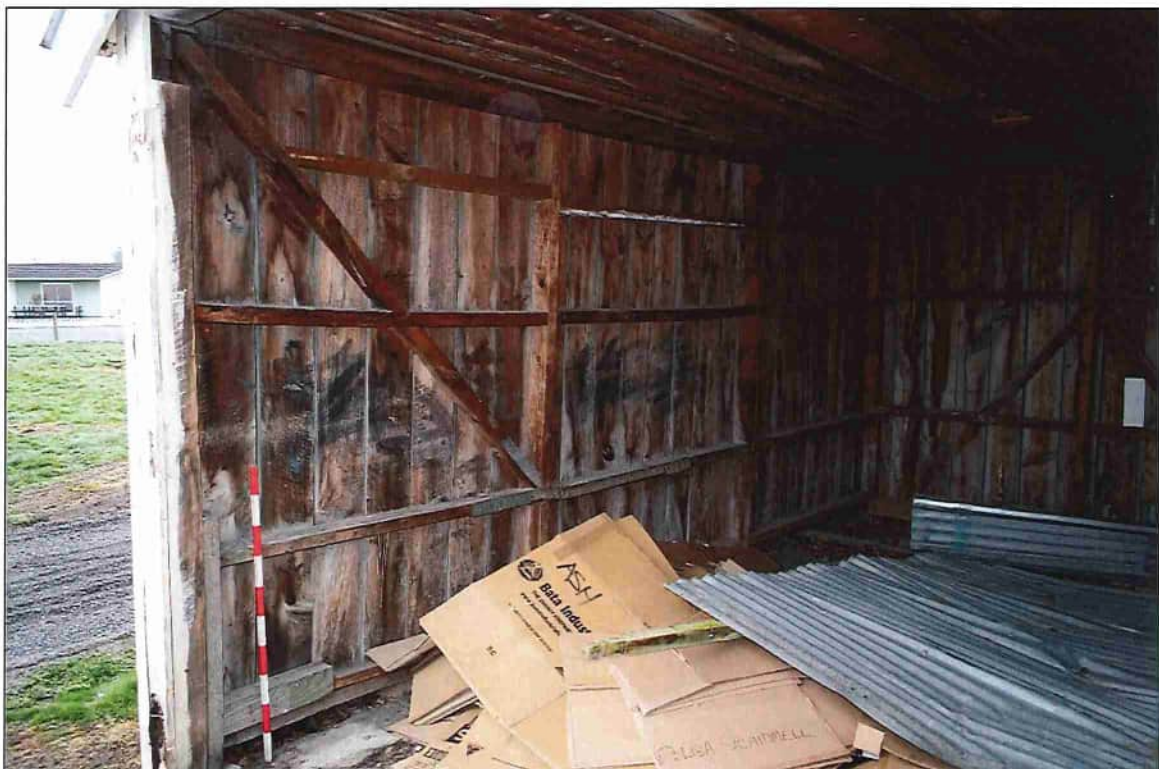
- The wall structure includes diagonal cross members that meet at a central point on the wall. This was the dominant construction technique throughout the 19th century (Figure 17 - Figure 19),
- The doors for this building were found within shed 2. These are ledged and braced doors that use a diagonal cross brace typical of 19th century design. The doors are made from wide (150 mm) boards tongue and groove boards. These are probably repurposed floorboards. 150 mm

Figure 17. Shed 1, southwest internal elevation. Scale = 10 cm increments.

Figure 18. Shed 1, northwest internal elevation. Scale = 10 cm increments.

Figure 19. Shed 1, southeast internal elevation. Scale = 10 cm increments.

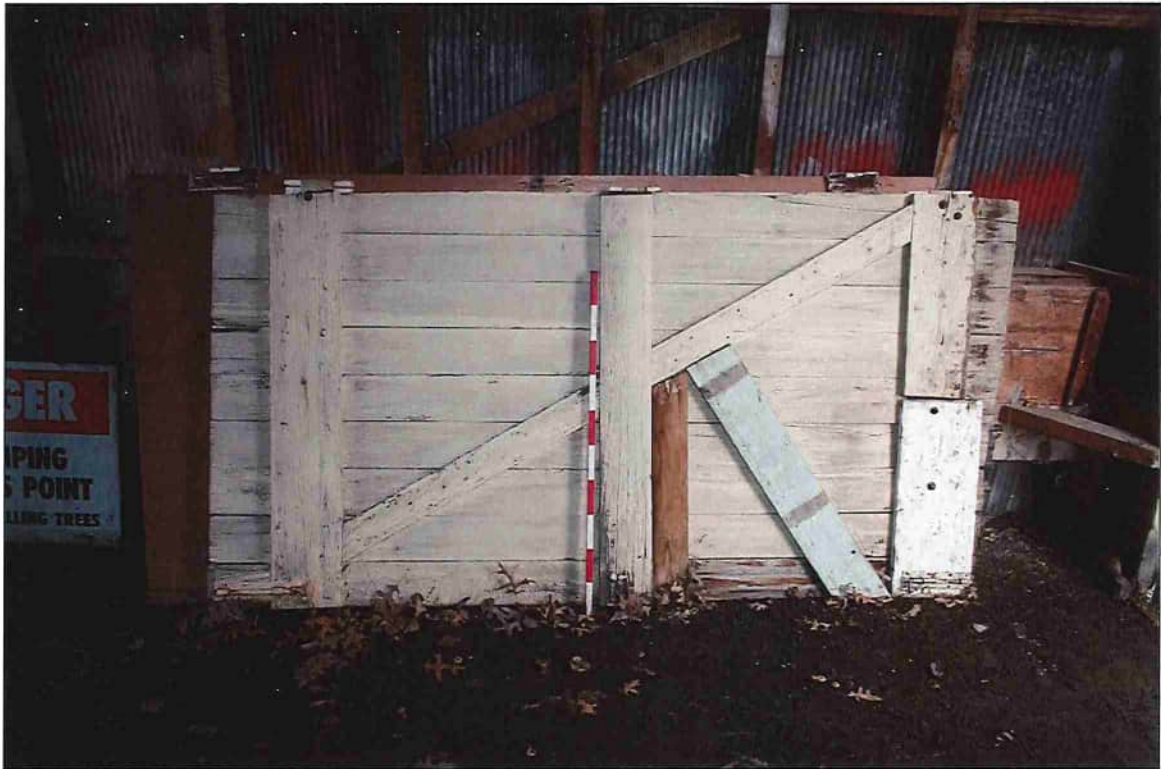
Figure 20. Shed 1 ledge and braced doors, located within Shed 2. Scale = 10 cm increments.

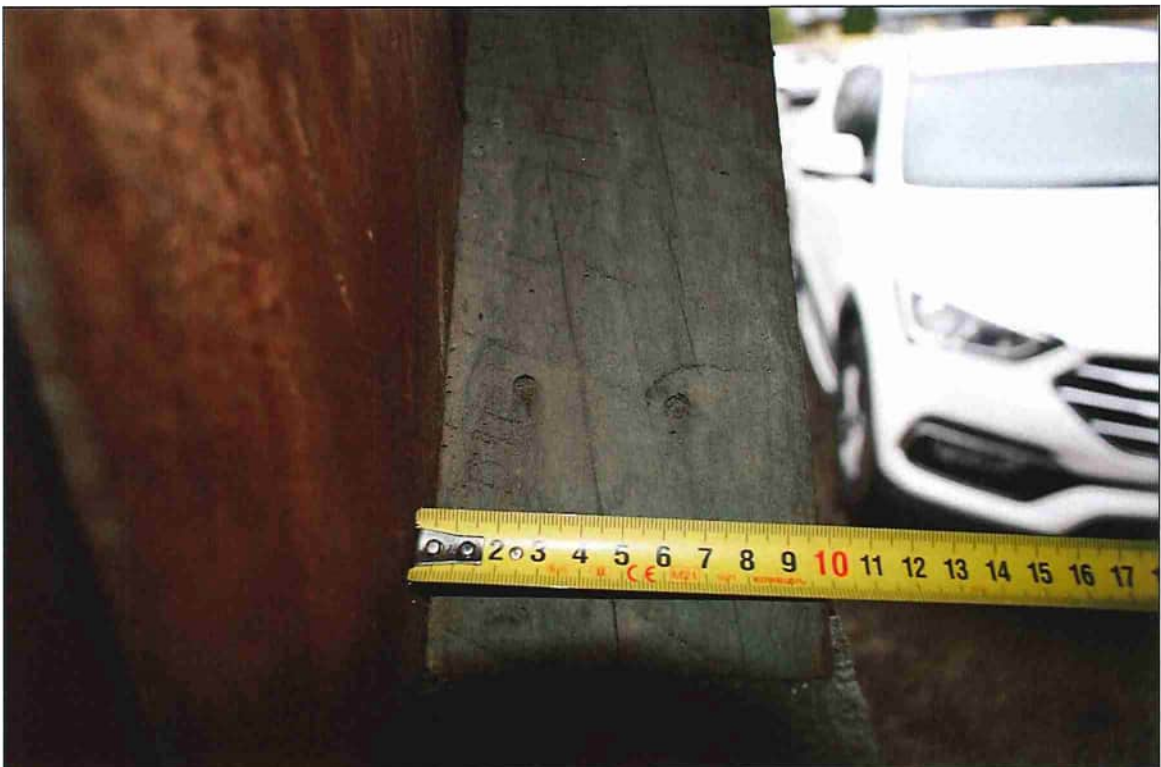
- The wall framing and the doors are constructed using smithed wrought iron nails with hammered heads (Figure 21),
- The framing appears to be rimu.

Figure 21. Shed 1 wrought iron, hammer headed, smithed nails.

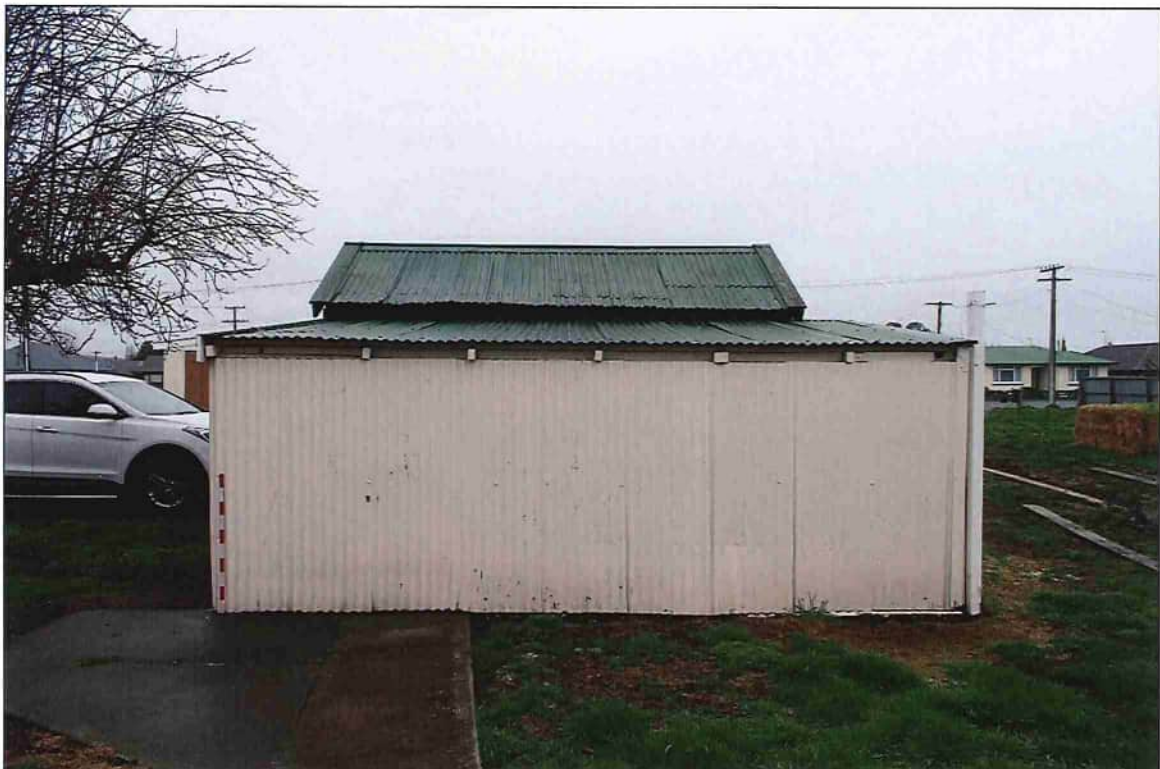
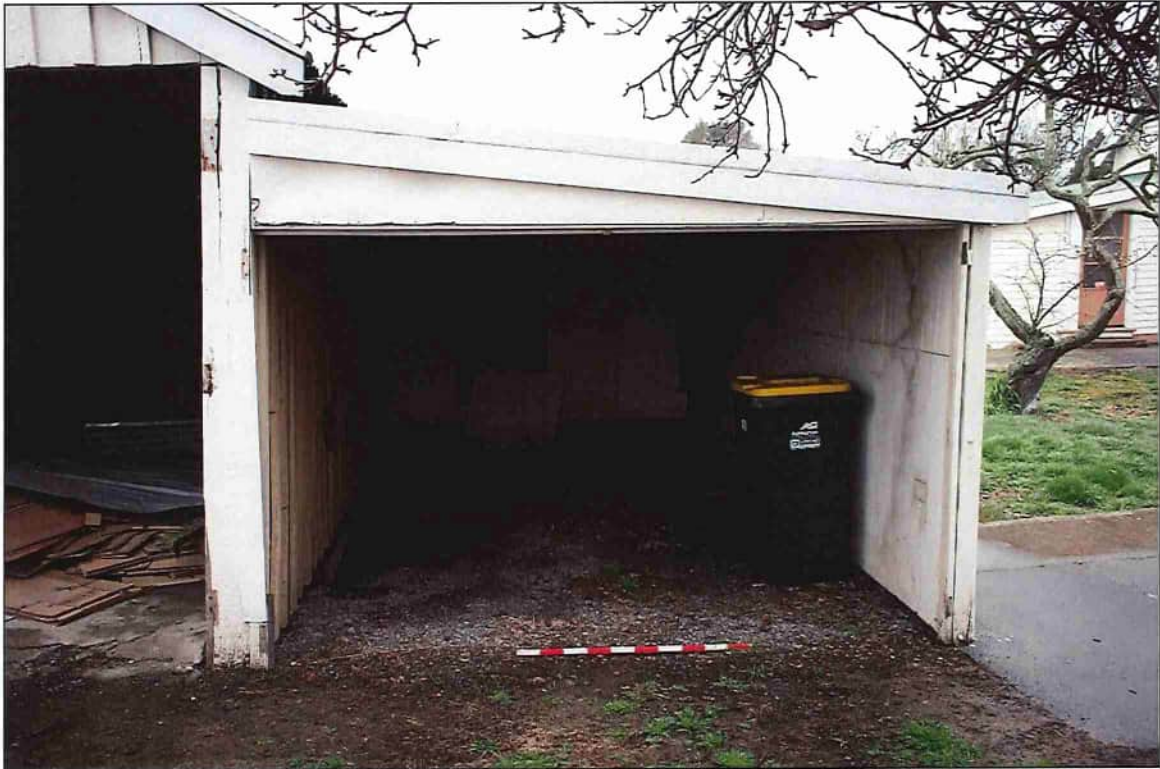
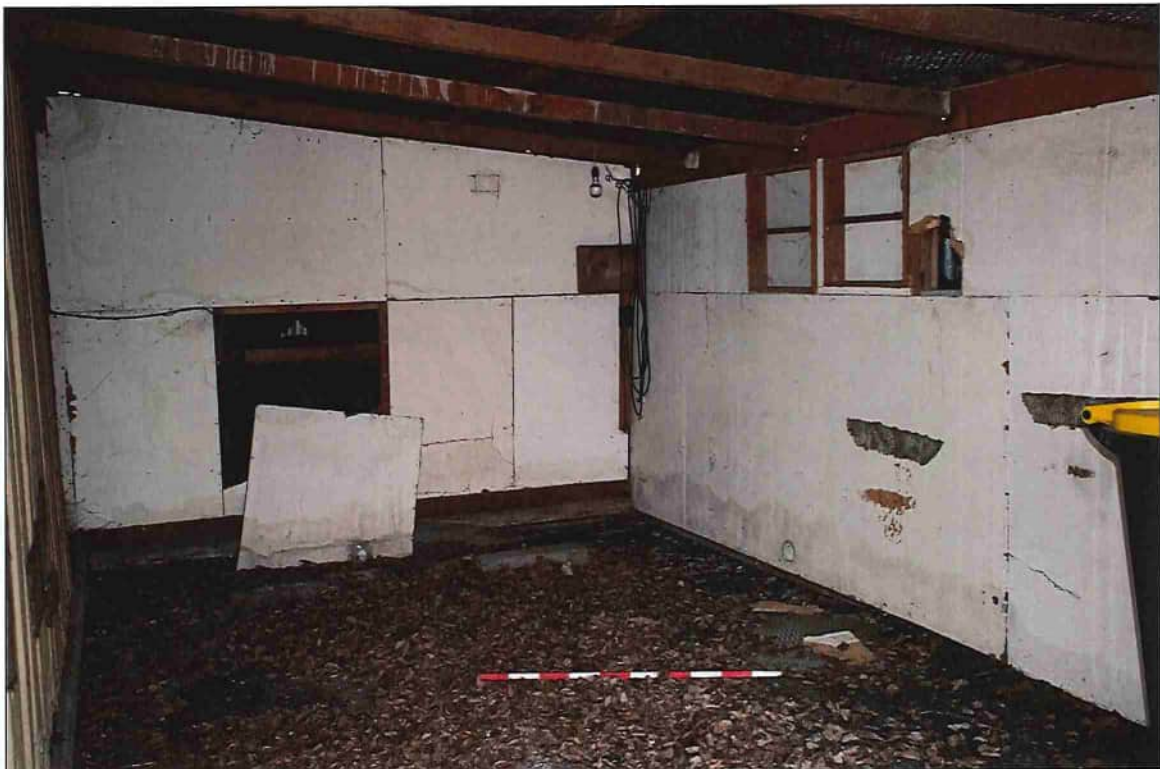
The lean-to is constructed of treated pine and medium density particle board (MDF). This is a 20th century addition to the building. (Figure 22 - Figure 24) The main structure is structurally unsound and is leaning towards the northwest. It appears that the lean-to may be holding it up.

Figure 22. Shed 1, northwest elevation of the lean-to. Scale = 10 cm increments.

Figure 23. Shed 1, northeast elevation of the lean-to. Scale = 10 cm increments.

Figure 24. Shed 1, interior of the lean-to, looking west. Scale = 10 cm increments.
