Application for Subdivision Consent

AJ Developments (2016) Ltd

4 Wilkin St, Tinwald

Date Produced - December 2022

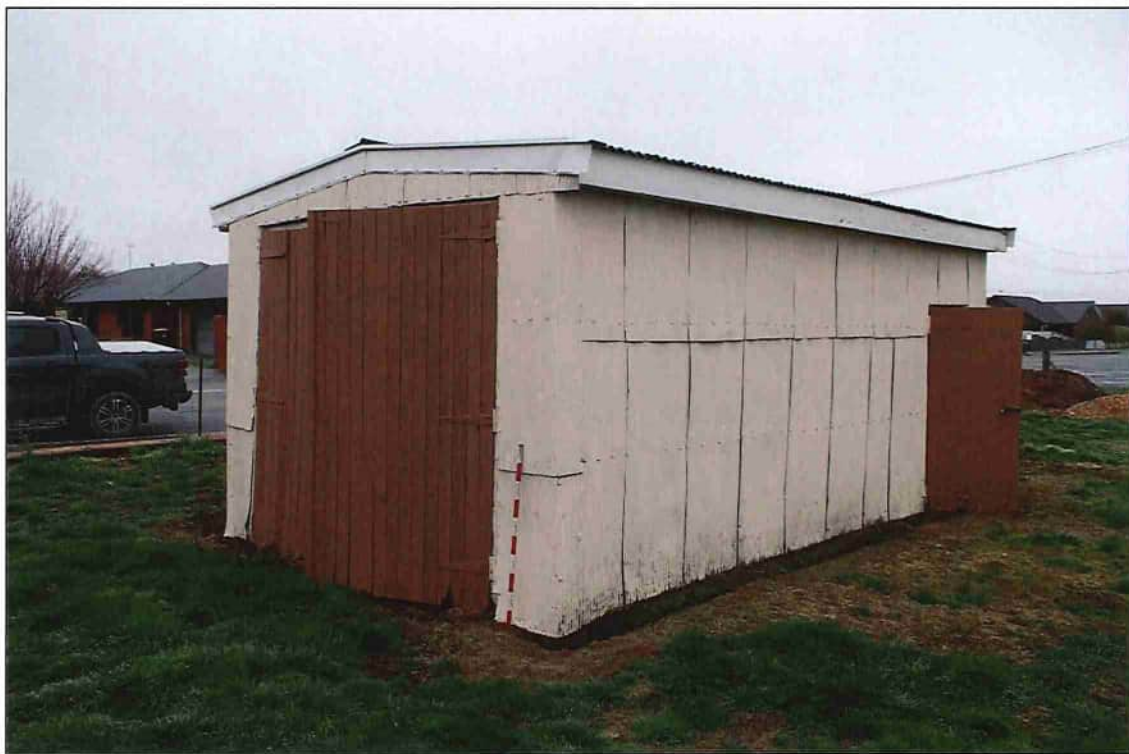
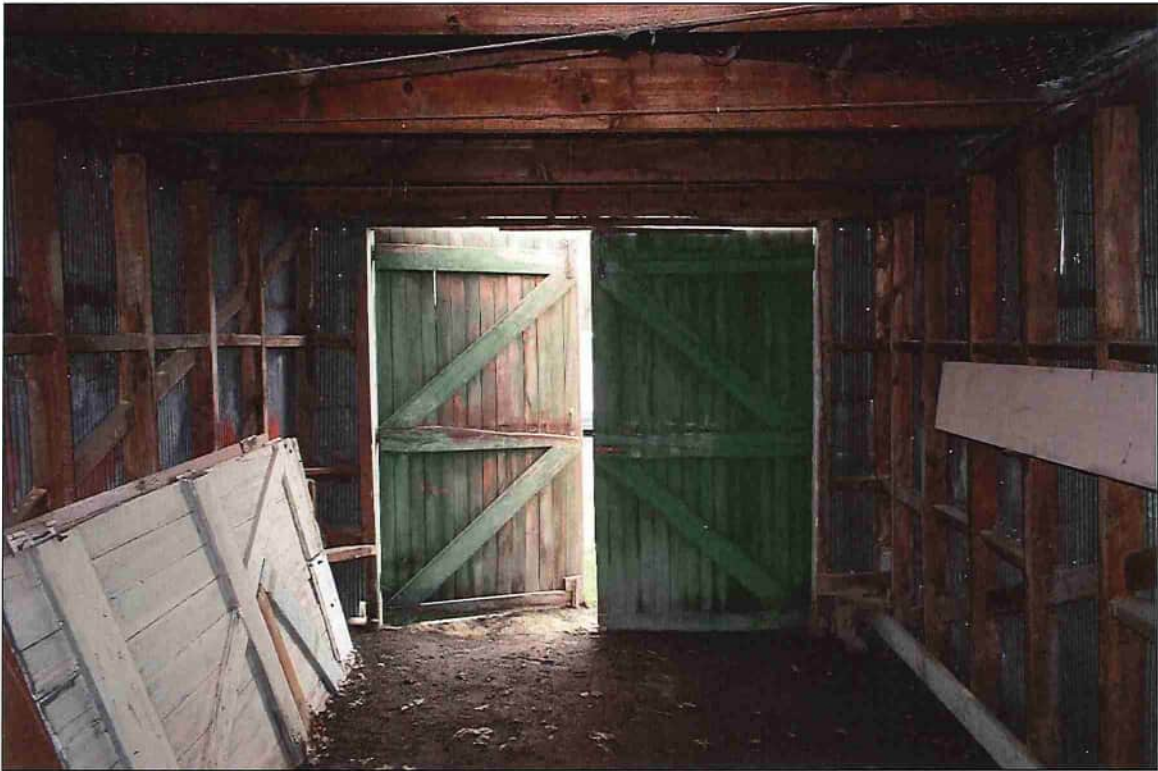
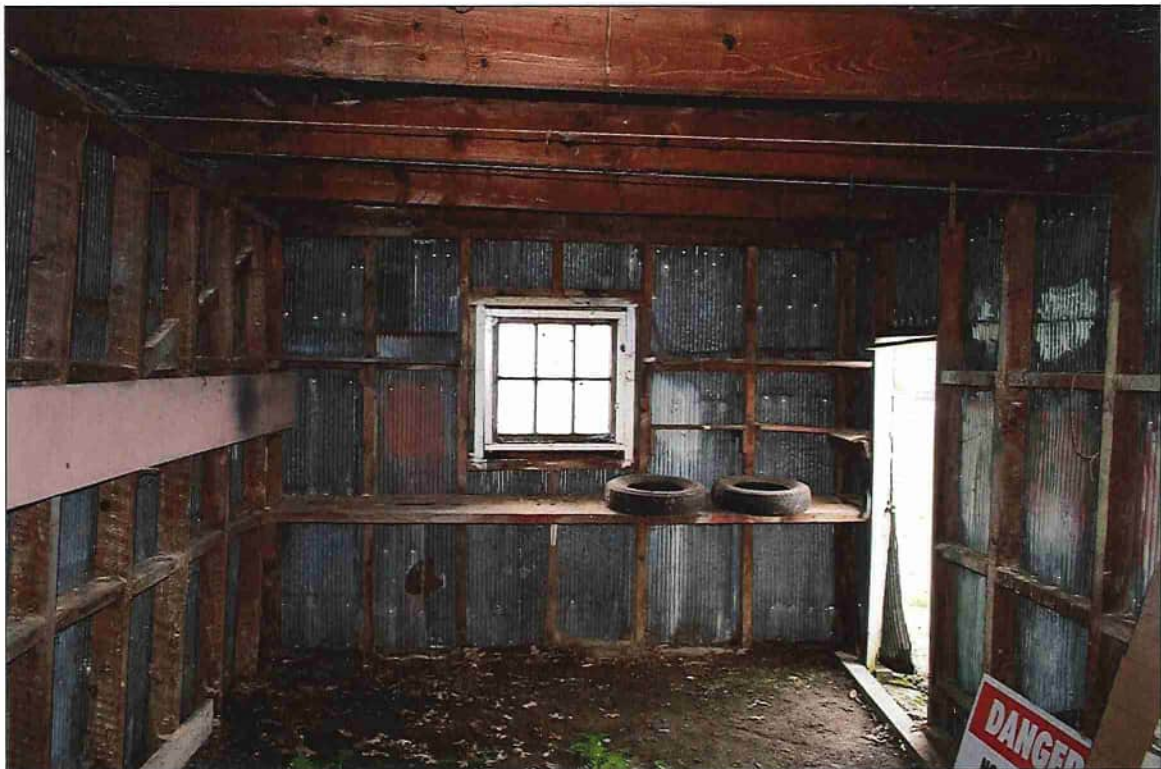
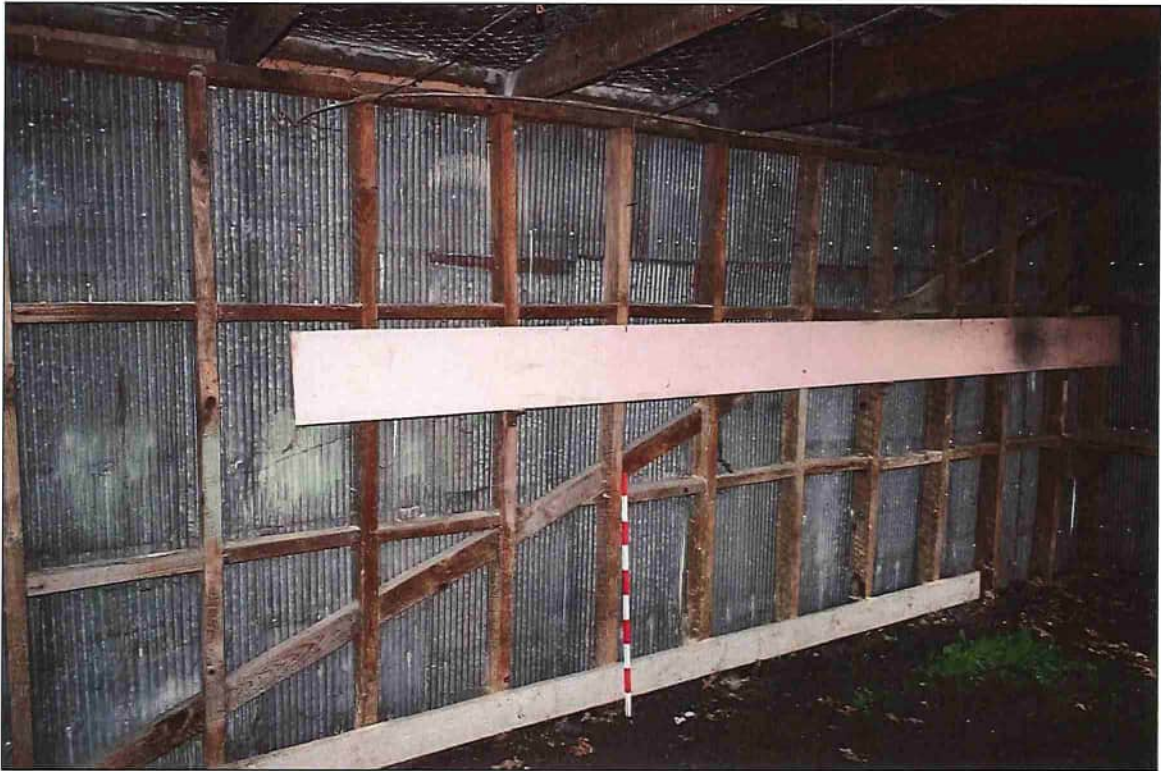
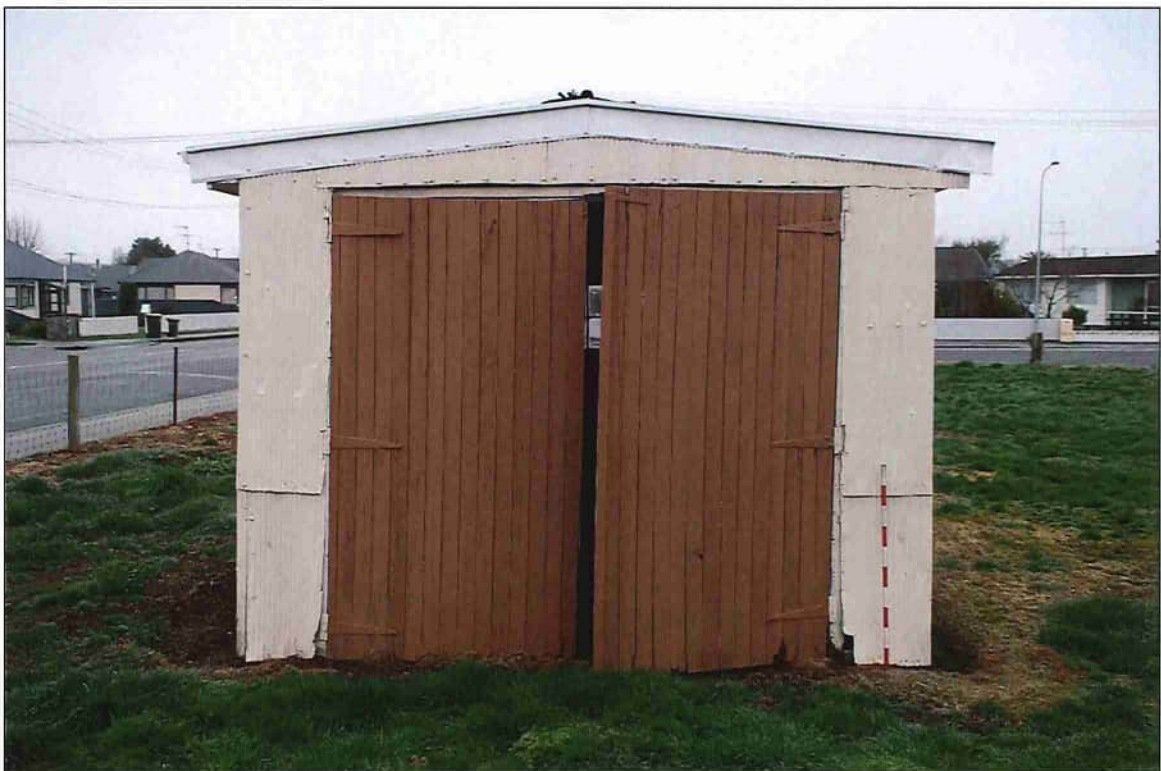
Figure 25. Shed 2, looking east. Scale = 10 cm increments.

Figure 26. Shed 2 interior, looking northwest. Scale = 10 cm increments.

Figure 27. Shed 2 interior, looking northwest. Scale = 10 cm increments.

Figure 28. Shed 2, southeast internal elevation. Scale = 10 cm increments.

Figure 29. Shed 2, northwest elevation. Scale = 10 cm increments.

While the building has been constructed using smithed nails these are a poor indication of a buildings age on their own. There is no established 'end date' for the manufacture of smithed nails and it is entirely possible that they continued to be manufactured into the 20th century. This may be particularly true for rural towns such as Tinwald that lacked the mechanisation seen in the cities. Nails also have a long shelf life. It is possible that these nails were manufactured in the 19th century but were not used until the 20th.

The building is clad with corrugated iron. No makers marks were visible on the iron, however, is noted that the sheets have many nail holes punched in them. The corrugated iron had probably been salvaged from another structure and reused to build this shed. It is also possible that the timbers and nails were also salvaged materials.

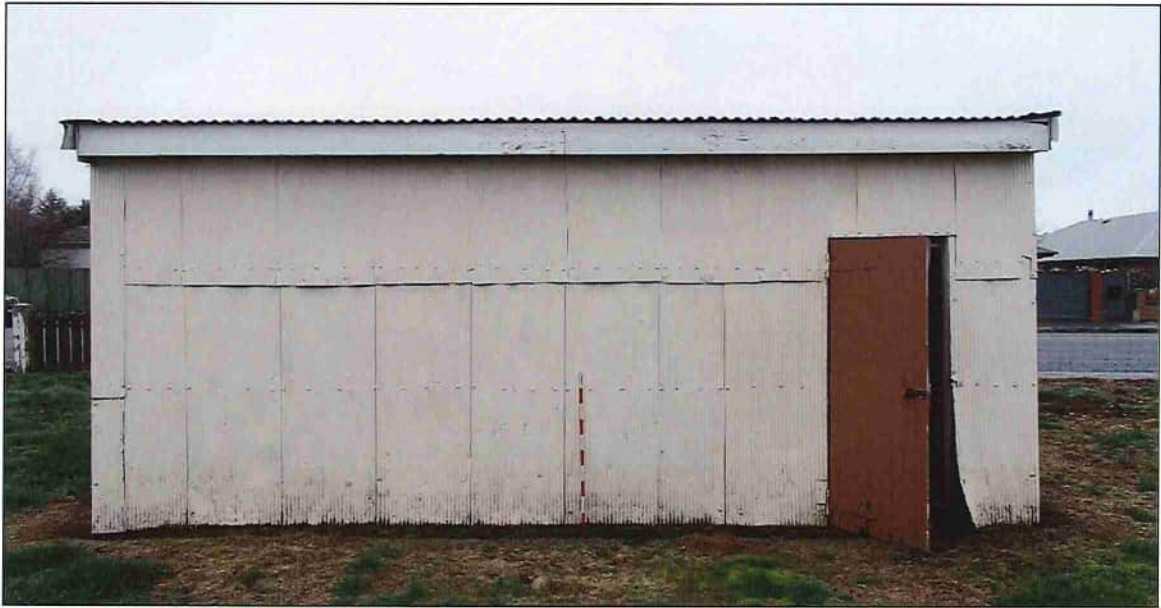
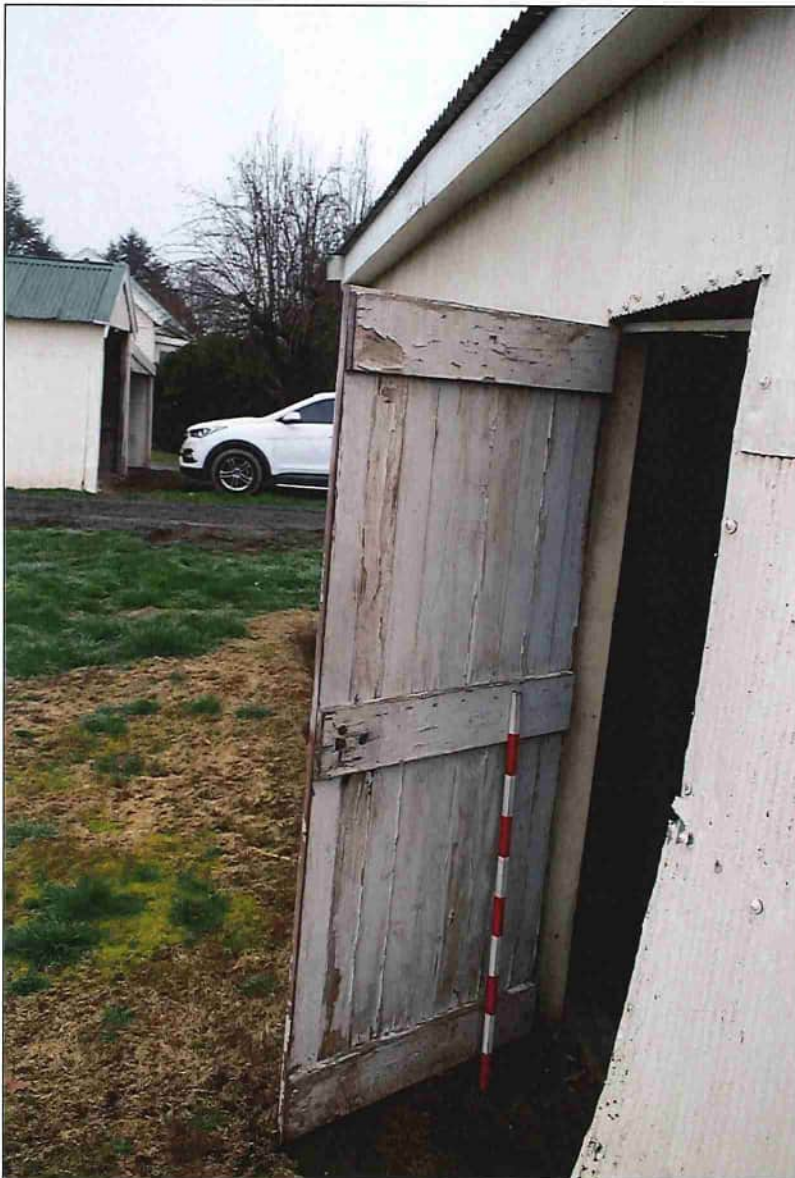
Figure 30. (Above) Shed 2, southwest elevation. Note the ledged and braced door. Scale = 10 cm increments.

Figure 31. (Left) Ledged and braced door on the southwest elevation of shed 2. Scale = 10 cm increments.

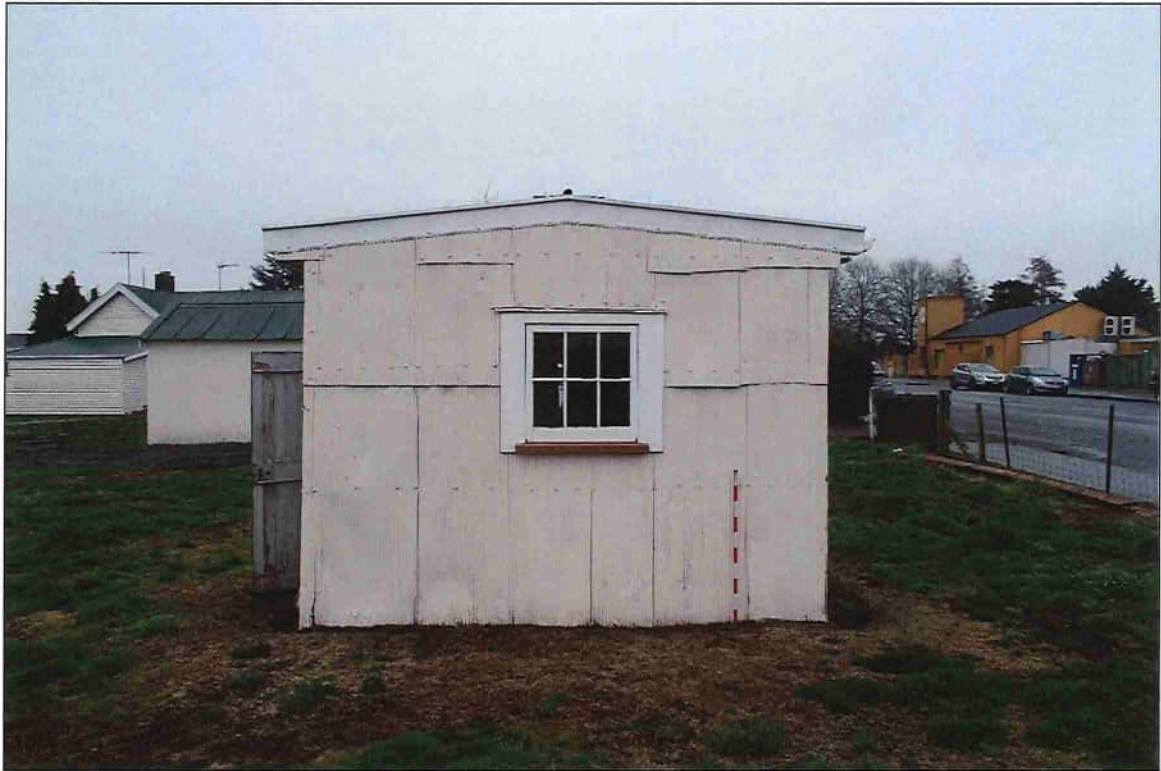
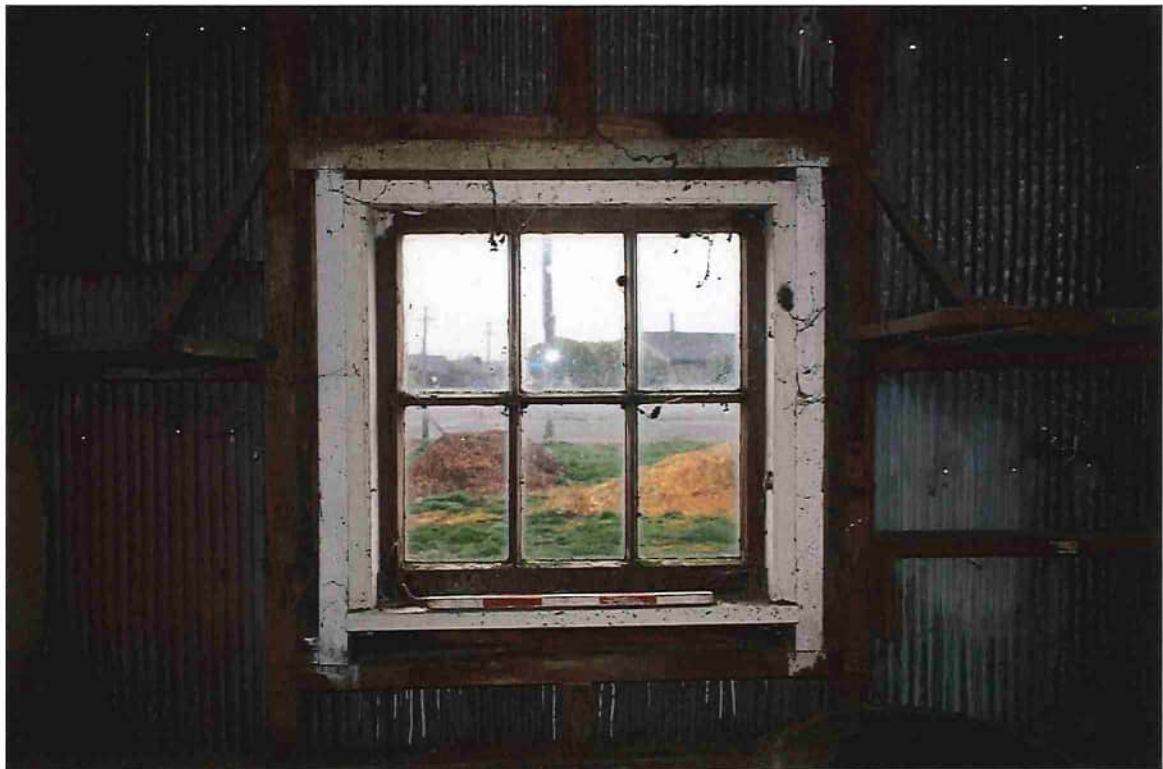
- The southeast elevation includes a casement window of typical 20th century design (Figure 32 and Figure 33).

Figure 32. Shed 2, southeast elevation. Note the casement window. Scale = 10 cm increments.

Figure 33. Shed 2 casement window interior. Scale = 10 cm increments.

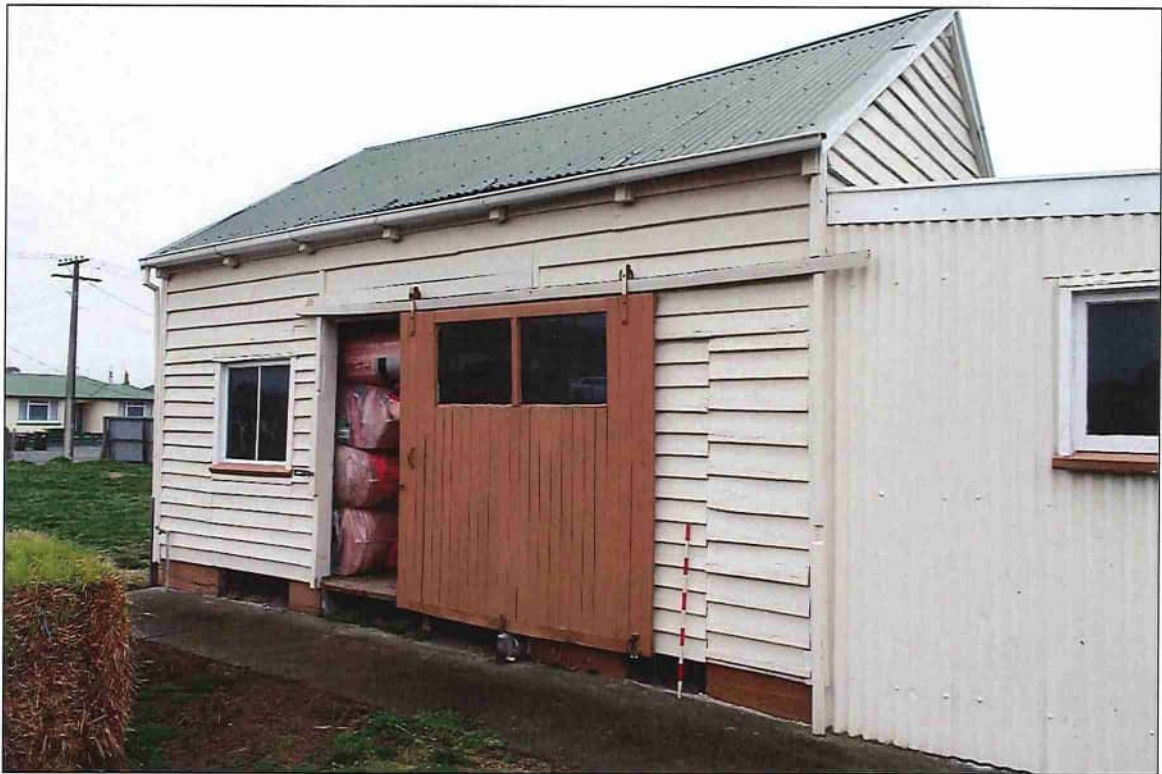
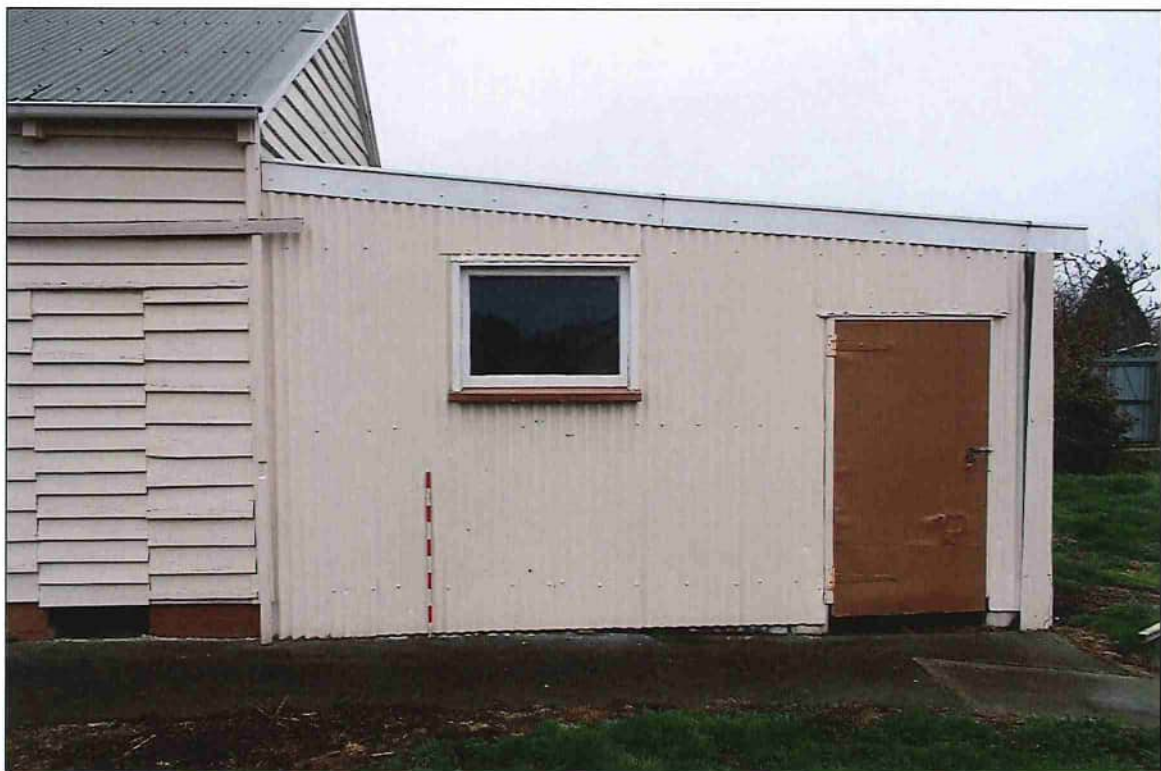
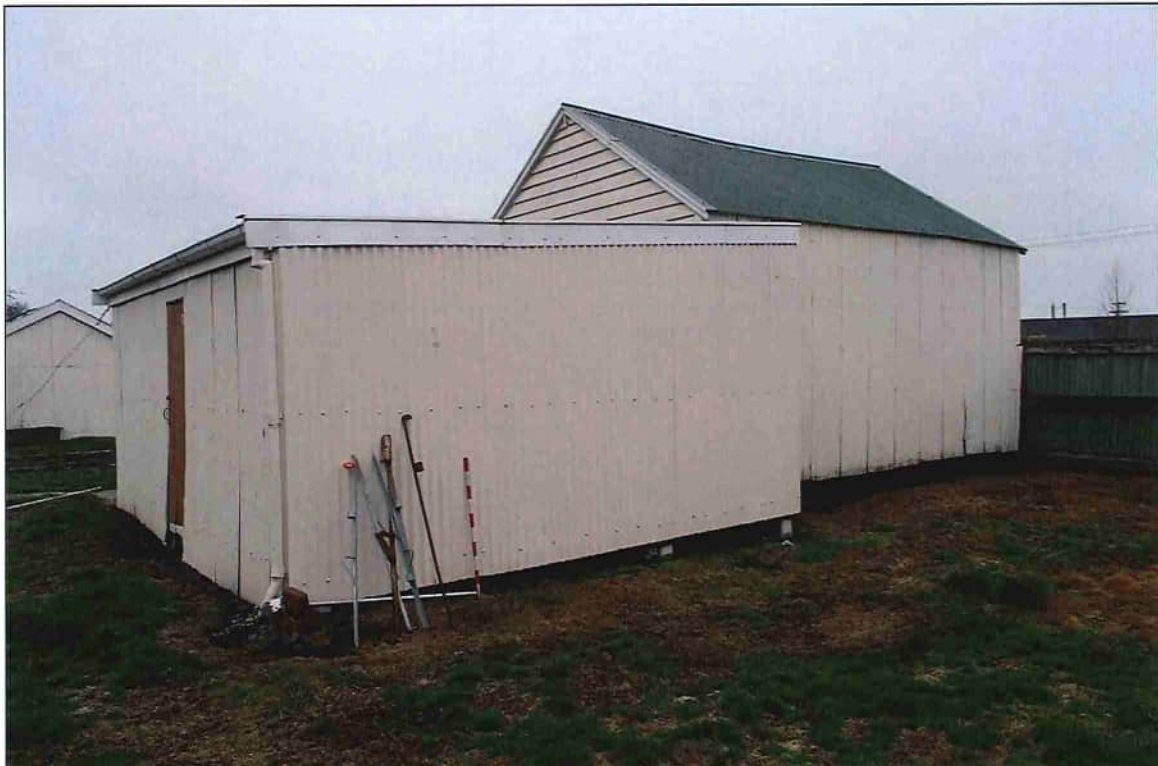
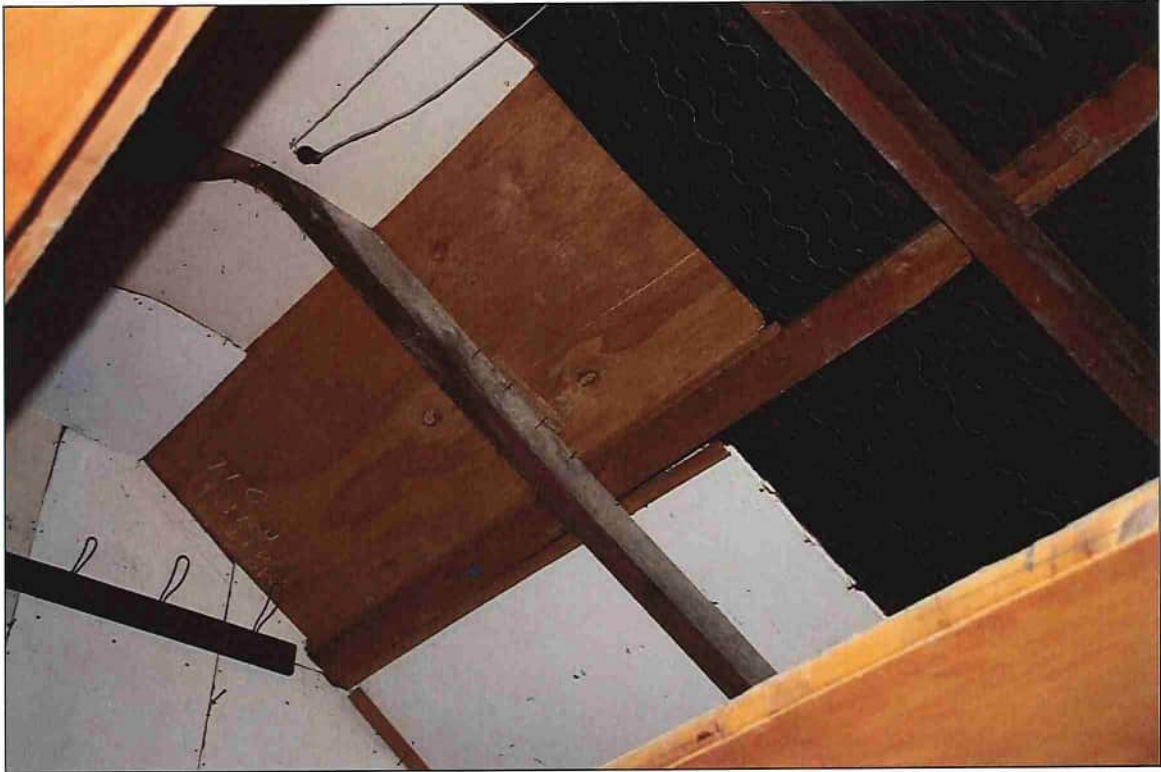
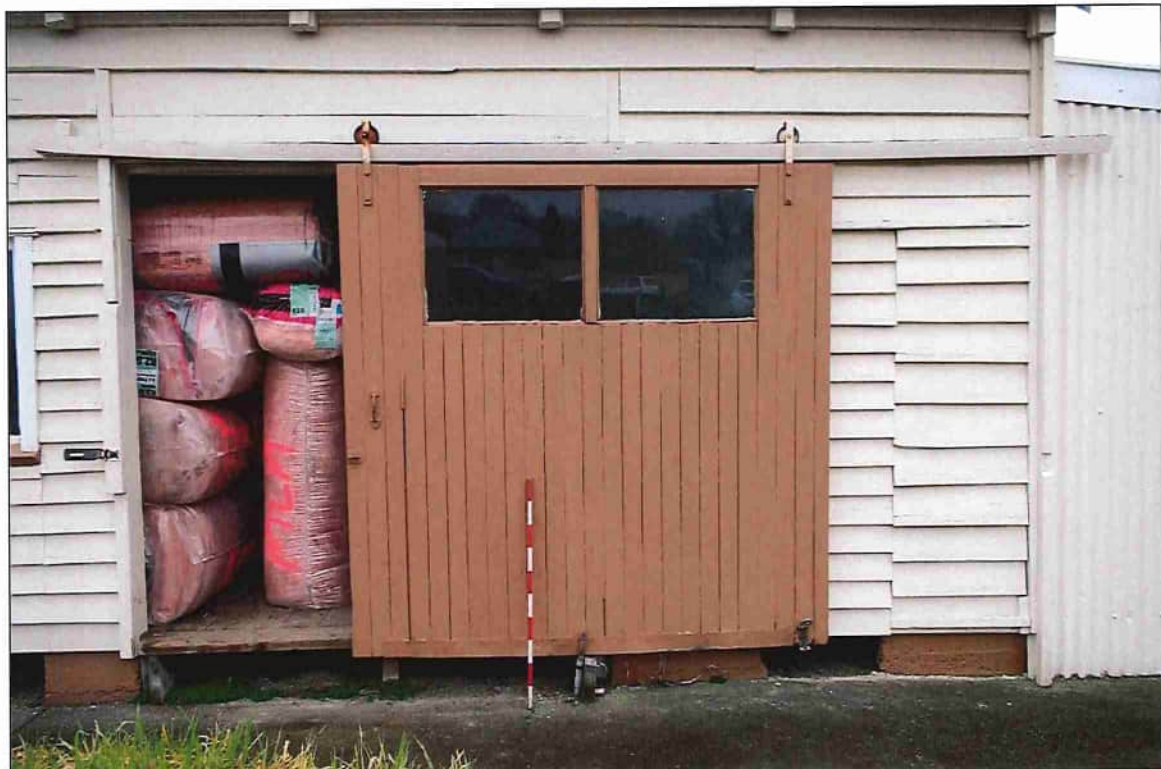
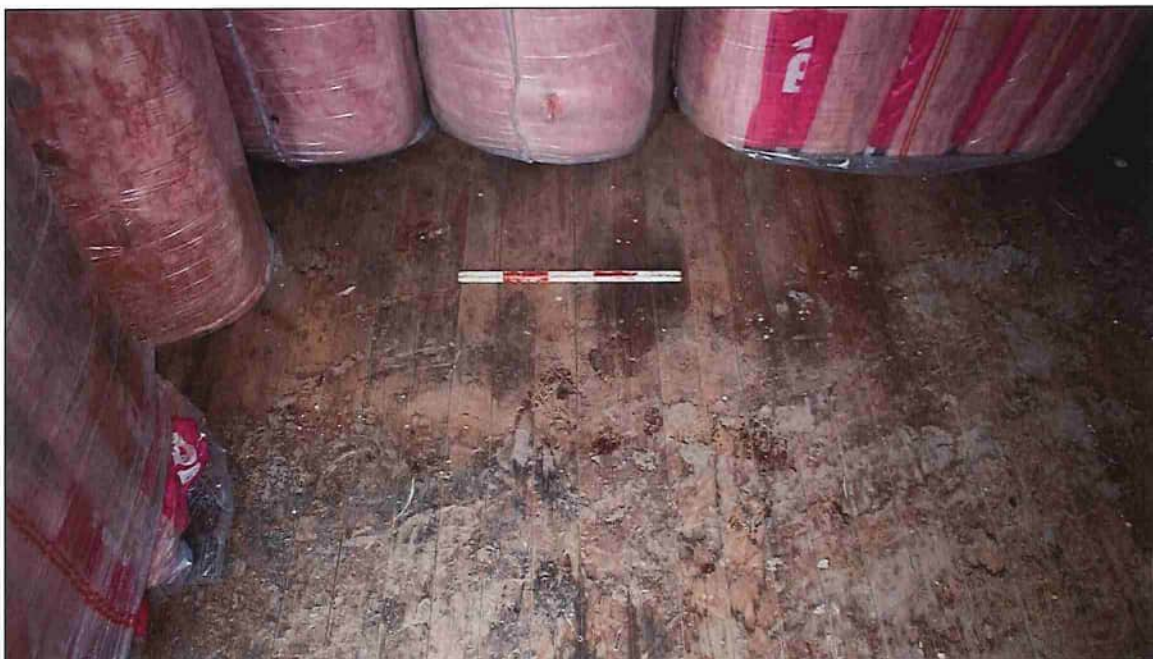
The wall structure of this building is not visible; however, the balance of evidence suggests that this building was constructed in the 20th century, possibly in the 1930s or 40s.

Figure 34. Shed 3, looking west.

Figure 35. Shed 3 lean-to, northeast elevation.

Figure 37. Shed 3, looking east. Scale = 10 cm increments.

Figure 38. Visible roof structure in shed 3.

Figure 39. Sliding door on the northeast elevation of shed 3. Scale = 10 cm increments.

Figure 40. Floorboards within shed 3. Scale = 10 cm increments.

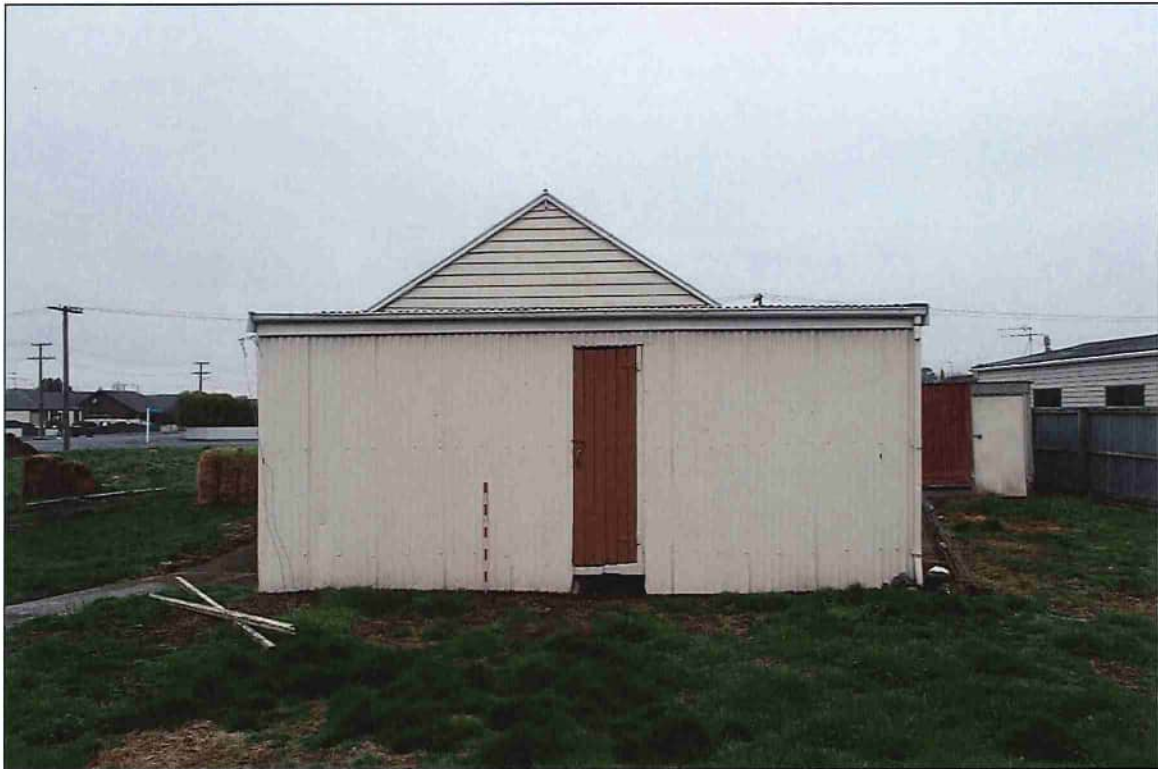
Figure 36. Shed 3, northwest elevation of the lean-to. Note the ledged and braced door made from narrow (85 mm) boards.

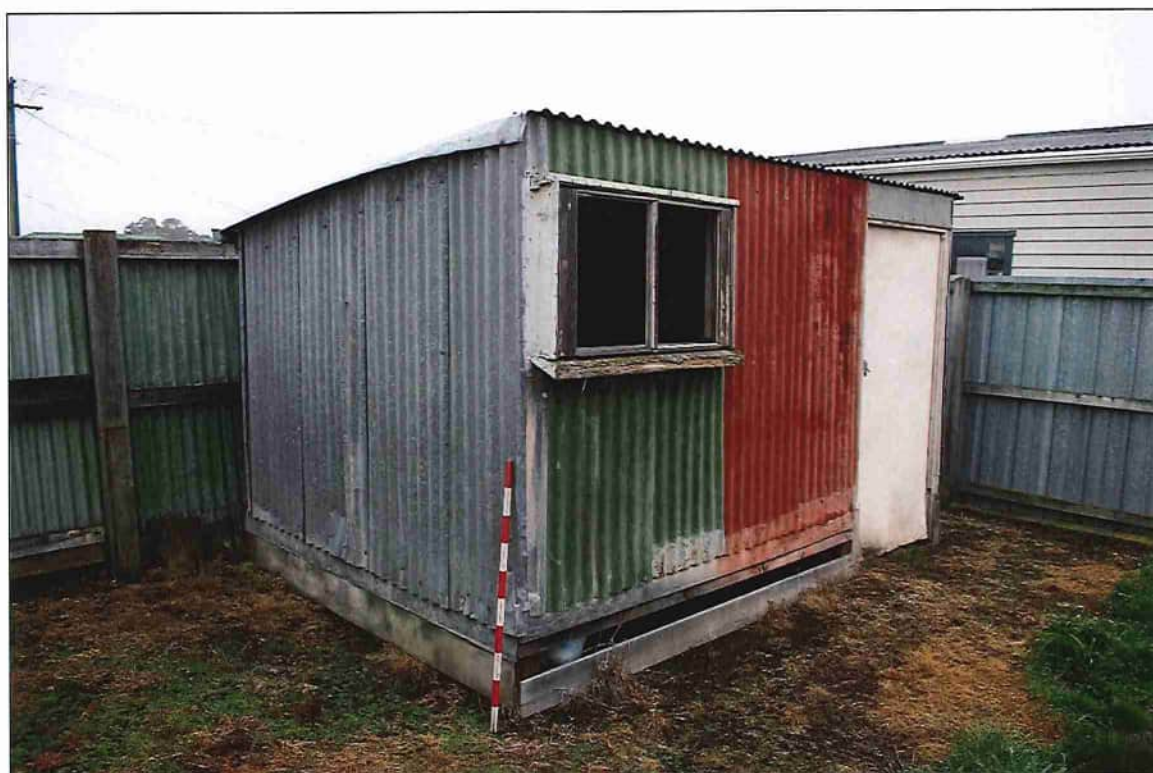
This is a makeshift building that appears to have been constructed in the 20th century (Figure 41).

Figure 41. Shed 4, looking southwest.

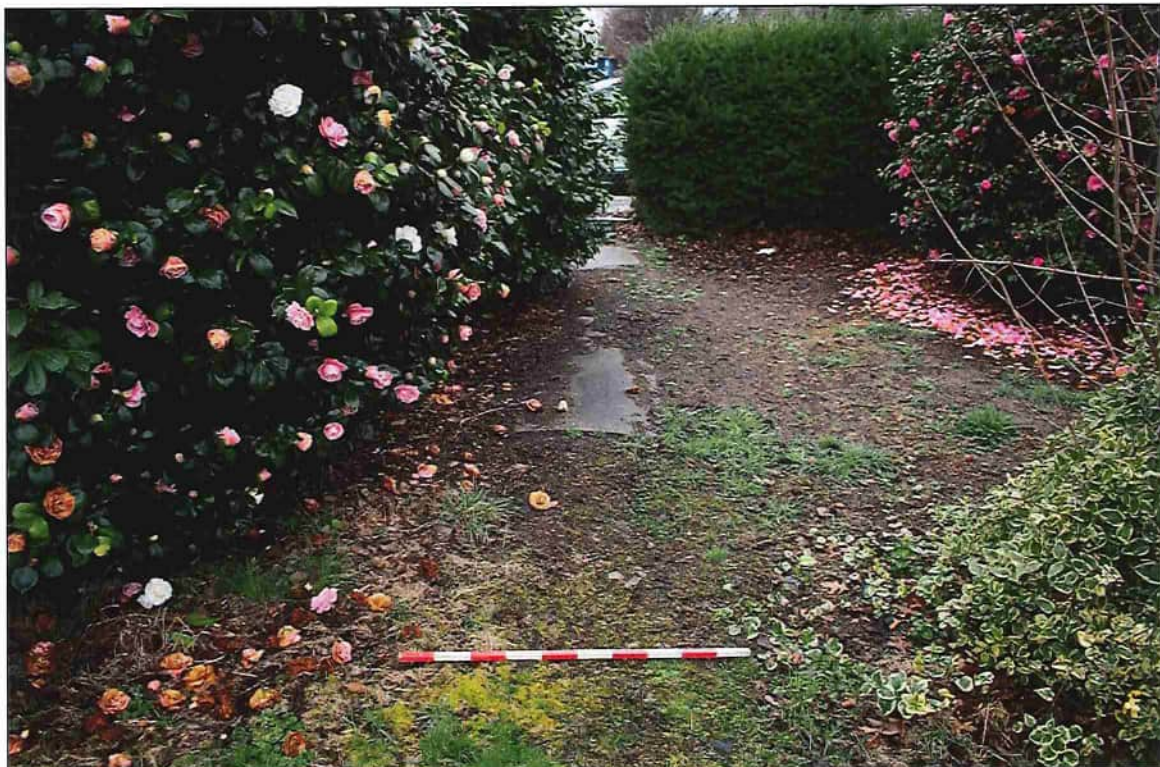
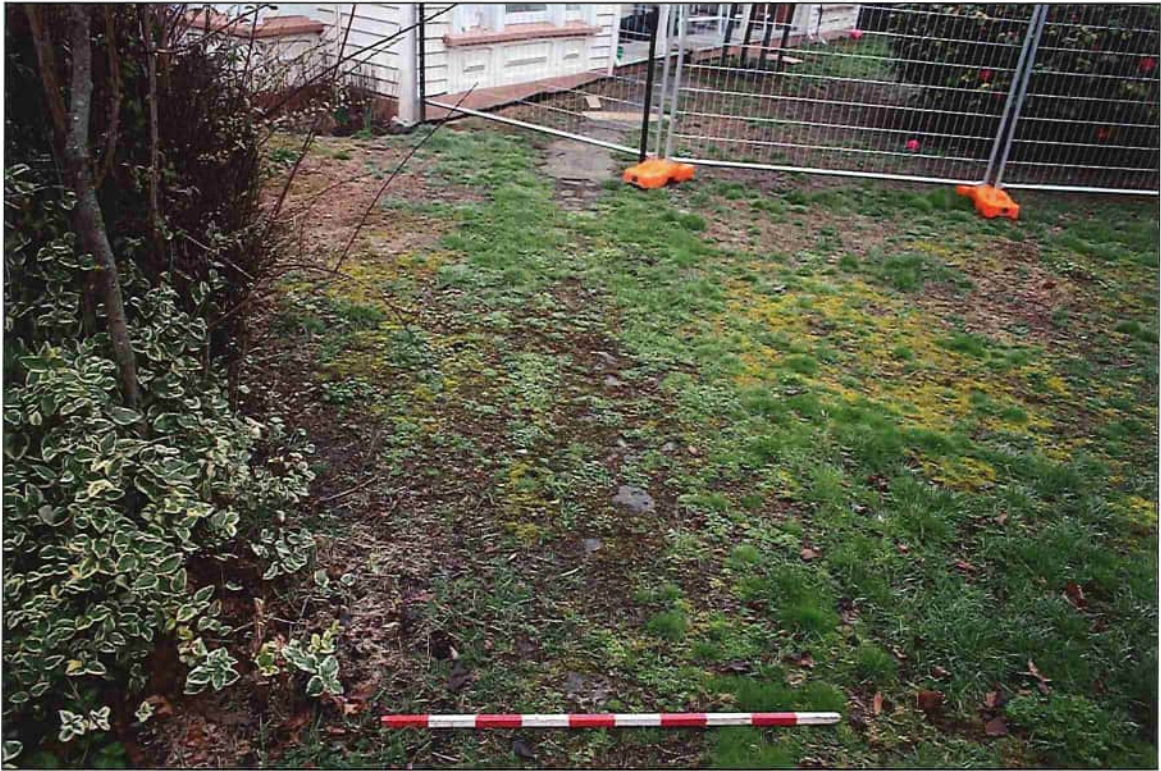
A concrete path is located northeast of the cottage, providing access from Wilkin Street to the front door (Figure 48). While no historical evidence could be found for when the concrete path was constructed, a path is visible in this area in the 1940s (refer to Figure 8), and the fabric of the concrete (which includes river rolled aggregates) is consistent with 19th or early 20th century manufacture. It is also probable that a path has always existed in this location as it is the closest point between the front door of the cottage and the road, potentially associating the path with the 19th century construction of the cottage. This concrete path should be considered an archaeological feature until proved otherwise.

Figure 48. Concrete paving, looking northeast towards Wilkin Street. Scale = 10 cm increments.

Figure 49. Concrete paving, looking southwest towards the cottage. Scale = 10 cm increments.

A concrete path observed running from the Wilkin Street property boundary to the front door of the 19th century cottage is interpreted as dating to the 19th or early 20th century. Whilst this path is located within Lot 4 and is not currently anticipated to be impacted by the proposed works, it should be considered an archaeological feature until proven otherwise and as such will be subject to archaeological recording if required.

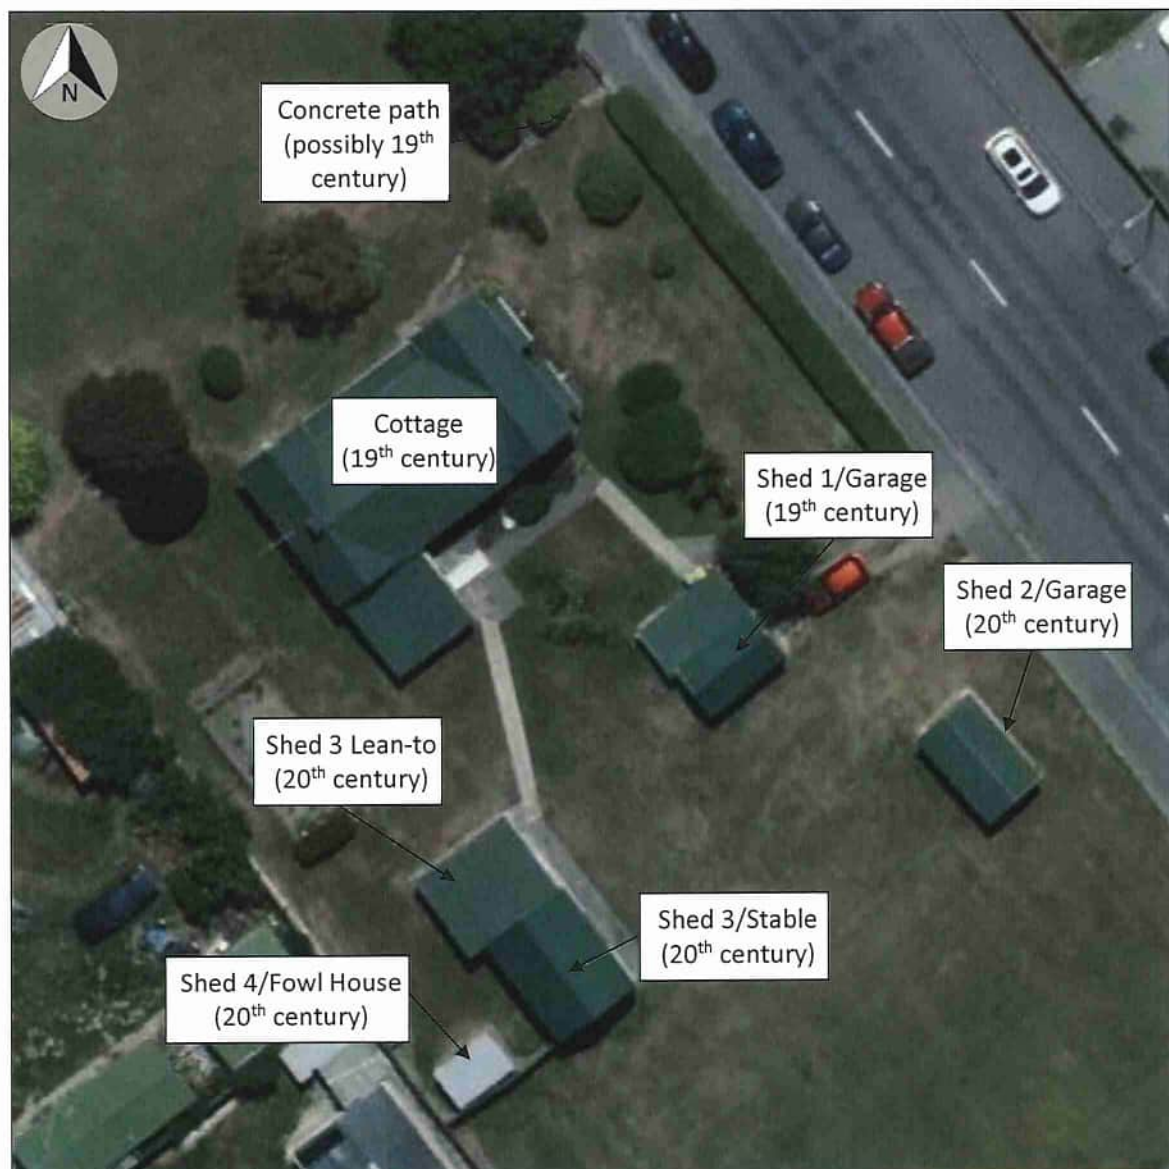
The archaeological site visit undertaken on the 22nd of August 2022 was intended to resolve the question posed in Kurmann (2022) relating to the age of the outbuildings present on the site. Of these buildings, only one (Shed 1/garage) was identified as being 19th century in age (Figure 53). This building is likely the “buggy shed” described as being on the property in 1896. An additional lean-to on Shed 1 dates to the 20th century. The remaining outbuildings were also identified as being 20th century. The 19th century cottage and potentially 19th century concrete path are not programmed to be impacted by the proposed works and therefore was not recorded or investigated in detail.

Figure 53. Interpreted ages of buildings at 4 Wilkin Street.

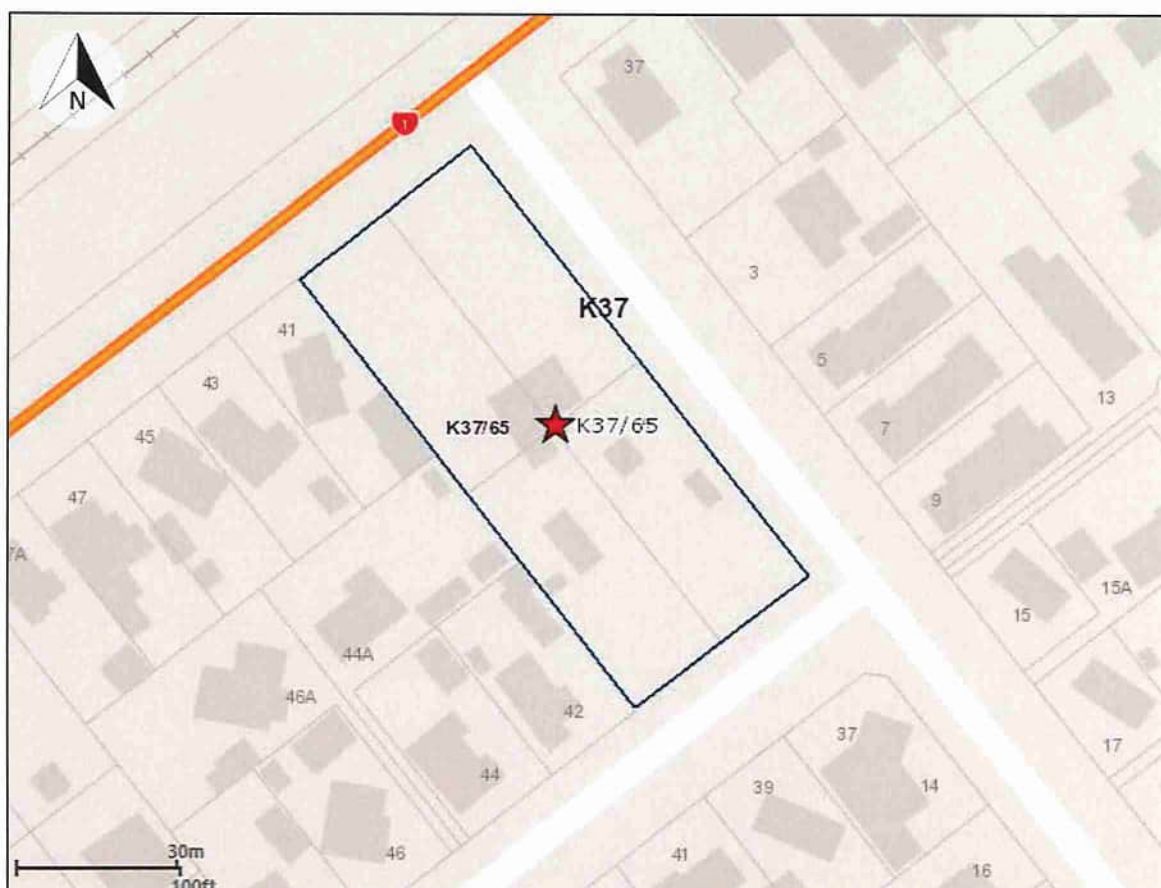
4 Wilkin Street has been recorded as archaeological site K37/65 as a result of this assessment (Figure 54).

Figure 54. Extent of archaeological site K37/65, recorded as a result of this assessment.
