Longbeach Estate Item N

Smokehouse / Bakery

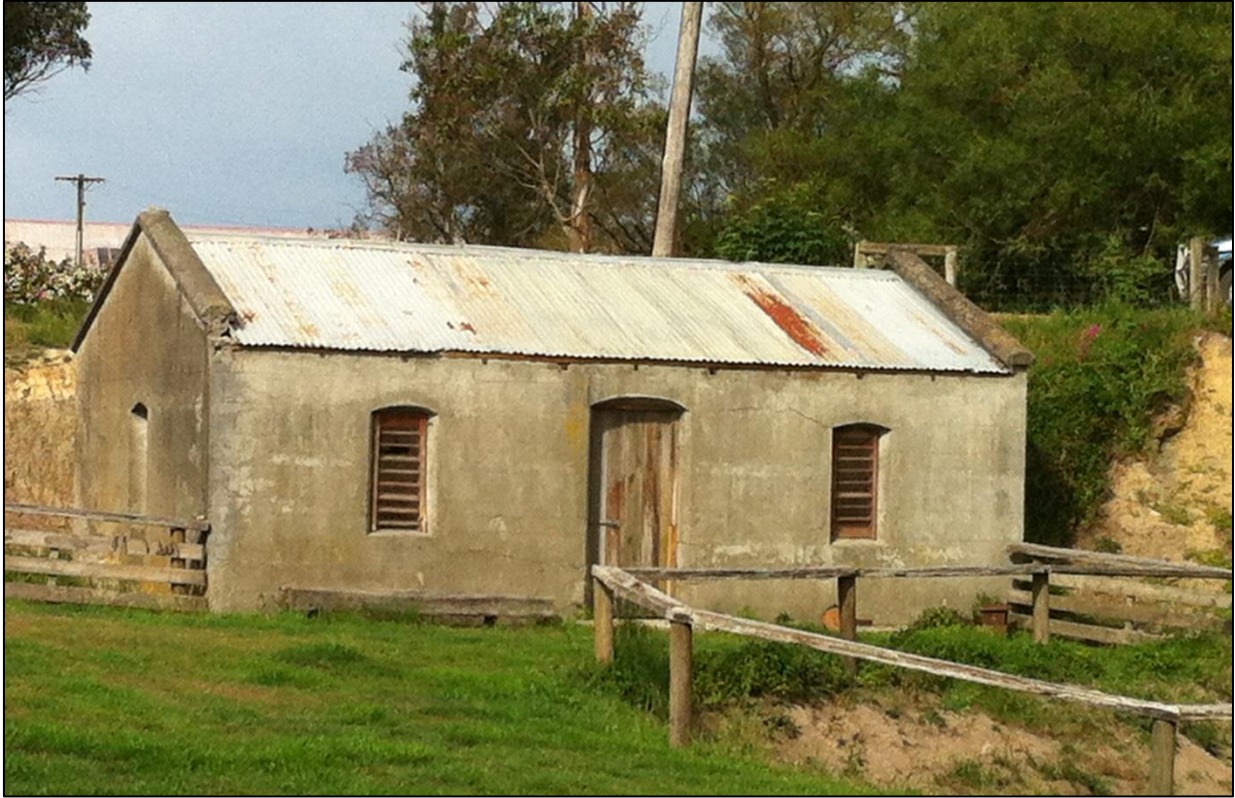
Detail	
Description:	<p>This is an attractive building tucked into the slope of the land to the rear of the flour mill. This former smokehouse/bakery is a small structure built of concrete 'block' rendered walls and a corrugated iron roof. It is possible that the roof was originally clad in other material but this is not established. Internally there is a concrete floor.</p> <p>There are two window openings to each side of the building (north-east and south-west) and one opening to the south-eastern gable. The window openings are not glazed but rather covered in mesh or wooden louvres. The window surrounds have a gradual moulded arch and deep splays, affording more light into the building and providing a very classical appearance to this small structure.</p> <p>There is one doorway on the north-eastern elevation with a timber door and arched and splayed surround similar to the widows. The exact date of construction is not known, but it is thought to be during the 1880's.</p>

Detail	
Notable features:	Concrete block construction; arched and spayed window and door surrounds; proportions; setting.
Condition:	The building is in relatively good condition. The roof is rusted but still intact and appears to be watertight. The render is cracked in many places and there are some small areas where it has chipped off. There are some small cracks in the brick arches above the doors and windows. The wooden door and louvers are weathered but intact. Internally intact and in good condition.
Setting:	This bakery is located in a hollow to the rear of the flour mill, next to the waterwheel. The building is not visible from the road and sits much lower than the track which runs to the south-west of the building. The setting is of high importance due to the building's relationship with the flour mill and other Estate buildings.
