Heritage Item 17

Staveley Lime Kiln – Christchurch Lime Company

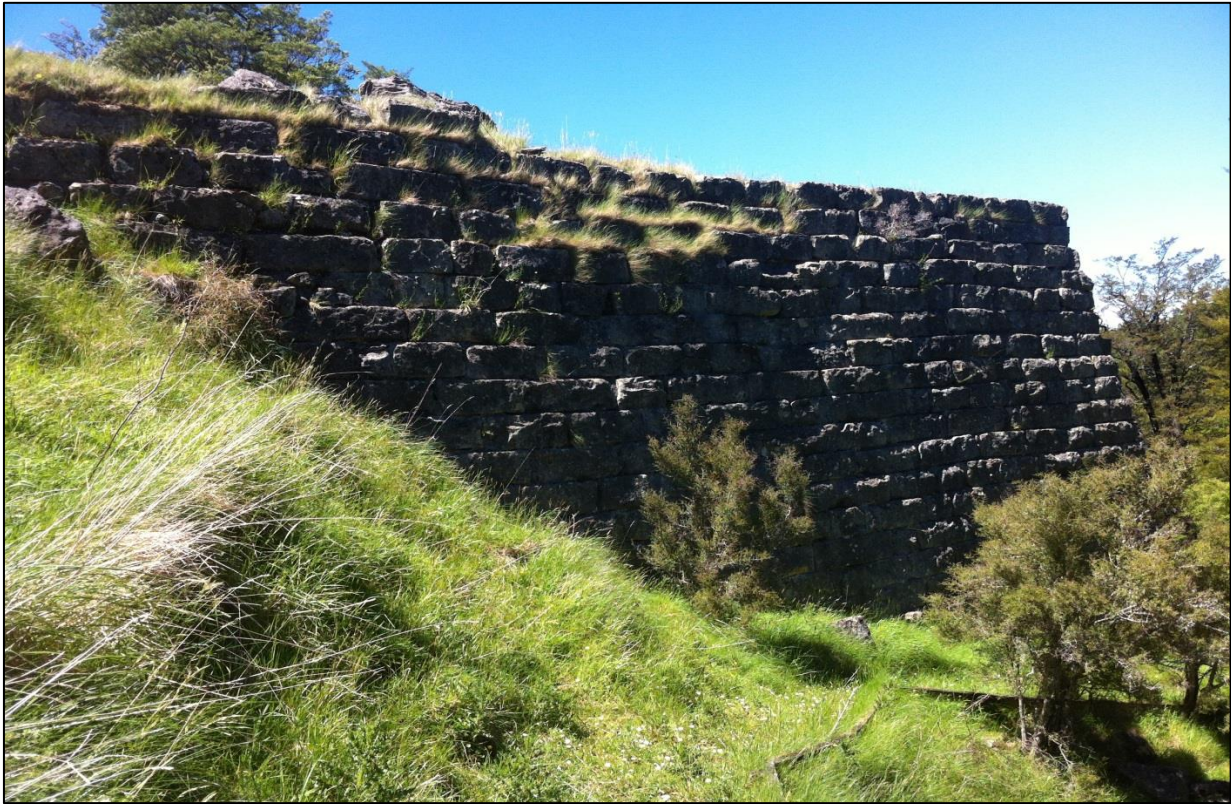
Detail	
Description:	<p>This was the second lime kiln built in the area and was constructed in 1904. It is built into the hillside on the edge of the beech forest just above a tranquil stream. The first kiln was the Langdown 'pot style' kiln constructed in 1897. Great variation exists over the historical details of these kilns – namely over which was built first, dates, names and the spelling of Langdown (often referred to as Langdon).</p> <p>In comparison to the cylindrical pot kiln, this is a chunkier structure built of large, quite regularly sized limestone blocks. The way in which the kiln is built out from the hill makes it appear quite organic, as if growing out of the side of the slope. The kiln is not particularly noticeable from above, other than the opening which is now covered by a metal grate. Metal straps are still evident down the sides of the limestone walls.</p> <p>The limestone for burning was supplied from a quarry close to the kiln. The method of firing was general to all the kilns - a layer of wood, usually manuka, was set at the bottom. Broken limestone and coal were then placed in alternate layers in the kilns until it was full. After the coal was ignited it took around a week of intense heat to burn the lime, the mixture was then allowed 48 hours to cool before being removed from the kiln by opening the hopper at the bottom and using iron shovels to dislodge the burnt lime. This was then bagged and transported by pony and waggon on the tramway.</p> <p>The burnt lime produced was used for agriculture. It may also have been used in the building industry for mortar, putty and whitewash.</p> <p>This kiln, along with the earlier Langdown Pot Kiln (heritage item H18) is an excellent historical example of an important industry in this region around the turn of the century.</p>

Detail	
Condition:	The kiln is mostly intact – the limestone walls appear stable with some having dislodged around the edges. A metal grate has been placed over the top entrance and over the exit the bottom of the hopper for safety purposes.
Setting:	The second kiln was built in this location as it was more accessible than the original pot kiln. The setting is of high importance as being part of the important industrial history of this region in the early 1900s.
