Heritage Item 18

Staveley Lime Kiln – Langdown Pot Kiln

Site Assessment

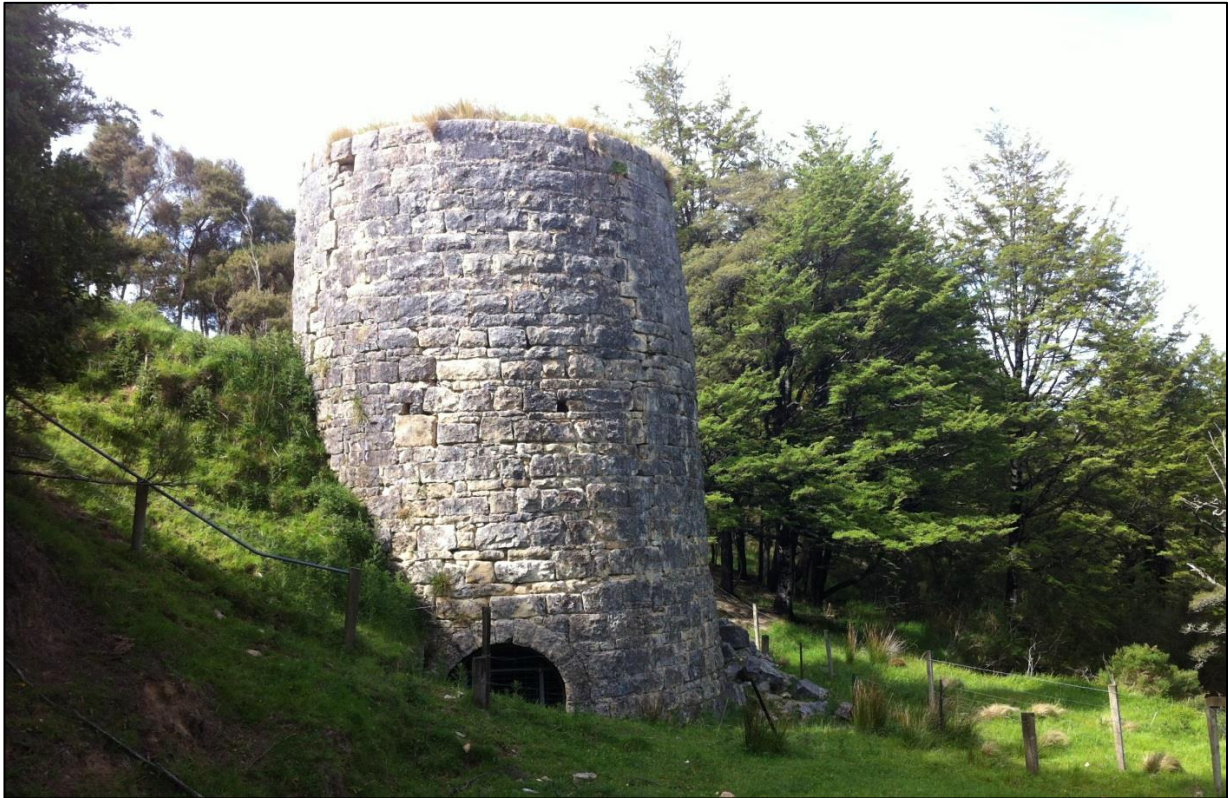
| Detail | |
|---|--|
| Description: | <p>The Langdown 'pot' kiln was constructed in 1897. It is a large, cylindrical structure built of limestone blocks of varying shapes and sizes. There are regular layers of reinforcing wires running around the kiln to provide additional strength and support. The keystone set in the archway of the tunnel has the number 189 (probably part of the date) and initials inscribed into it – although now very faint. Holes exist in the walls - these were used to control the draught when firing up the kiln. Fire bricks lined the interior of the kiln – the original firebricks which were probably made from clay on the site, were apparently unable to withstand the heat in the kiln and had to be replaced at some stage by more resistant firebricks from Brunner.</p> <p>A wooden tramway ran to the kiln, up to 40 feet above ground, allowing the wagons of coal or lime to pass over the top of the kiln. Coal was mined nearby to supply the kiln – this coal was pushed down a flume by a water race to a hopper where it was loaded onto wagons and taken to the kiln.</p> <p>The limestone for burning was supplied from a quarry about 100m east of the kiln (heritage item H132). The method of firing was general to all the kilns - a layer of wood, usually manuka, was set at the bottom. Broken limestone and coal were then placed in alternate layers in the kilns until it was full. After the coal was ignited it took around a week of intense heat to burn the lime, the mixture was then allowed 48 hours to cool before being removed from the kiln by opening the hopper at the bottom and using iron shovels to dislodge the burnt lime. This was then bagged and transported by pony and waggon on the tramway.</p> <p>The kiln sustained extensive damage during the earthquakes of 2010/2011 and has been closed to the public since. The top third (approximately) of the southern side of the kiln has been worst effected with all of the limestone blocks being dislodged. These still remain scattered around the base of the structure. On the remainder of the kiln, large cracks are evident and the whole structure appears to be quite unstable.</p> <p>This kiln, along with the later Christchurch Lime Company kiln (heritage item H17) is an excellent historical example of an important industry in this region prior around the turn of the century.</p> |

| Detail | |
|---|--|
| Condition: | The kiln is in a bad state of disrepair. Extensive damage was sustained during the 2010/2011 earthquakes which has left the kiln unstable. The limestone blocks on the top third of the southern side of the kiln have been dislodged and lie around the base of the structure. The kiln is currently closed to the public for safety reasons and will require extensive reconstruction or stabilisation to be in a position to be reopened. |
