INFRASTRUCTURE SERVICING REPORT

TM30625 / Farm Road, Ashburton /
CONISTON PARK LIMITED

Title: Infrastructure Servicing Report

Client: Coniston Park Limited

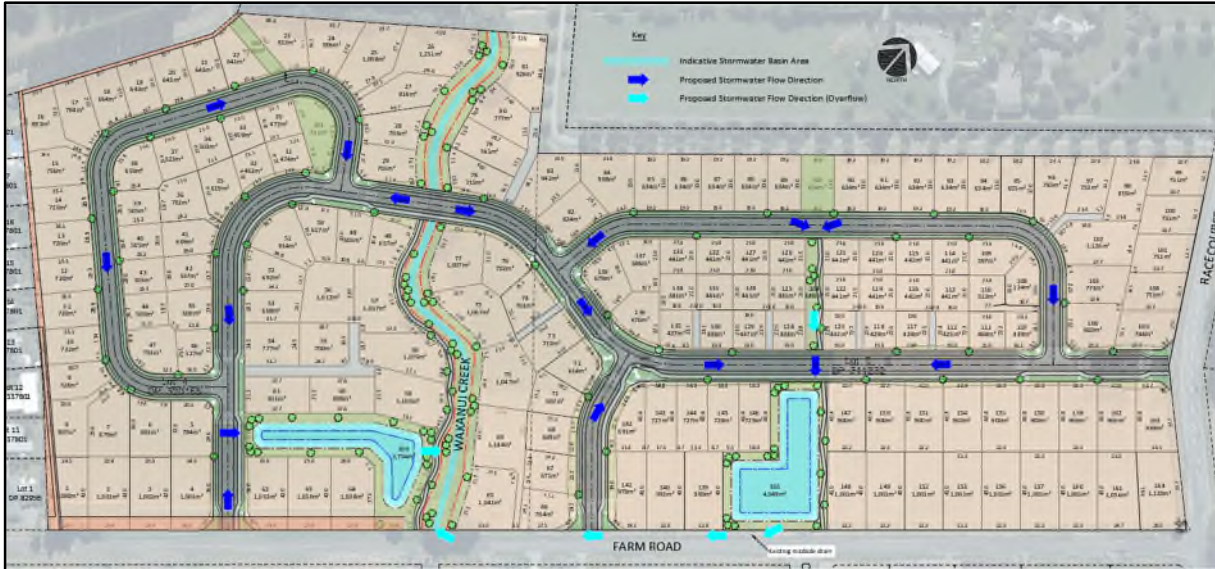
For events greater than the stormwater reticulation design event, excess surface runoff within the site will be conveyed within the road carriageway via road carriageway and swales to the soakage basin. Within this period, the soakage basin will be full and any excess stormwater will overflow to Wakanui Creek. The secondary flow path is shown in dark and light blue arrows as shown in Figure 25.

Figure 25: Stormwater Secondary Flow Path

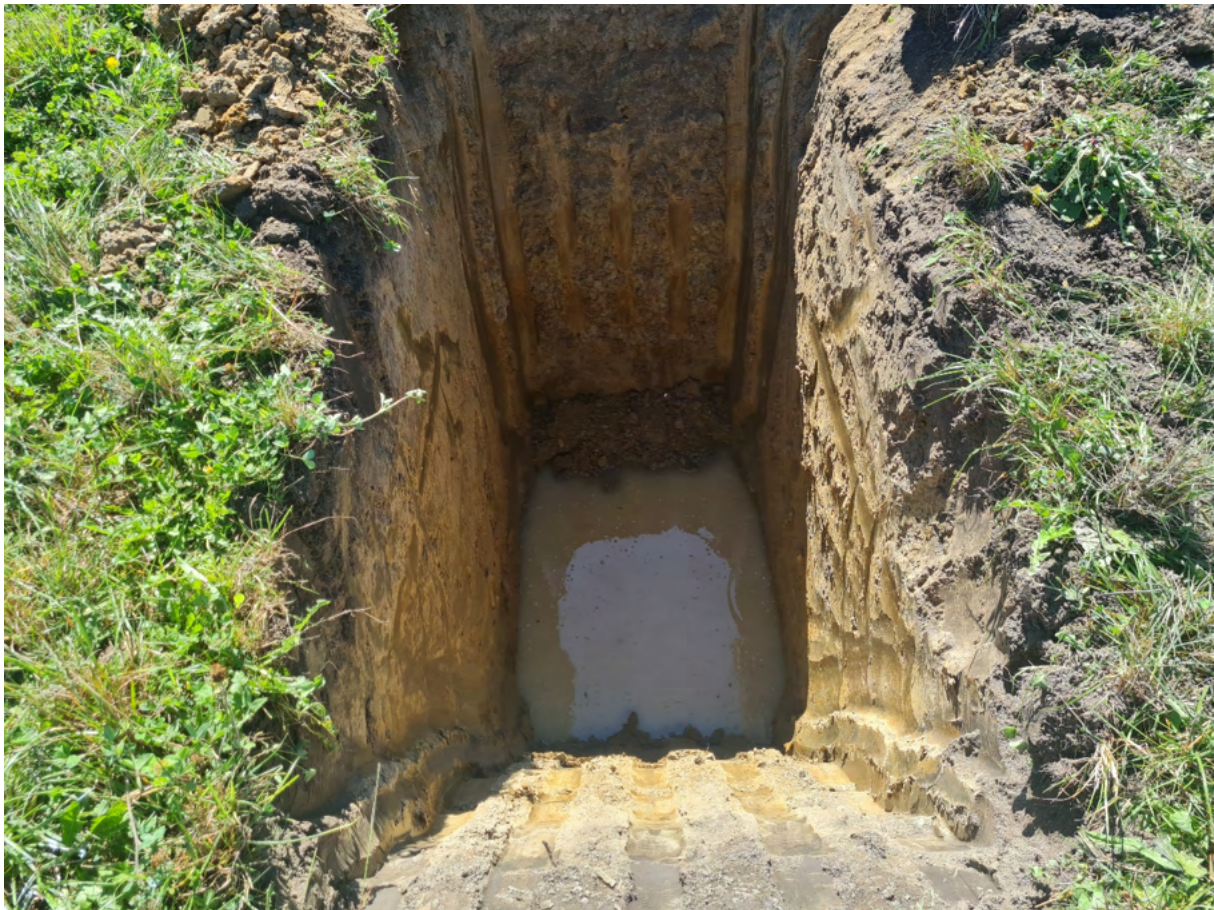
Photo - Test Pit 02

Groundwater depth in the pit: TBC

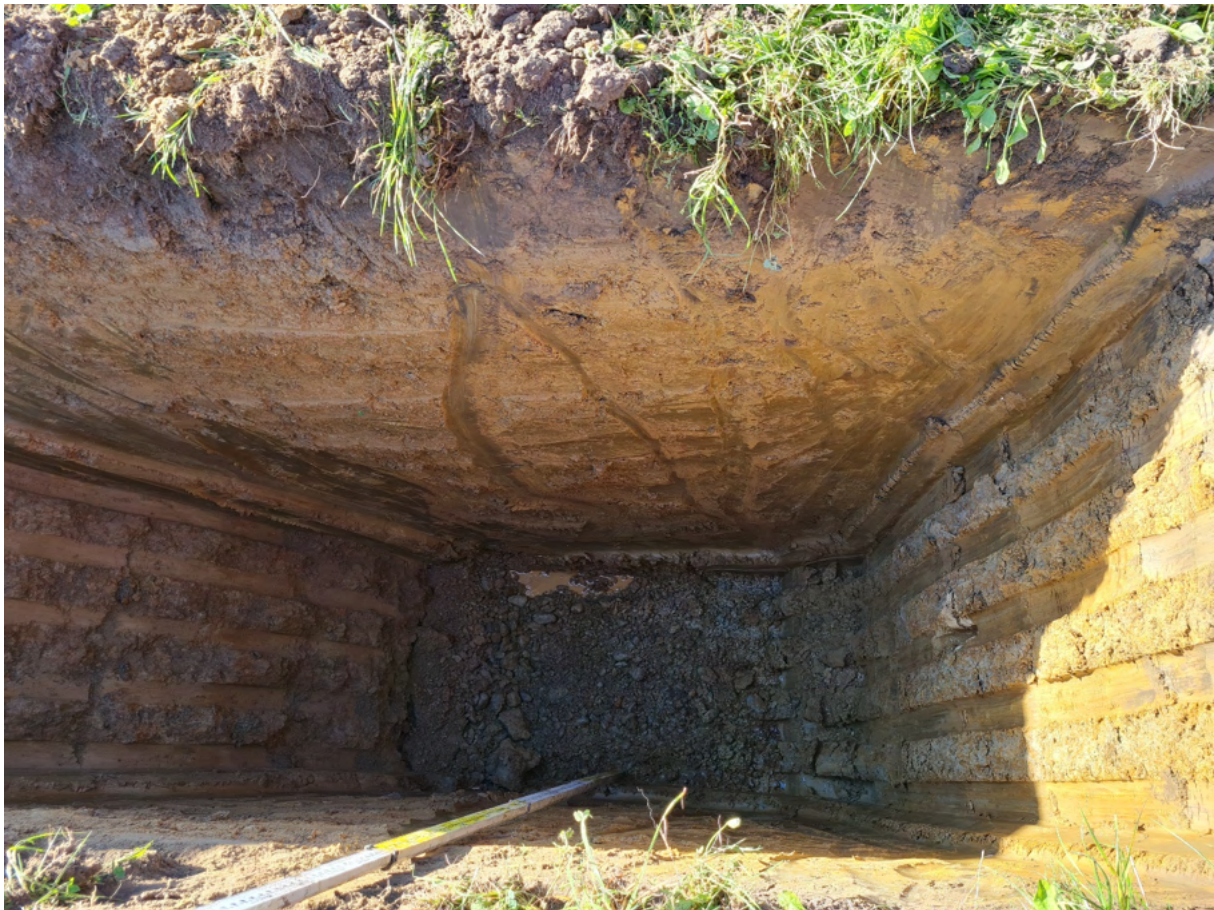
Photo – Test Pit 06

Groundwater depth in the pit: 100mm

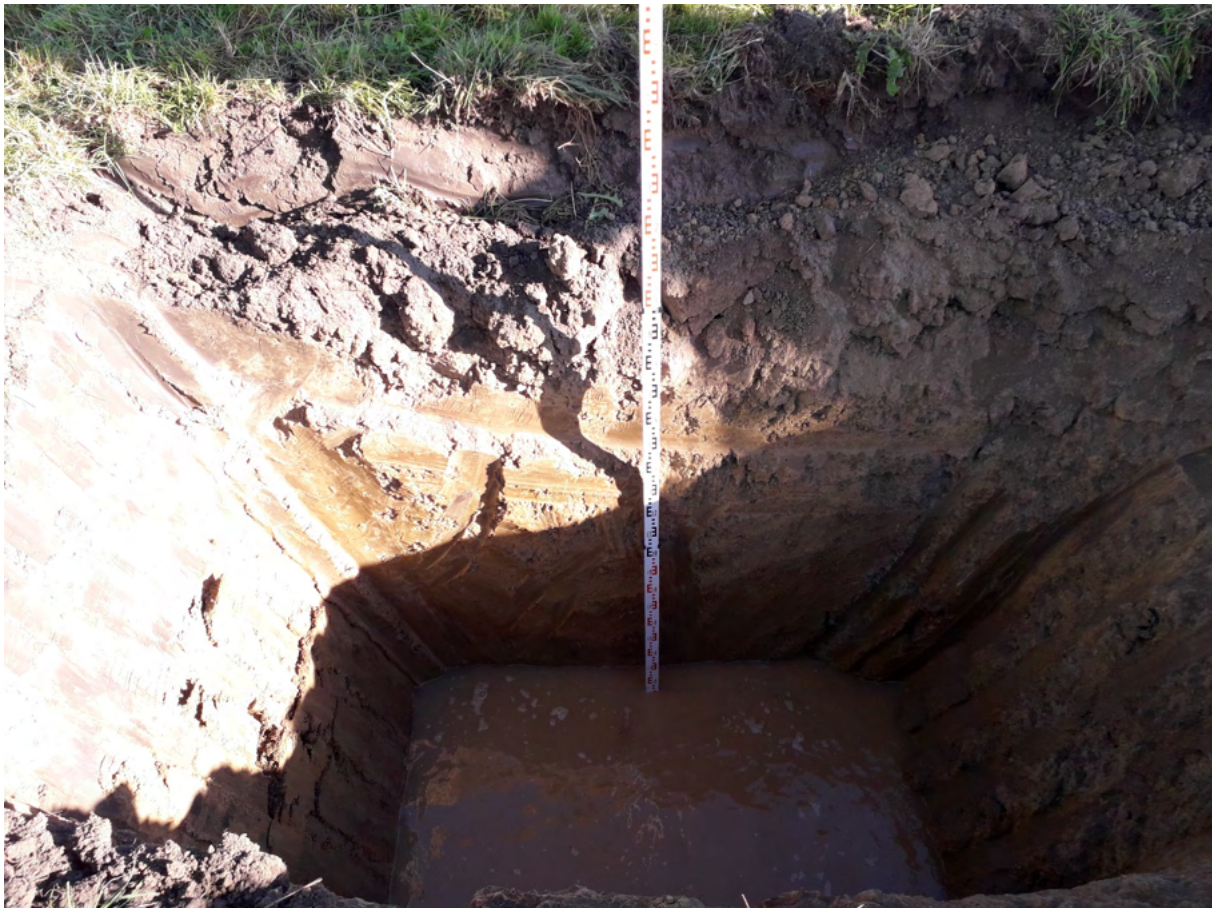
Photo – Soakage Test Pit 2

Groundwater depth in the pit: 1600mm

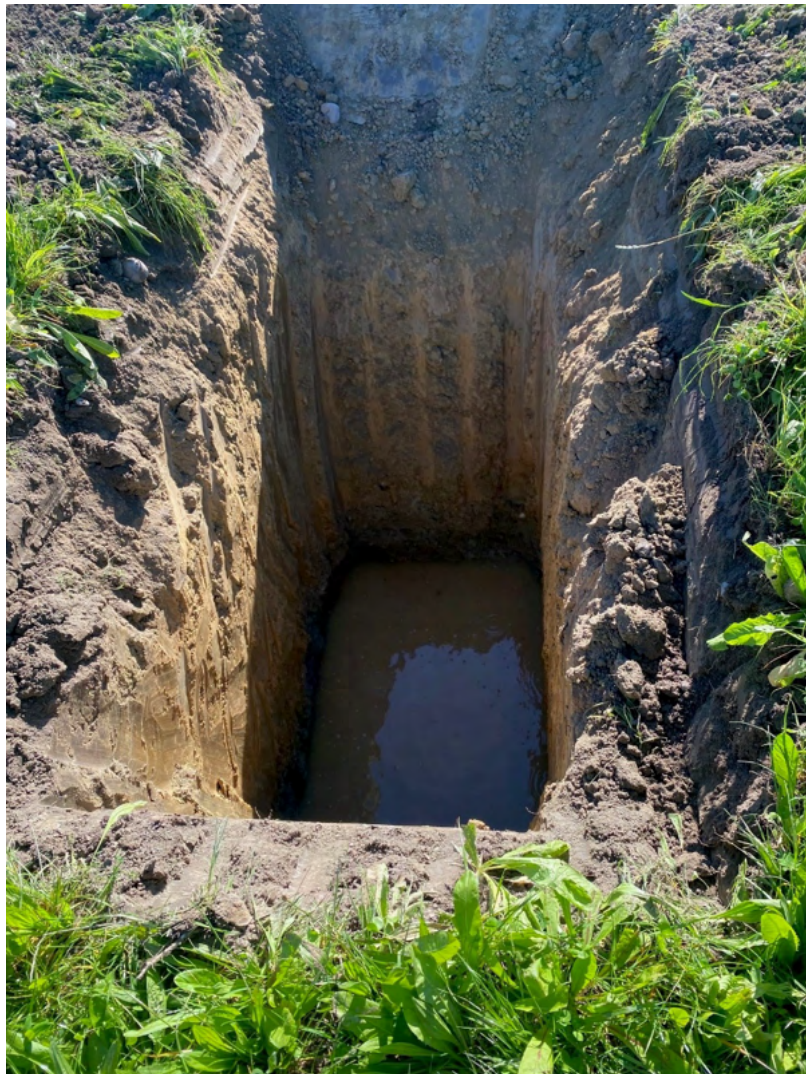
Photo – Soakage Test Pit 7

Groundwater depth in the pit: 650mm

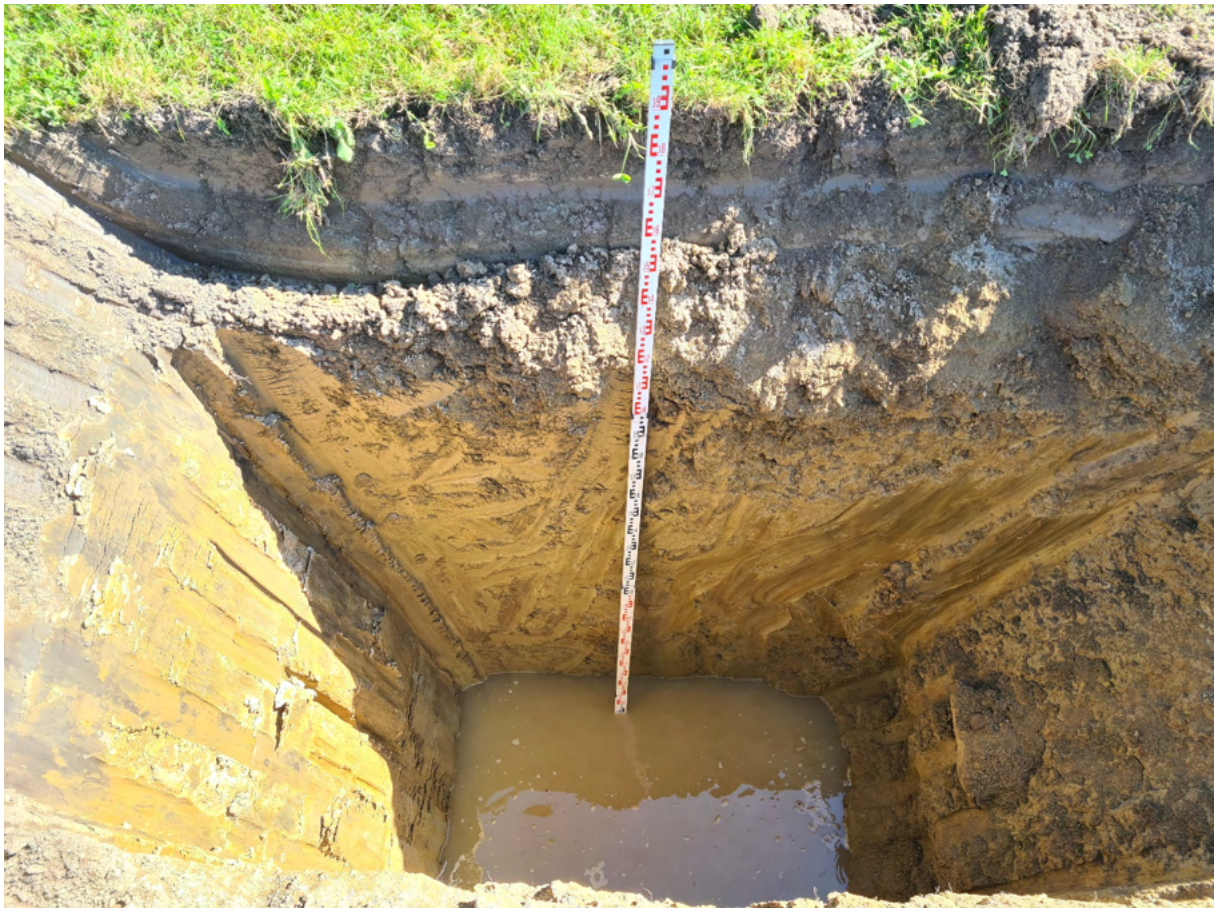
Photo – Soakage Test Pit 8

Groundwater depth in the pit: 900mm
