43 to 47 Allens Road, Allenton, Ashburton

Geotechnical Design Report

Prepared for Kāinga Ora Prepared by Beca Limited

18 April 2023

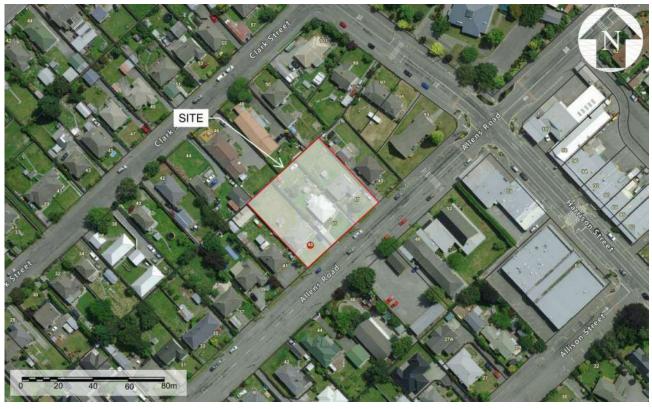
Figure 2-1:Site Location Plan.

The house development site is located in Allenton at 43 to 47 Allens Road in the north of Ashburton. The site is being uplifted from three houses to nine houses on a plot covering an area of 2170 m² and has predominantly flat topography. The site is 0.7 km from the nearest waterway Wakanui Creek to the northeast. The site location and basic details of the proposed development are presented in Figure 2-1.

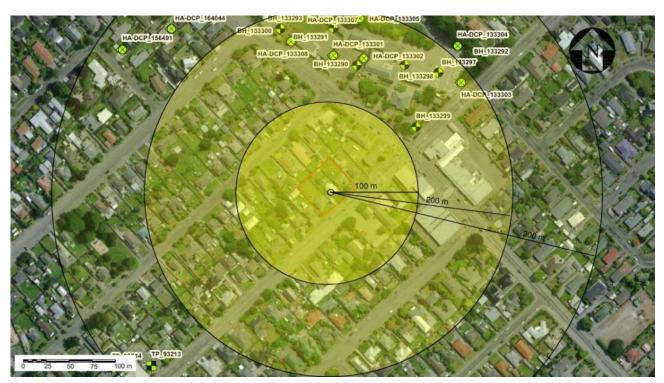
Figure 4-1: Ground Investigation data within 600m of the site (New Zealand Geotechnical Database (NZGD), 2023).

- There is existing geotechnical data within 100 m of the site. This information showed the site is likely underlain by interbedded loose to dense sand and soft to very stiff silt underlain by dense gravels from depths of approximately 0.8 m to 5.3 m bgl. This indicates that there is a risk of liquefaction in the area.

Groundwater well bore logs, K37/0775 and K37/3129 (New Zealand Government, 2023) 500 to 600 m from site, indicates that gravel extends to at least 30 m depth. Borehole data from BH_133290 (New Zealand Geotechnical Database (NZGD), 2023), approximately 100 m from site, show sandy gravel extending to the base of the borehole, 1.4 m bgl, which is similar to what we found on site.

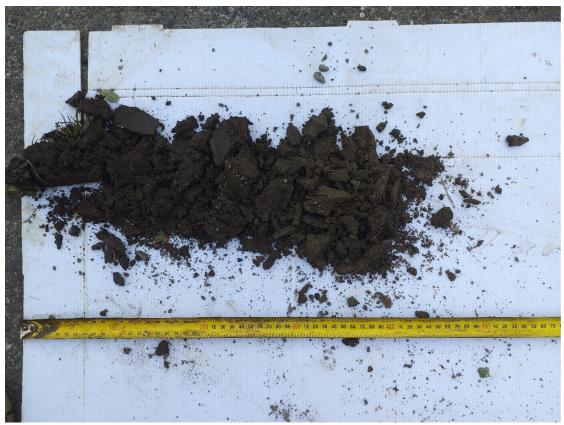
Box 1 - 0.00mbgl to 0.40mbgl

Location: Front yard, south eastern corner. Coordinate system: NZTM2000 Vertical datum:

Coordinate system:NZTM2000Vertical datum:LVDNorthing:5139884.5Ground level (mRL):108.55Easting:1498867.5Location method:Survey

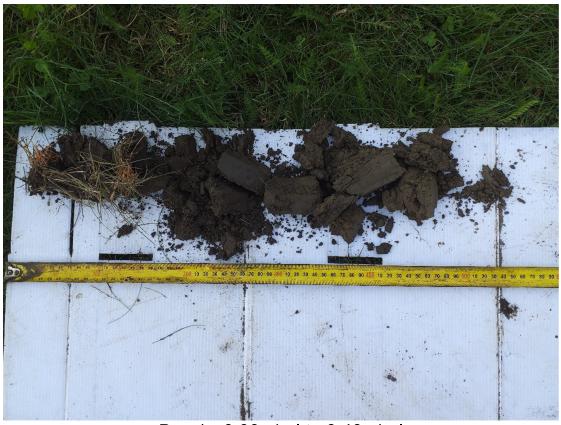
Box 1 - 0.00mbgl to 0.40mbgl

Location:Back yard, north western cornerCoordinate system:NZTM2000Vertical datum:LVDNorthing:5139899.6Ground level (mRL):108.69Easting:1498843.6Location method:Survey

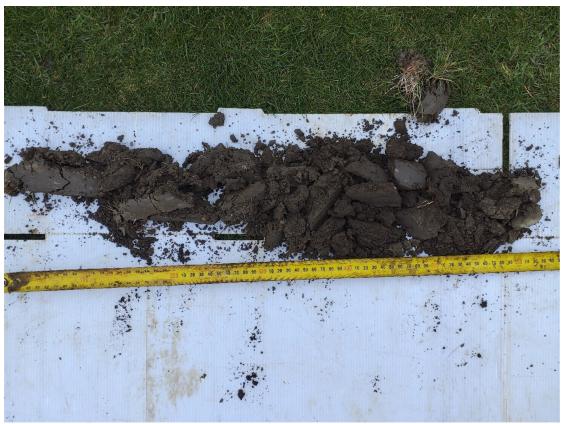
Box 1 - 0.00mbgl to 0.55mbgl

Location:Front yard, south eastern side.Coordinate system:NZTM2000Vertical datum:LVDNorthing:5139886.7Ground level (mRL):108.69Easting:1498877.5Location method:Survey

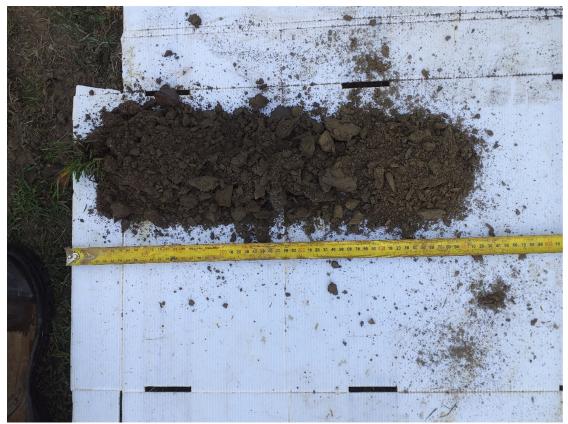
Box 1 - 0.00mbgl to 0.45mbgl

Location:Back yard, western side.Coordinate system:NZTM2000Vertical datum:LVDNorthing:5139903.0Ground level (mRL):108.72Easting:1498889.5Location method:Survey

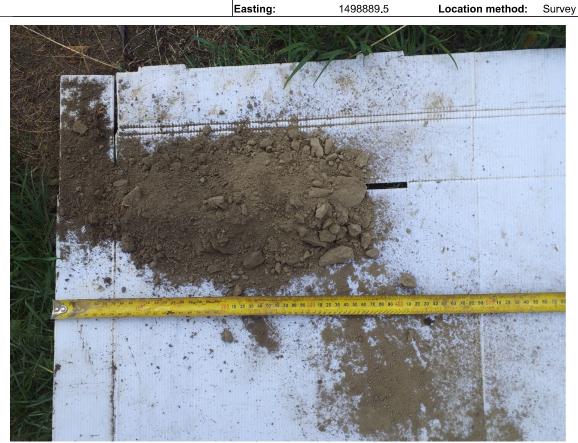
Box 1 - 0.00mbgl to 0.35mbgl

Location:Front yard, south eastern side.Coordinate system:NZTM2000Vertical datum:LVDNorthing:5139905.9Ground level (mRL):108.61

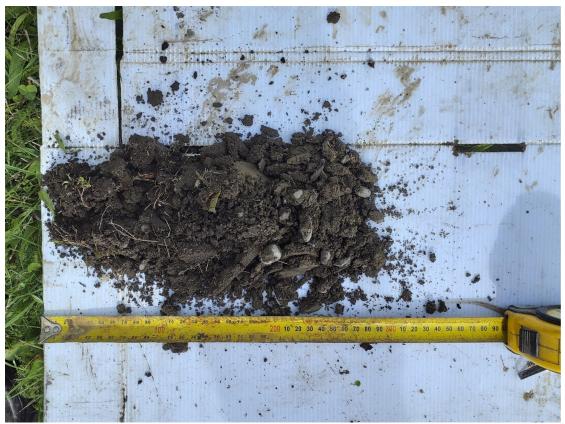
Box 1 - 0.00mbgl to 0.25mbgl

Location:Back yard, northern corner.Coordinate system:NZTM2000Vertical datum:LVDNorthing:5139921.7Ground level (mRL):108.74Easting:1498875.3Location method:Survey
