**Work Instruction**

**6-10 Orr Street, Ashburton**

**Prepared for**  
Kāinga Ora Homes and Communities  
**Prepared by**  
Tonkin & Taylor Ltd

**Date**  
April 2024  
**Job Number**  
1018898.2000 v1

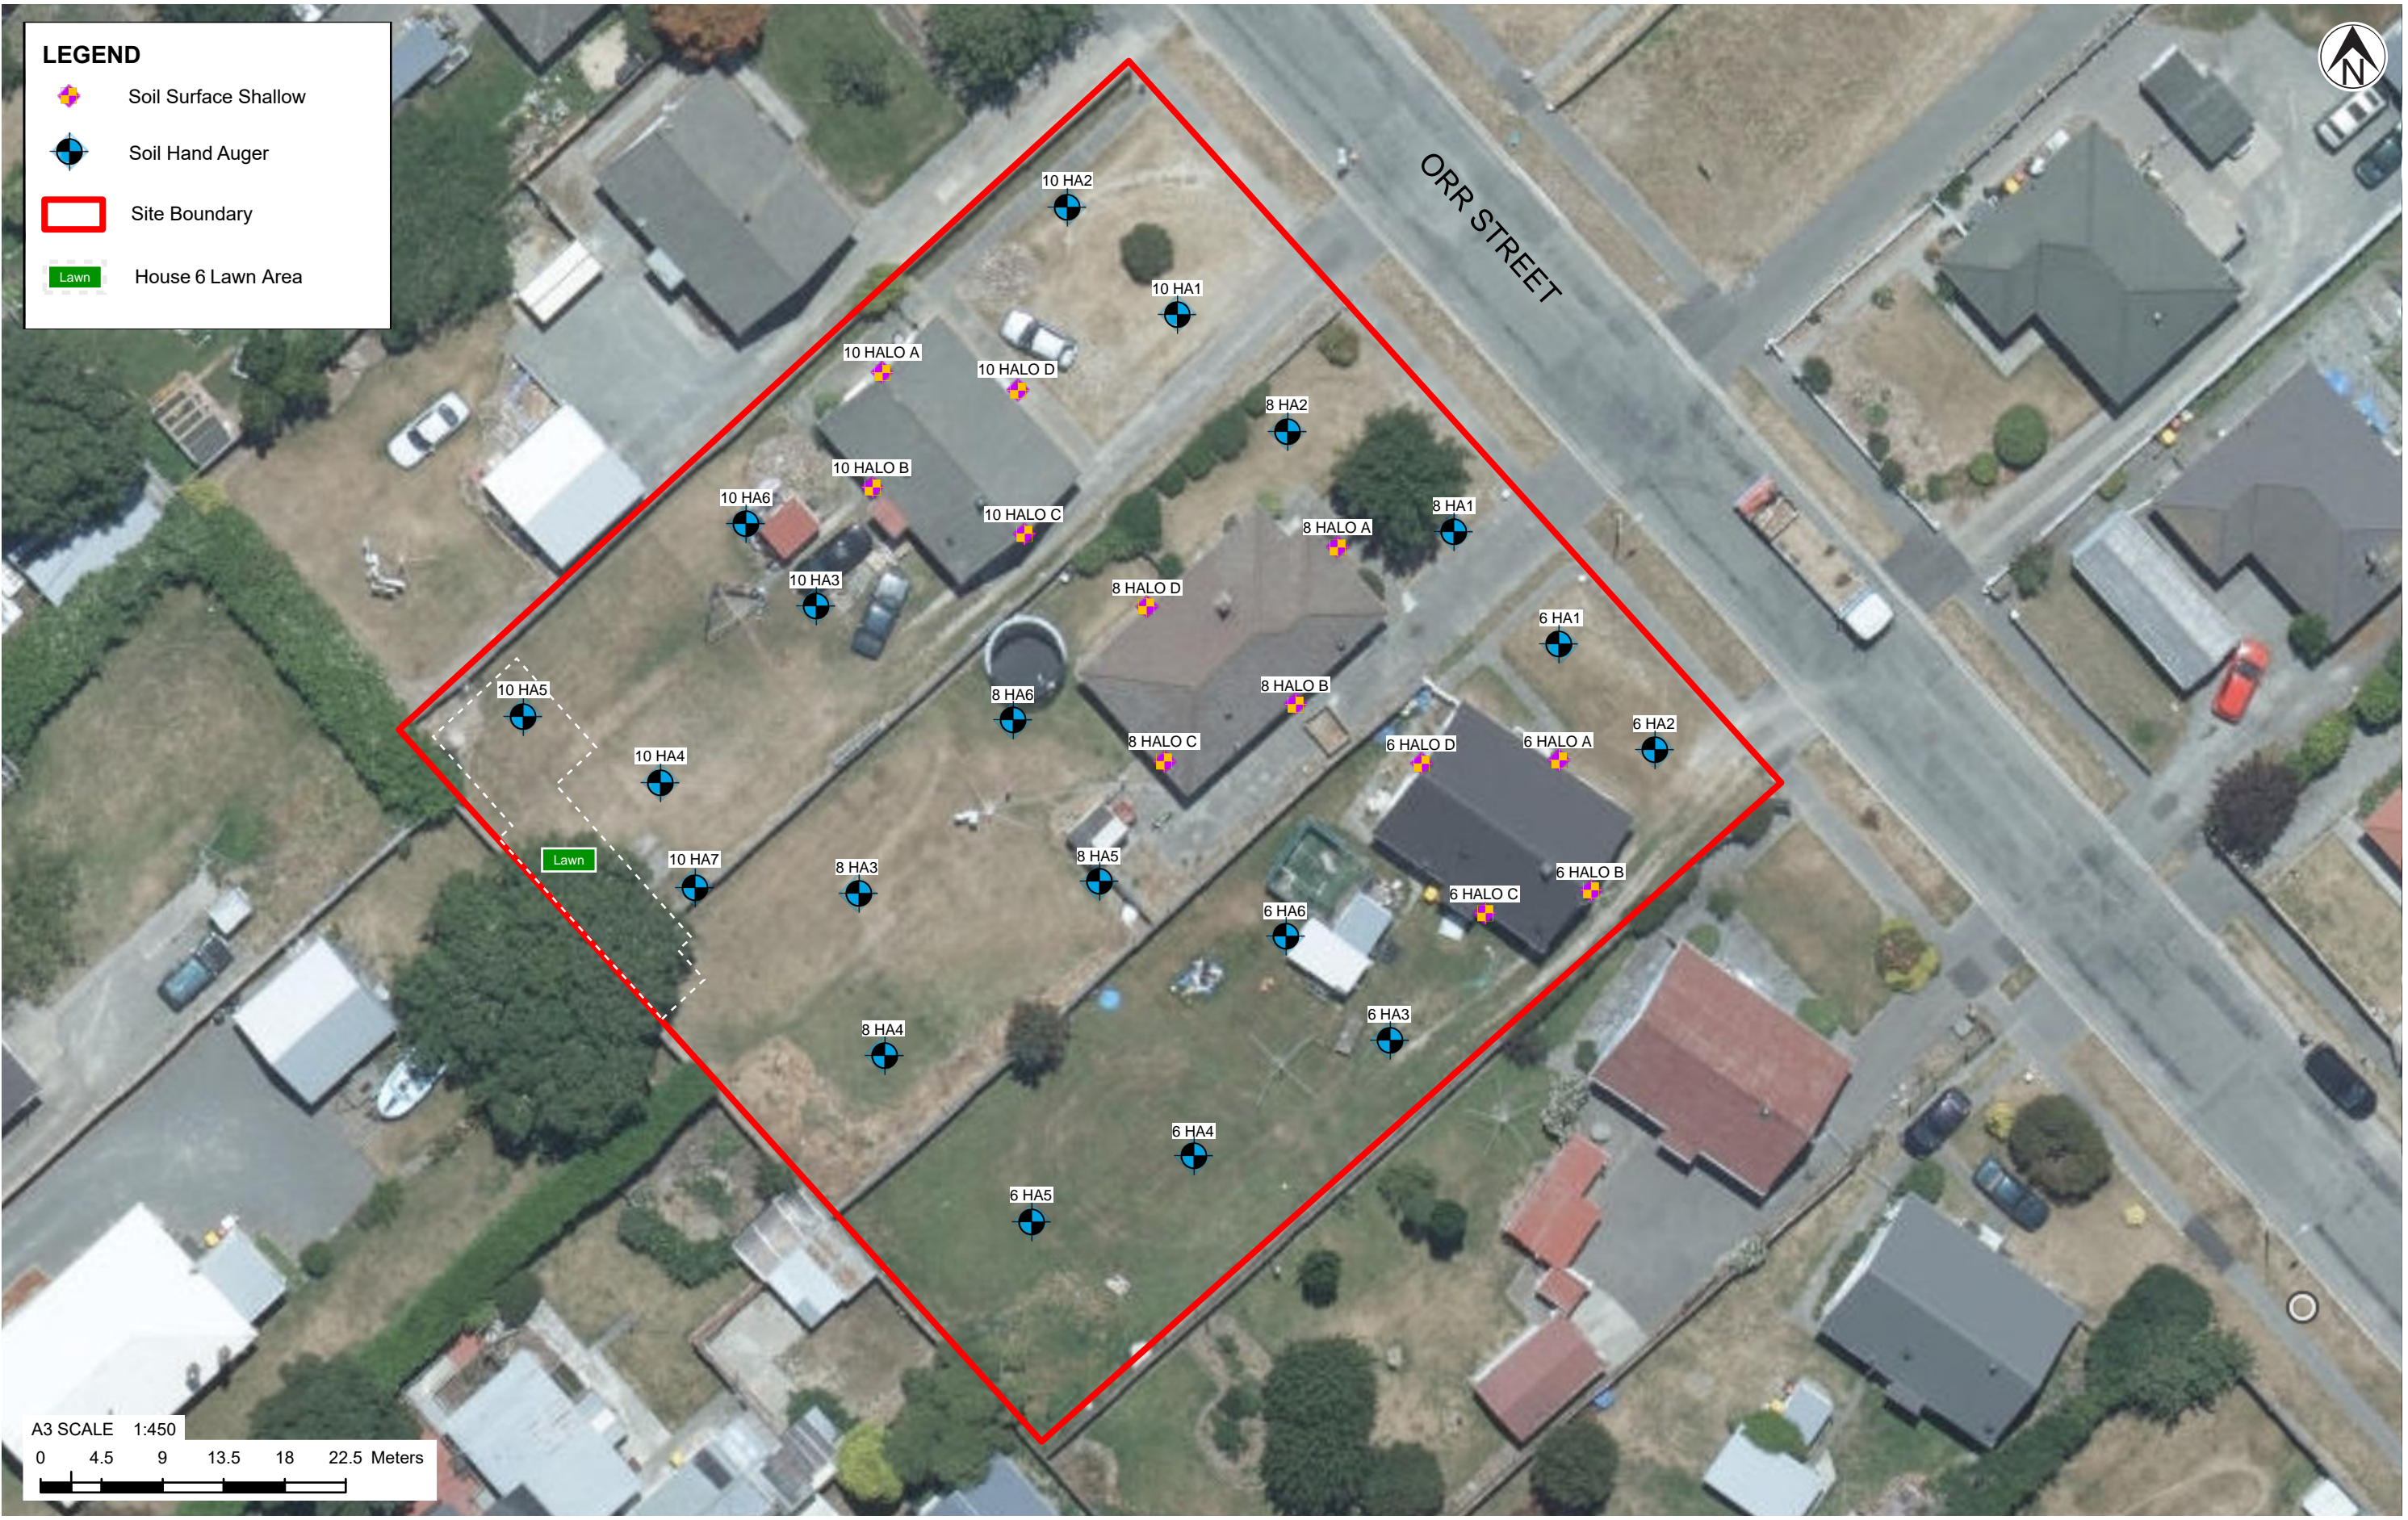
- **Figure 1: Ground Contamination Investigation Plan.**
- **Figure 2: Soil disposal 0.0 – 0.3 m bgl.**
- **Figure 3: Soil disposal >0.3 m bgl.**

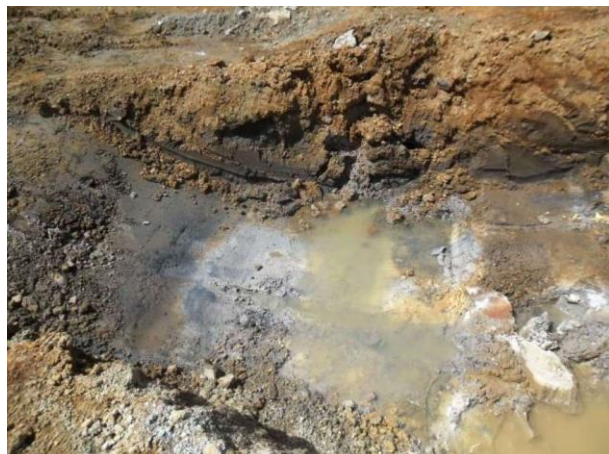
## 5.2 HEAVY METALS

- Metal workshop
- Metallisation works
- Electroplating industries
- Timber treatment facilities

Heavy metal-contaminated soil can be placed in a truck and covered with tarpaulin for disposal at a facility authorised to receive material of that kind.

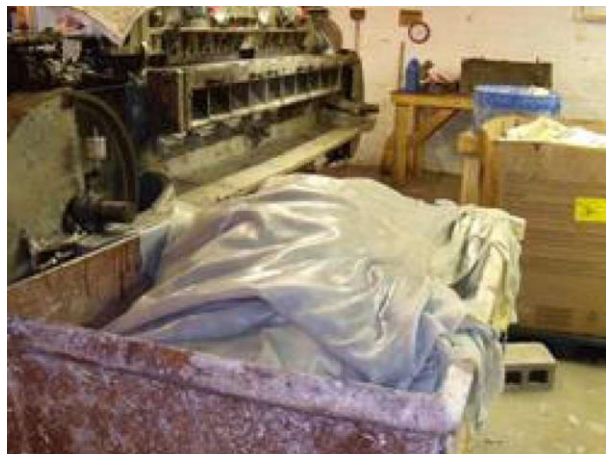
## 5.4 TANNERY/ LEATHER PROCESSING

- Leather manufacture/ treating facility

Pooled liquid spills can be removed by using tailor-designed absorbent materials and via tanker or pump. Contaminated soil can be placed in a sealed skip bin or covered truck for disposal at a facility authorised to receive material of that kind.

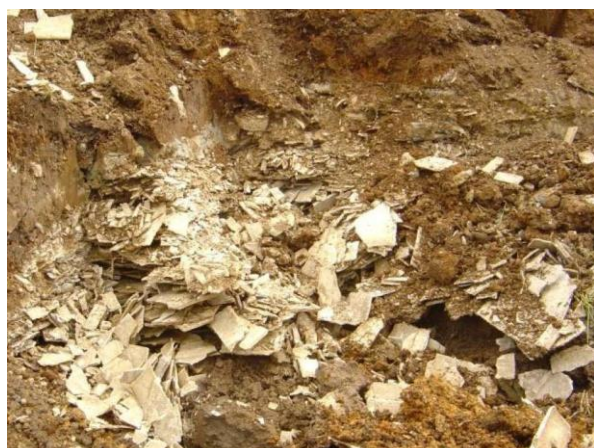
## 5.5 ASBESTOS

- Improper disposal of asbestos-containing building materials

KEEP DAMP to suppress fibre generation. Large fragments may be collected by hand and place in double skinned plastic bags. Asbestos-contaminated soil can be placed in a sealed skip bin for disposal at a facility authorised to receive material of that kind. Soil of this kind can also be transported via sealed doubled bags or a sealed skip bin.
