7 – 15 Church Street (Ashburton)

Geotechnical Design Report

Prepared for Kāinga Ora Prepared by Beca Limited

7 August 2023

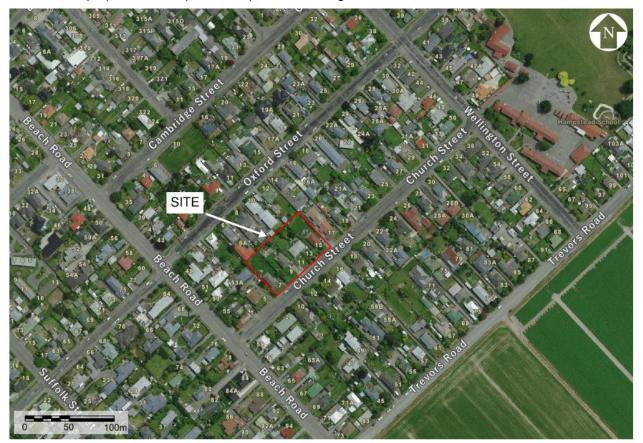
Figure 2-1:Site Location Plan.

The house development site is located in Hampstead on 5 - 15 Church Street to the southeast of the Ashburton CBD. The site is being uplifted from five houses to 15 on a plot covering an area of 4038 m² and has predominantly flat topography. The site is 0.4 km from the nearest waterway which is unnamed and heavily modified to the east. The site is 0.9 km northeast of the Ashburton River. The site location and basic details of the proposed development are presented in Figure 2-1.

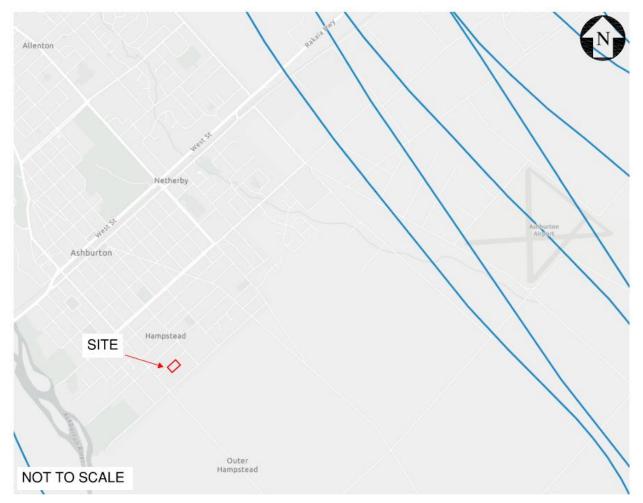
Figure 5-1: Groundwater contour map sourced from Canterbury maps (2018)

The depth to groundwater within the CPTs and hand augers was checked with dip meters following completion of the activity. Groundwater was not encountered or observed in any of the site-specific investigations conducted for this project.

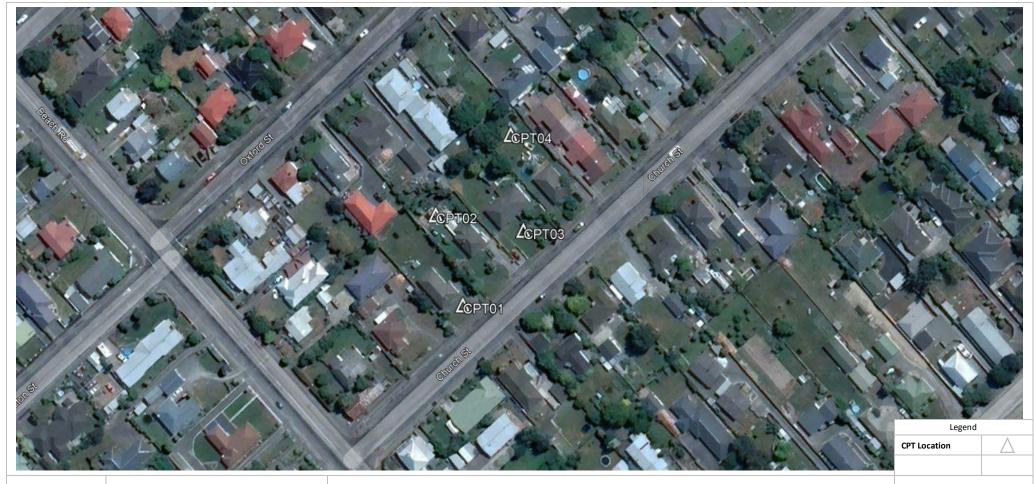
LOCATION PLAN

Piezocone Penetration Testing – 7 – 15 Church Street, Ashburton – 12th July 2023

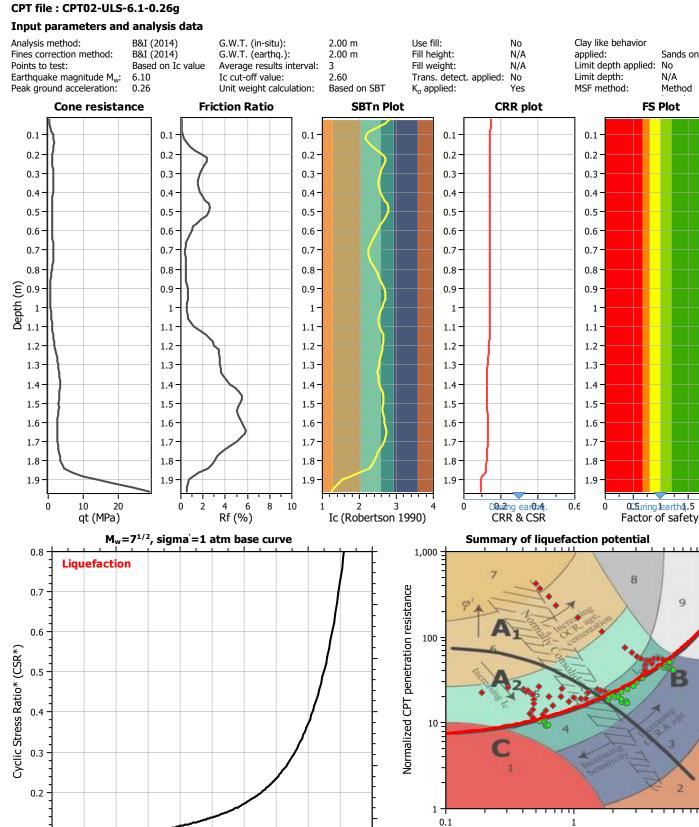
10 Normalized friction ratio (%) Zone A₁: Cyclic liquefaction likely depending on size and duration of cyclic loading Zone A₂: Cyclic liquefaction and strength loss likely depending on loading and ground geometry
