### Willowby Water Race Diversion

#### Proposal

Appendix I. Photographs mentioned in the text.

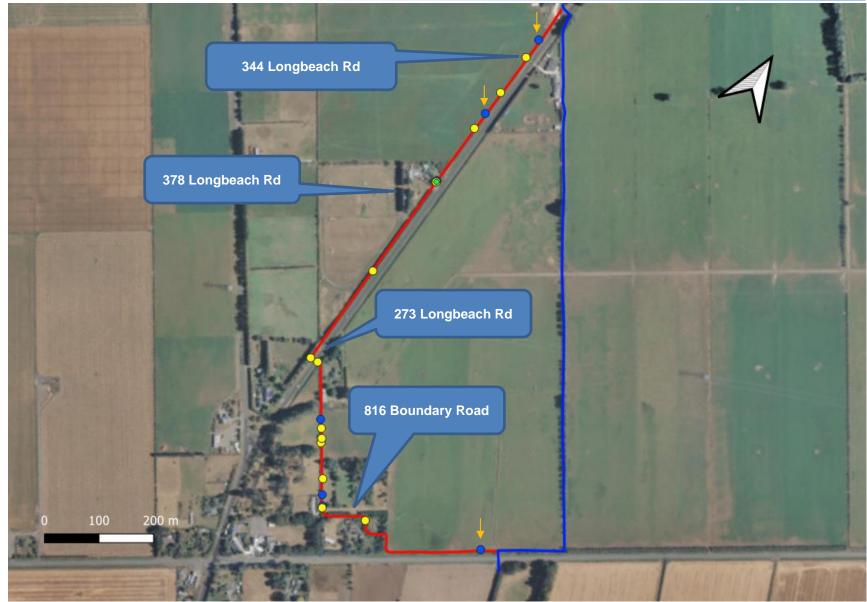
Figure 1. Showing the current path of the Willowby Water Race (red line), and the alternative water race route (blue line). Areas surveyed using GM traps are marked in blue, electric fishing sites are marked in yellow, and the site of invertebrate sample is marked in green. Orange arrows mark the sites where upland bullies were identified.

The relevant reach of Willowby Water Race traverses four properties (344, 378, & 273 Longbeach Road, 816 Boundary Road, Fig. 1). The substrate in this reach varies between hard clay and soft sediment. The upper section, at 344 Longbeach Road, flows through a potential stock paddock but is unfenced. Both banks have been sprayed with herbicide (App. I, Fig. a). Patches of macrophytic growth were present, however no native macrophytes were found. Downstream of this section, a short reach of the Water Race flows through 378 Longbeach Road. This approximately 50 m reach is not sprayed and displays an abundance of watercress and monkey musk (App. I, Fig. b). The Water Race then flows southwest alongside Longbeach Road for 380 m. At the time of survey, this section appeared to have been recently dredged of all macrophytes, resulting in a hard clay stream bed with no instream cover (App. I, Figs. c, d). After crossing Longbeach Road through a culvert, the stream flows south through the 273 Longbeach Road and 816 Boundary Road properties. Most of this downstream section consists of a deep channel and soft sediment, with an approximately 1 m wide fenced riparian section on the true left bank and a hedge on the true right bank (App. I, Fig. e). Part of this section, in the 816 Boundary Road property, has native instream and riparian planting (Carex, Juncus and harakeke) and a cobble bed (App. I, Fig. f). The planted section is approximately 40 m in length, however patches of native plants such as Carex and raupo continue for approximately 100 m (App. I, Fig. g) before returning to a deep channel with soft sediment. A slight backflow was present where the Willowby Water Race re-joins the alternative water race at the Boundary Road culvert.

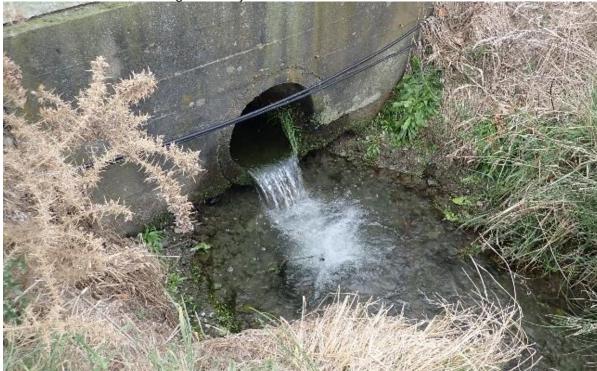
Figure k. Perched culvert across Boundary Road, at the downstream limit of ecological survey.

As an aside, native riparian planting will enhance the visual appeal of the New Willowby Water Race, and enhance the instream ecology, especially in respect to aquatic macroinvertebrates. The Boundary Road culvert will minimise any ecological enhancement of New Willowby Water Race Based, and based on the Google StreetView photo (vicinity of 779 Boundary Road) New Willowby Water Race may have its own perched outlet at the confluence with Boundary Road Water Race.

Ecological values in the Willowby Water Race are low, with particularly low stream health scores. The ephemeral nature of the flow, the presence of perched culverts, and bank spraying are probably major reasons for the low health score. The fishing effort was of an intensity that we are confident that the fish fauna is composed of only one species, the upland bully, a common species throughout New Zealand. We are also confident that freshwater mussels are not present given the ephemeral nature of the flow, and the poor water quality.

New Willowby Water Race was not fished, but it may have higher ecological values than Willowby Water Race, as it may have permanent (i.e., perennial) flow. However, fish diversity will always be constrained by perched culverts mentioned above, and potentially others between Boundary Road and the sea.
