## Work Instruction

7-15 Church Street, Ashburton

Kāinga Ora Homes and Communities

Tonkin & Taylor Ltd

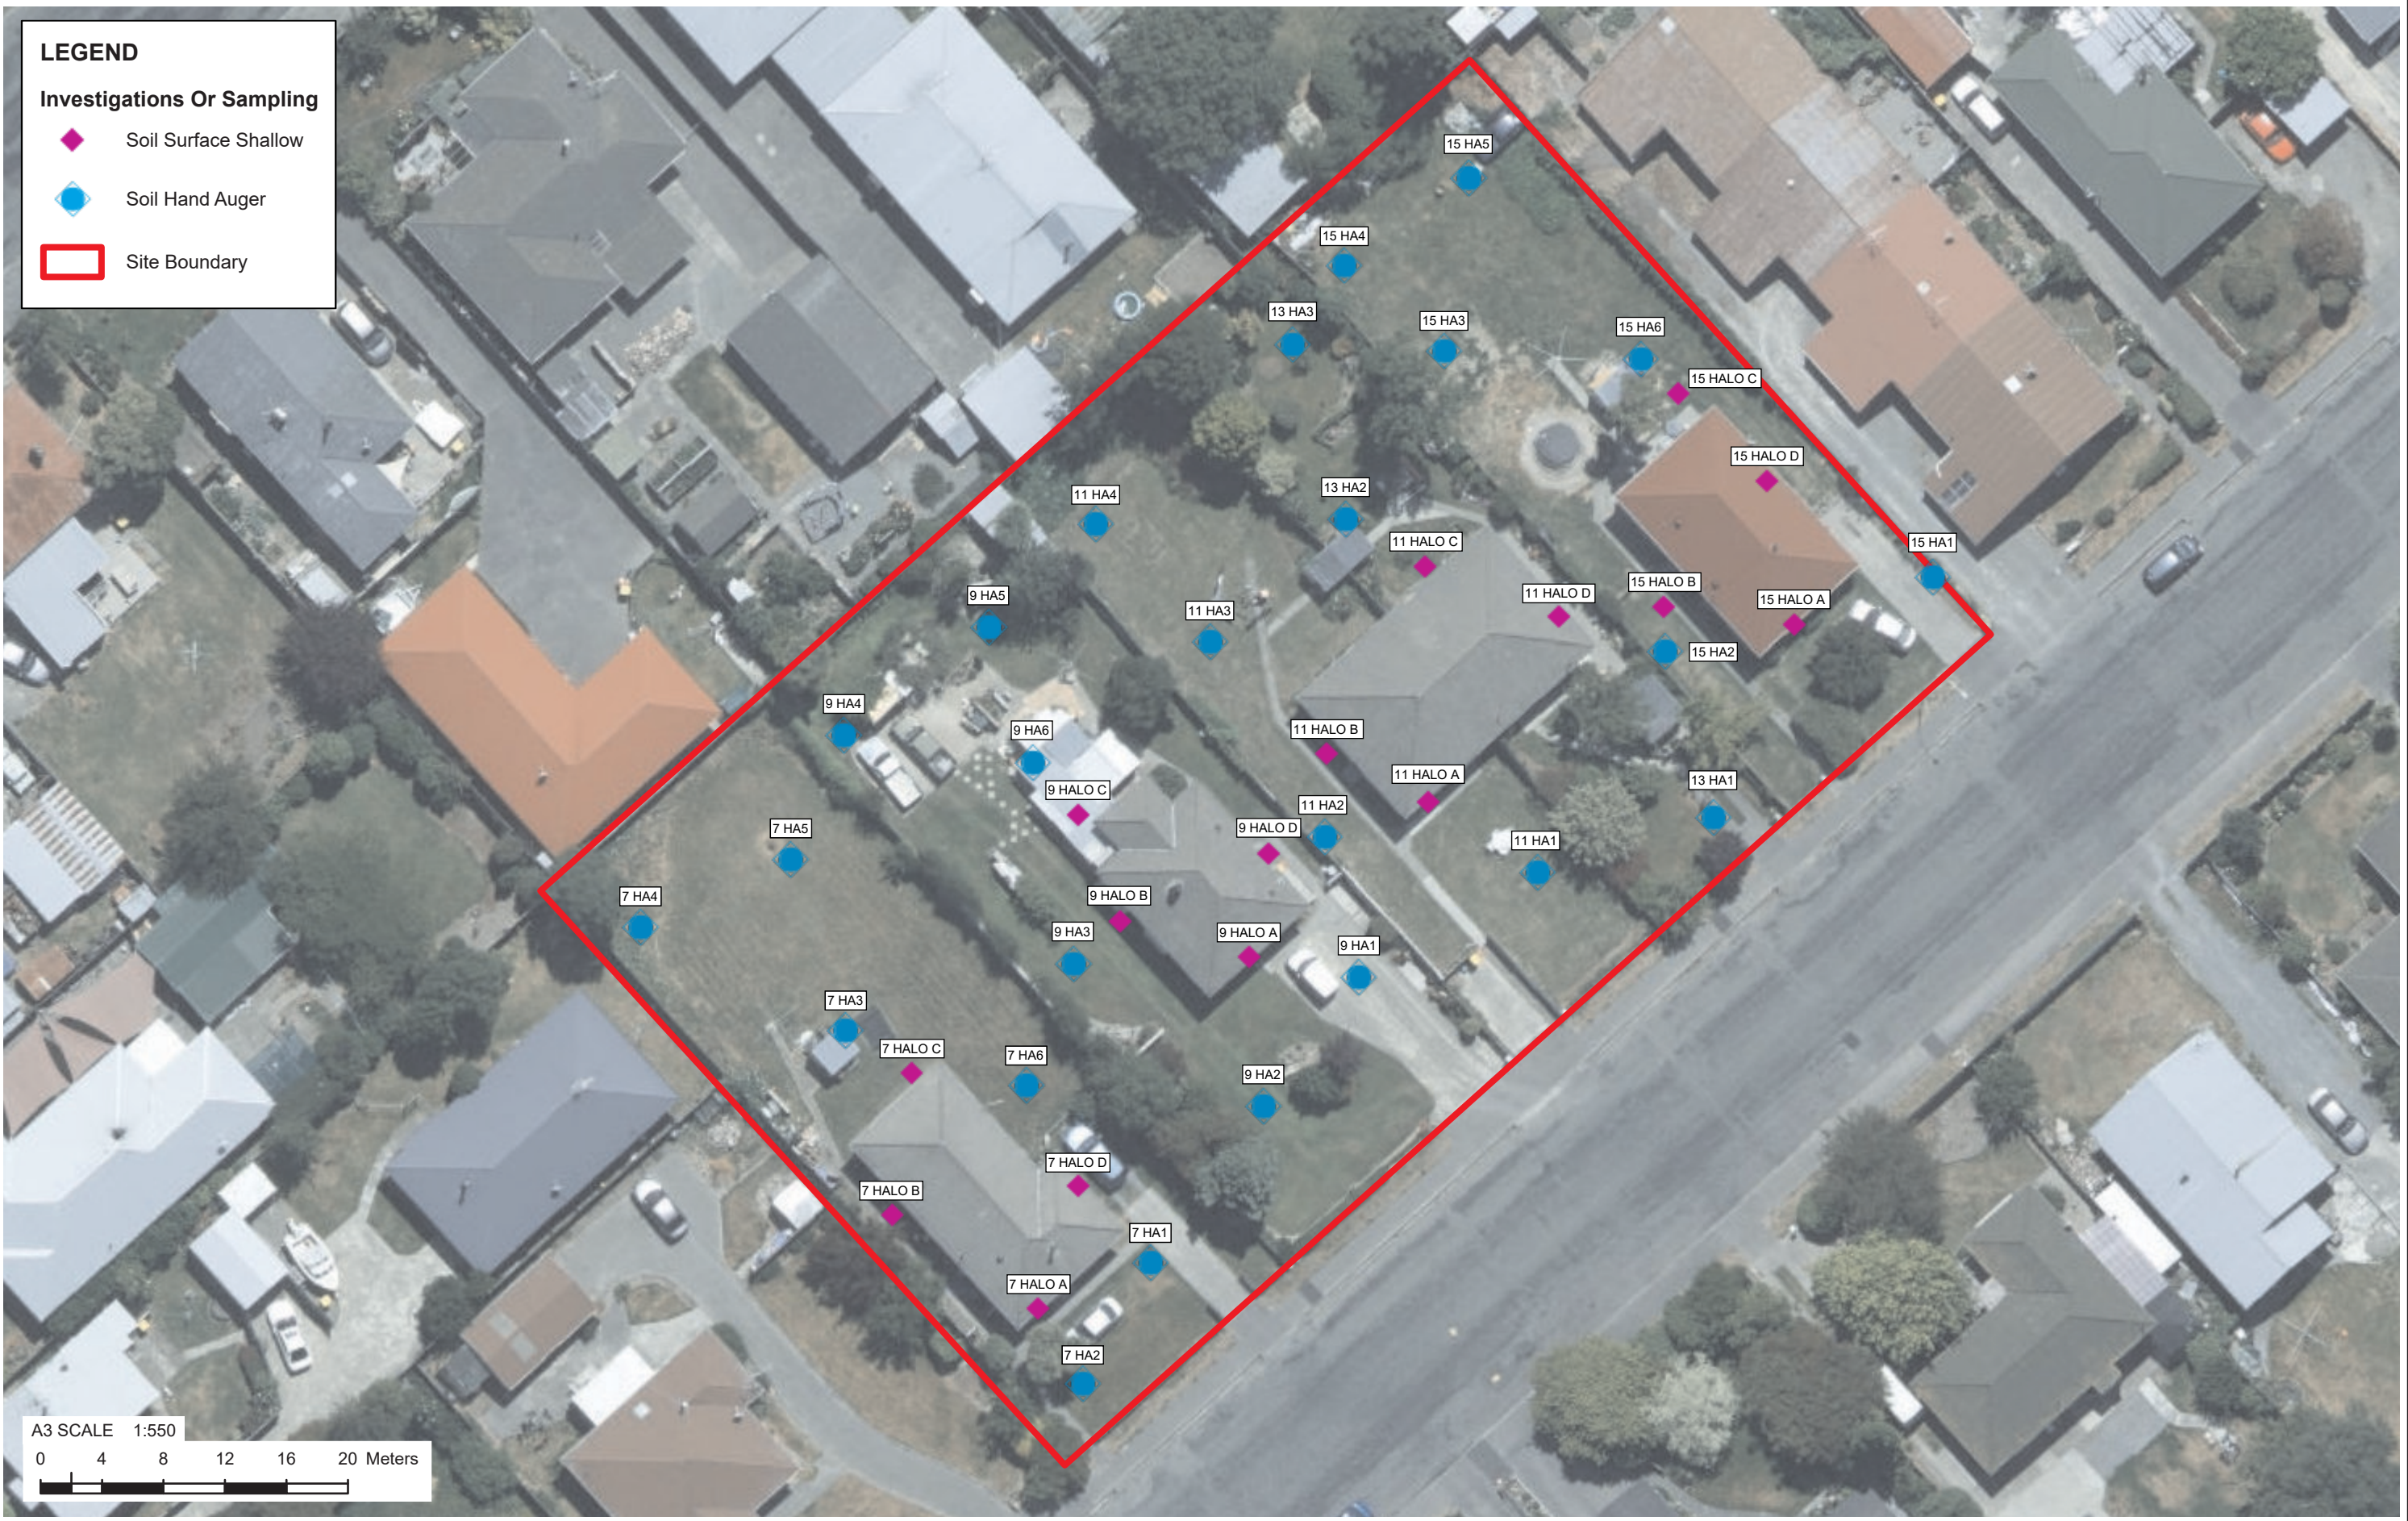
- **Figure 1: Sampling location plan.**
- **Figure 2: Soil disposal plan 0.0 – 0.3 m bgl.**
- **Figure 3: Soil disposal plan 0.3 – 0.5 m bgl.**
- **Figure 4: Soil disposal plan 0.5 – 0.7 m bgl.**
- **Figure 5: Soil disposal plan 0.7 – 1.0 m bgl.**
- **Figure 6: Soil disposal plan  $\geq 1.0$  m bgl.**

1. All offsite soil disposal is subject to approval from the facility operator.
2. All dimensions are approximate in metres (m)
3. Cleanfill disposal assumes soils from site are excavated and mixed in bulk. Following visual inspection and removal of ACM post-demolition.

A summary of the results and laboratory reports containing the soil testing results from the PSI/DSI are presented in Appendix A to assist contractor negotiations with consented off-site disposal facilities regarding disposal of excavated soil. The T+T PSI/DSI sample locations are illustrated on Figure 1, Appendix B.

A site plan showing the soil sample locations of the site (Figure 1, Appendix B), results, and laboratory reports are attached to assist with offsite soil disposal negotiations with facility operators. The Contractor must ensure the disposal facility operator is provided with the soil testing results and receives written confirmation from them confirming acceptance of the material prior to commencement of the site excavation work.

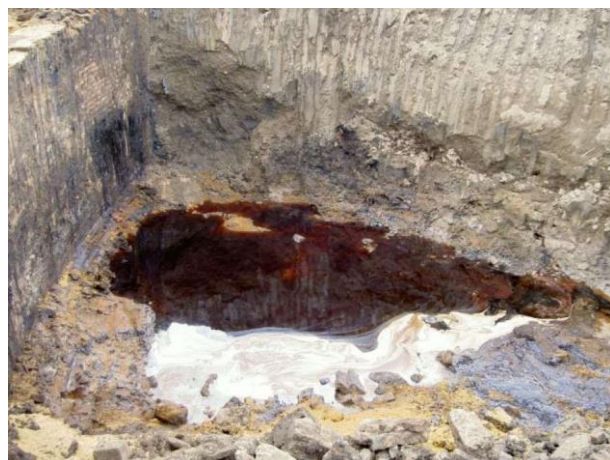
### 5.1 PETROLEUM HYDROCARBONS

- Petroleum service station
- Vehicle workshop
- Gasworks sites

Pooled hydrocarbon spills can be removed using suitable absorbent materials or collected by a suitably rated vacuum tanker. Spills can also be transferred to a sealed container by an appropriately rated vacuum pump or similar. Hydrocarbon contaminated soil can be placed in a sealed leak proof skip bin or truck for disposal at a facility authorised to receive material of that kind.

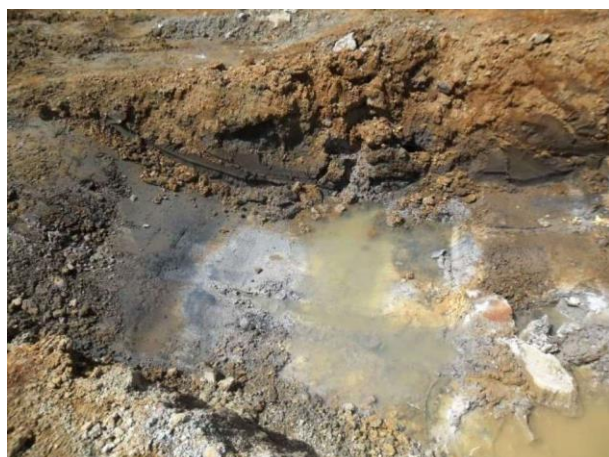
## 5.2 HEAVY METALS

- Metal workshop
- Metallisation works
- Electroplating industries
- Timber treatment facilities

Heavy metal-contaminated soil can be placed in a truck and covered with tarpaulin for disposal at a facility authorised to receive material of that kind.

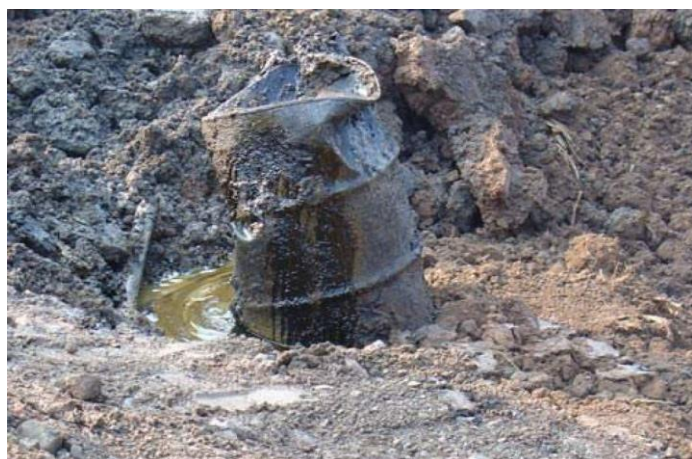
### 5.3 DRY CLEANERS

- Dry-cleaners

Pooled hydrocarbon spills can be removed using suitable absorbent materials or collected by a suitably rated vacuum tanker. Spills can also be transferred to a sealed container by a suitably rated vacuum pump or similar. Solvent contaminated soil, including drums or containers, can be placed in a sealed leak proof skip bin for disposal at a facility authorised to receive material of that kind.

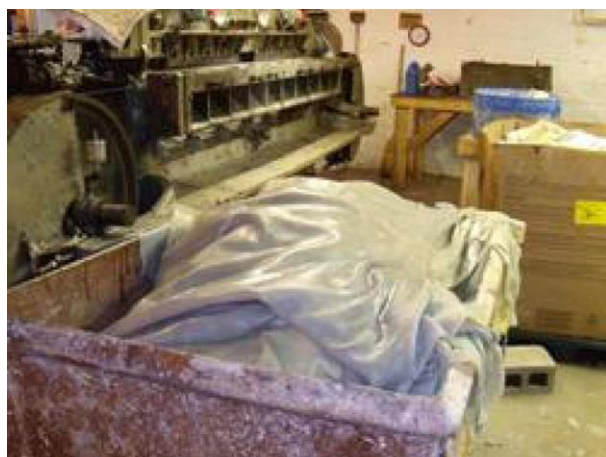
## 5.4 TANNERY/ LEATHER PROCESSING

- Leather manufacture/ treating facility

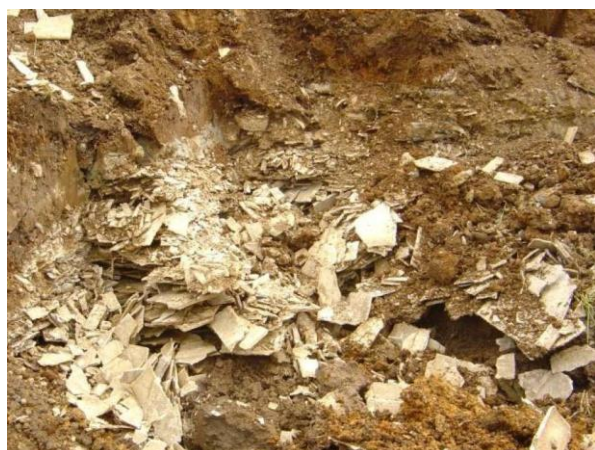
## 5.5 ASBESTOS

- Improper disposal of asbestos-containing building materials

KEEP DAMP to suppress fibre generation. Large fragments may be collected by hand and place in double skinned plastic bags. Asbestos-contaminated soil can be placed in a sealed skip bin for disposal at a facility authorised to receive material of that kind. Soil of this kind can also be transported via sealed doubled bags or a sealed skip bin.

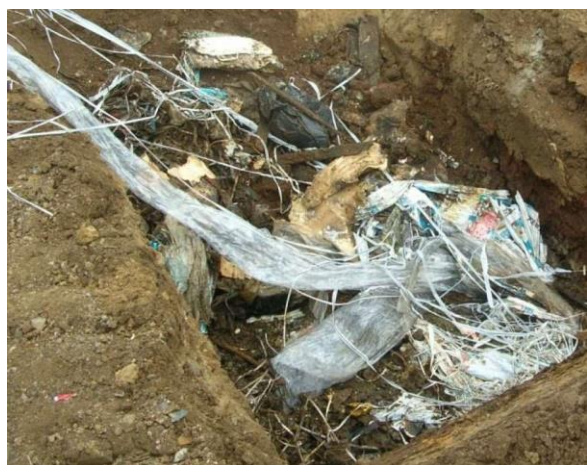
## 5.6 REFUSE

- Inorganic/ Organic refuse disposal

Handling and disposal of refuse will be dependent upon the waste material identified.

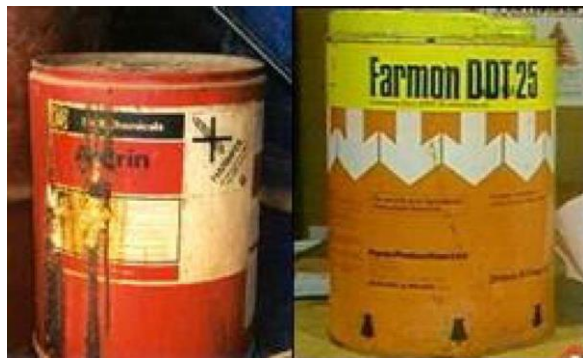
## 5.7 PESTICIDES

- Horticultural activity Pesticide manufacture

If bulk pesticide storage containers are found, the site manager must be advised. Pesticide-contaminated soil can be placed in a truck and covered with tarpaulin for disposal at a facility authorised to receive material of that kind.

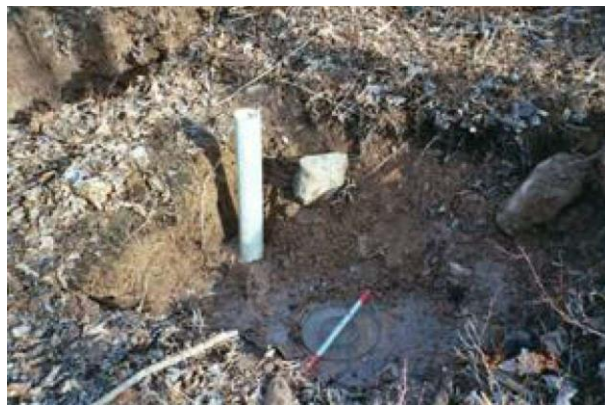
## 5.8 SEWAGE

- Underground sewage tanks/ pipelines
