June 2022

# Ashburton District Council-

Playground Report  
2022

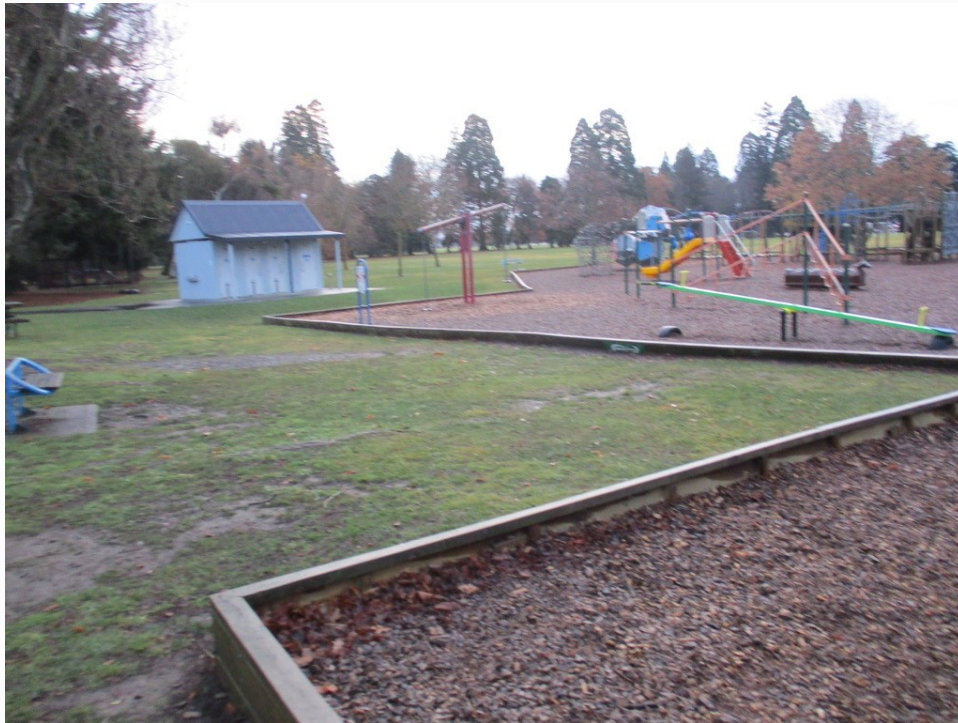
The Domain is the Destination playspace for the District. It has a wide range of play experiences. This site should cater to all children and be accessible to all users. Many of the play items have been added into the playspace in an adhoc manner. As such, the surfaces are scattered through the area without any cohesion. The surfaces have raised timber edges and are not accessible to all users. It is also important when items are renewed that they are done in a manner to rectify non-compliance with falling spaces.

It is recommended that the entire playspace is reviewed and an overall plan/design is put in place. The plan to address accessible surfacing and equipment, compliance and condition for the equipment and surfaces.

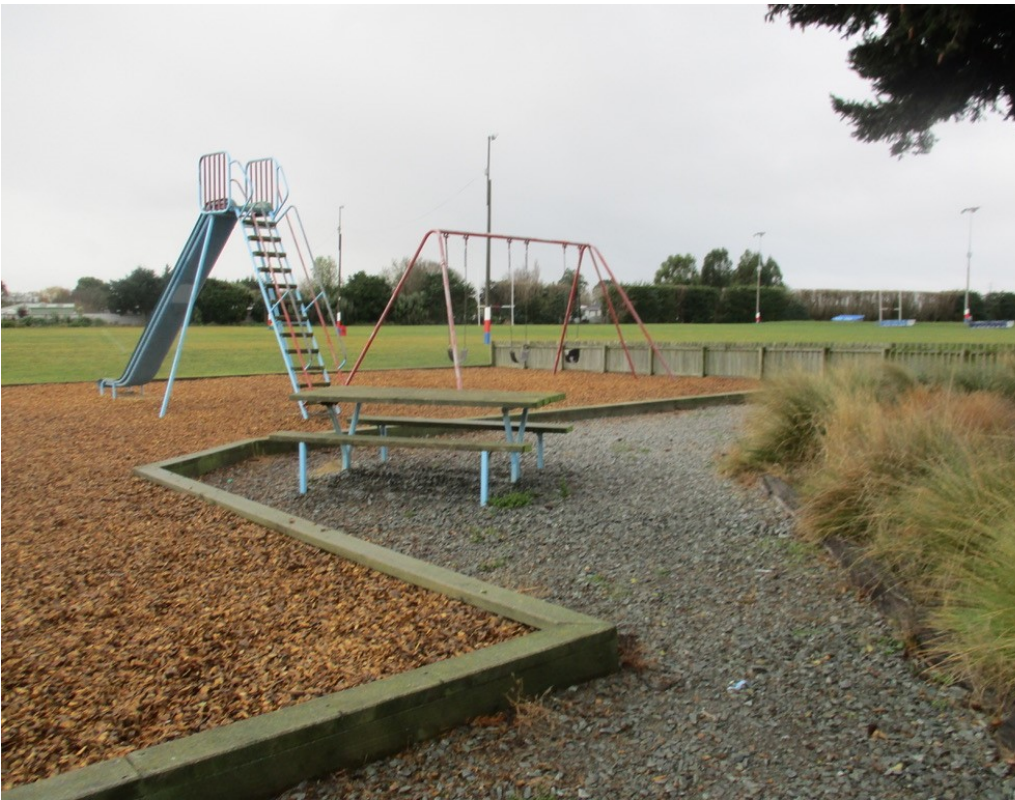
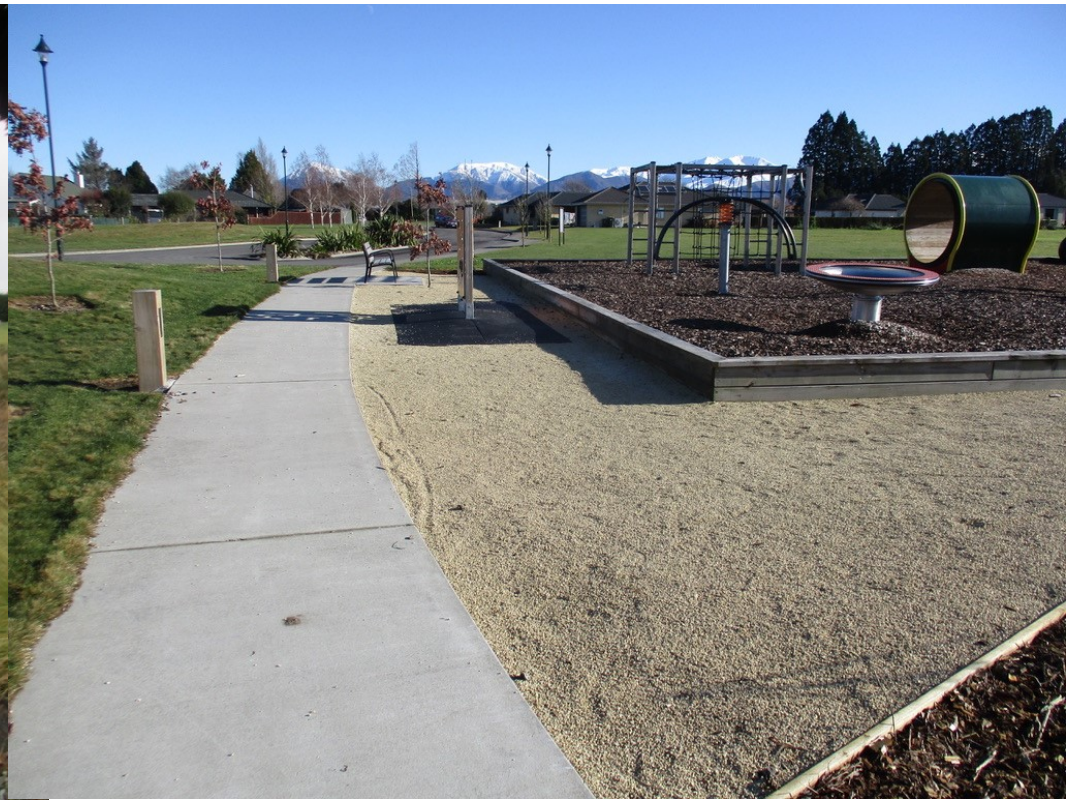
The majority of playspaces have raised timber edges and no footpath – along with loosefill materials such as pea gravel. These are all major restrictions for those with mobility issues being able to access the playspace.

The individual playspaces have been assessed with recommendations on how to address the access at each site.

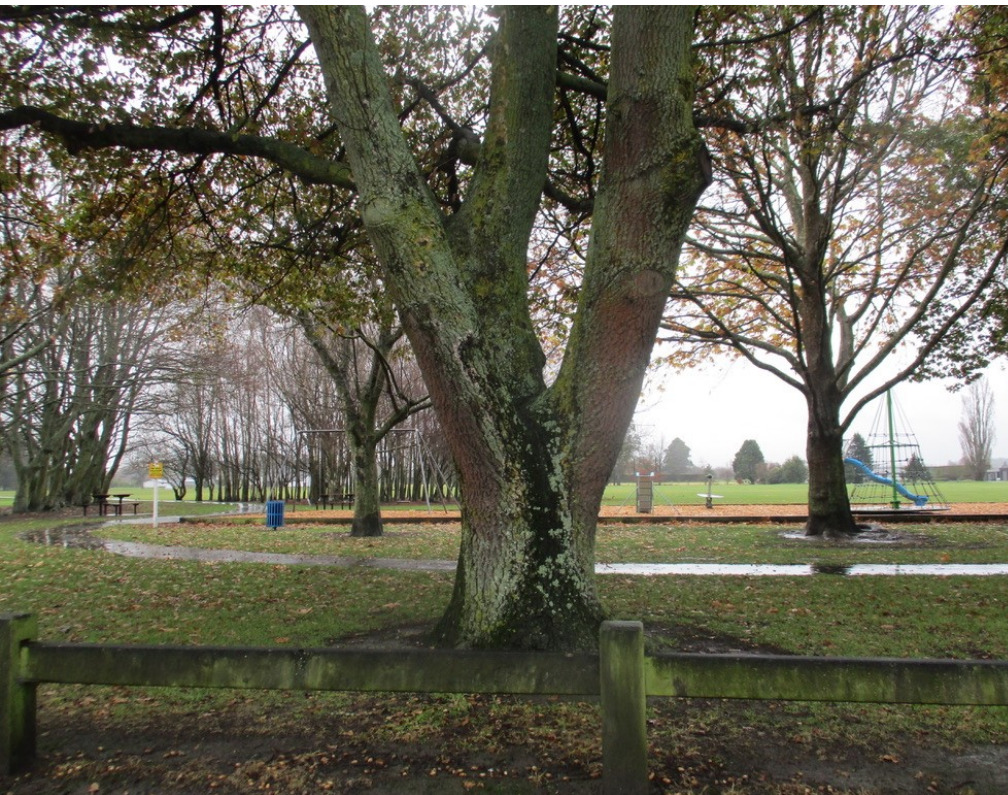
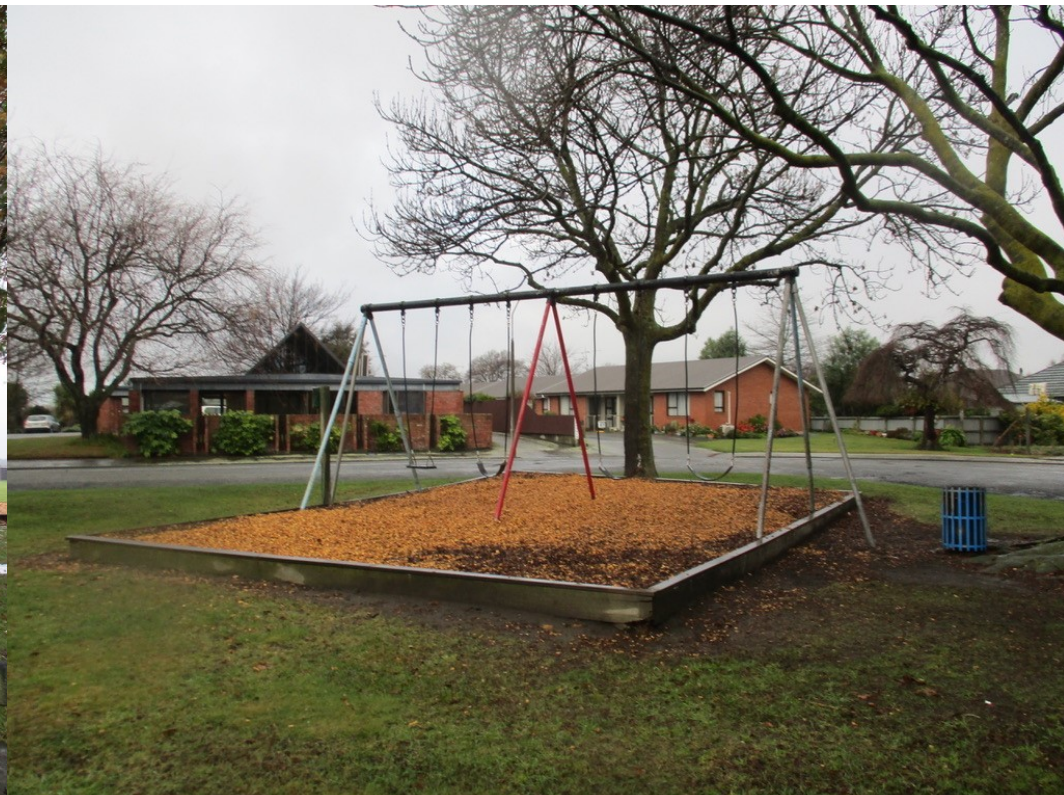
Those without and or with poor shade provision have been identified with recommendations on how to address the shade provision.

The options for providing shade could be either planting trees that will provide shade over time, and once they have grown, or provide shade sails over playspaces.
