Ashburton Water Supply
Water Safety Plan

Version 3.0: January 2019

Version	Description	Authorised	Approval Date
V1.0	PHRMP Ashburton March 2013	AG	19 March 2013
V2.0	Water Safety Plan 2018	AG	May 2018
V3.0	WSP Minor Review - Improved CCPs and revised timeframes	CS	January 2019

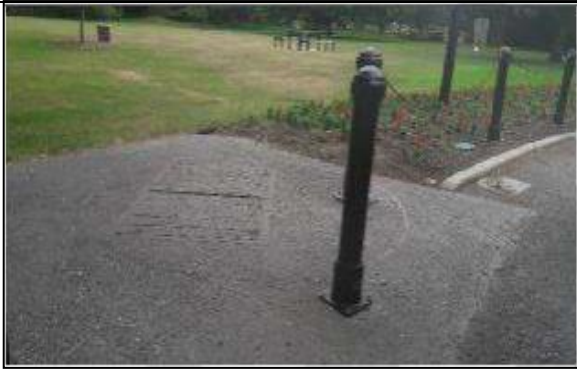
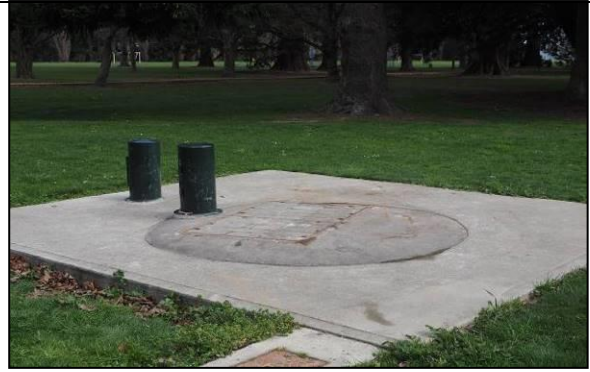
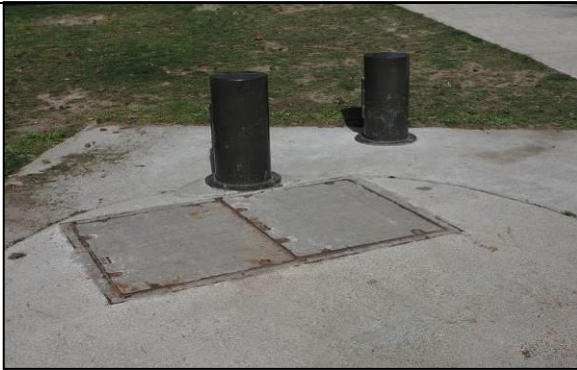
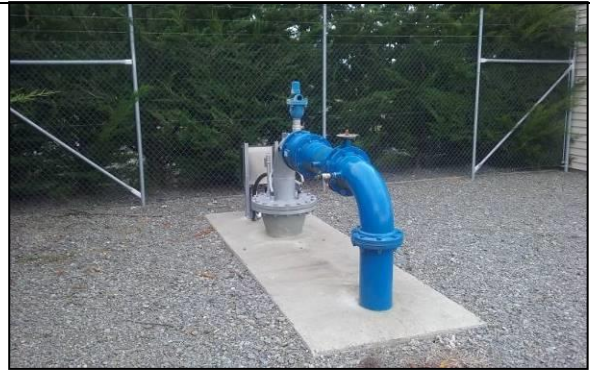
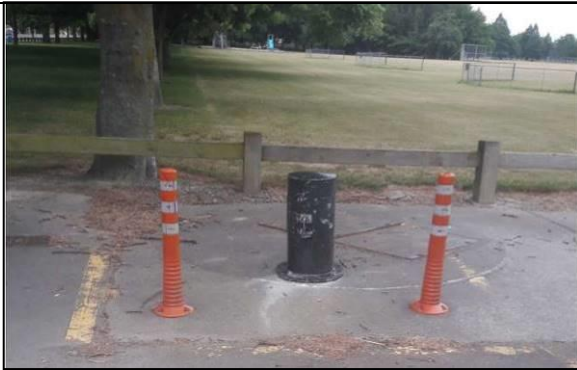
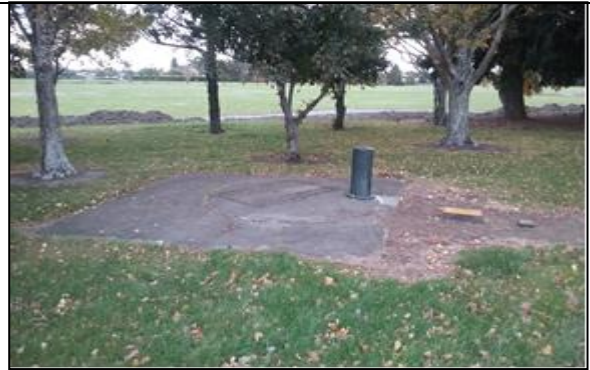
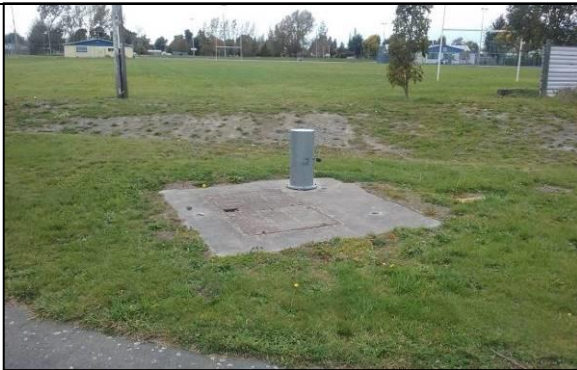
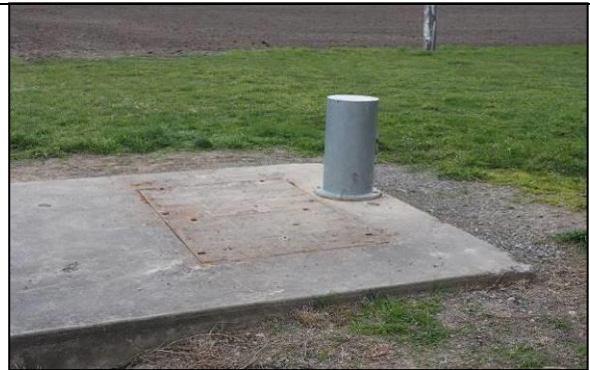
Table 4: Ashburton Water Supply Bore Headworks Photographs

The eight deep bores range from 74m deep to 124m deep. Until 14th February 2018, all 8 bores had “Secure” status as defined in DWSNZ 2005 (2008). This “Secure” status was revoked on 14th February 2018 following a report into the condition of the sanitary seals of the Argyle 1 & 2, Bridge St 1 & 2 and Domain 5 bores. The report indicated that these bores did not meet the necessary requirements and thus were no longer deemed to provide sanitary security of the bores. Please see notes in the Critical Points for Hazard Management, the Risk Tables and the Improvements Schedule regarding actions to regain this “Secure” status.

The bore pumps supply water directly to the distribution (via treatment plants, described below). There is no storage. Each site can be operated independently and surplus source capacity is provided so that water supply can be maintained even if a bore or headworks site is inoperable for any reason.

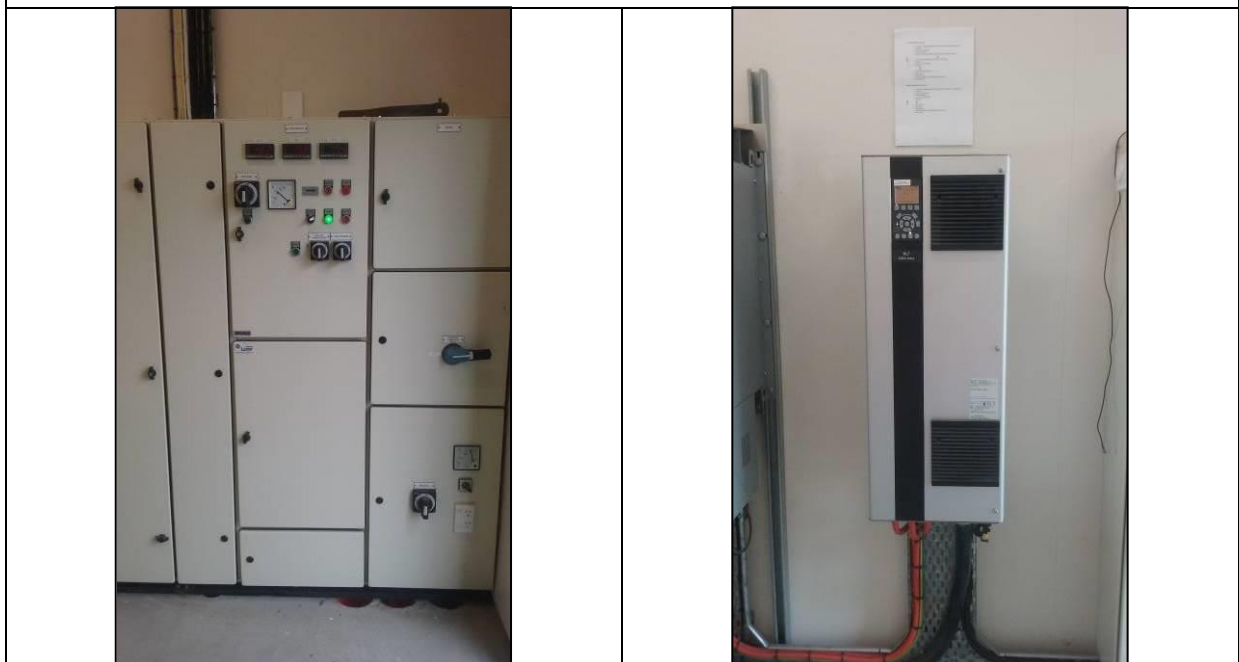
Figure 29: Tinwald Control Panel; Bore Pump Variable Speed Drive

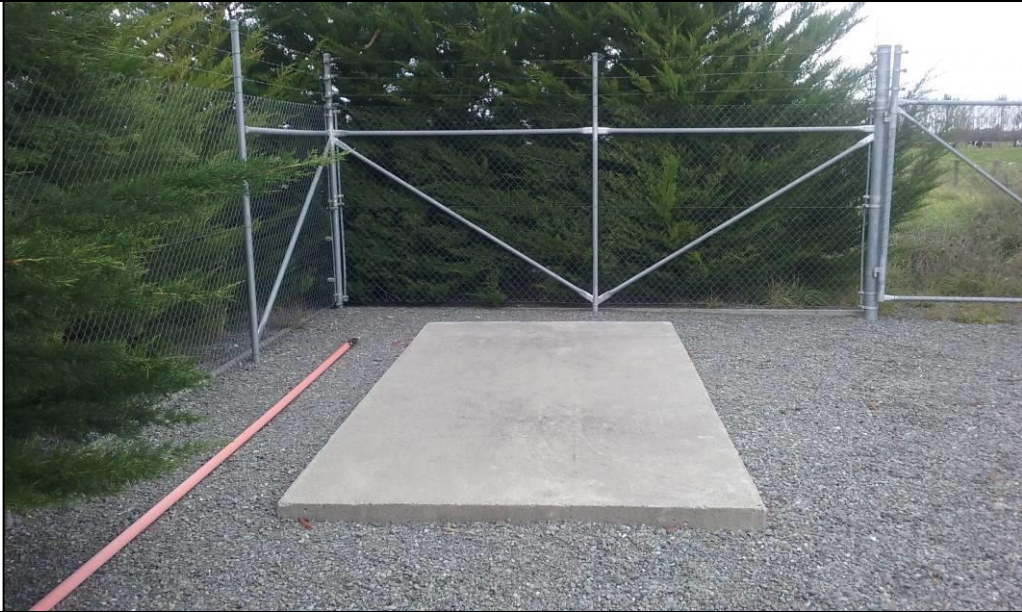
Figure 30: Tinwald Generator Pad (see improvements section for generator comments)

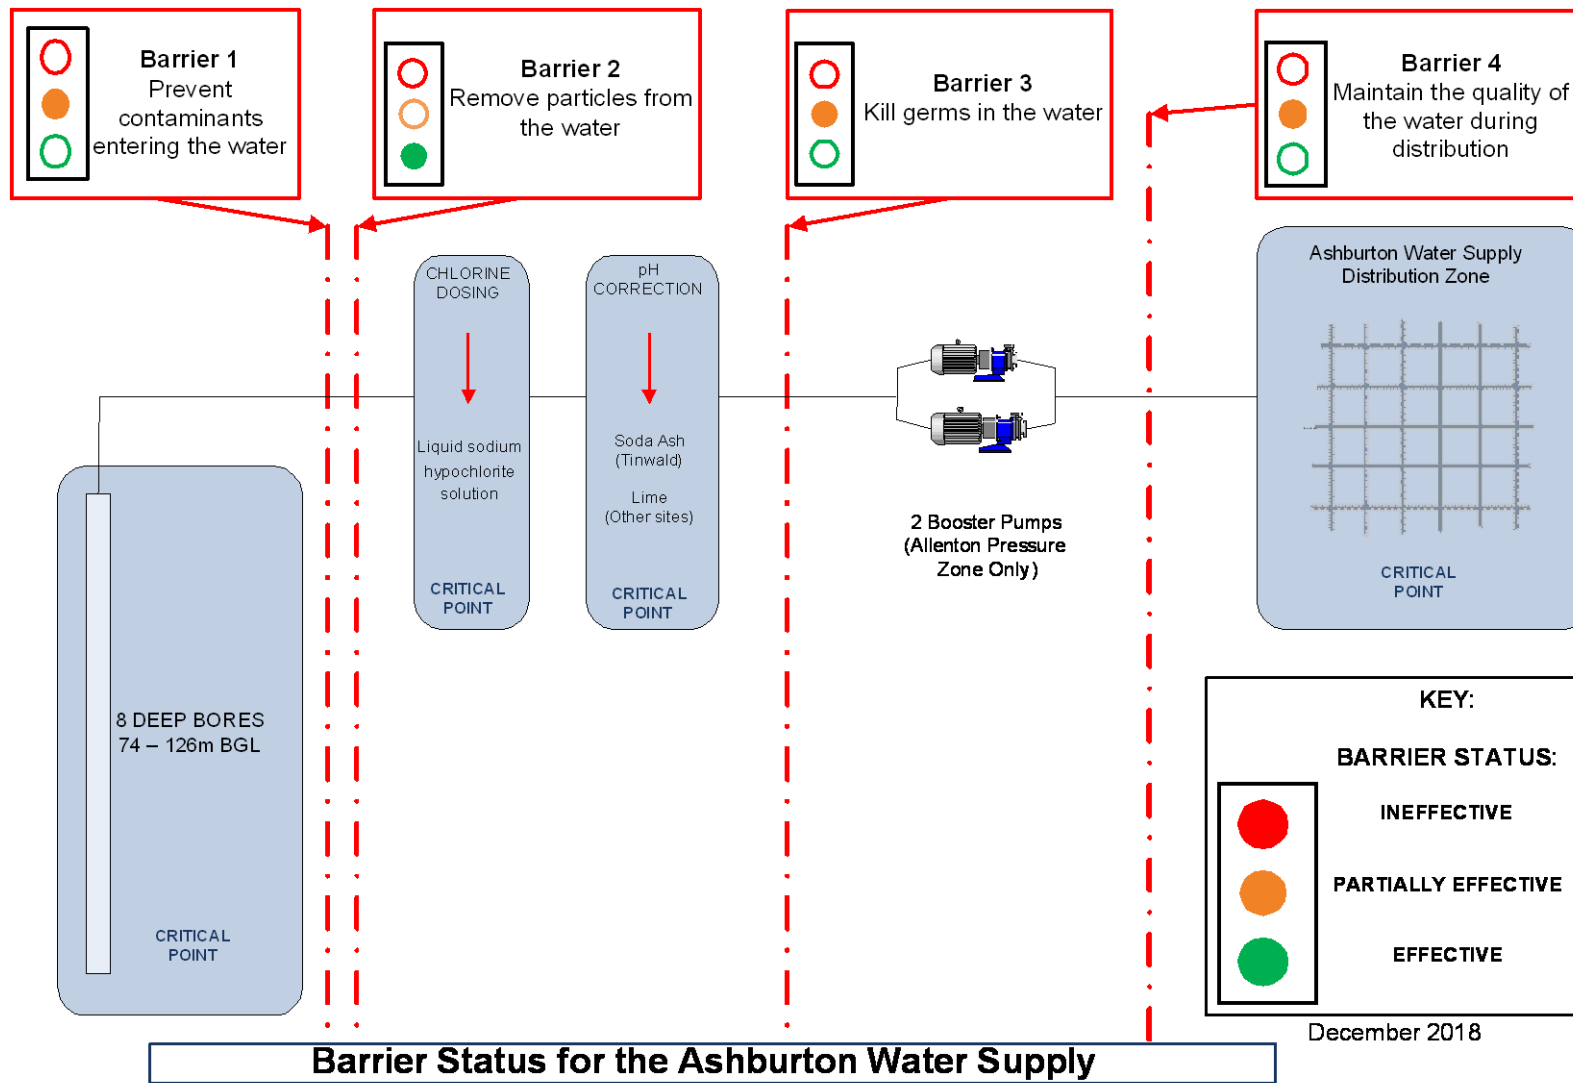
Figure 33: Ashburton Water Supply Schematic

Figure 27 (over the page) presents a schematic of the water supply from source to consumer. Critical points, where hazards can be eliminated, minimised or isolated are indicated in blue. Barriers to contamination are indicated in red.
