Hakaterere Water Supply
Water Safety Plan

Version 2.2: August 2018

Prepared by: _____
Berna Dabbak
Environmental Engineer
Opus International Consultants

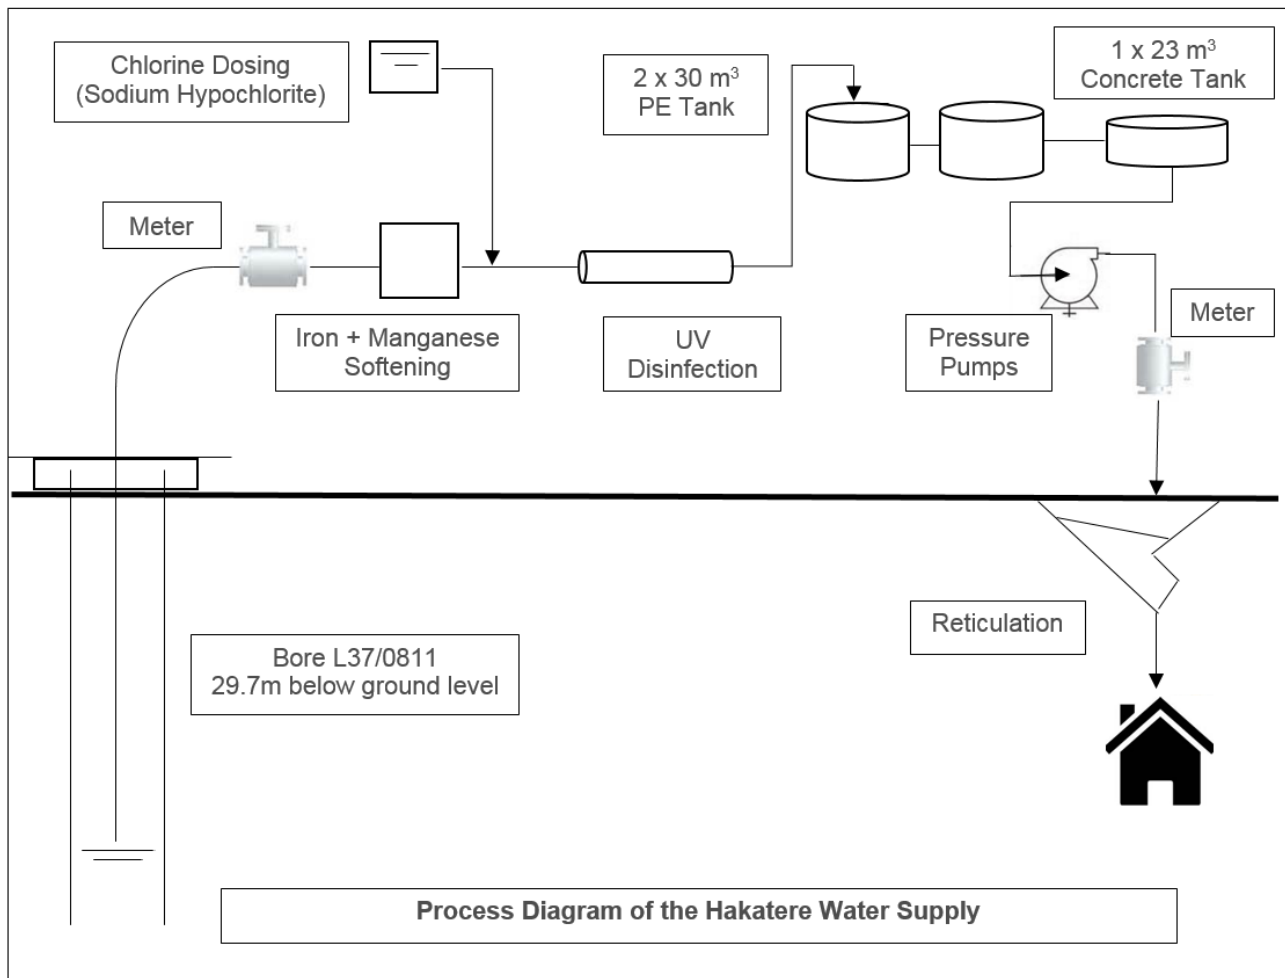
Figure 2 - Hakatere Water Supply Process Diagram

A depiction of the Hakatere water supply process is included below in Figure 2.

Two new 30m³ PE storage tanks and one 23m³ concrete tank are positioned on site and are interlinked for balancing and constant water “turn over”. Two booster pumps (duty and duty assist) supply the distribution zone and are controlled by pressure switches for a reduced number of starts. All pumping information is linked and recorded by SCADA.

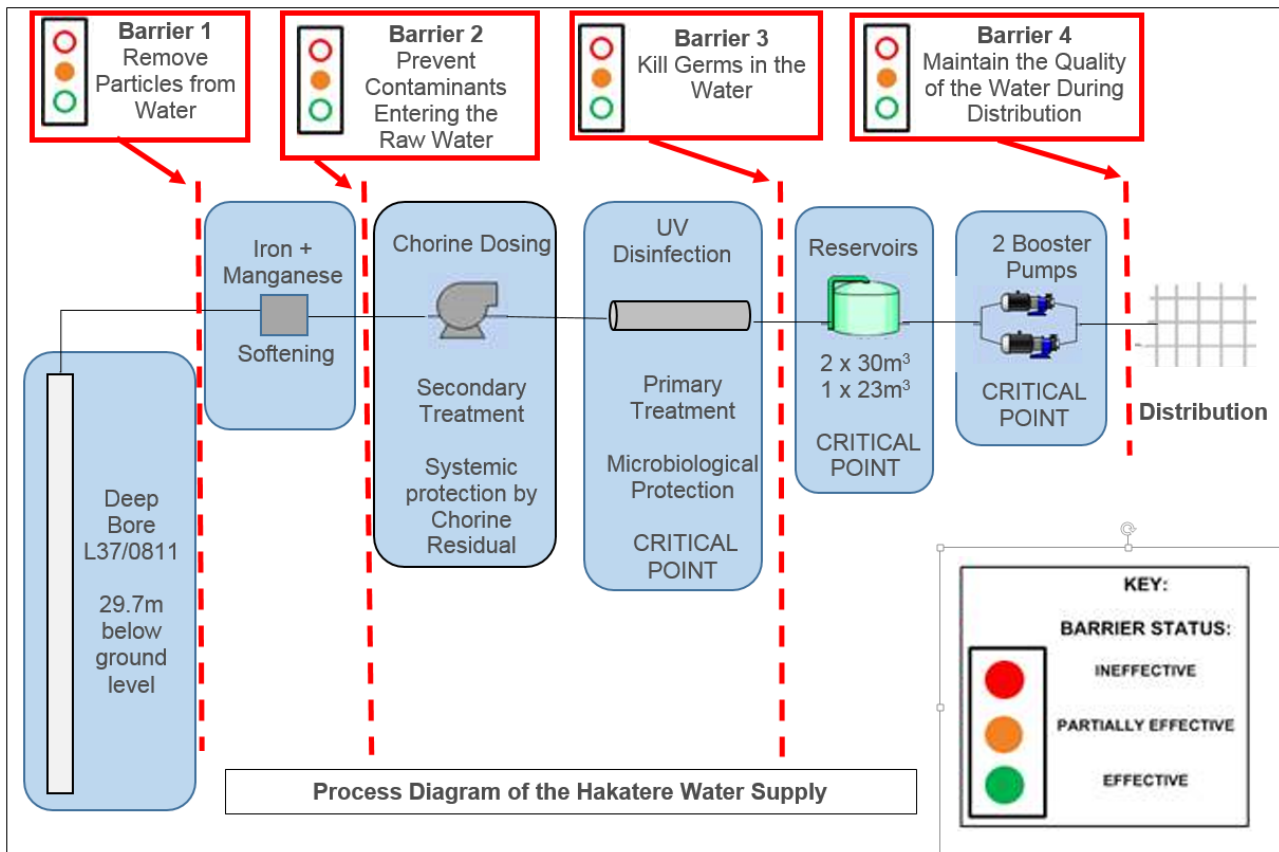
Figure 4 - Hakatere Water Critical Points and Barriers to Contamination

Figure 4 below presents a schematic of the water supply critical points and barriers to contamination. Critical points, where hazards can be eliminated, minimised or isolated are indicated in blue. Barriers to contamination are indicated in red.

Critical points where hazards can be eliminated, minimised or isolated are tabulated below.
