INVESTMENT AUDIT REPORT

Technical Audit of Ashburton District Council

Report of the investment audit carried out under Section 95(1)(e)(ii) of the Land Transport Management Act 2003.

1 JULY 2021

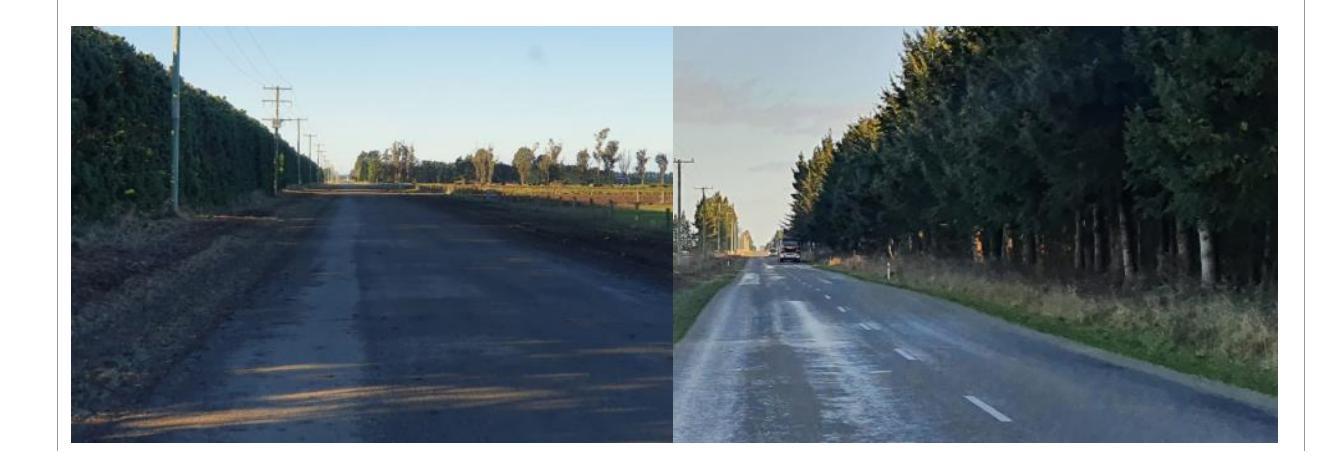
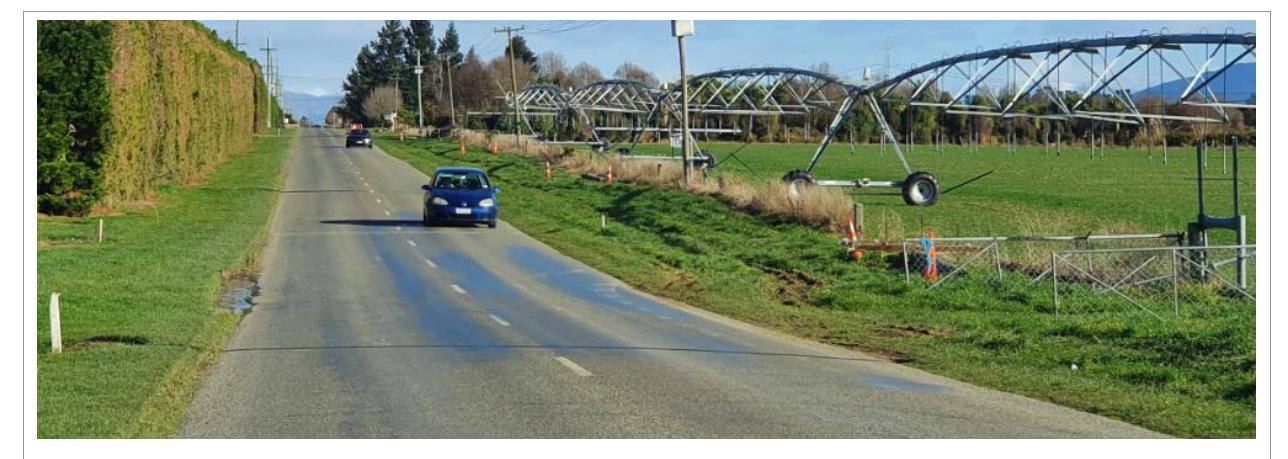
The audit team observed areas where adjoining landowner activities are impacting road network safety and operational efficiency, such as:

- temporary fencing in road berms (including the use of waratah standards and other unsafe fencing practices on or adjacent the road carriageway)
- the use of road berms by farm machinery and for stock movement or grazing resulting in:
 - mud tracking reducing skid resistance and obscuring road marking
 - o damage to roadside drainage
- farm irrigators saturating road pavements (thereby reducing asset lifecycles),
- shelter belts encroaching over the road boundary, increasing motorist safety risk (due to reduced sight distances) and reduced skid resistance (due to frost where shelter belts shade the road surface)

Figure 1: Examples of adjoining landowner activities impacting road network operational efficiency. Top left – roadside drainage damage resulting from farm machinery use and stock movement on road berm (Winslow Road); top right - shelter belt encroaching over the road boundary (Arundel Rakaia Gorge Road); bottom - farm irrigator adjacent road corridor (Pudding Hill Road)

We understand the roading team has been focussed on limiting the impacts of adjoining landowner activities through increased bylaw compliance monitoring in recent years. We encourage continuing this compliance focus and suggest an opportunity may exist for Council to review the effectiveness of current bylaws (refining these, where appropriate, through the next bylaw review process).

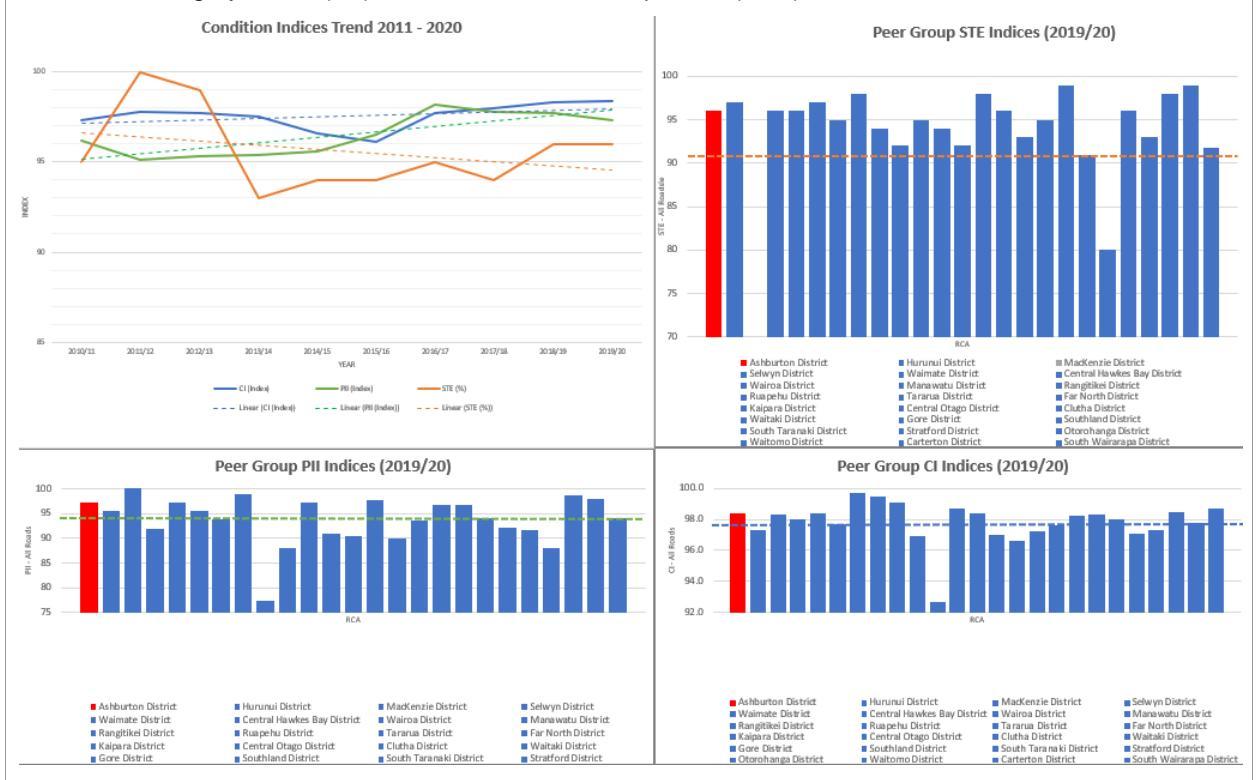
Figure 2: Network Condition Indices - source WK Transport Data

Network condition as measured by the key indices of CI, PII and STE show the sealed network is in good condition. CI and PII indices are showing an improving trend over the last 10 years, and the STE index has been steadily improving over the last 6 years.

A decline in the rural PII over the last 3 years aligns with the audit team observations of deteriorating rural pavements. This suggests Council's current focus on rural pavement interventions (including drainage, pavement and surfacing maintenance and renewals) is imperative in order to respond to this declining trend, through optimising investment in these assets.

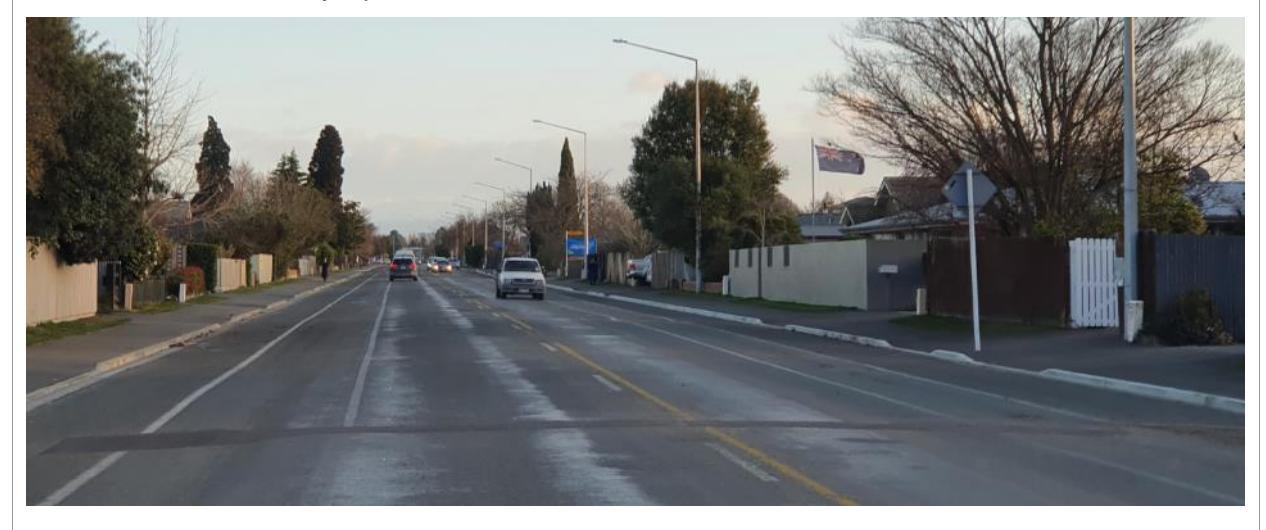
Areas of 'manufactured' roughness were observed within the road carriageway in some urban areas inspected, as a result of poor service trench reinstatement by other Council infrastructure suppliers or utility authorities in the past. An opportunity exists for Council to further refine work programme integration (referenced in the '*Activity Management Planning*' subject area of this report) and ensure utility operators' service trench reinstatement standards are being met as provided for within the 'National Code of Practice for Utility Operators' Access to Road Corridors'.

Figure 3: Example of service trench reinstatement impacting road roughness (Harrison Street, Ashburton).

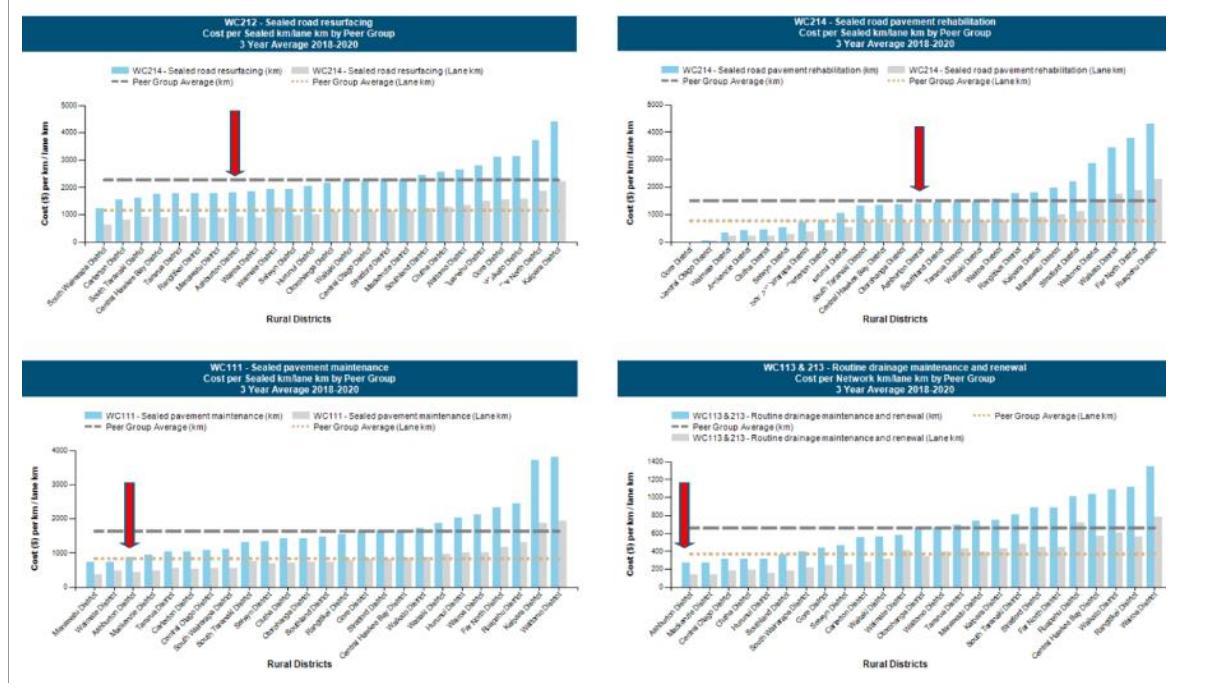
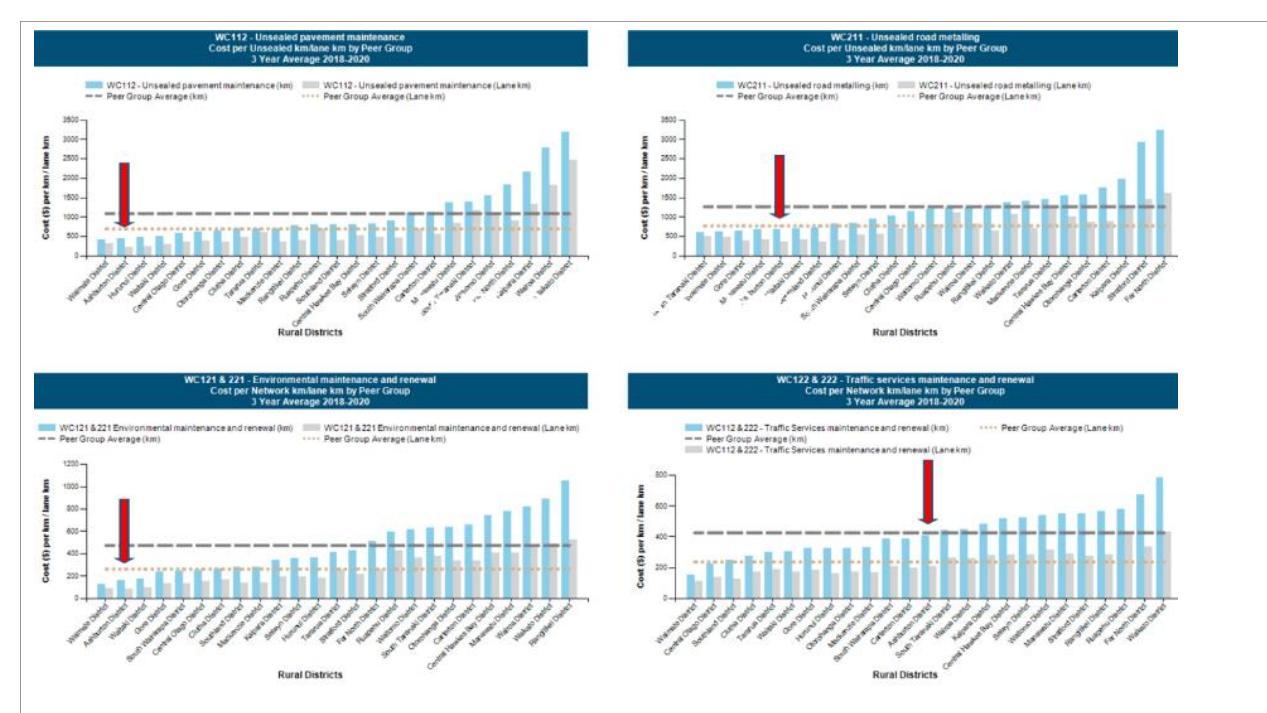
The cost per km for MOR (maintenance, operations and renewals), excluding emergency works, as a three-year average (2018-2020) is \$4,125/km, which is in the lower quartile of costs for the rural districts peer group. This relatively low cost per kilometre is consistent across work categories that make up the maintenance, operations and renewals activity class, with the exception of sealed road pavement rehabilitation and traffic services maintenance and renewals where the cost per km for these activities are closer to the peer group average, as shown in the peer group comparison graphs below.

Figure 4: Peer group costs/km cost comparison, source Waka Kotahi MOR Report

Audit field observations (supported by the cost comparisons above) suggest that opportunities may exist to re-balance some MOR activities (and costs) to optimise levels of service achievement. Examples include activities which contribute toward sealed road surface and pavement performance (incl. all drainage, surface and pavement maintenance and renewal activities). Traffic services maintenance and renewal also require more focussed investment to improve signage and delineation in line with industry good practice. A greater focus on signage and delineation will reduce road user safety risk (particularly in rural areas).

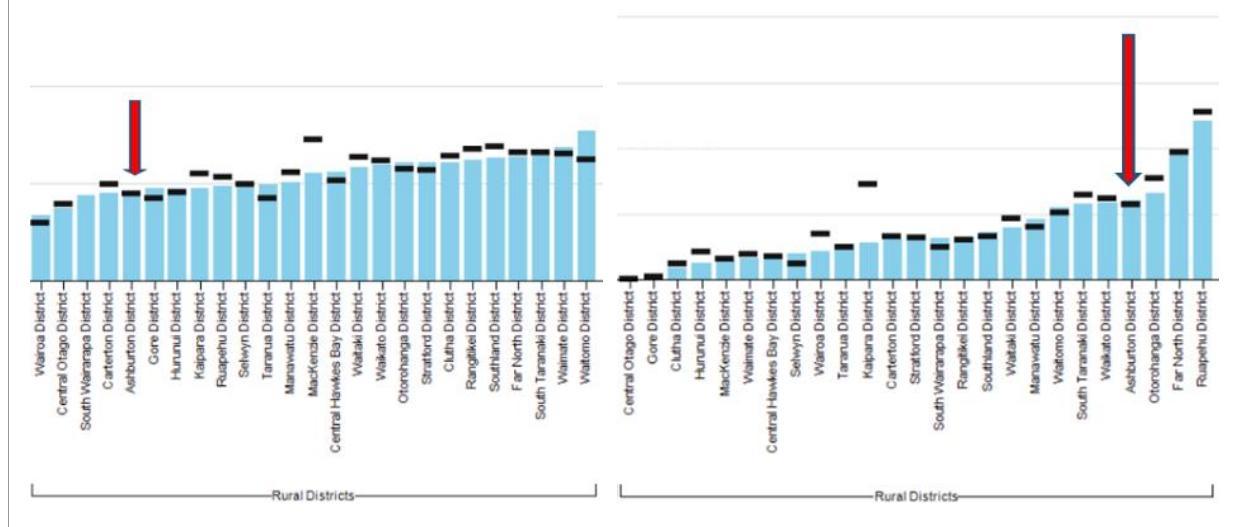
Council's rate of resurfacing is in line with their peer group and national averages, and the rate of pavement renewals is above peer and national averages. Pavement rehab may be the optimal treatment for many of the sites identified in the work programme, however, as discussed in the opening paragraphs, an opportunity exists to further consider alternate intervention strategies and treatments. Targeted pavement investigation and traffic data collection will allow improved evaluation of drainage improvements, heavy maintenance and resurfacing treatments in the intervention (pavement rehabilitation) option analysis and will likely enable further optimisation of level of service delivery (i.e. at reduced lifecycle costs).

Figure 5: Resurfacing rate as % of sealed network (left) and pavement rehabilitation rate as % of sealed network (right), source Waka Kotahi MOR report

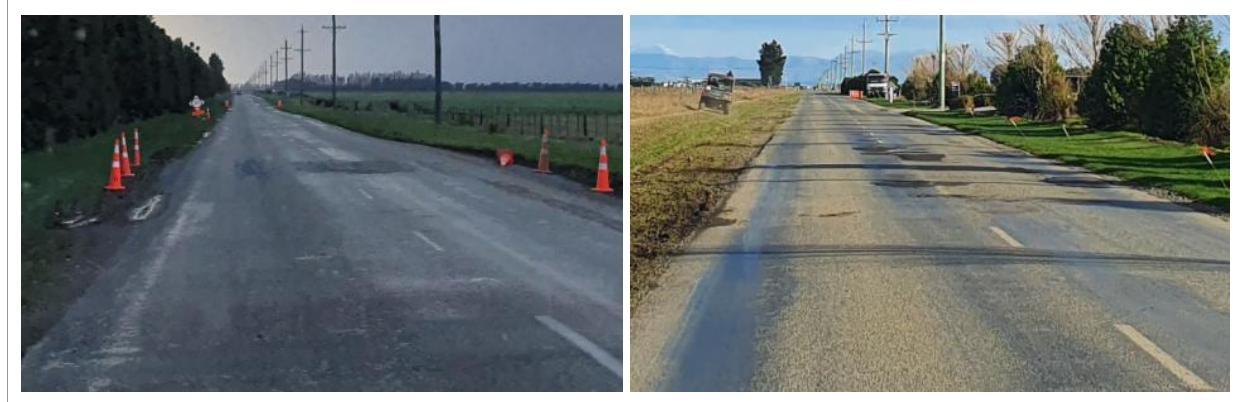
Widespread surface flushing was also observed during the network field inspection. Council staff advised the extensive areas of flushing is primarily due to historical resealing practice issues and multiple seal layers causing an unstable top surface. Ensuring the reseal treatment selection and design is focussed on addressing road surface performance issues (such as flushing), by engaging specialist resurfacing expertise to peer-review resurfacing design (focussed on achieving asset owner outcomes), may be one way of improving surface lifecycle performance.

Figure 6: Planned 2021/22 pavement rehabilitation sites with ineffective drainage, exhibiting various pavement failure indicators and flushed surfaces. Left – Christys Road; right – Thompsons Track

We also suggest that by increasing the maintenance intervention focus on the cause of defects, presents an opportunity to optimise pavement and surface lifecycles (thereby reducing lifecycle costs). Enhancing Councils' rural drainage maintenance programme, using a road hierarchy/risk-based approach to address road drainage deficiencies (one of the primary causes of reduced pavement strength/lifecycles), is one approach to extend pavement and surfacing lifecycles.

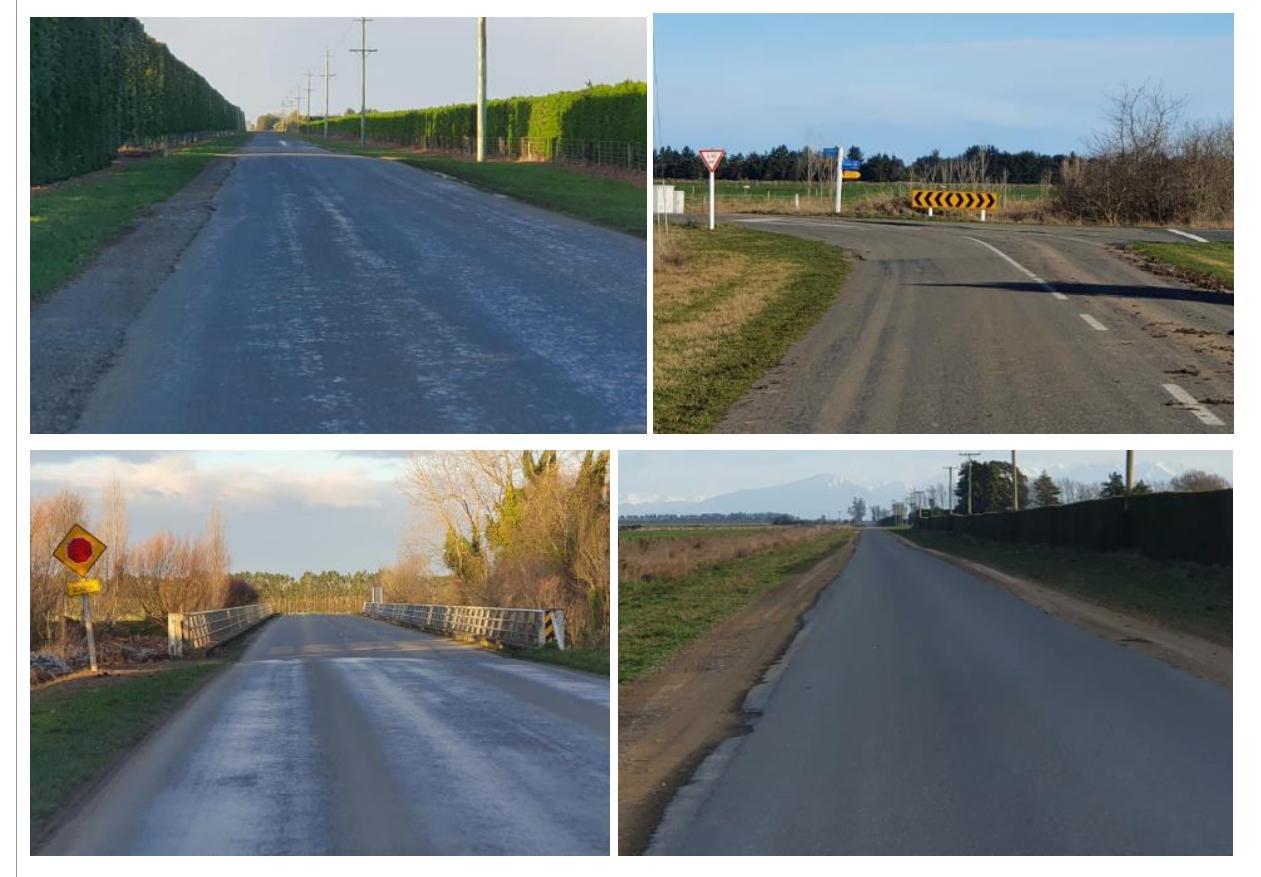
- Sub-standard road surface reinstatement associated with other infrastructure renewals and improvements within the road corridor, resulting in rough road surfaces, user dissatisfaction and increased maintenance costs.

- Use of non-standard and some missing, damaged or obscured (by vegetation) signage and delineation, such as permanent warning signs, chevrons (particularly headway chevrons), bridge end markers, hazard markers, culvert markers and edge marker posts.

Figure 7: Top left – example of edge break, ineffective drainage, flushing, missing EMPs and hazard markers (Fairfield Road); top right – example of non-complying use of headway chevron sign on curve (Coldstream / Lloyds Road intersection); bottom left – missing bridge end marker and flushing (Ashburton Staveley Road); bottom right – edge break and use of basalt wearing course on high-wear unsealed shoulders (Seafield Rd).

These types of maintenance defects should be identified and either addressed or programmed for repair by the road maintenance contractor. Council needs to ensure alignment between their requirements and the contractor's performance. We suggest Council considers increasing focus in these areas through various means, including contract management meetings; joint Council staff/contractor inspections, and; refining their Maintenance Intervention Strategy and Guidelines to assist with shared understanding of interventions/response requirements.

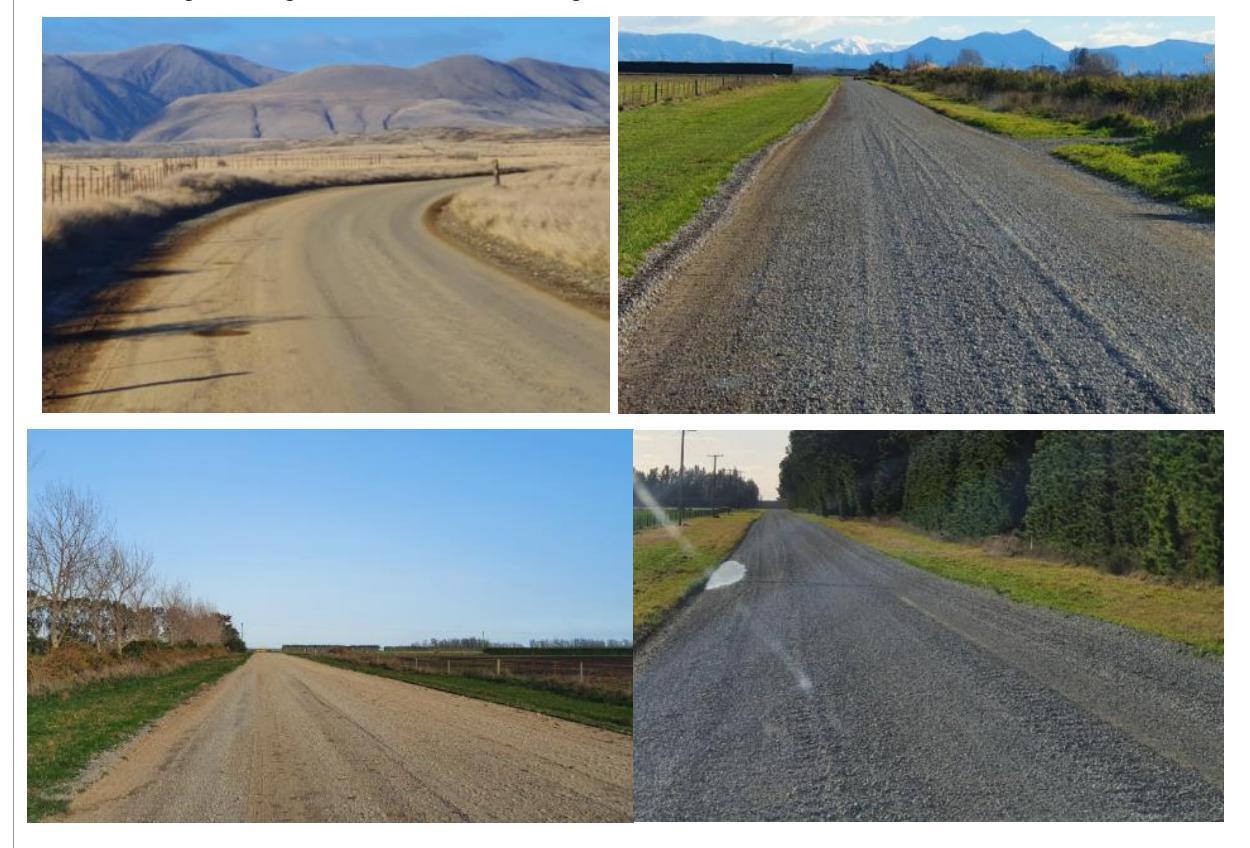
We commend Council for identifying and trialling alternate wearing course materials and practices to extend maintenance cycles and reduce dust, with traffic safety, cost and health benefits. For example, the use of the basalt wearing course material on Hakatere Potts Road (sourced from Harmers Quarry) and stabilising wearing course material on Maginness Rd.

Figure 8 – unsealed roads. Top - examples of good practice, left – effective use of Basalt wearing course and achievement of high standard finish (Hakatere Potts Rd); right – trialling stabilised wearing course (Maginness Rd). Bottom – examples of improvement opportunities, left - grading resulting in excessive road carriageway width (Hamptons Road); right - unbound and windrowing of wearing course (Highbank Cairnbrae Road), noting high shoulder and absence of table drains.

Council staff advised that limited customer requests are received in relation to unsealed road surface condition, however the audit team suggests that wider trialling/use of wearing course materials with a higher clay content will extend maintenance cycles, deliver improved levels of service and reduce maintenance costs. Like the sealed network, we also observed areas of high shoulder and ineffective roadside drainage on the unsealed network, which if addressed, would also extend maintenance and renewal intervention frequencies.

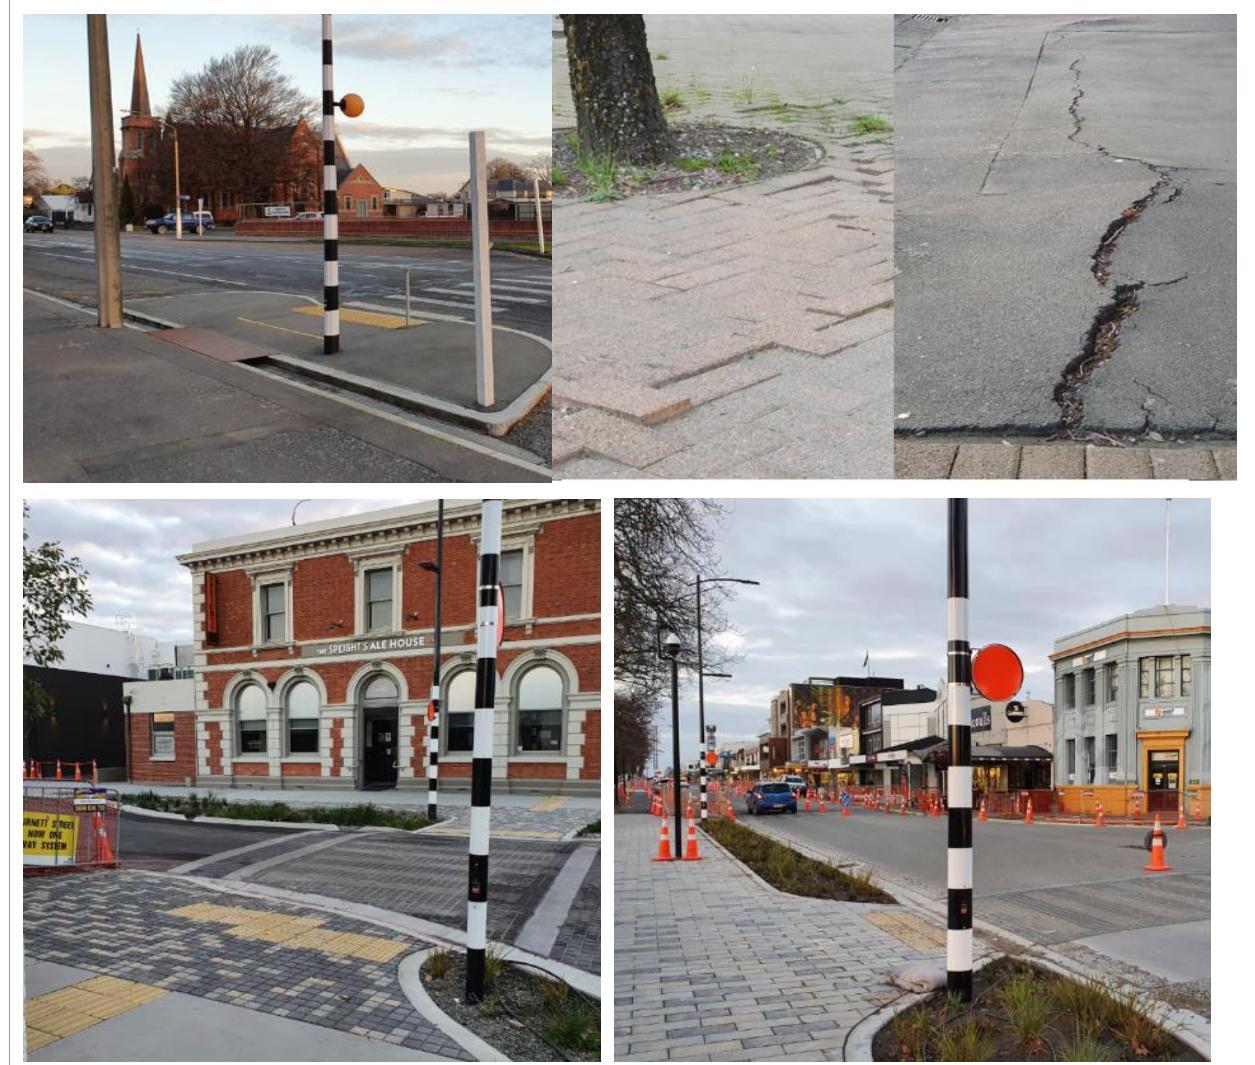
Maintenance and renewal of footpaths is now funded by Waka Kotahi and good asset management practices need to be followed. This includes collecting accurate inventory, condition, and maintenance activity data to support investment decisions. The sample of higher pedestrian use areas inspected, identified areas where the Waka Kotahi Pedestrian Planning and Design Guide design requirements for footpaths, pedestrian cutdowns and vehicle crossings were yet to be implemented.

Figure 9: Examples of urban safety issues and improvement observed. Top left – pedestrian crossing without tactile indicator pavers (Havelock Street); top right - examples of trip hazards (West Street / Burnett Street intersection); bottom left - tactile indicator pavers installed at pedestrian crossing (Burnett Street); bottom right - new pedestrian crossing installed without tactile indicator pavers (East Street).

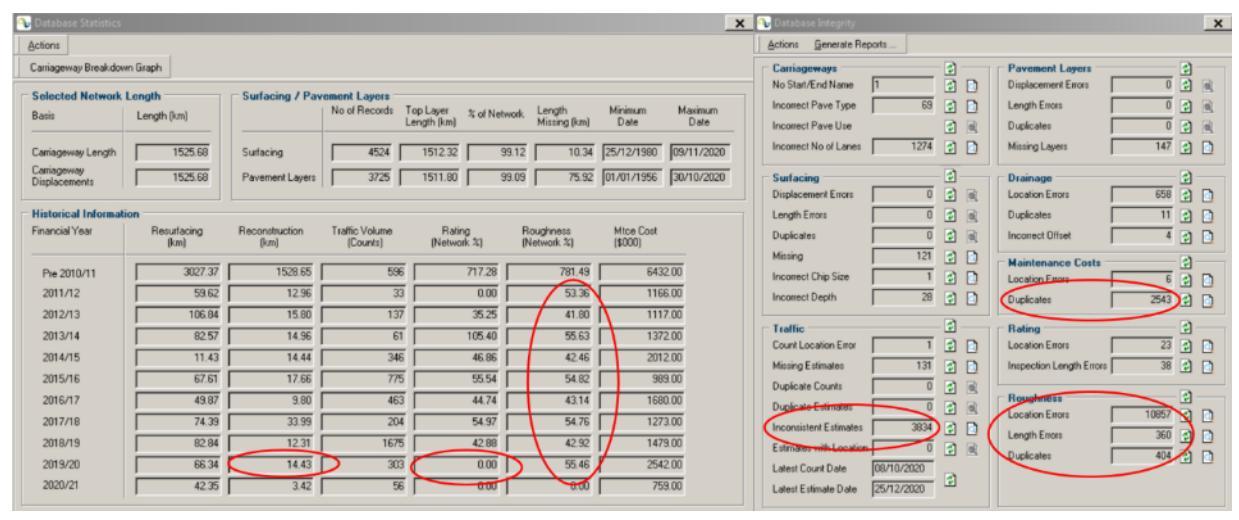
Queries run through RAMM (database statistics and integrity reports), identified some data gaps, as highlighted on the screenshot below. These queries indicate missing or incorrect pavement renewal, condition rating, traffic count estimate and maintenance cost data. It is important that Council proactively manages their RAMM database to ensure data accuracy, decision-making has a sound evidence base and allowing Council to more accurately compare its ONRC performance with its peers.

Figure 10: Database statistics and database integrity reports, source RAMM.57

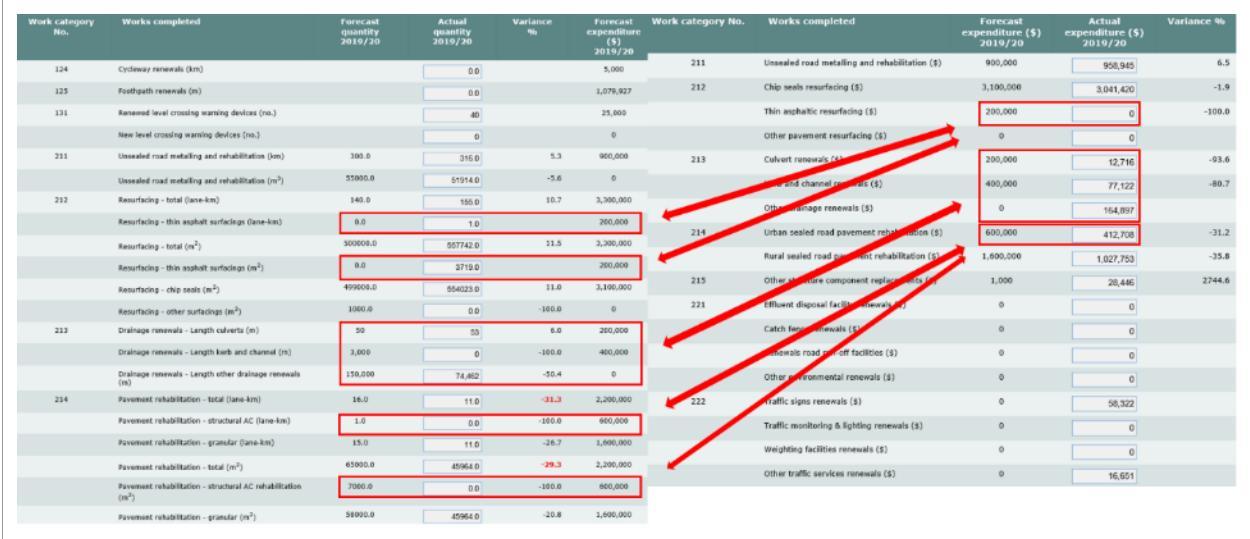
Figure 11: Local roading works completed and renewals expenditure, source TIO 2019/20 AAR

This aspect of data quality should be easily remedied by Council for future NLTPs and AARs. We recommend that 2021-24 NLTP renewal quantities and cost forecasts are reviewed (and amended if required) to ensure alignment with the approved work category allocations.

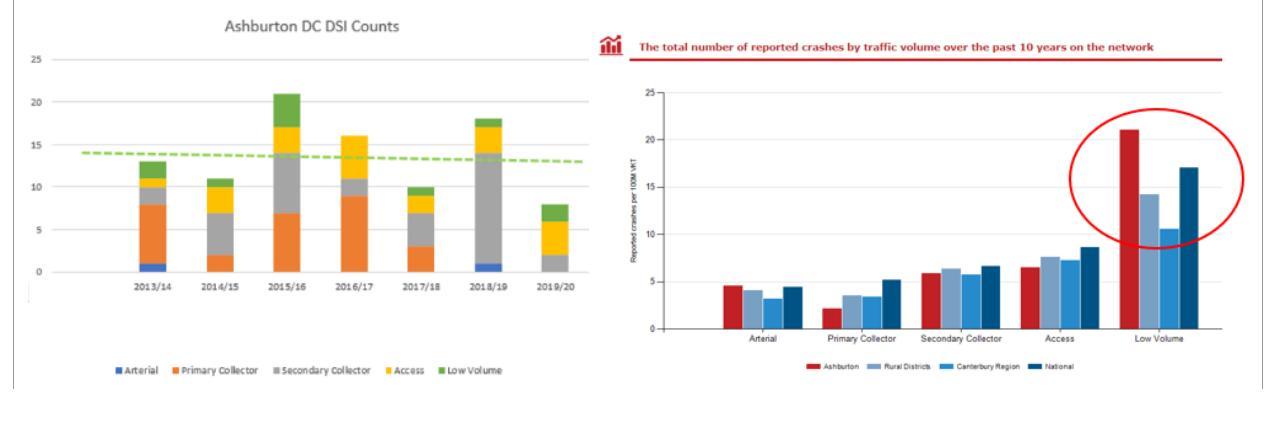
Providing a network that is safe for users is a high priority for Waka Kotahi. The number of annual deaths and serious injuries (DSIs) on Council roads trending down¹ across the network and we commend Council for achieving this result. Ashburton DC's rate of crashes for urban low volume road classifications is significantly higher when compared to Council's peer group, Councils in the Canterbury region and Nationally. We suggest this statistic warrants further investigation to determine whether these crashes are the result of a common cause.

Figure 12: Left - Ashburton DC DSI statistics 2014-2020, source Crash Analysis System; right –10-year personal crash risk (by traffic volume on urban roads) ONRC comparison, source PMRT.

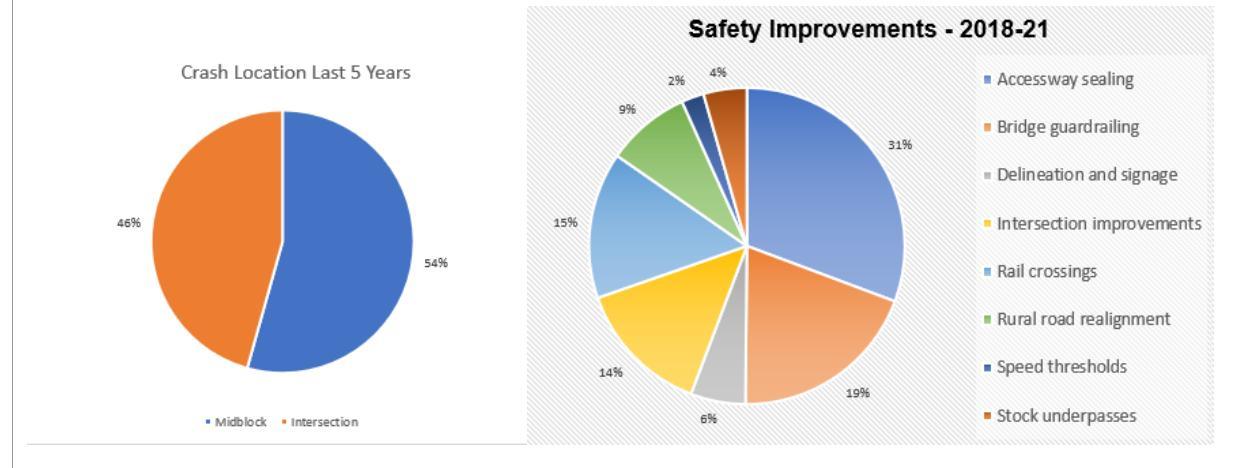
The percentage of DSIs for the period 2014-2020 by road classification aligns closely with the percentage VKT for each classification, suggesting a similar personal risk for each classification. DSI trend analysis also shows that DSIs are generally moving from higher to lower classification roads over this period, suggesting Council has focussed investing in the higher risk areas. Note that intersection crashes account for 46% of Ashburton DC's crashes, however investment in intersection safety improvements makes up only 14% of the 2018-21 NLTP safety improvement investment programme as shown below.

Figure 13: Left – crash location for the last 5 years, source CAS; right - 2018-21 NLTP safety improvement investment by intervention, source TIO.

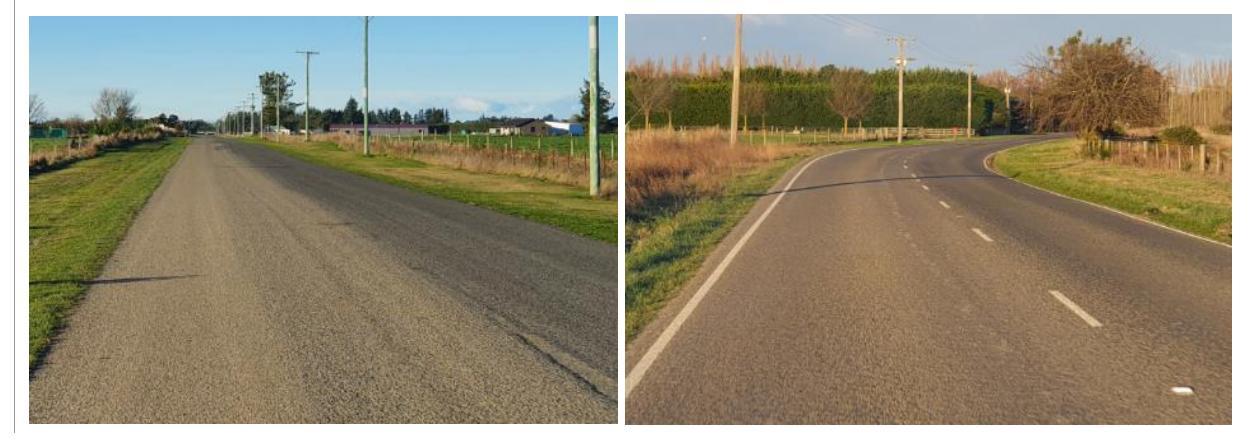
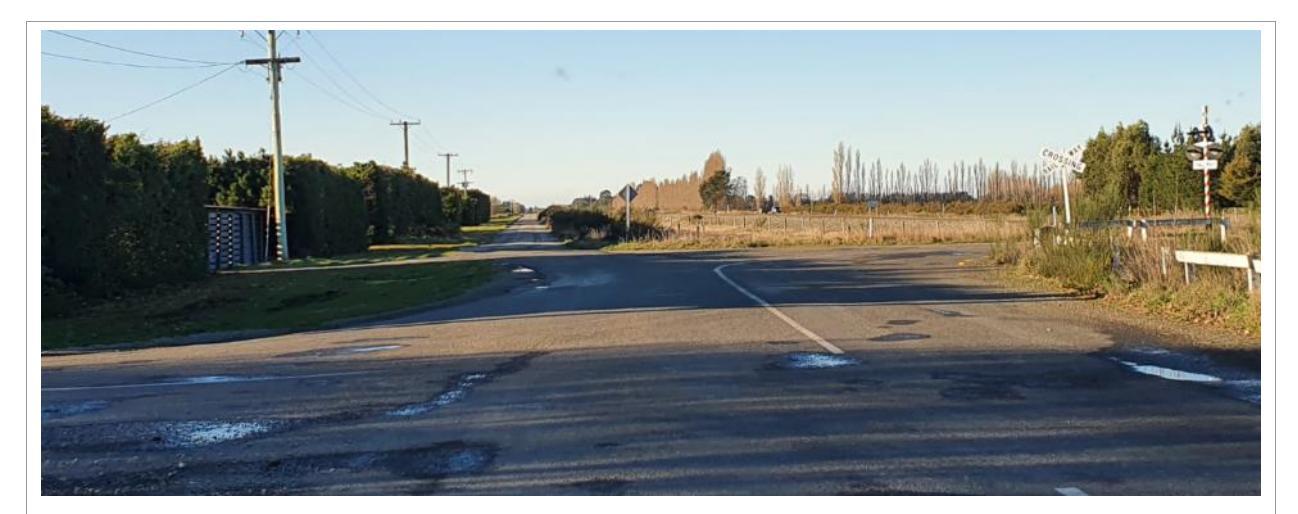
The purpose of the One Network Road Classification system is to ensure roads of the same classification have the same levels of service, including motorist guide features (i.e. delineation and signage). On our field inspection the audit team noted areas of sub-standard and inconsistent delineation on extensive lengths of the rural road network.

Figure 14: Top – examples of inconsistent delineation. Left – secondary collector road with no delineation (Winslow Road); right – secondary collector road with raised pavement markers, centreline and edge lines (Ashburton Staveley Road). Bottom – example of limited intersection control signage or curve advisory delineation (Winslow/Winslow Chesterfield/Hendersons/Winslow Willowby Road).

It is important that road safety remains a high priority for Council and their suppliers. Ensuring that consistent application and maintenance of delineation (edge marker posts, road marking, reflective raised pavement markers) and signage, based on road classifications (as detailed in the Traffic Control Devices standard – RTS 5), is the next step to further reduce the risk of death and serious injury crashes.

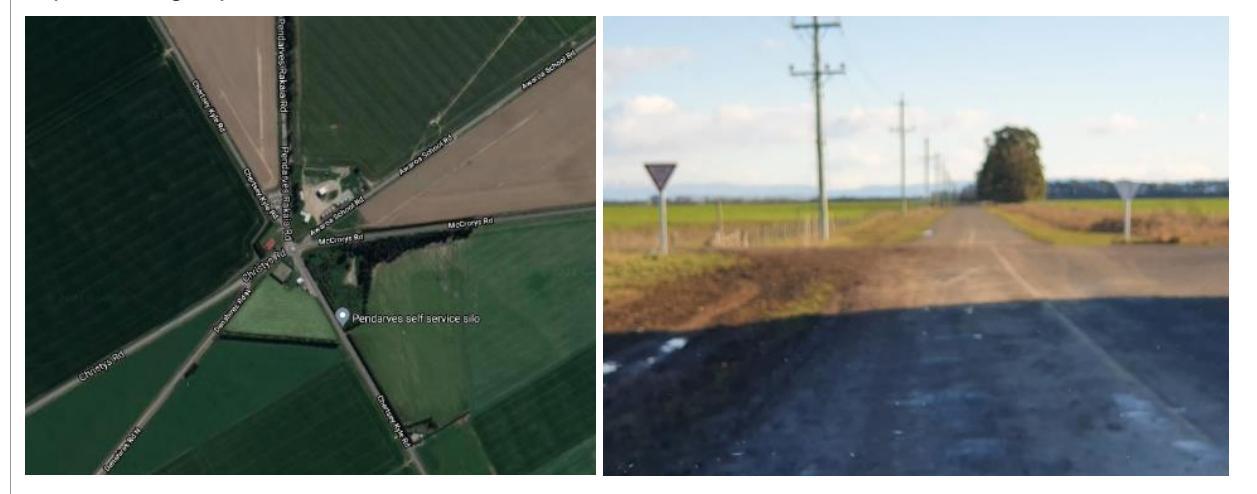
The audit team observed many 'multi-legged' rural intersections, having non-standard layouts and signage, some intersection control markings obscured by debris tracked from adjoining farming operations and some non-complying use of headway chevrons on curves near intersections (refer figure 5). These deficiencies all contribute to the relatively high communities at risk rating for rural intersection safety.

We encourage Council to reinforce the need for a timely response to safety issues by their maintenance contractor and review best practice guidelines such as Austroads Guide to Road Design Part 4: Intersections and Crossings and Austroads Guide to Road Design Part 3: Geometric Design, when implementing improvements at these locations.

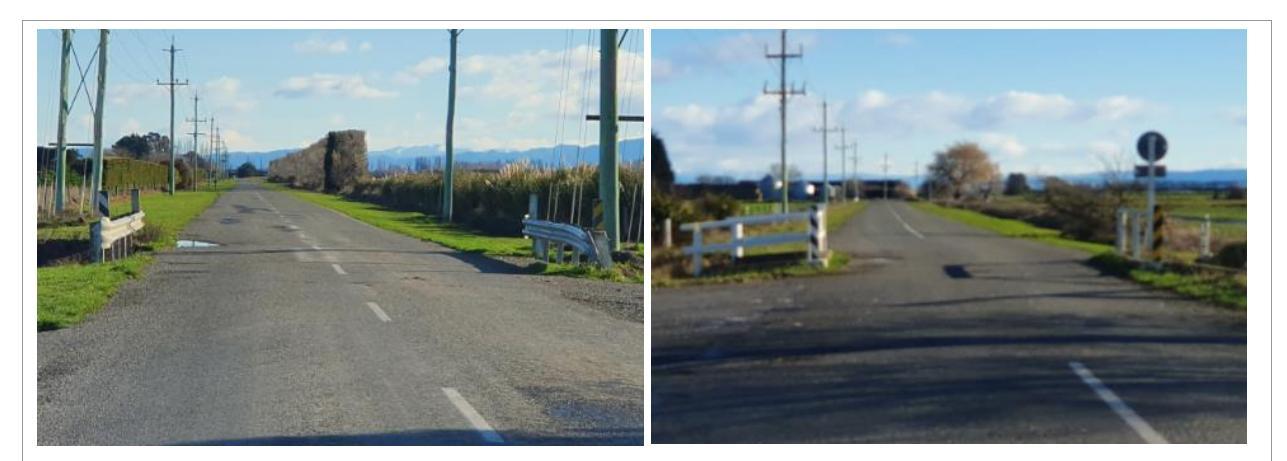
The audit team also observed several bridges with missing or non-compliant bridge barrier systems during our network drive-over, requiring replacement as part of a prioritised work programme. We understand a programme of bridge barrier improvements is being undertaken using a risk-based approach and that these improvements will need to continue for an extended period due to the size of the programme compared with current investment levels. Examples of non-complying barriers observed include fishtail treatments with no vehicle approach flare and Texas twist terminal treatments.

Figure 16: Non-complying bridge guardrail examples (Poplar Road). Top left — 'fish-tail' type guardrail end treatment without taper; top right – wooden bridge railing.

It is important that road safety continues to be a high priority for Council and their maintenance suppliers. Ensuring delivery of a refined risk-based safety improvement work programme, as referenced in the *Activity Management Planning* subject area of this report, is the next step to further reduce the risk of death and serious injury crashes. From our audit observations, and as noted above, the areas of safety focus for Council include delineation, intersections and bridge barrier systems.

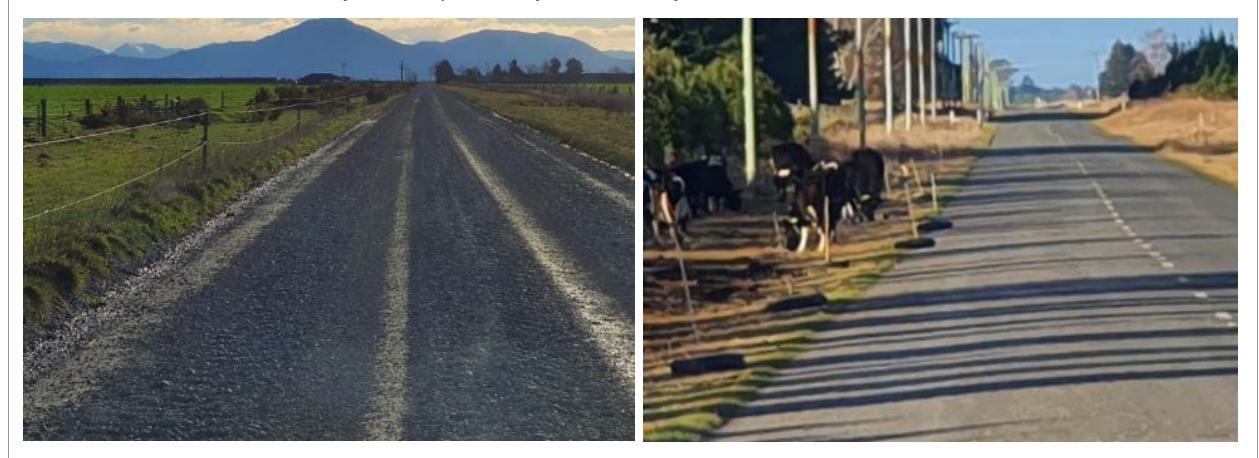
Council have a good understanding of its legislated responsibility as the road 'owner' to effectively manage public safety and has improved various areas of bylaw compliance through licencing activities in recent years. We suggest an opportunity remains for Council to increase focus on enforcing their bylaw prohibiting the use of steel posts (including waratah standards) as temporary fencing on road berms, to remove the road user safety risk imposed by this activity.

Figure 17: Examples of road safety deficiencies/hazards. Top – examples of temporary road berm fencing hazards; left – use of waratah standard fences adjacent road carriageway (Pyes Rd); right – use of car wheels with concrete bases for temporary fencing, encroaching on the road carriageway (Cracroft Maronan Rd).

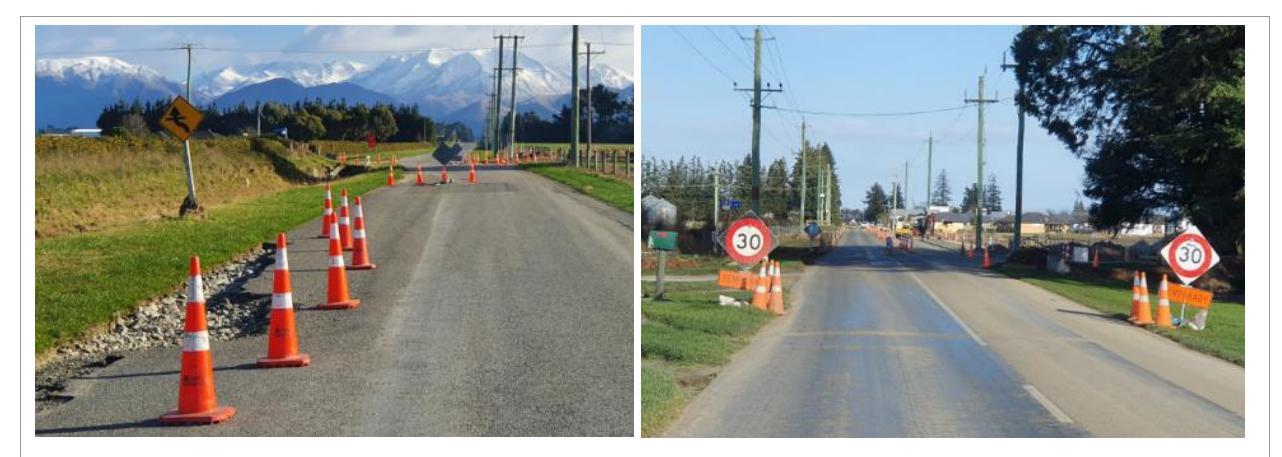
During our field inspection we travelled through several road maintenance, renewal, improvement and emergency worksites. The application of temporary traffic management at these sites was observed to be of a high standard of compliance with the Code of Practice for Temporary Traffic Management (CoPTTM). These observations coupled with the TTM audit examples provide confidence in the strength of health and safety culture and delivery within Council's transport activity.

Figure 18: photos showing effective temporary traffic management. Left – shoulder scour/emergency reinstatement site (Methven Chertsey Road); right – residential development site (Barkers Road, Methven).

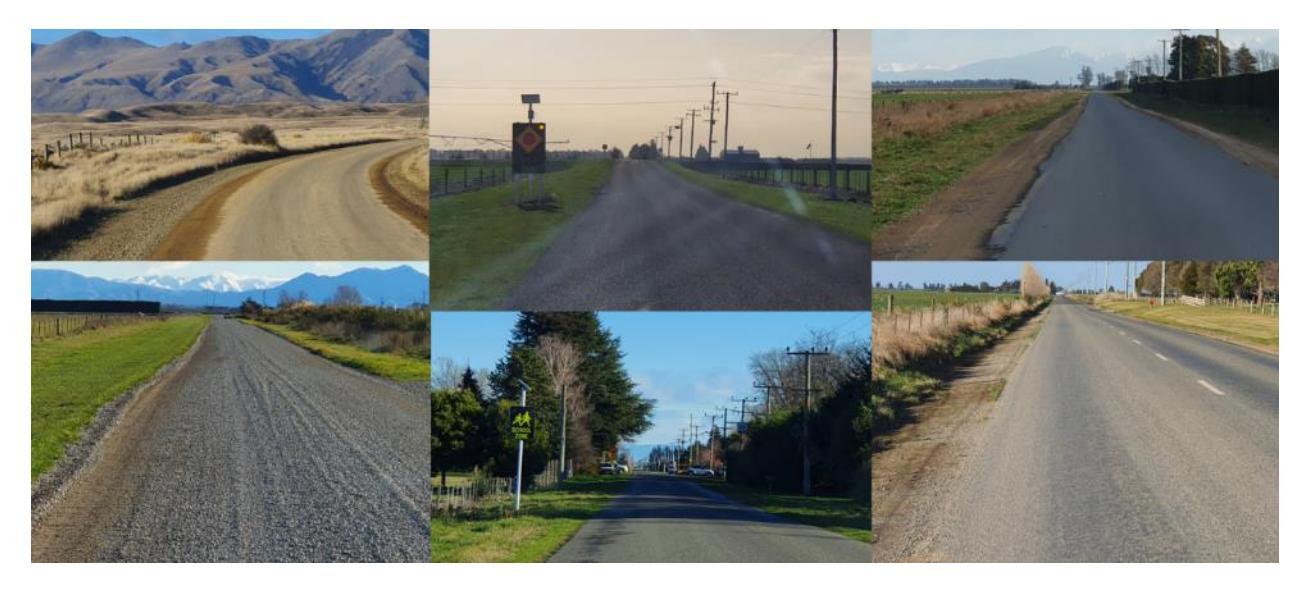
Observations of good rural examples. Top left – effective use of Basalt wearing course (Hakatere Potts Rd); bottom left – stabilised wearing course (Maginness Rd); top centre – vehicle activated intersection warning signage (Somerton Road / Thompsons Track intersection); bottom centre – rural school zone sign (Boundary Road); top right – use of basalt wearing course on high-wear unsealed shoulders (Seafield Rd); bottom right – example of high-edge removal with 'potato harvester' (Line Rd).

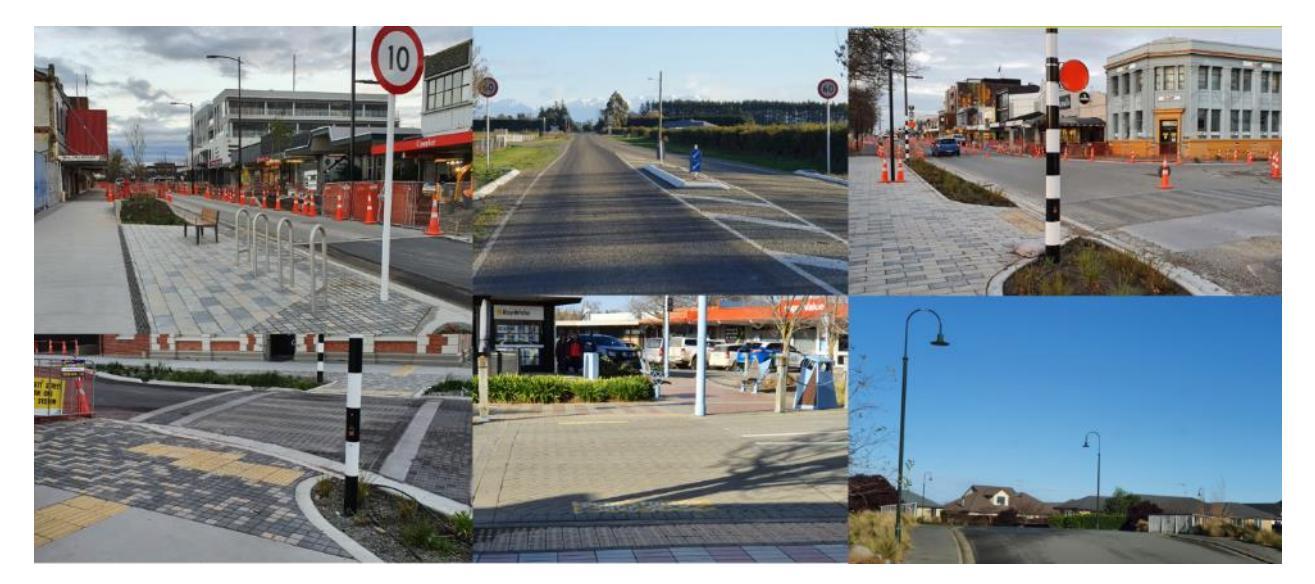
Left – town centre improvements examples of good (Burnett Street), top - pedestrian seating and cycle stand (note speed disk indicating inconsistent (10km/h) urban speed limit), bottom – tactile indicator pavers installed at pedestrian crossing; top centre - speed threshold treatment (Fairfield Rd West); bottom centre – pedestrian platform with priority guidance markings (McMillan St, Methven). Right – examples of improvement opportunities, top – new pedestrian crossing installed without tactile indicator pavers (East Street); bottom – over specified street lighting with high maintenance/replacement cost (Lake Hood residential development).
