INVESTMENT AUDIT REPORT

Technical Audit of Ashburton District Council

Report of the investment audit carried out under Section 95(1)(e)(ii) of the Land Transport Management Act 2003.

1 JULY 2021

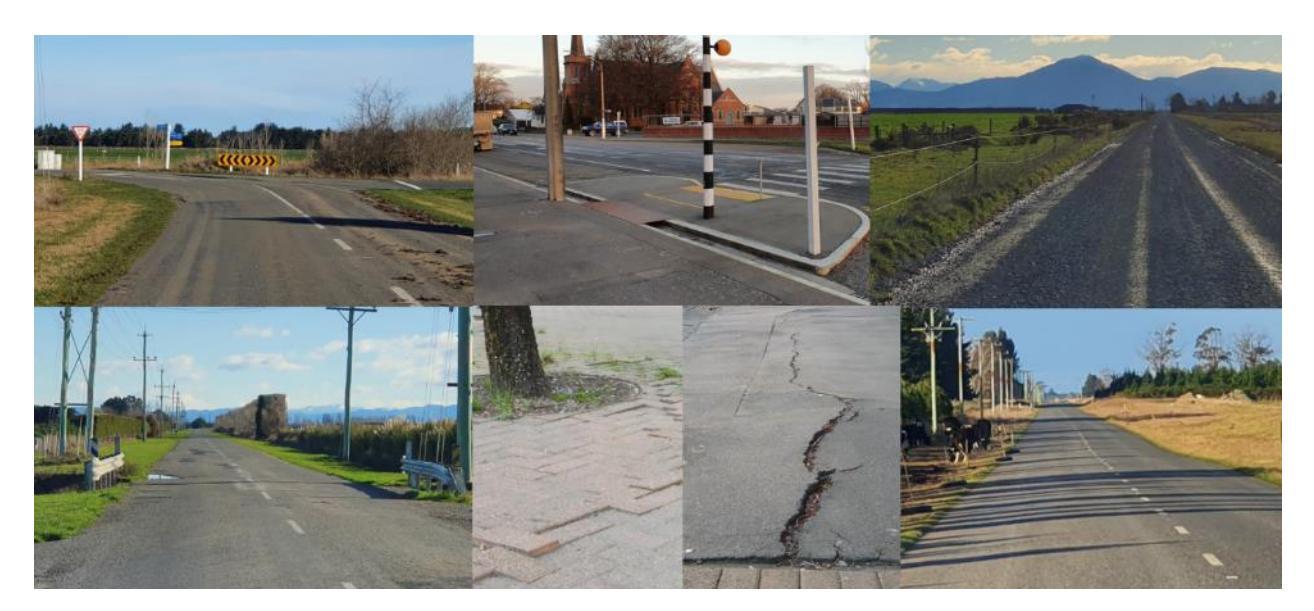
Examples of road safety issues. Top left – non-complying use of headway chevron signage (Coldstream / Lloyds Road intersection); bottom left – example of non-complying 'fish-tail' type guardrail end treatments (Poplar Road); top centre – pedestrian crossing without tactile indicator pavers (Havelock Street); bottom centre – examples of trip hazards (West Street / Burnett Street intersection). Right – examples of temporary stock fences; top - waratah standard fences adjacent road carriageway (Pyes Rd); bottom – temporary fence with concrete tyre bases encroaching onto the road carriageway (Cracroft Maronan Rd).

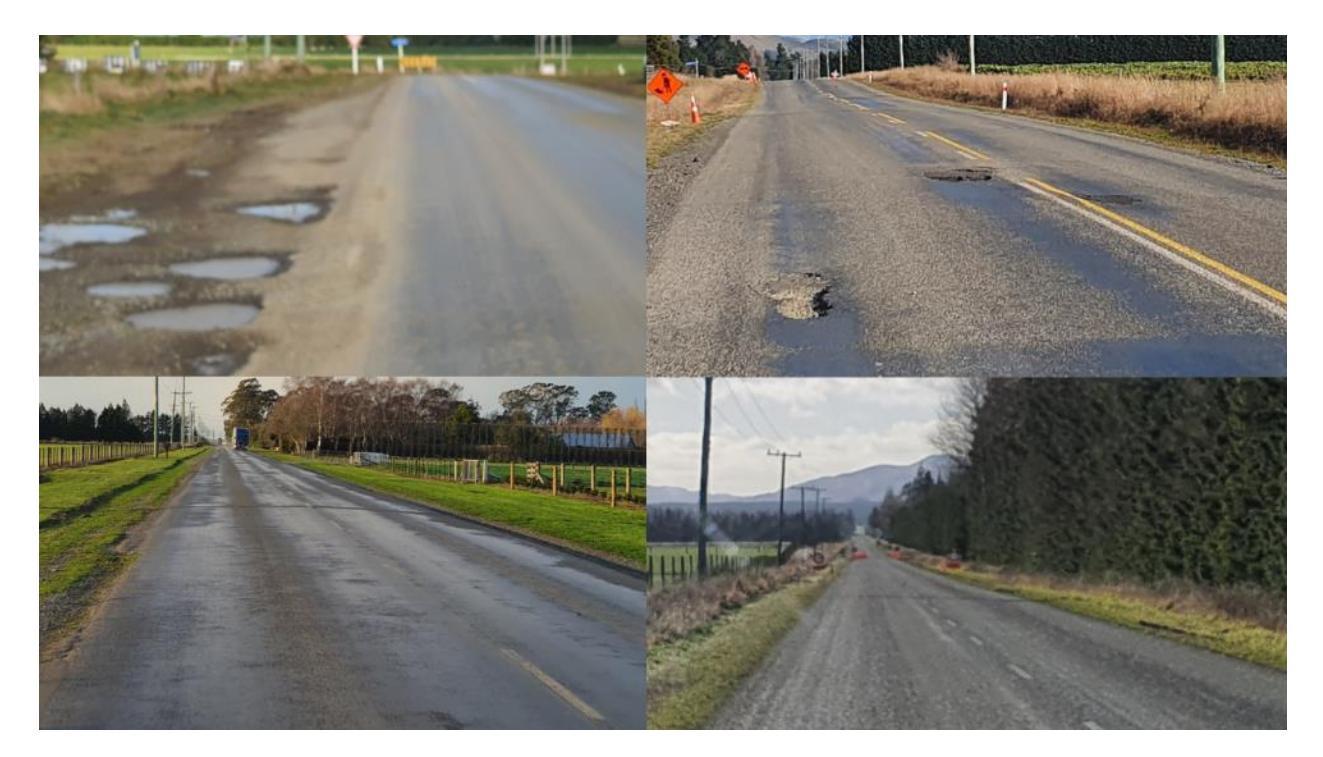
Examples of rural road maintenance issues. Top left – insufficient road shoulder crossfall resulting in standing water in pull-over bay (Rosehill Rd access to Mt Hutt); bottom left – road surface flushing where subject matter expert could assist with surface treatment (Beach Rd East); top right – need for improved pothole repair response (Arundel Rakaia Gorge Rd); bottom right – example of high edge and shelter belt encroachment (Arundel Rakaia Gorge Rd).
