Heritage Item 3

Ashburton Glassworks

Site Assessment	
Assessed by:	Arlene Baird, Davie Lovell-Smith Ltd.
Date Assessed:	27 November 2014

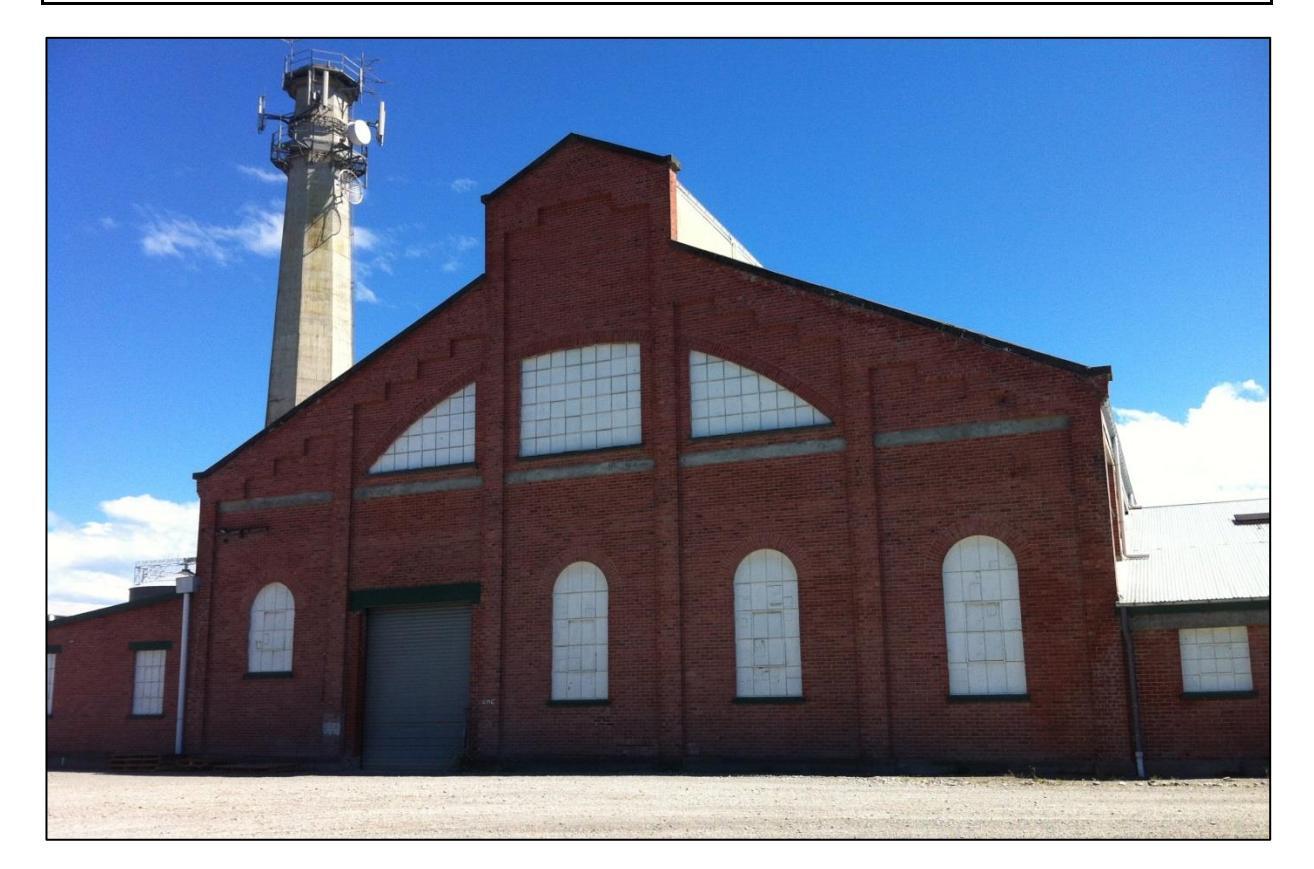
Detail		
Description:	The extent of the Heritage New Zealand listing includes: The entire brick glassworks complex, concrete brick lined chimney and adjoining corrugated iron building; the part of the land on Lot 1 DP 9084, Certificate of Title 413/165 on which these structures stand, with a curtilage extending to the Glassworks and Bremners Road frontages.	
	The former Ashburton Glassworks, also known as the International Malting Co. Ltd. and the Southern former Cross Glass Company Building, is one of Ashburton's most imposing and distinctive industrial buildings.	
	The large double brick factory building has a high, steeply pitched roof crowned by a tall glazed clerestory (high windows between two roofs) – in earlier pictures you could see that the glass in these windows was broken and these have now been covered over with clear plastic. It has an attractive symmetrical façade with detailed brickwork and lower wings on each side. A 38.4 metre high concrete brick lined chimney is the dominant feature of the factory complex. There are many windows around the building, most are small-paned windows with round arch brickwork above, apart from the long elevations of the lower wing to the north-east of the group, which has rectangular windows. There is an adjoining corrugated iron building, which hides much of the rear of the brick building.

Detail
Notable Features:	Brick façade of the main building; clerestory windows; chimney; original crane mechanism in the roof of the building; subterranean channels.
Condition:	Most elements of the building are still in good condition. The brickwork appears to be almost totally intact. The clerestory windows have been covered over and/or replaced with clear plastic. Many of the arched and rectangular windows to the front of the building have been filled in, whereas ones to the rear remain clear. Roof all appears to be in good condition.
Setting:	The building is set in a large yard, with other industrial buildings to two sides and the road to the other two sides. The setting is of high importance as being the location of one of the only purpose built glassworks complexes in New Zealand.
