Ashburton Museum and Art Gallery
Existing trees - to be retained and transplanted
ISSUED FOR COMMENT
27/04/09

Gallery & Museum Site Survey

LOTS 1, 2, 3, & 4 DP 46522

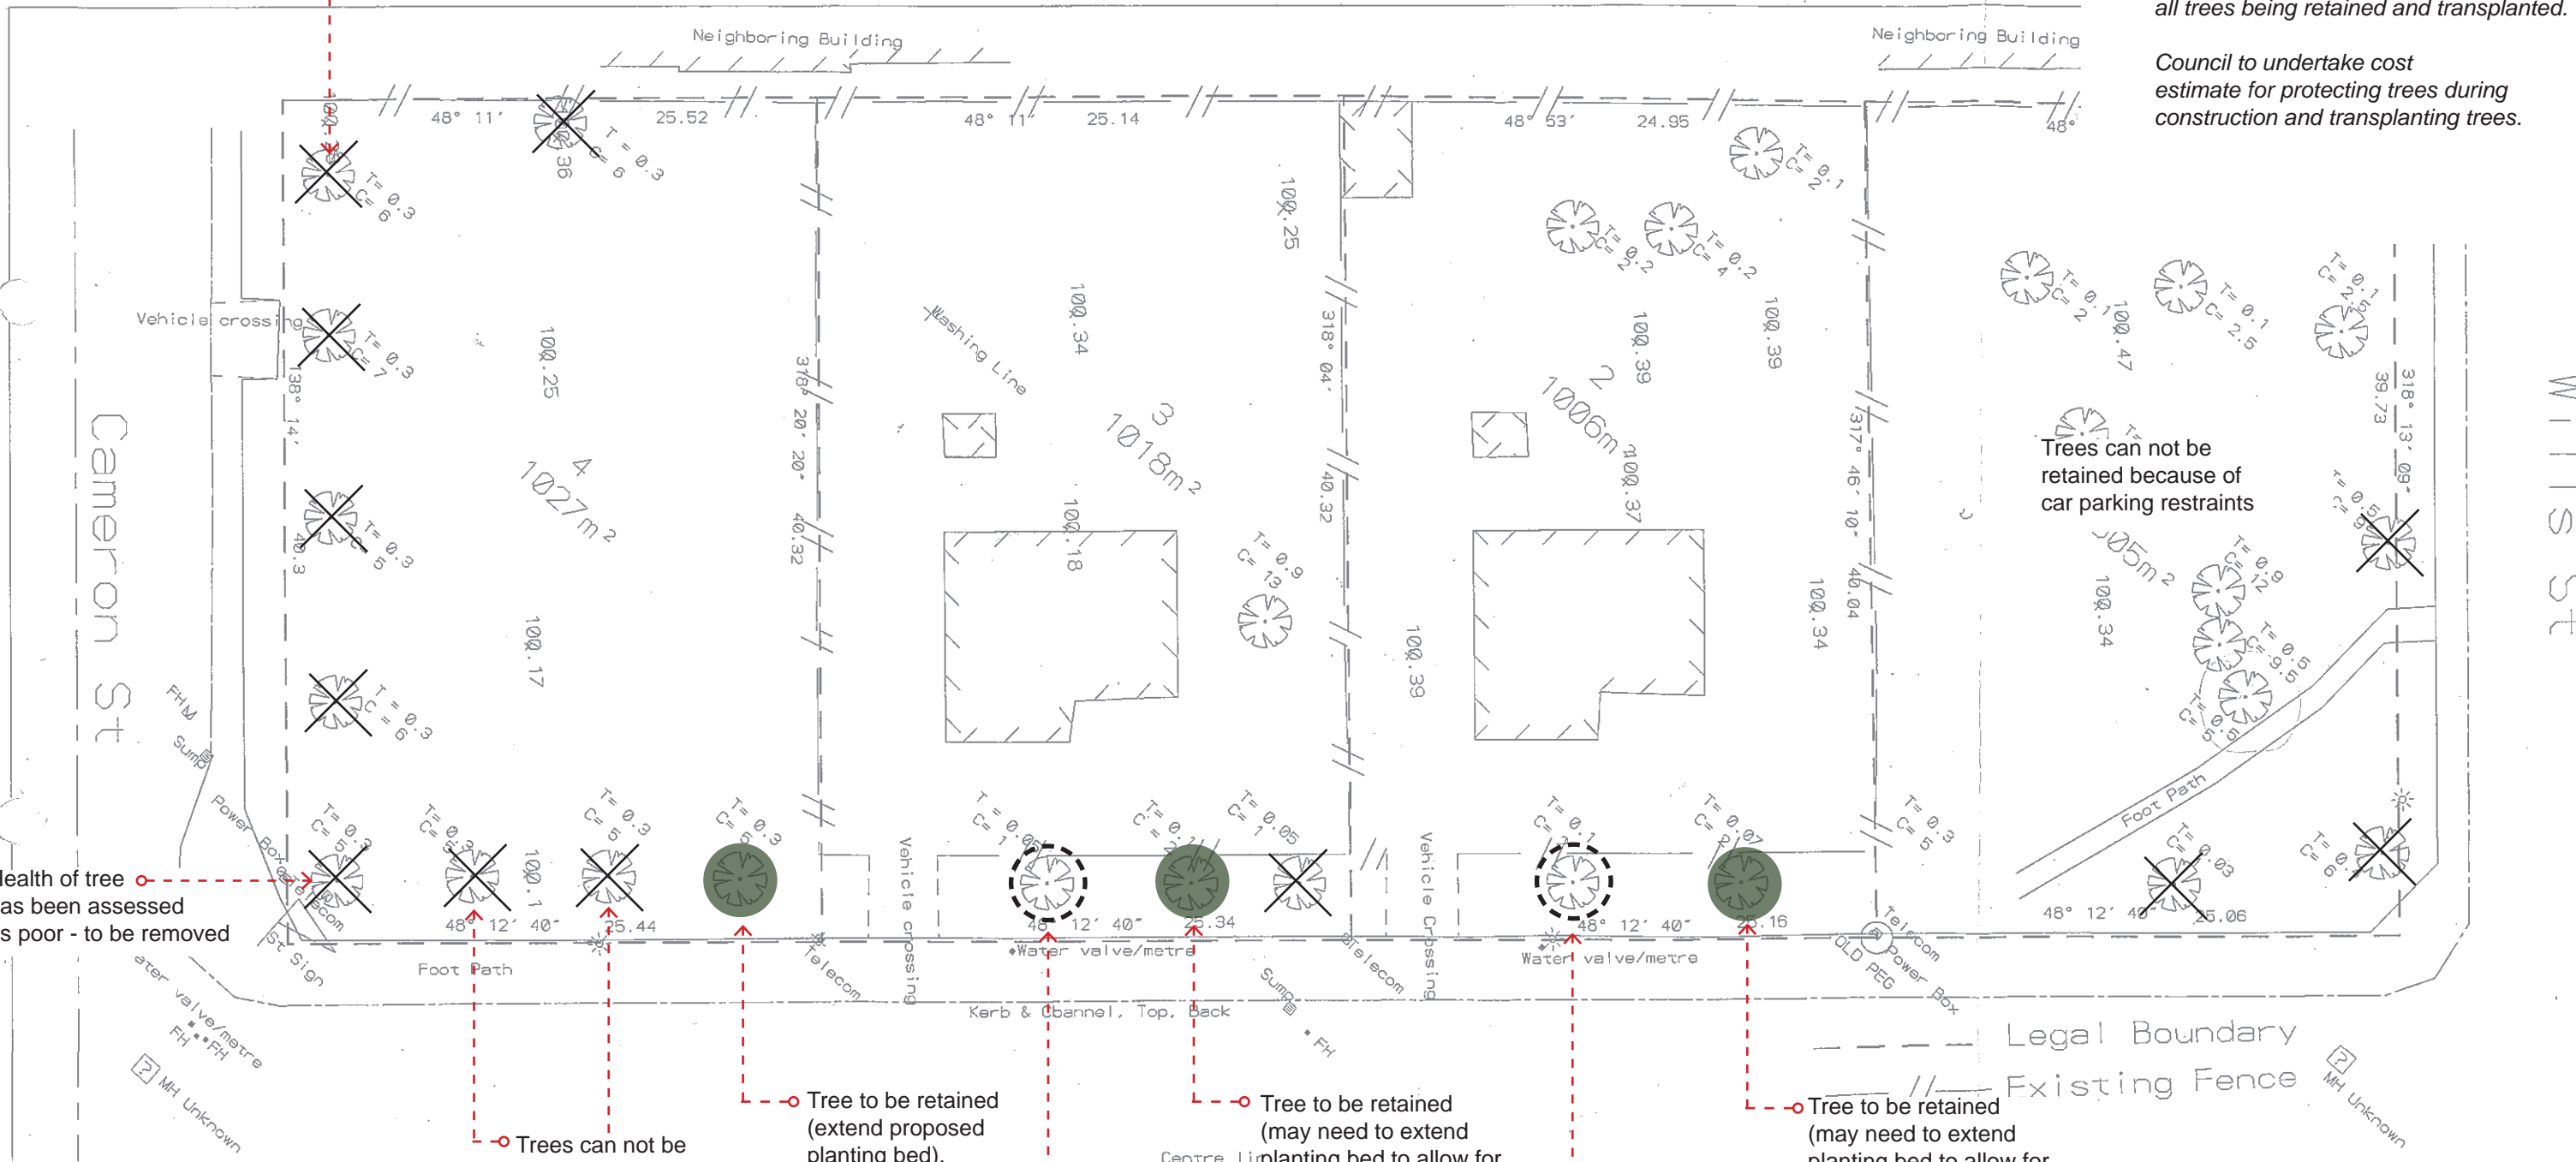
All other trees on site to be removed.

Arborist assessment to be undertaken on all trees being retained and transplanted.

Trees can not be retained because of car parking restraints
To large to be transplanted.

Trees can not be retained because of car parking restraints

Health of tree has been assessed as poor - to be removed

Tree to be retained (extend proposed planting bed).

Tree to be retained (may need to extend planting bed to allow for paving levels).

Tree to be transplanted to the corner of Cameron Street and West Street

Tree to be transplanted to the corner of Wills Street and West Street
