## Longbeach Estate Item I

### Butchery

#### Site Assessment

<b>Assessed by:</b>	Arlene Baird, Davie Lovell-Smith Ltd.
<b>Date Assessed:</b>	9 December 2014

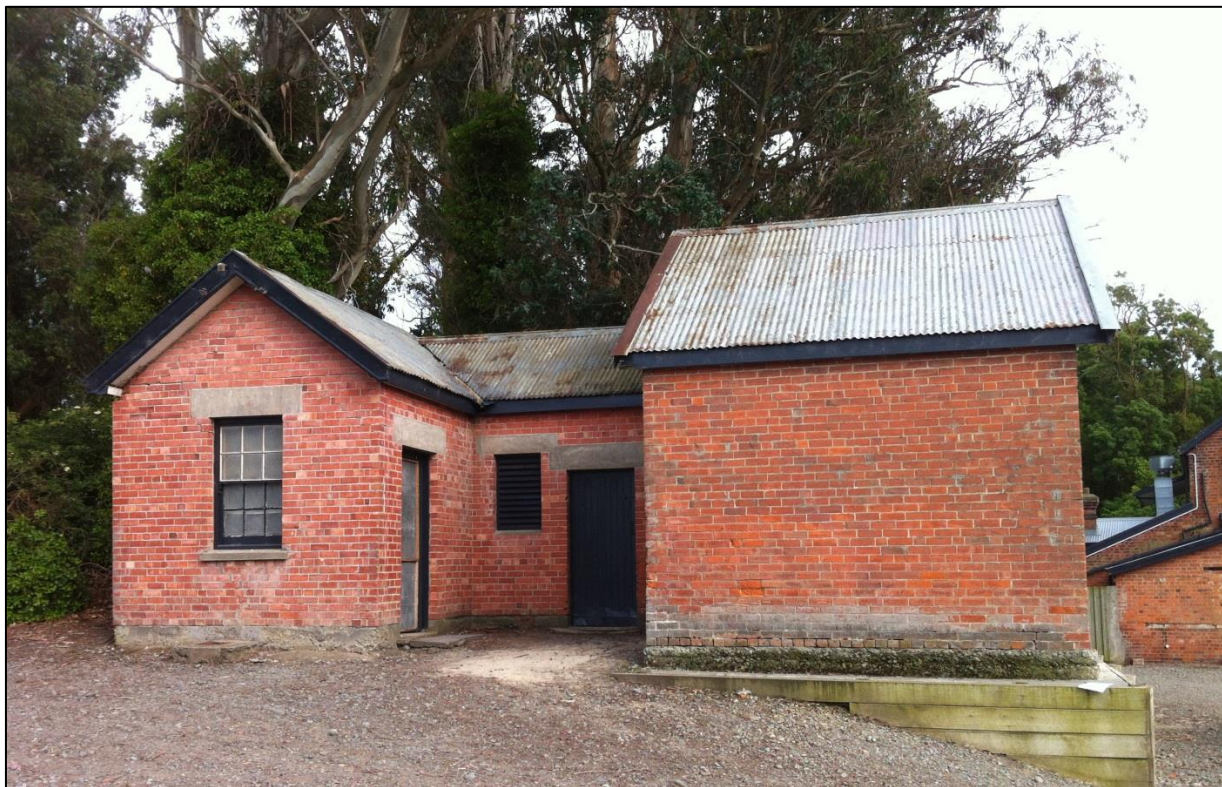
Detail	
<b>Description:</b>	<p>The old Longbeach Estate butchery/meat shop is a small building constructed of brick walls and a corrugated iron roof. The bricks for this and other Estate buildings were made on the Estate when John Grigg established a brickworks to provide field bricks for the drainage system he was creating.</p> <p>The building is formed of three sections, the largest being to the east nearest the cookshop and is orientated with gables to the west and east. It appears this may have started as a smaller building and been added to. This section has older bricks and a deep segmental brick arch lintel over the door. All other doors and windows have straight concrete lintels. This wing has one vent style window on the eastern elevation and three on the northern elevation.</p> <p>To the west is a lower brick wing which is oriented with gables to the north and south – this is joined to the other wing by a central brick connection, resulting in three entrance doors all opening to a porch area to the southern side of the building. This section has four vent windows to the west, one to the north and a glazed small pane sash-opening window to the south (front).</p> <p>This building is no longer used and has evident structural deterioration.</p>

Detail	
<b>Notable features:</b>	Brick construction; deep segmental arched lintel over one door.
<b>Condition:</b>	The former butchery is in a moderate condition with structural issues evident. The roof appears in good condition, a little rusted but watertight. The brickwork is good in some areas and showing cracking, movement and weathering in other areas. The section of brickwork beside the door with the segmental arch lintel is weathered and has lost much of its mortar. As has a section on the bottom of the eastern gable of this wing. The western elevation of the building has large cracks running at an angle to and from one of the windows and there is some movement in the window sill. There are also large cracks evident in the southern gable. The paintwork has been kept tidy and well maintained.
<b>Setting</b>	The building is located in the heart of the Estate buildings, between the cookshop to the north east (heritage item J) and the draught stables to the south west (item H). It sits right on the roadside. The setting is of high importance due to the building's relationship with the homestead and other Estate buildings.
